Structural Addendum Report
Flat 4, 24 Narrow street, E14 8DQ
Cantilever balconies at Fourth and Fifth Floor Level

Job No.: 00873

X1	Issued for Information Purposed Only	GM	SH	27/10/2020
Rev	Status	Amended	Checked	Date

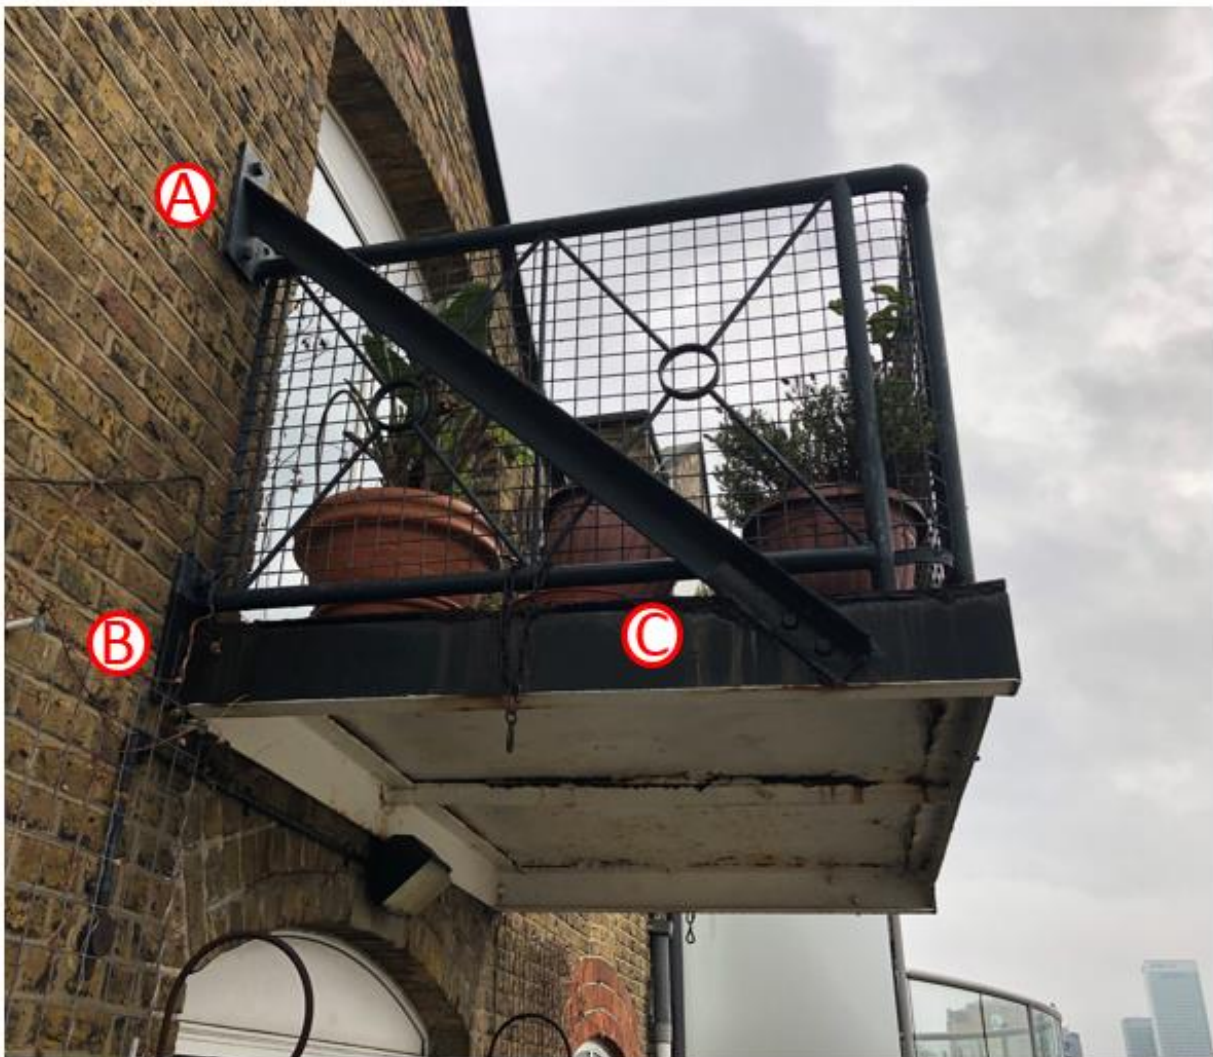
Figure 1 - Fifth floor balcony

2.1.2 The structural system is a cantilever beam with diagonal bracing tying back to the brickwork above as seen in Figure 1, point A

2.1.3 A unusual combination of welded/bolted connections are used shown in Figure 1 and Figure 2 , points A,B and C

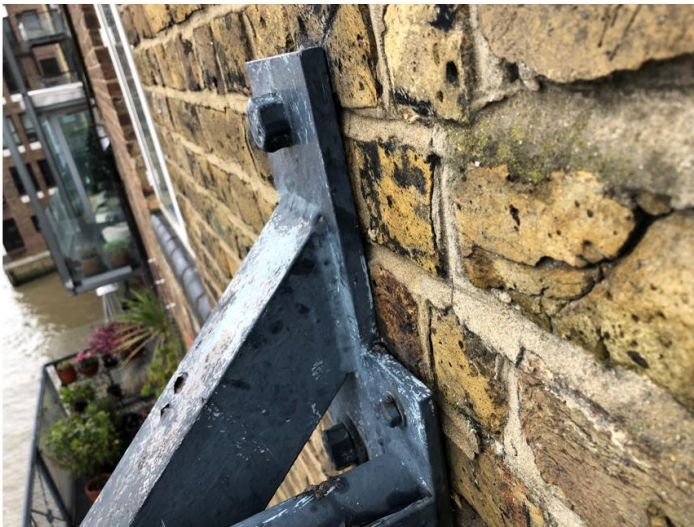
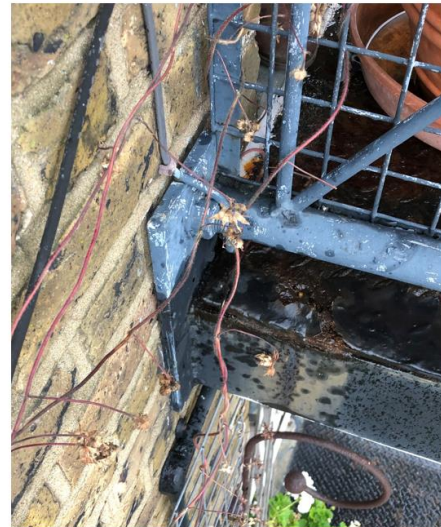
Figure 3 - Diagonal bracing to brickwork fixing (left) and Cantilever brickwork connection

2.1.4 The diagonal support members (props) are bolted to the brickwork and the cantilever structural frame. The propping members are also welded to the connection plate of the balustrade. The bottom of the balustrade is also welded to the cantilever joist, at the plate/brickwork connection. This is also shown in Figure 3.

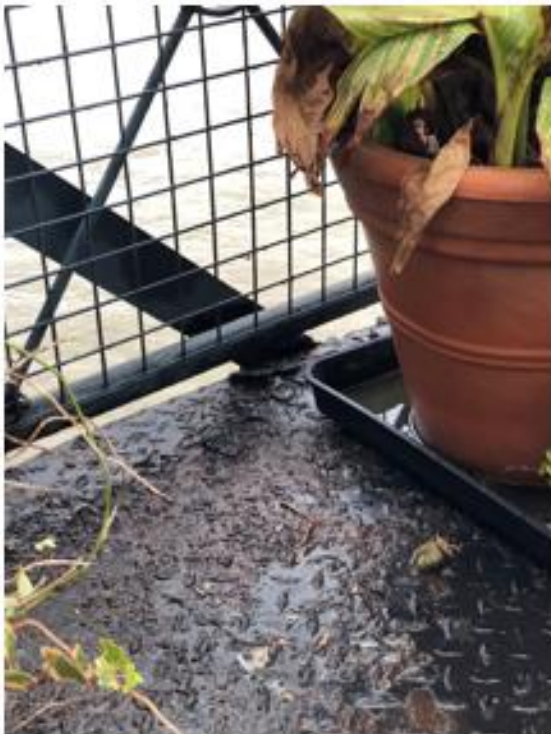
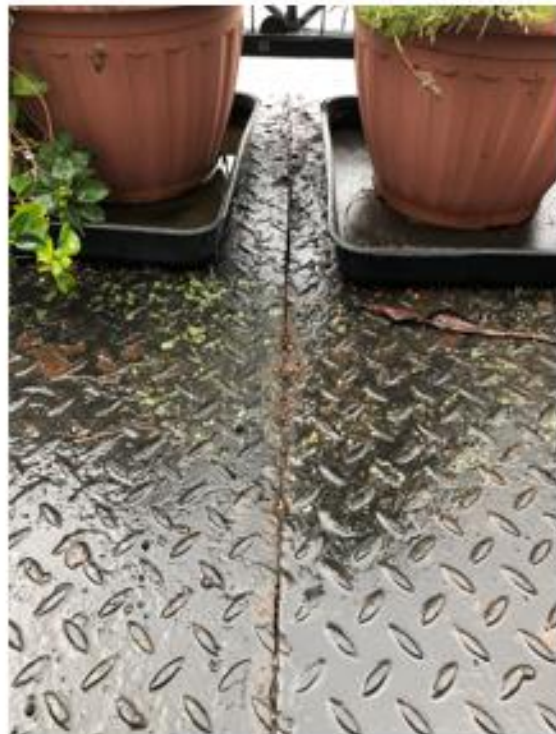
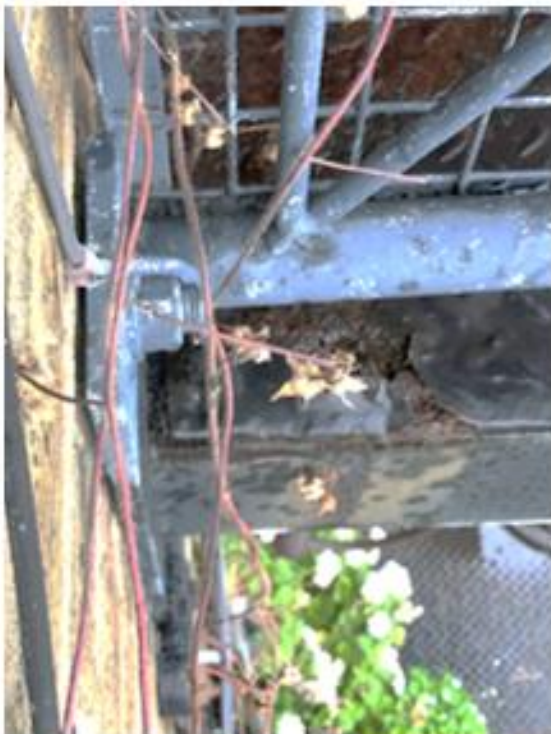
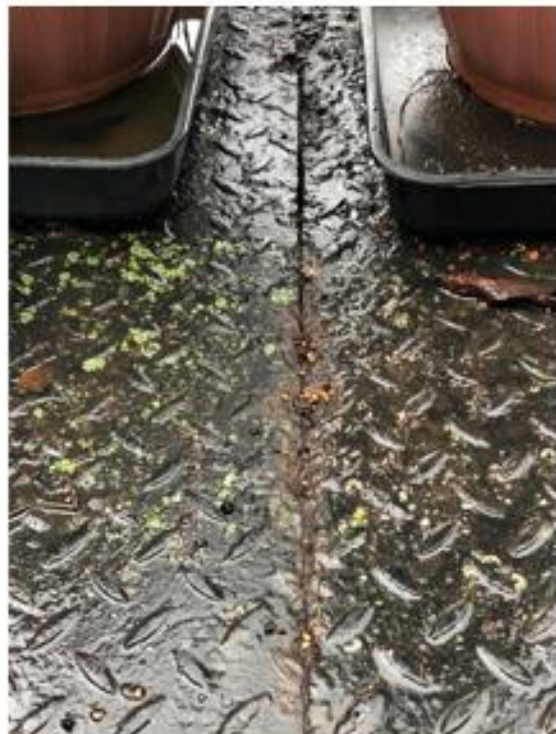
2.1.5 Two steel treadplates form the deck, which are stitch welded to structural frame. Figure 4 shows plate corrosion at various locations on the 5th floor balcony.

Figure 4 - Corrosion on fifth floor deck, (Top Left) across surface, (Top Right & Lower Right) Butted region of plates in centre of balcony, (Lower Left) design encouraging water to drip and collected at edge of plate.

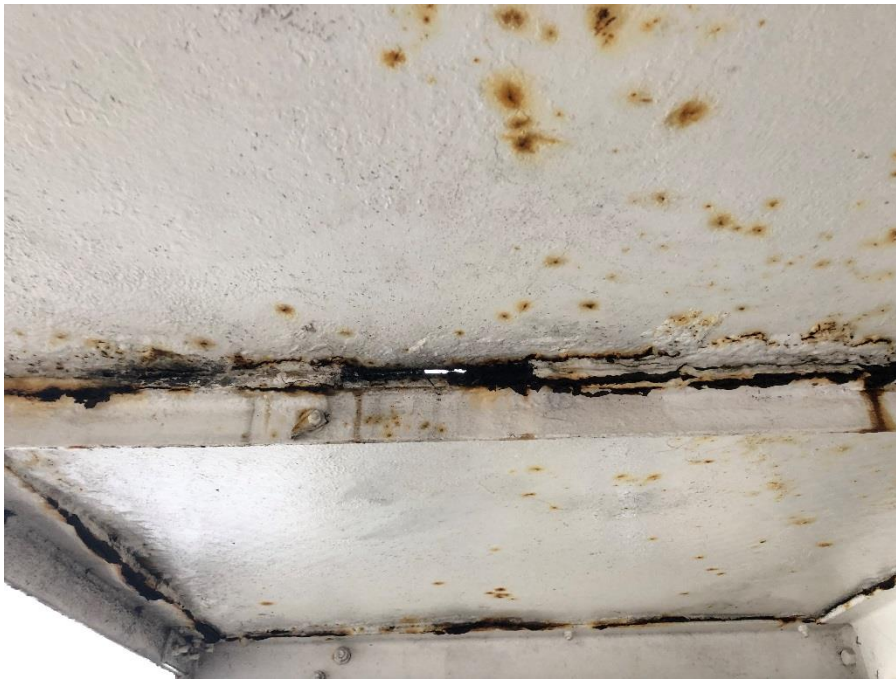
Figure 5 - Underside of fifth floor deck

2.1.6 The underside of the 5th floor deck and frame displaying extensive signs of corrosion. (Figure 5)

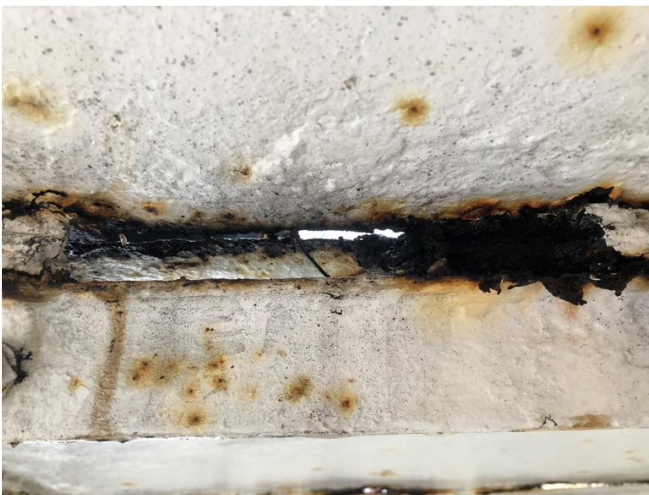
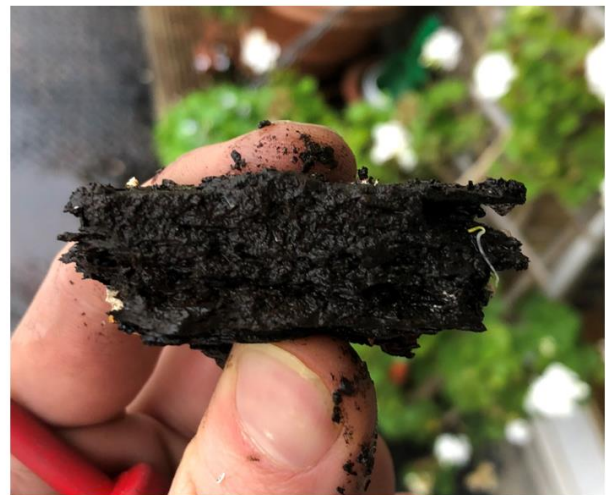
2.1.7 The central member, steel angle section, positioned beneath the butted connection of the plates above, appears to cause entrapment of water, which enters from the crevice above, created by butting the plates and not providing adequate sealing or incline of the deck for drainage

Figure 6 - Central support (Left) and the material flaking away (right)

2.1.8 The steel angle section supporting the central deck plate butt is not fastened to the plates, with the 'spacer' material (this is likely steel which has completely oxidised) between support member and plate, simply flaking away when touched.

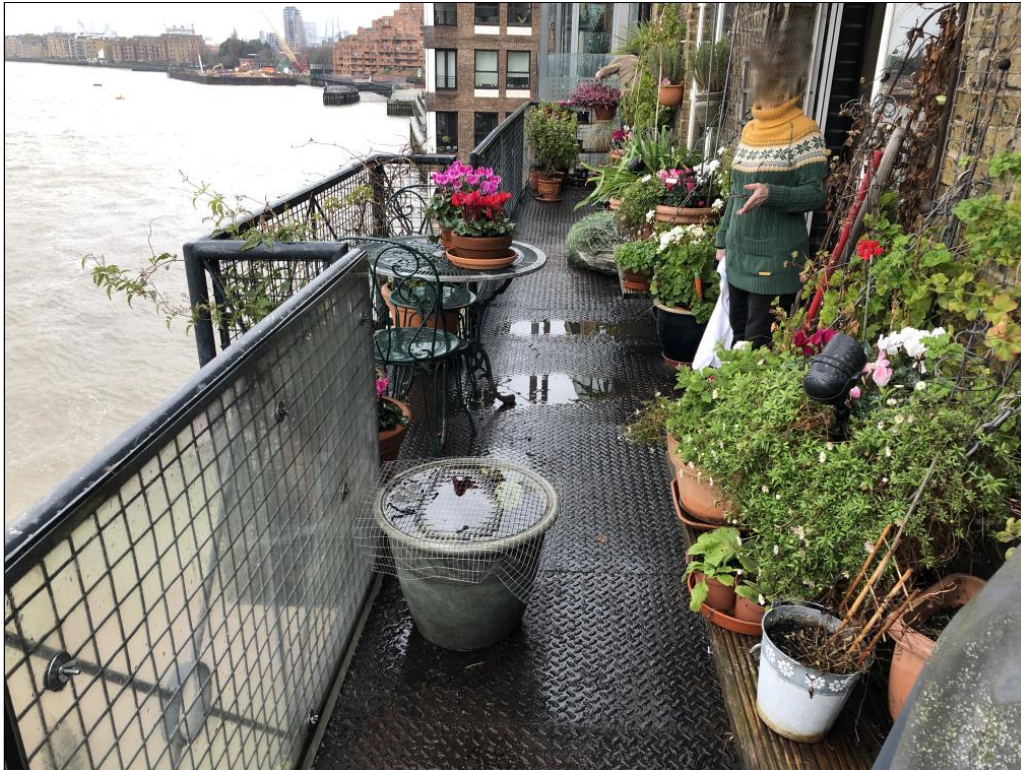
Figure 7 - Fourth floor balcony

2.2.1 The balcony runs along the whole width of the property, accessed via double doors. Figure 7

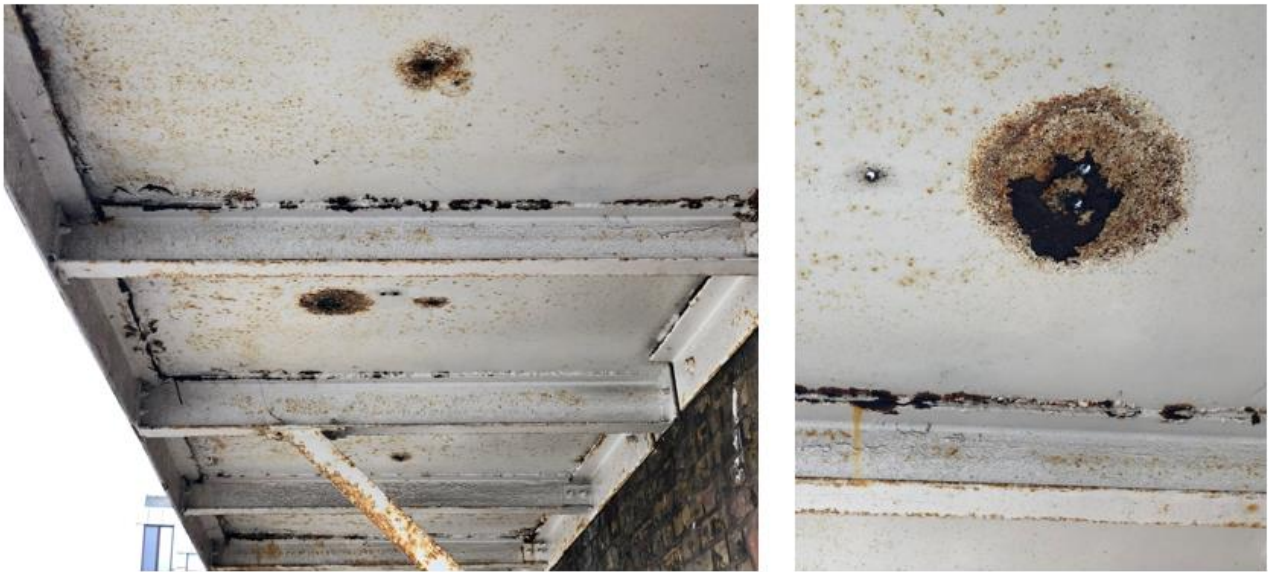
2.2.2 The Balconies decking is designed to be horizontal with no incline for drainage, encouraging water to puddle and pool. This is exacerbated by minor deflection of the tread plate between supporting members creating a depression on the surface. In some locations, holes have been drilled to enable pooled water to drain through the plate, which in turn has encouraged further corrosion loci, displayed below in Figure 8.

Figure 8 - Underside of fourth floor deck and drilled holes

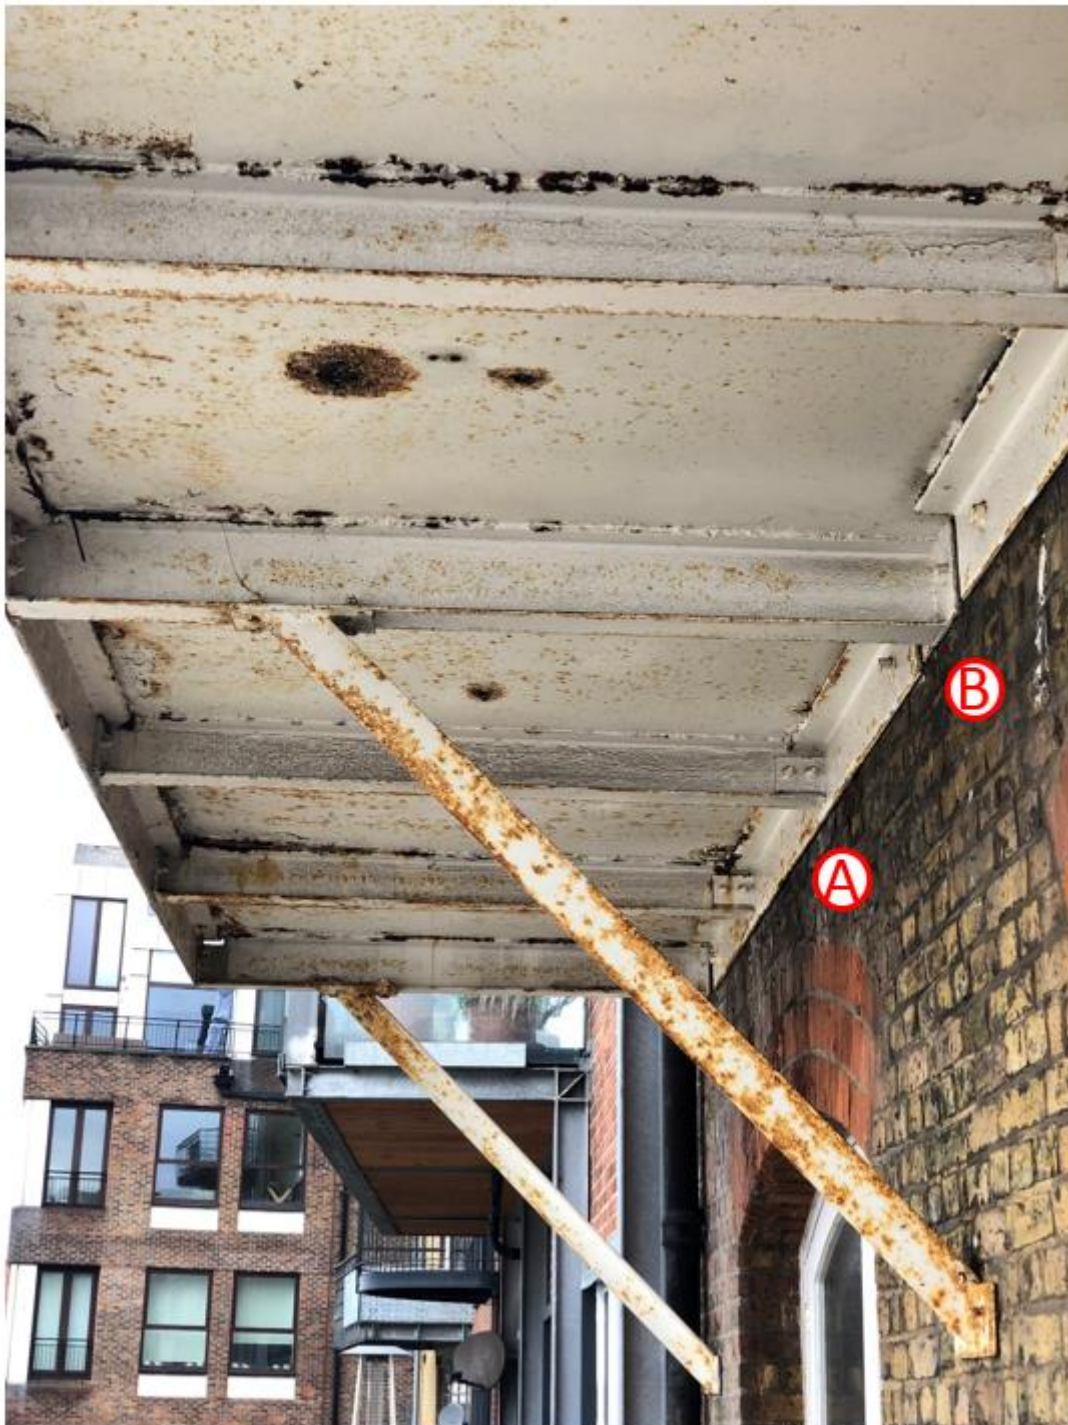
Figure 9 - Underside of fourth floor balcony deck, with diagonal propping

- 2.2.3 The structural frame is composed of I beam's bolted back to the wall, in a semi continuous fashion, with some elements independently fastened to wall (B), others welded to backing plate (A) shown in Figure 9.

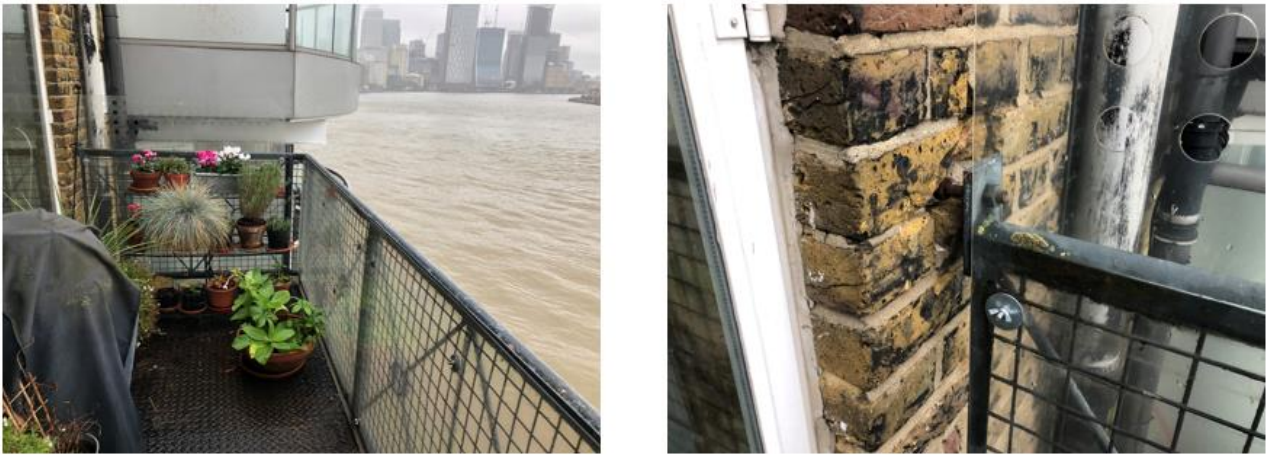
Figure 10 - Balustrade and connection to wall

- 2.2.4 The balustrade design offers some structural rigidity utilising internal cross bracing members. It is not clear whether this was the intention. The connection to the stonework is bolted. The stud that has pulled out (Figure 10 and Figure 11), is short and appears to be a simple bolt (set screw) with the head cast into mortar, situated in a damaged brick. The threaded body of the bolt extends out past the connection plate. This bolt is no longer connected to the wall in any manner, subsequently this balcony connection point is offering no structural support.

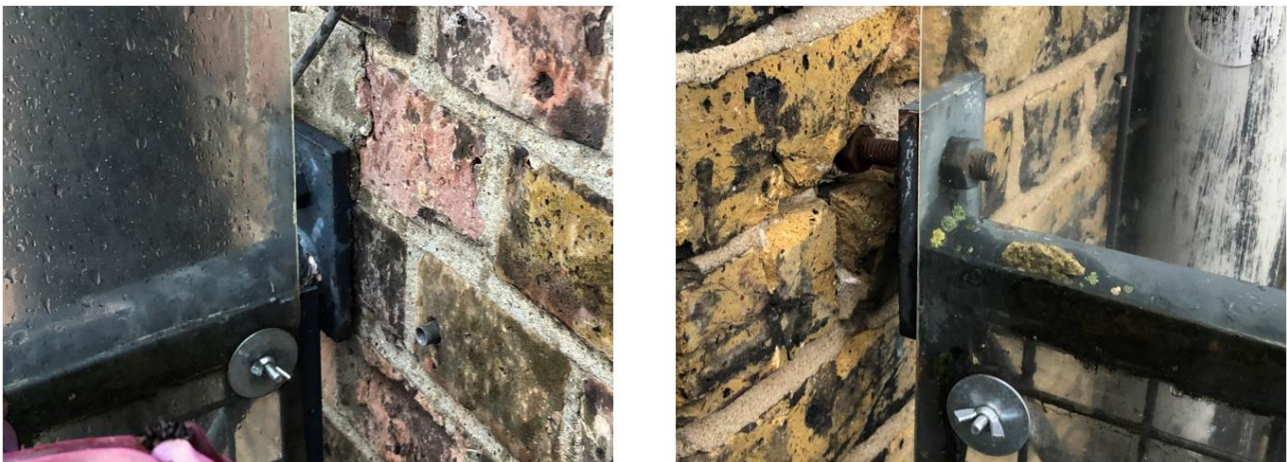
Figure 11 - Fourth floor balustrade - both ends connection to wall for comparison

2.2.5 At the opposing end of the balcony balustrade, the same connection design is utilised but is implemented differently as shown in Figure 11, with a traditional anchoring into the wall, although it is not possible to determine the depth into the brickwork.

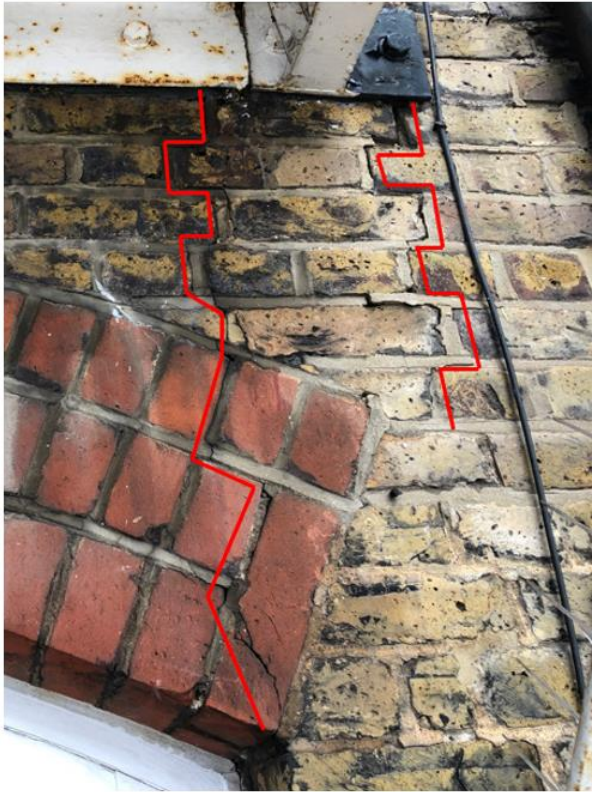
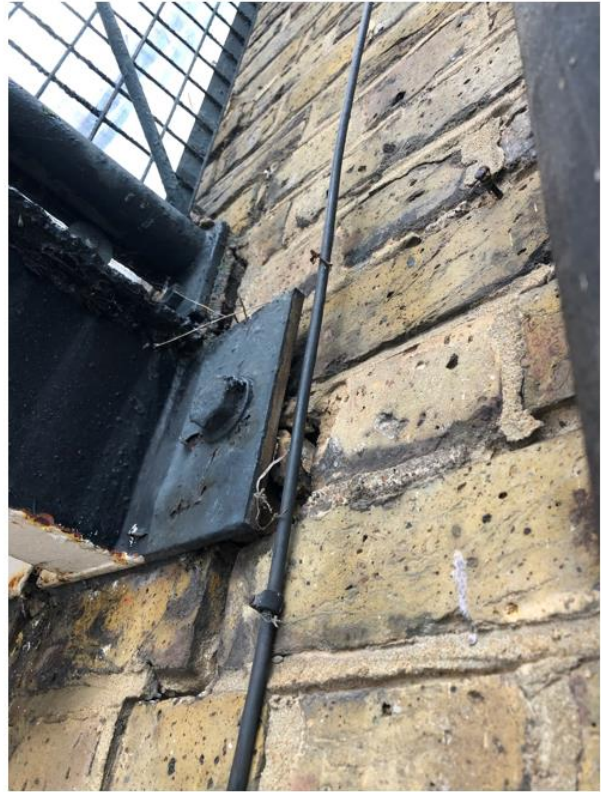
2.2.6 Where the balustrade fixing has pulled out from the wall, the structural frame which supports the tread plate, has also moved outwards from the original surface of the wall. In this instance the surrounding brickwork has moved outwards (Figure 12).

This has created a vertical region where the brick work has moved outwards away from the wall, breaking the mortar, highlighted with red line in Figure 12, a close up in Figure 13.

Figure 12 – Displaced brickwork at structural frame level (balcony 4th floor)

2.2.7 The cracking highlighted in Figure 12 displays horizontal movement only, with no vertical slip visible. This is most likely caused by a combination of; the outward force being imposed by rotation of balcony around the supporting prop, and internal expansion forces created by the steel anchor fitting embedded within the wall.

Problems with the arch would be evidenced by vertical movements at the spring of the arch, or a pattern of tapered cracks at the centre and springs of the arch. These signs are not visible, so the arch is not expected to be a cause of this cracking. However, there may also be underlying less visible issues with the arch.

Vertical cracking travelling from the beam fixing down to the spring of the window arch below, at the Eastern end of the 4th floor balcony, appears to be a result of the surround brickwork being pushed apart by corrosion and resulting expansion of the steel balcony beam fixings. The window arch itself appears to be constructed from solid brick (without a wooden internal lintel) and does not appear to be compromised. However, it is possible underlying problems also exist in the arch.

The existing fixings to the balcony must be removed, the brickwork must be fully repaired using thorough brick stitching methods (using matching bricks and mortar which matches the hydraulic lime mortar used during initial construction and be suitable for the salty environment) and then new stainless-steel fixings installed to re-support the beam.

The new anchors will need to be a lot deeper than the existing ones, to tie into the core of the brickwork wall, or perhaps through bolts with steel backing plates may be required. This can be assessed by a visual inspection by a suitably experienced engineer while the brickwork is being repaired.

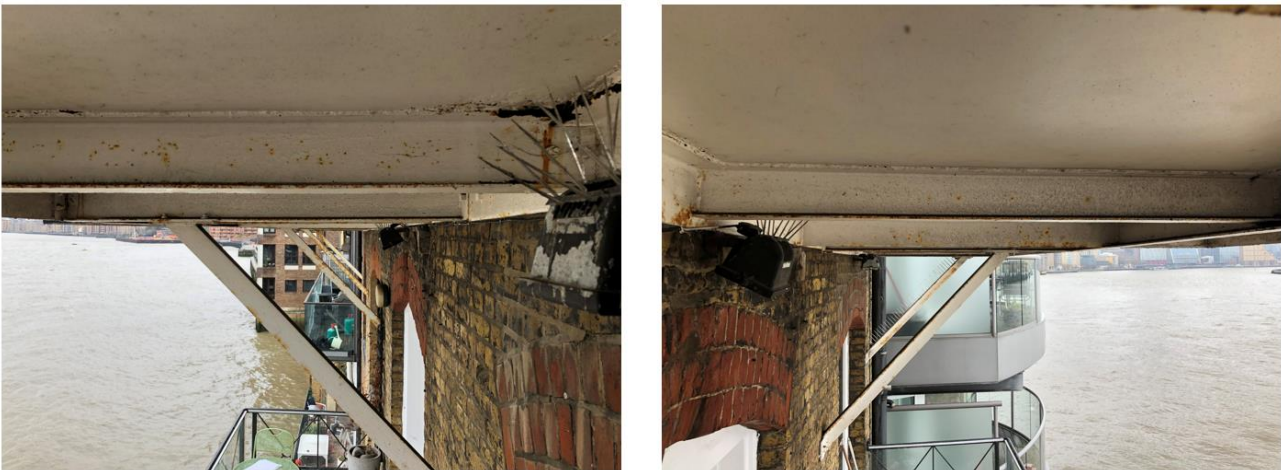
Figure 14 - From the double door access point, towards the West (Left) and towards the East (Right)

2.2.8 The structural frame and tread plate are propped from the underside (Figure 14)

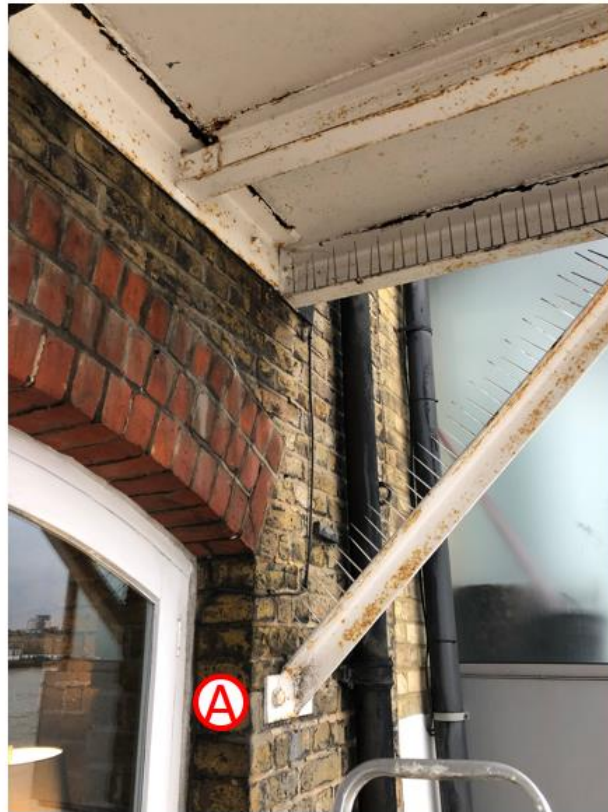
Figure 15 - Prop under balcony at Eastern end

2.2.9 At the Eastern end of the balcony (Figure 14, Right), the balcony is rotating around the supporting prop (Figure 15, Point A). This corresponds to the distance the brickwork has moved outwards at the level of the deck, and the distance the balustrade has moved outwards from the wall at the detached anchor point (Figure 11).

The Eastern end of the balcony has rotated around the last prop by approximately 0.6 degrees, as demonstrated by the gaps where the tie bar, balustrade wall fixings have pulled out of the wall. The balustrade fixing gap was measured to be 30mm. Although these are not the primary system of structural support for the balcony, which is the diagonal props below, they do indicate that significant deflection has occurred.

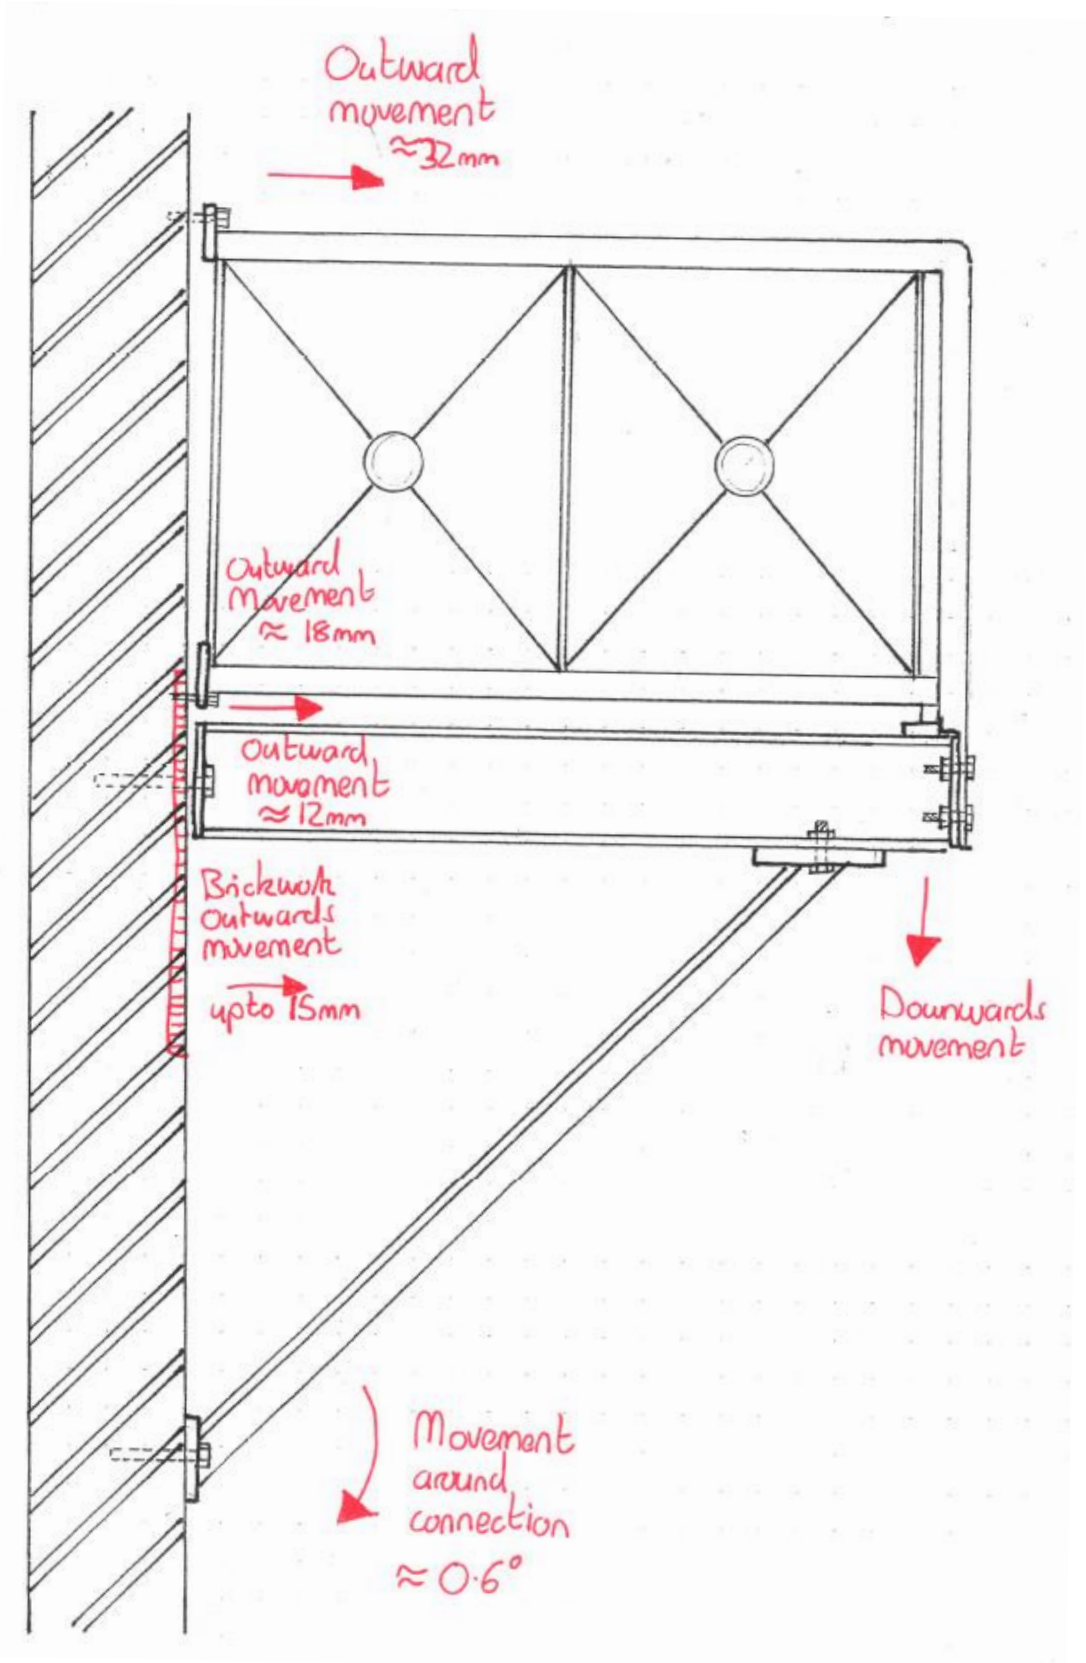
Figure 16 - Sketch of balcony movement at Eastern end

2.2.10 A sketch detail is provided at the end of this document and outlines the approximate movement occurring at the Eastern end of the 4th floor balcony.
