Appendix II

Photo evidence of the tree's condition as of 18.01.2021.

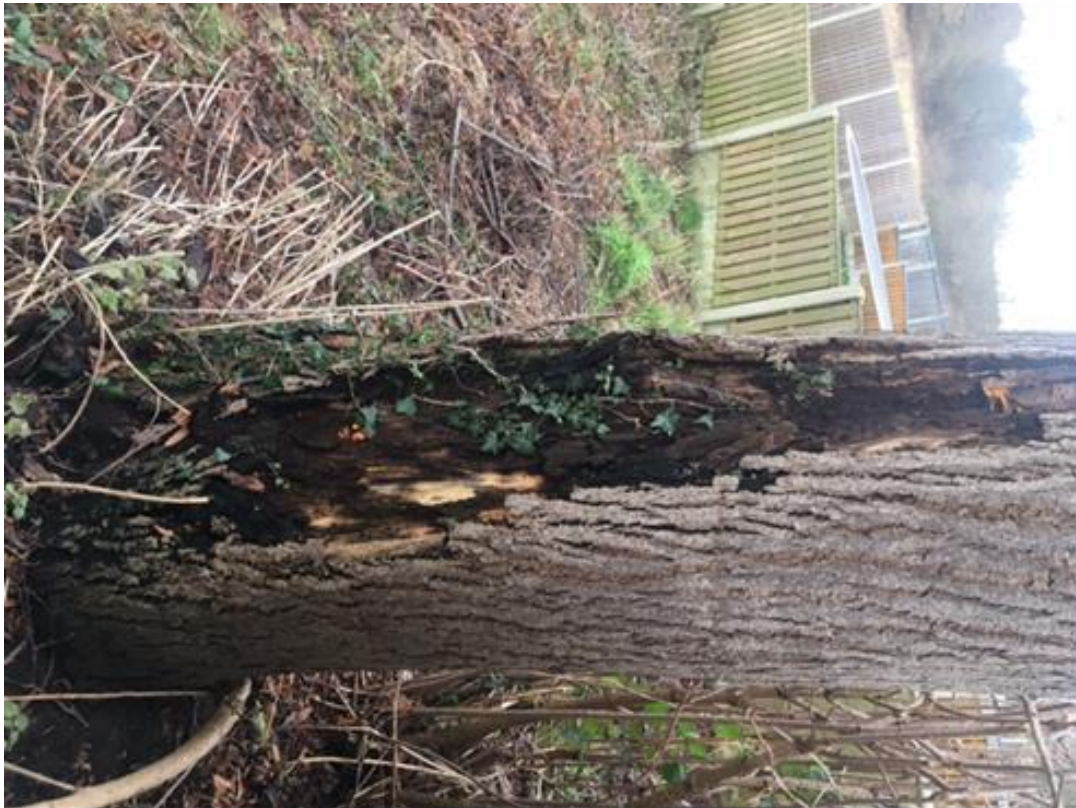
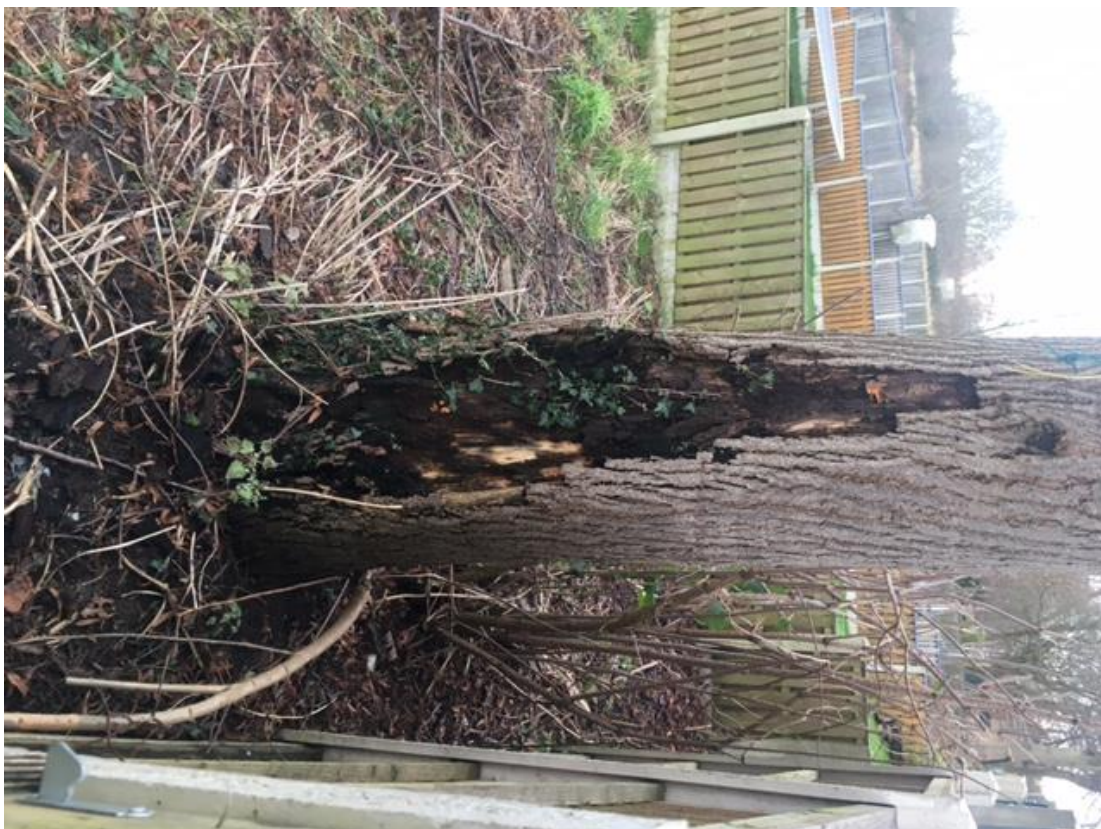
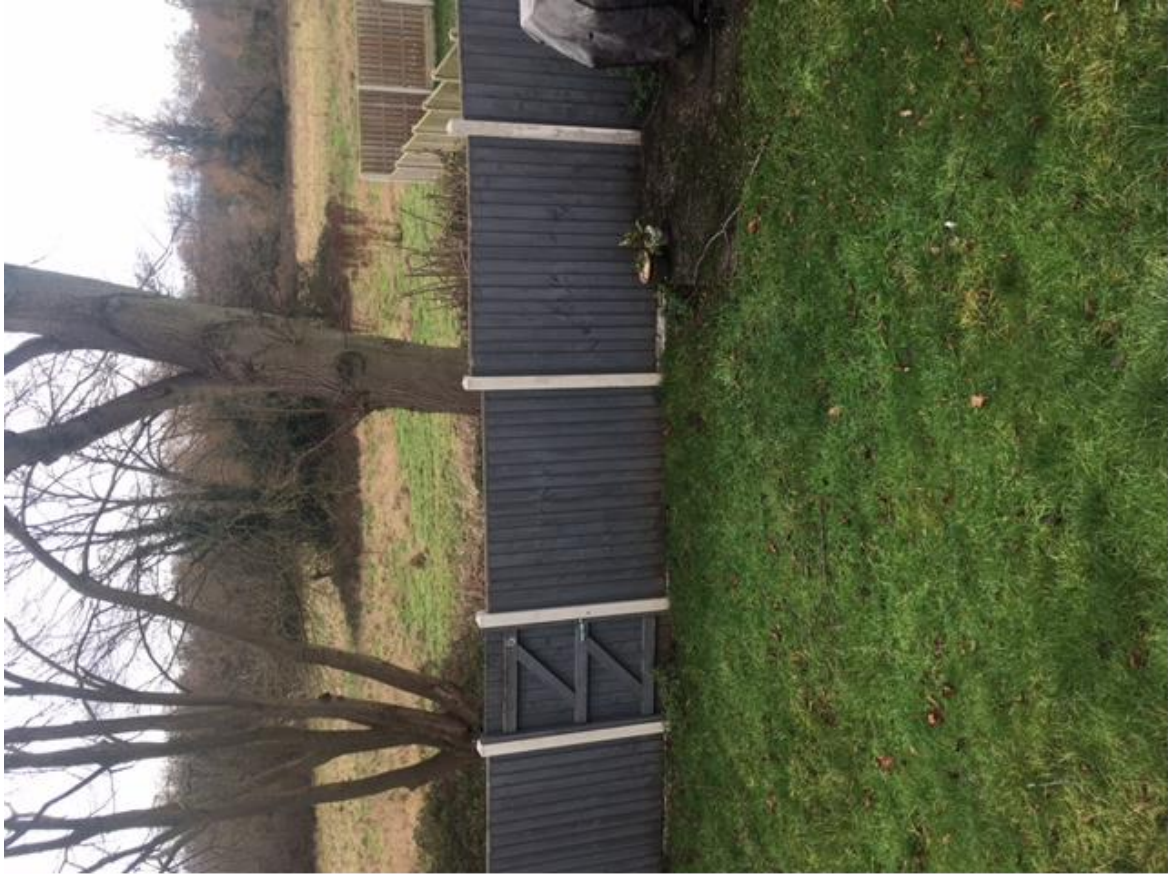
The tree is leaning
