MANCHESTER OPERA HOUSE.

DESIGN, ACCESS AND HERITAGE STATEMENT

**FOR THE INSTALLATION OF PAVEMENT LIGHTS AND REPLACE-
MENT OF EXISTING STEEL BEAMS**

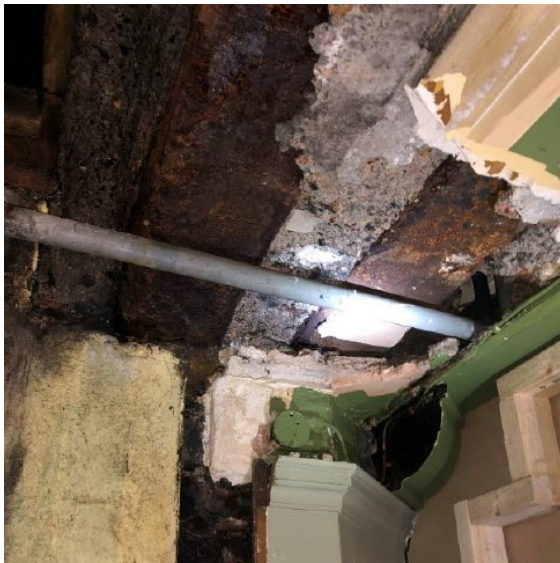
There are currently 2 No. steels within the stalls bar area of the Opera House. These steels support the wall above the opening creating a lightwell area that was previously boarded up.

As can be seen from the photo the steels are heavily corroded and in need of replacement. This opening up has been achieved by the removal of the existing window and the temporary propping of the beams.

'In our opinion the corroded outer beam is no longer adequate and should be replaced. The inner beam and the concrete infill is likely forming a steel and concrete composite section, and removal of

the outer beam will compromise this system. As such, we recommend allowance is made to replace the inner beam and infill structure also.'

It is therefore proposed that the two existing beams will be removed and 2 No. new steel beams to be installed in their place with infill between as recommended by the structural engineer.

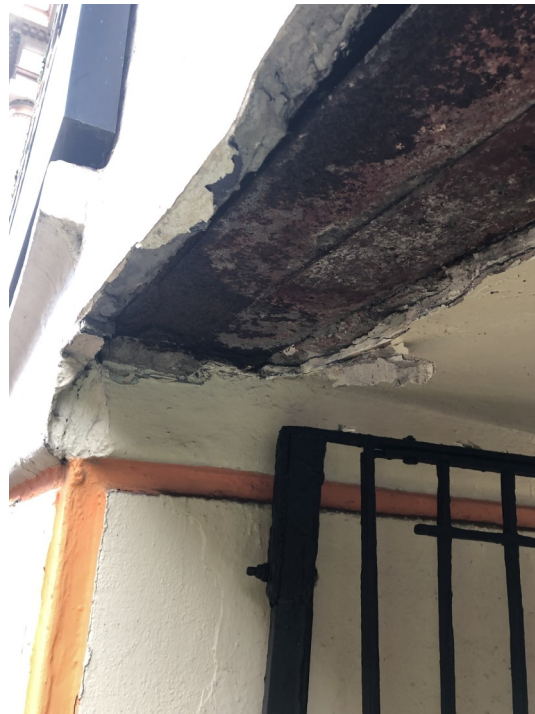
Existing corroded steel

Following the failure of a section of render to the underside and front of the link extension investigations of steels were undertaken to determine the cause for the render failure.

The structural engineer advised that the beam has badly corroded and as such temporary propping was installed underneath the beam to stabilise the opening and to reduce the risk of collapse.

As part of the works it is proposed include the replacement of the steel in this area on a like for like basis.

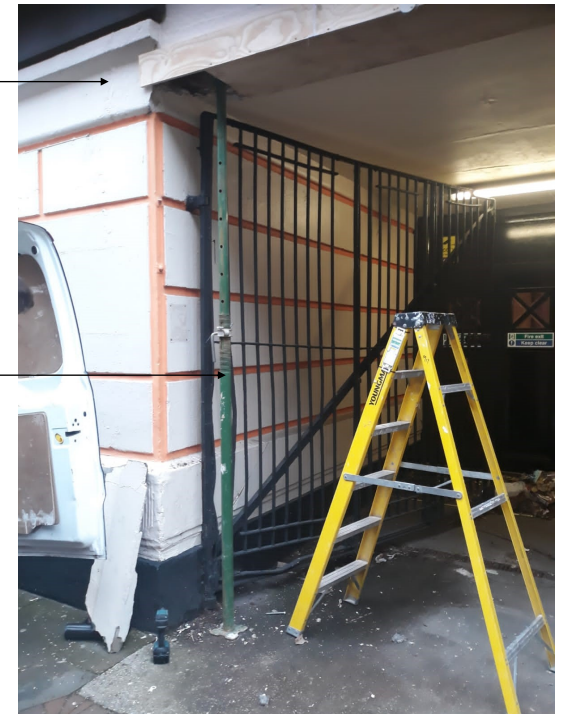
As the existing beams bear onto the existing corner of the wall, a small localised section of render will be removed to allow the removal of the existing beam. Once the new beam is in place, the render will be made good to match the existing and redecorated. Following inspection it appears that a section of render in this area had previously been replaced, it is possible this occurred during previous works to install the original beam in this area.

Area of render showing evidence of previous repairs/ work

Temporary propping

The proposed work will disturb the existing render to the walls. New render will be applied following the steel beam replacement. New cement render (analysis of existing render to be undertaken prior to repair in order to match) and paint decoration to match existing.

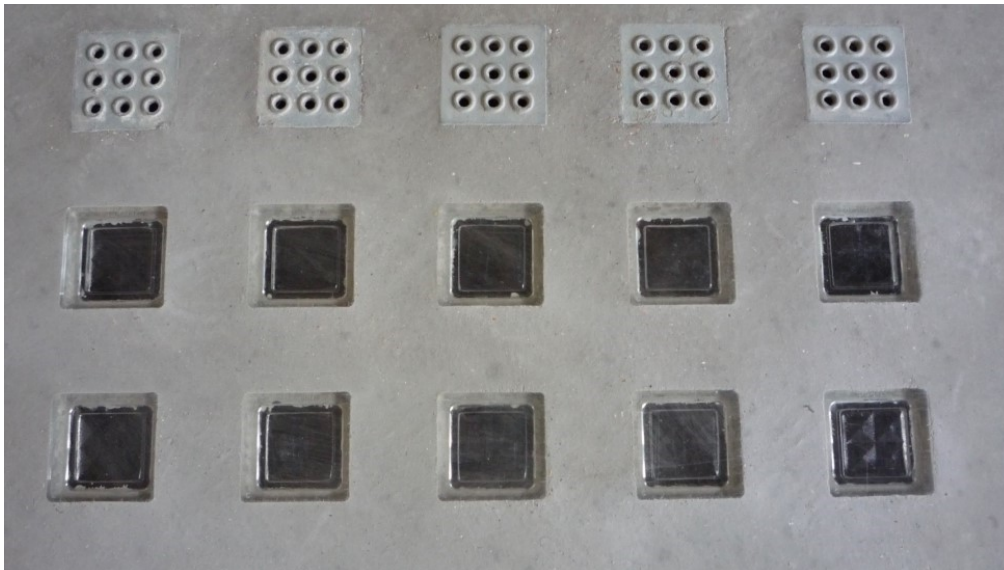
It is proposed that this concrete fill be replaced with new reinforced concrete pavement lights with both glass lenses and ventilation tiles. The photograph opposite shows the

external view of the concrete fill which is outlined in red for ease of identification.

The corrosion of the steels in this areas was caused by moisture in this confined space. The provision of ventilation tiles would help to alleviate this problem. The photograph below opposite shows an example of a concrete pavement lights systems, with both the square glass lenses and the inclusion of ventilation tiles.

The installation of pavement lights will provide two main benefits, firstly these will provide natural daylight into the lower ground bar area. Secondly this will provide the opportunity for the installation of ventilation tiles as part of the new system.
