ARBORICULTURAL REPORT & Impact Assessment to BS 5837:2012 at:

Hillsborough House, Boat Lane, Hoveringham, Nottingham, Nottinghamshire NG14 7JP

Date: December 2020

Reference: AWA3476

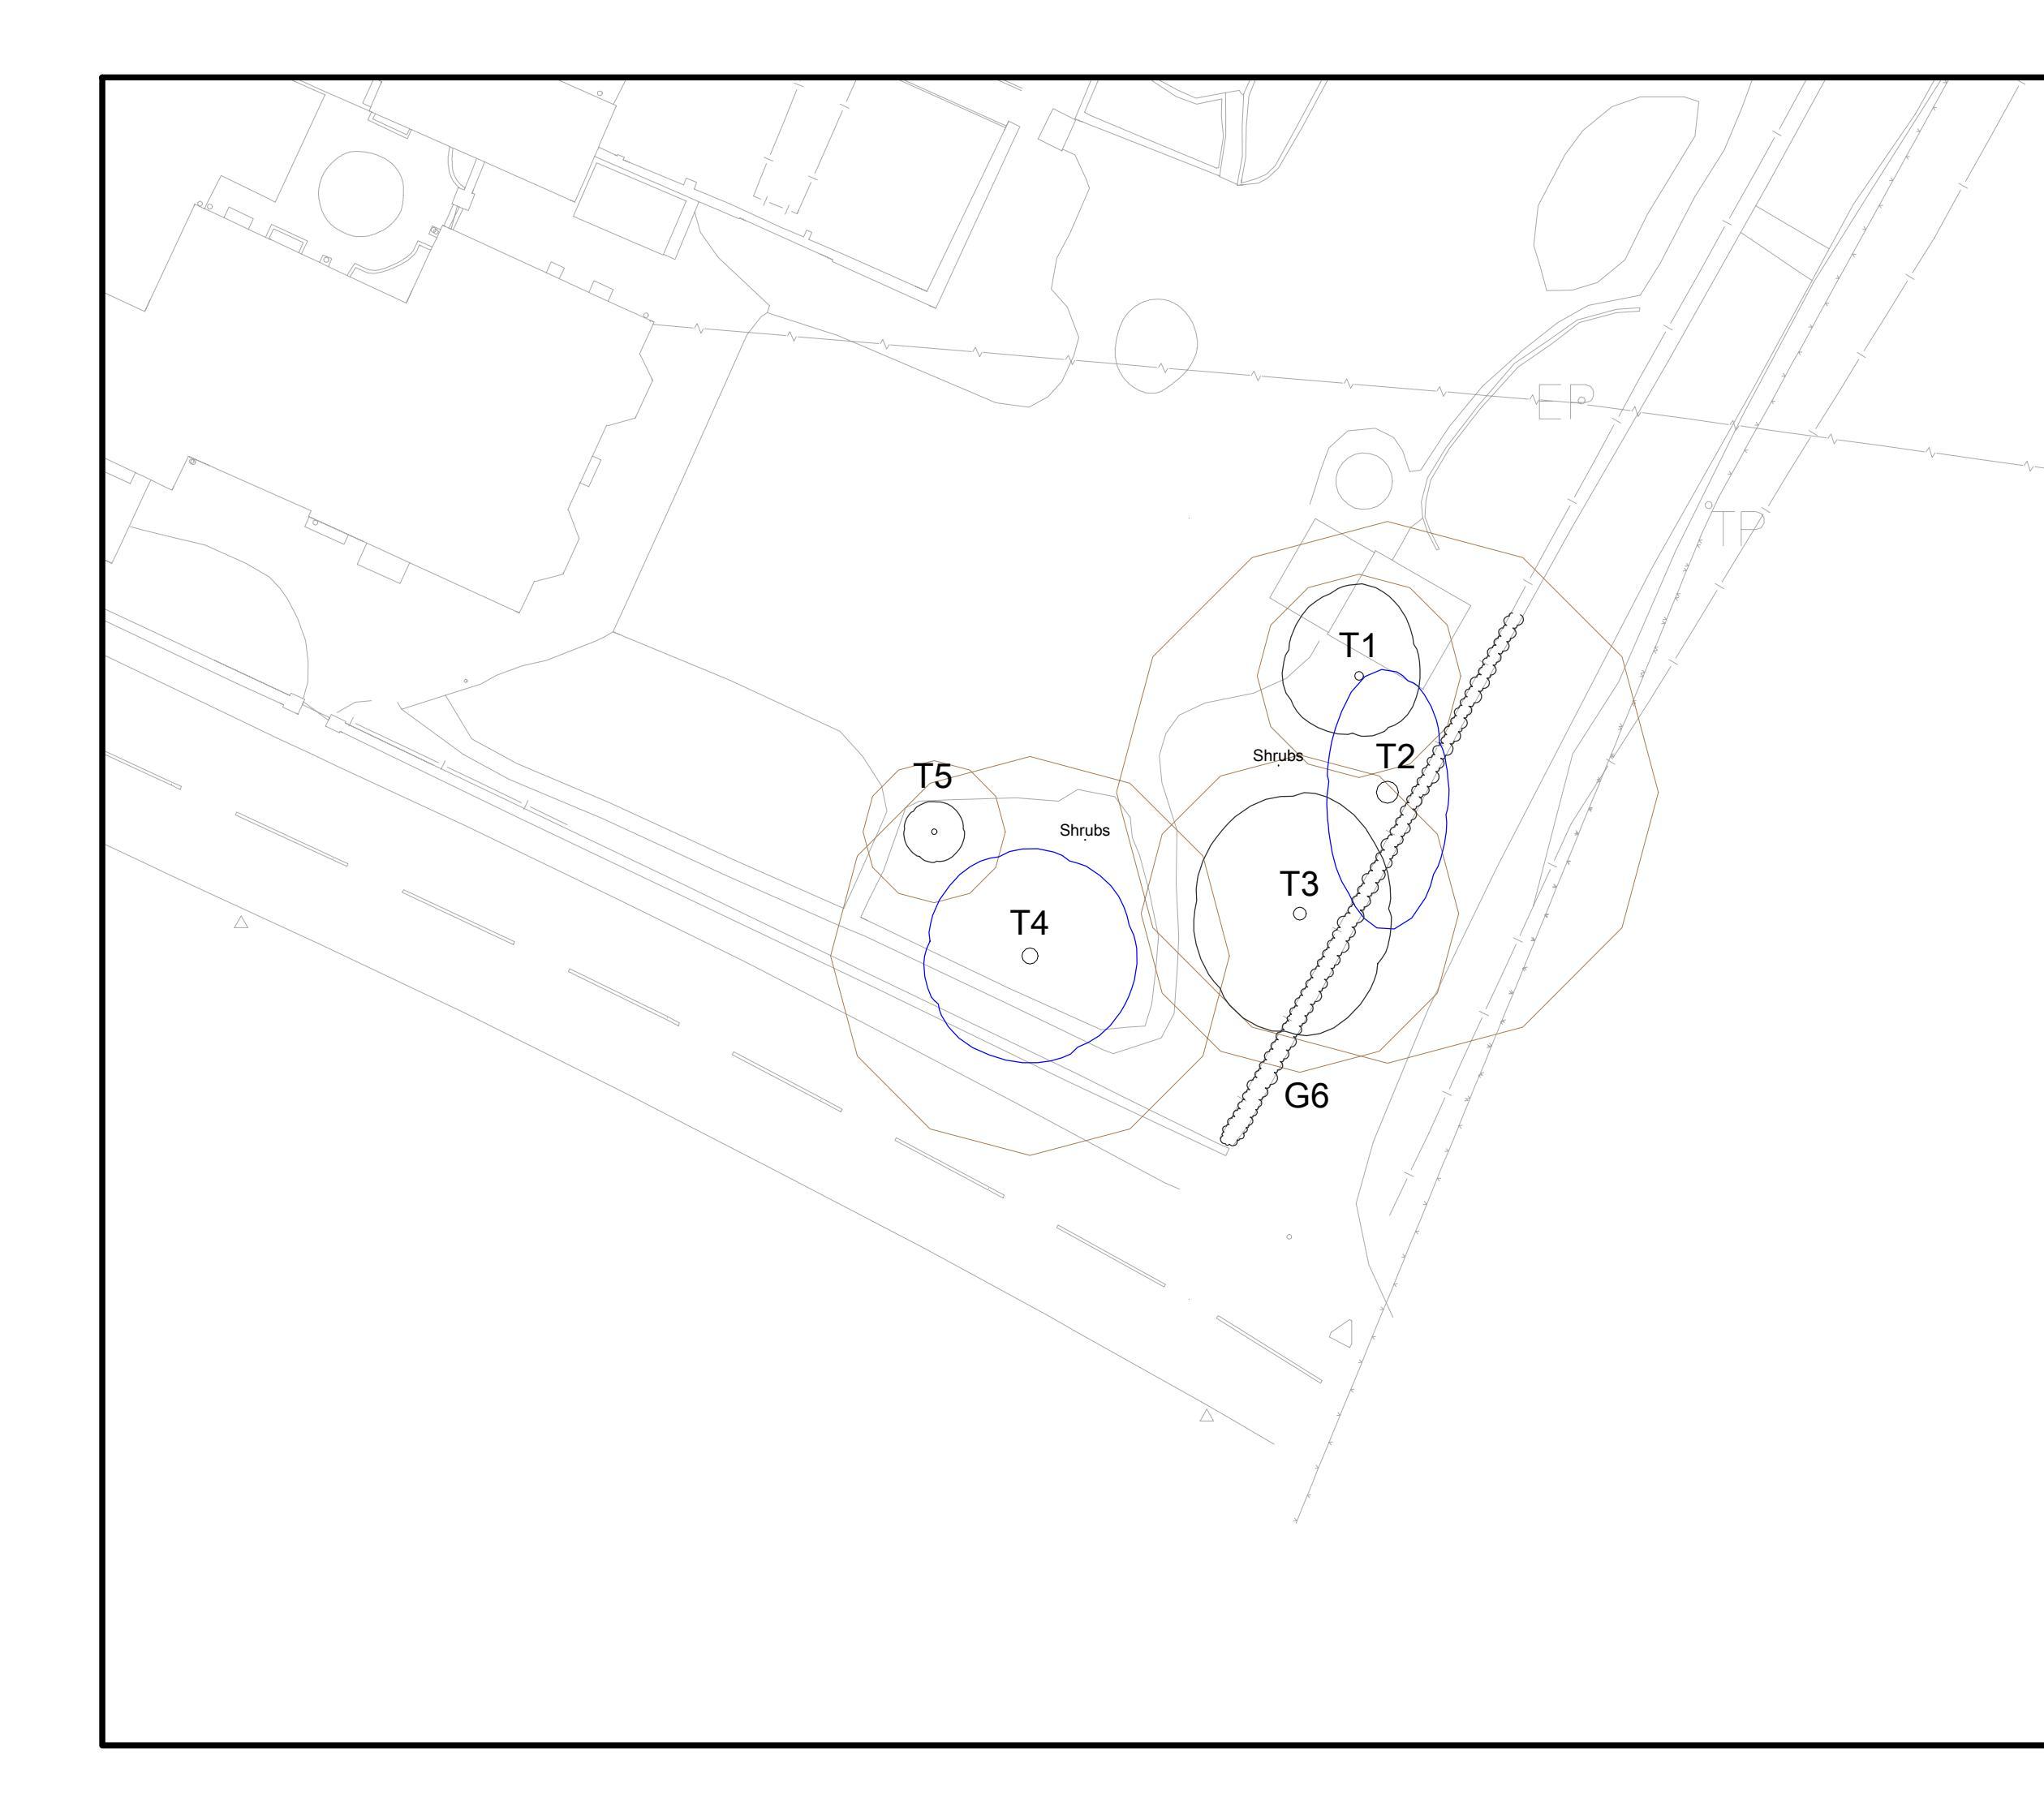
- 3.2.9 The tree Root Protection Area (RPA) for each tree has been plotted as a polygon centred on the base of the stem. Due to the presence of roads, structures, topography (and past tree management) the RPA is likely to be a simplified representation of the tree roots' actual morphology and disposition. However, detailed modifications to the shape of the RPA would largely be based on conjecture and so have been avoided.

- 4.3.1 The tree Root Protection Area (RPA) detailed on the Tree Plans at Appendix 5 and 6, has been used as a layout design tool, to inform on the area around a tree where the protection of the roots and soil structure is treated as a priority.

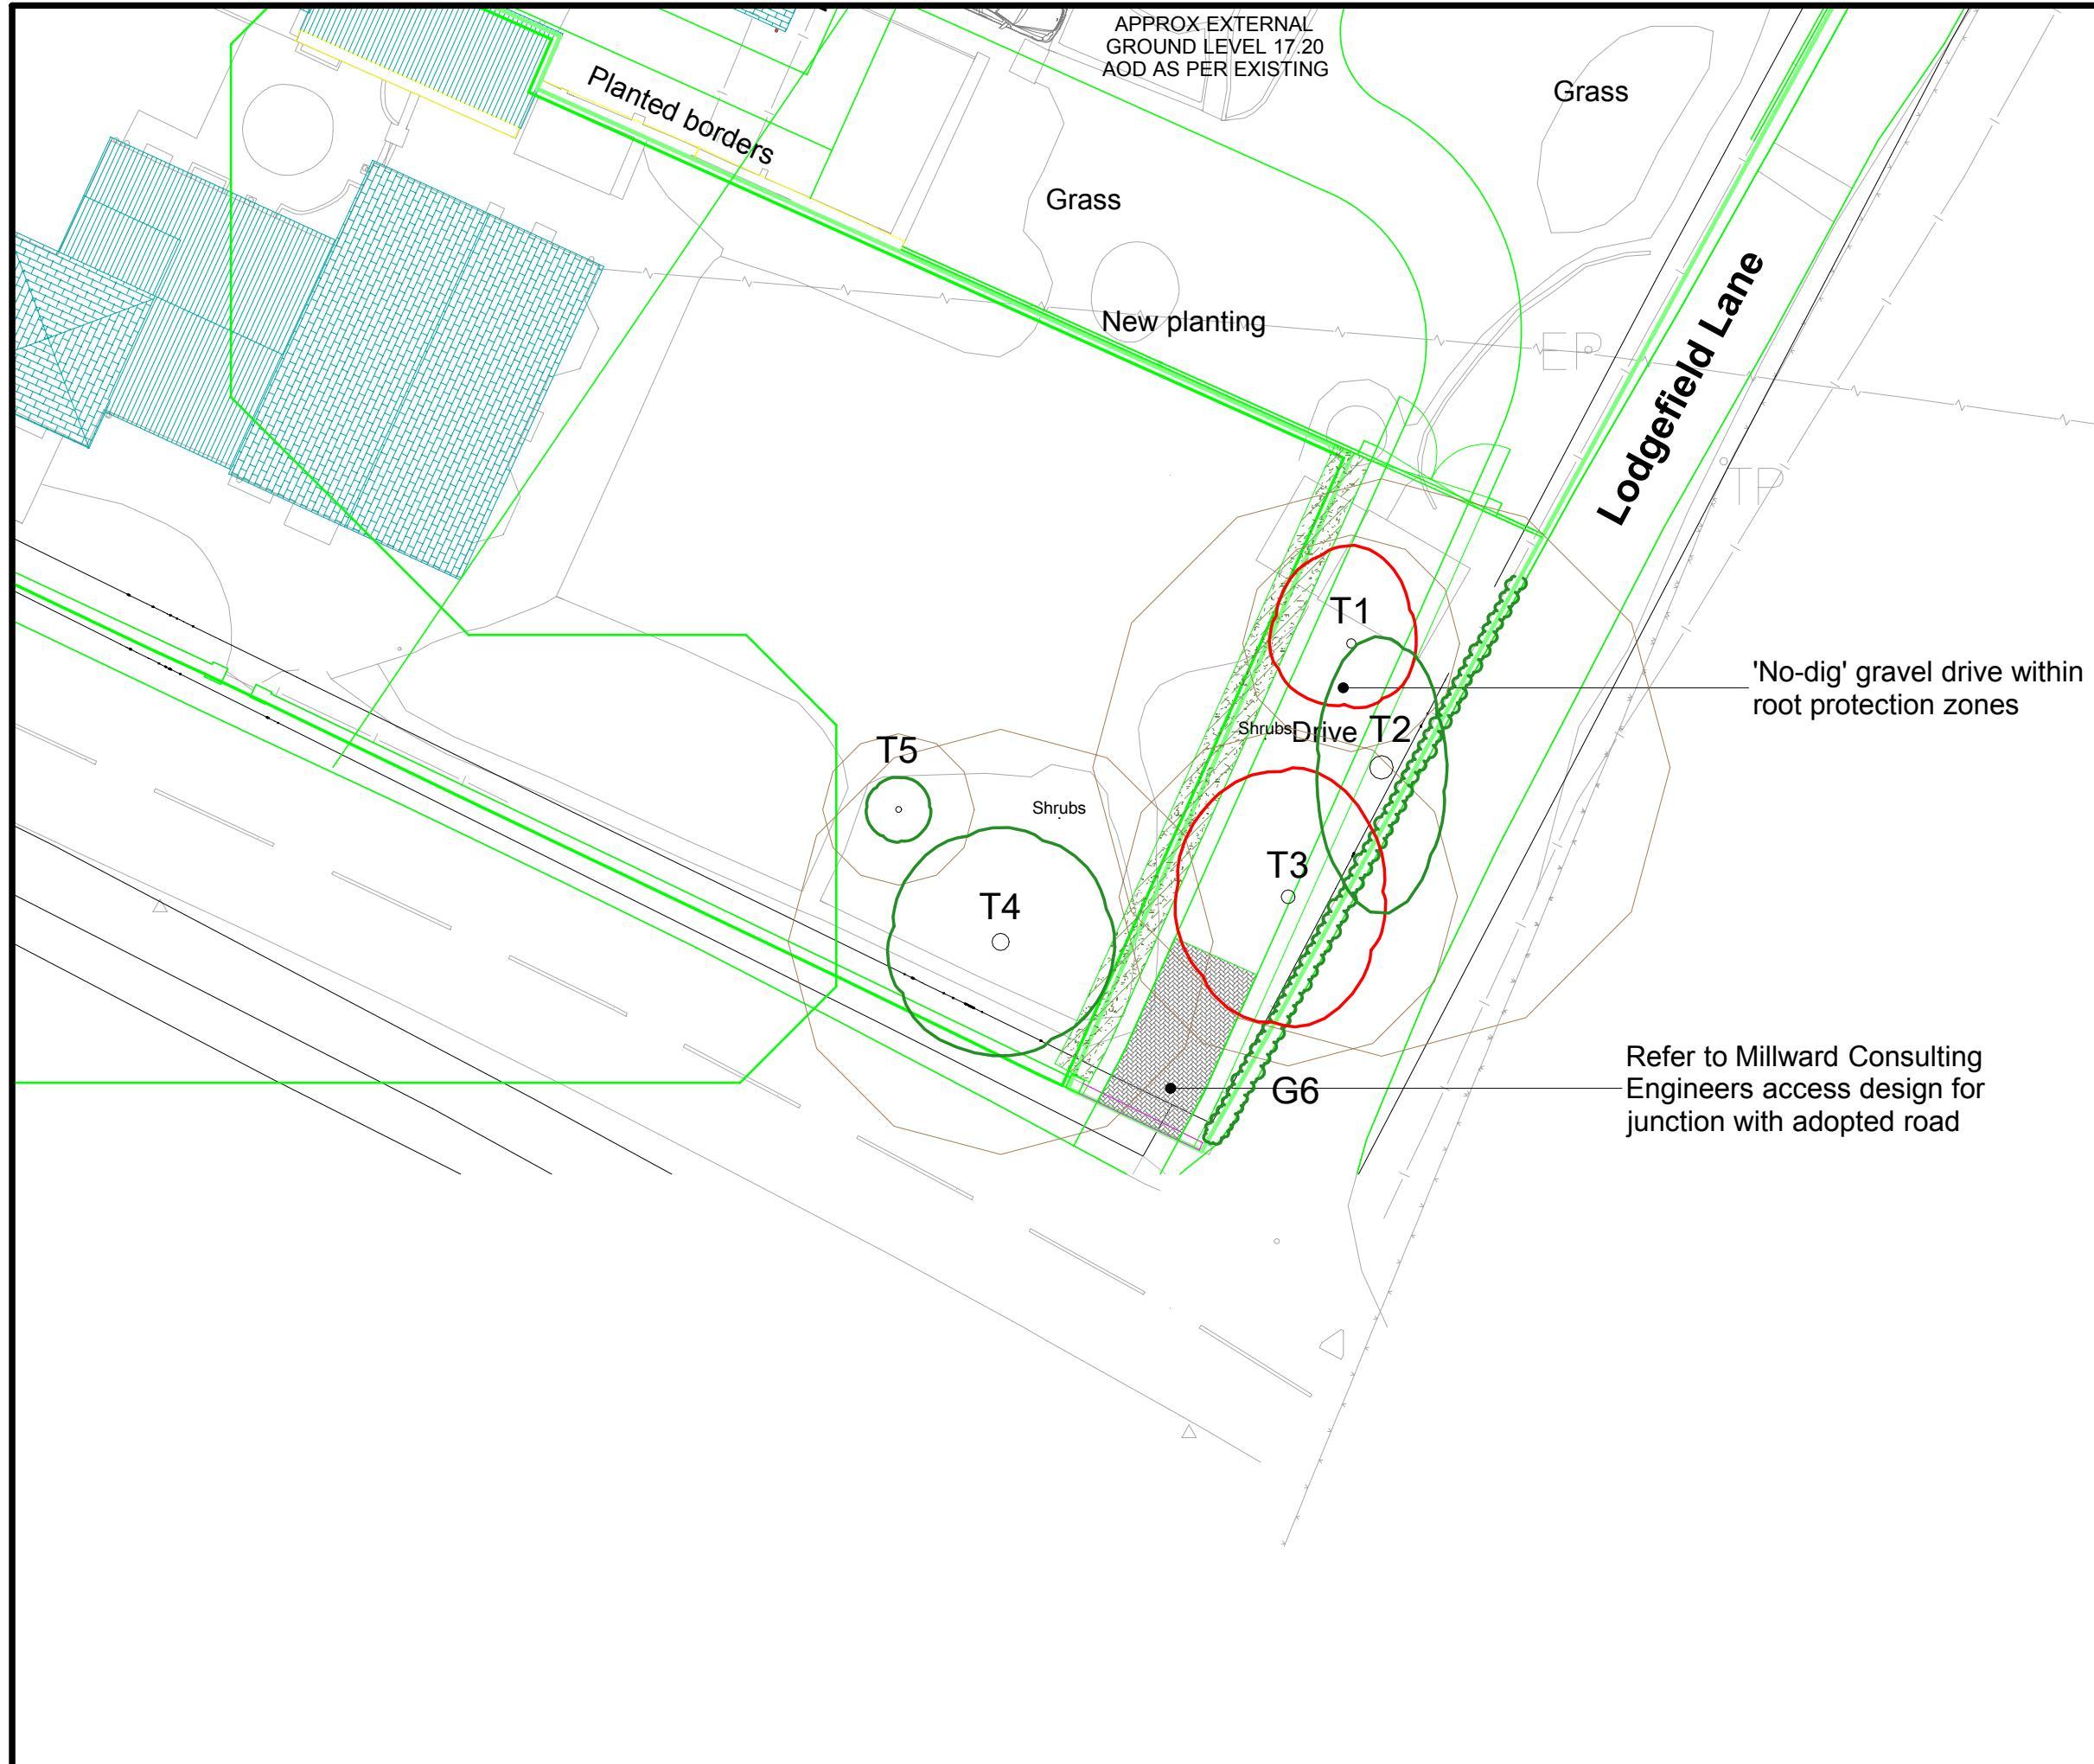
- 4.2.1 From assessing the new development proposals, 2 trees will require removal to facilitate the development as they are situated in the footprint of the proposed access drive.
- 4.2.2 The trees that are required to be removed are the Hollies T1 and T3, they are of low value and their removal will have little negative impact.

- 4.3.2 Potentially damaging activities are proposed in the vicinity of retained trees. The proposed new access drive is situated within the RPA of retained trees T2 and T4. The construction of hard surfaces within the RPA can have negative impacts on tree roots, however, the potential negative impacts can be overcome or minimised by employing a `no-dig' type construction method with a porous final surface.

- 4.3.3 New entrance gates are proposed within the RPA of retained tree T2, however, the encroachment is very minor, and the retained tree should remain largely unaffected by the works, provided care is taken during construction.

- 4.3.4 The proposed new boundary fencing within the RPA of retained trees T2 and T4 should not significantly adversely impact on the health or future condition of the trees, provided posts and panels type footings are used as opposed to strip footings, with the holes for the posts dug by hand, avoiding significant tree roots where possible.

- 4.5.1 The retained trees will require protection by fencing in accordance with BS 5837: 2012, during the development phase.
- 4.5.2 If required by the Local Planning Authority, an associated Arboricultural Method Statement, detailing protective fencing specifications and construction methods close to the retained trees can be provided.
