**CAR PARKING DC1 & DC2,  
PROLOGIS PARK BIRMINGHAM  
INTERCHANGE,  
BLACKFIRS LANE, SOLIHULL**

**ARBORICULTURAL IMPACT  
ASSESSMENT**

Report No: RT-MME-153311-02 **Rev A**

Date: October 2020  
**Revised: December 2020**

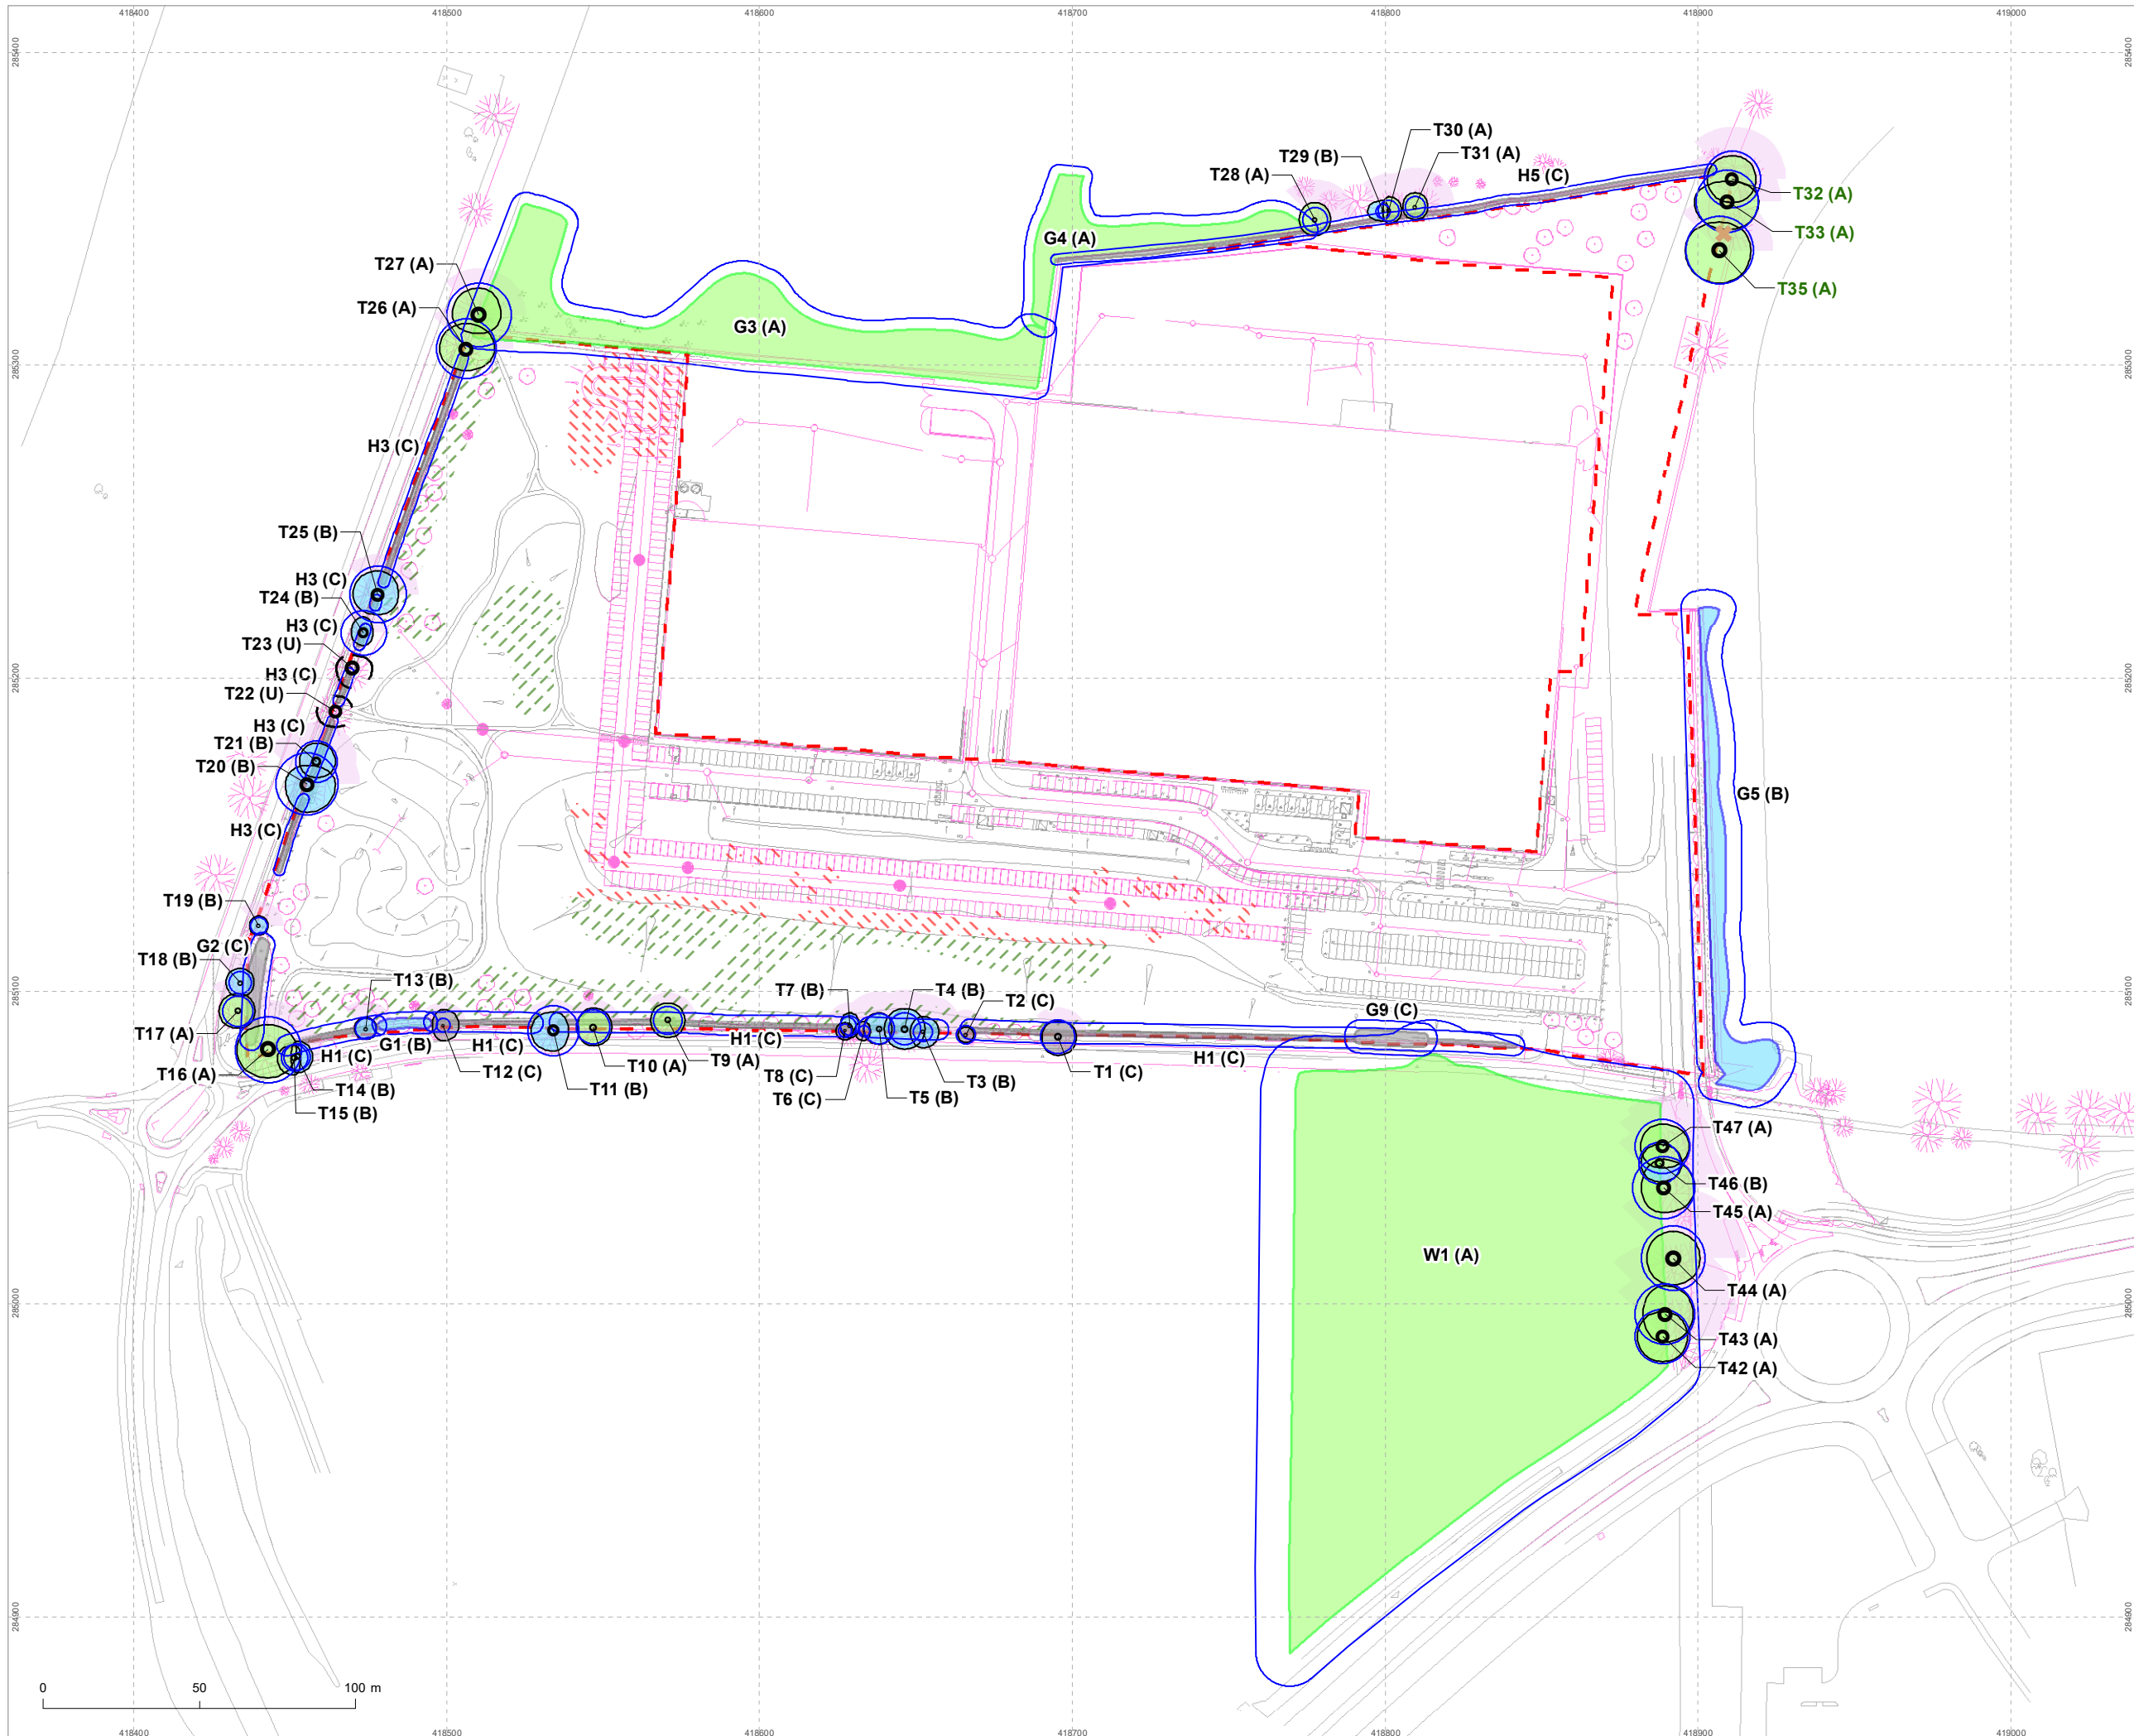
The trees to be removed are identified on the Tree Retention Plan, Drawing Number (C153311-02-01), attached to this report. All trees, groups and hedgerows not discussed herein or identified on the Tree Retention Plan are to be retained within the proposed development.

In addition to the removal required for development, the removal of two individual trees along the western site boundary (T22 & T23) is recommended. These trees are in poor structural condition, with multiple significant defects, and considered to be unsuitable for long-term retention within the site.
