**Tudor Lodge  
Burchett's Green Lane  
Burchett's Green  
Maidenhead  
Berkshire  
SL6 3QP**

# **Preliminary Bat Roost Assessment**

Ref: R2692/a

**February 2021**

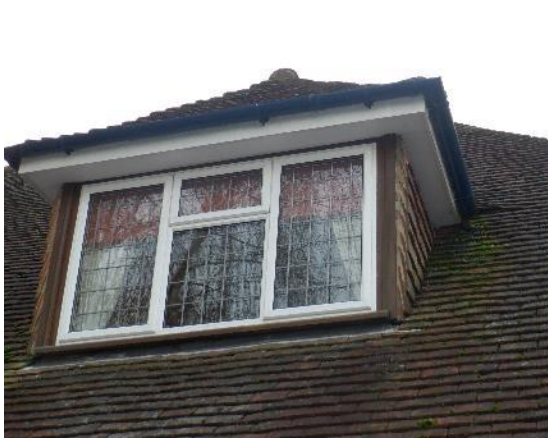
5. Hanging tiles on northern dormer window .

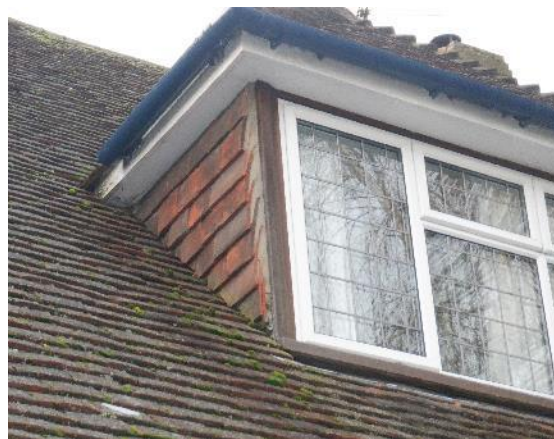
6. Slightly lifted hanging tiles on southern dormer window.

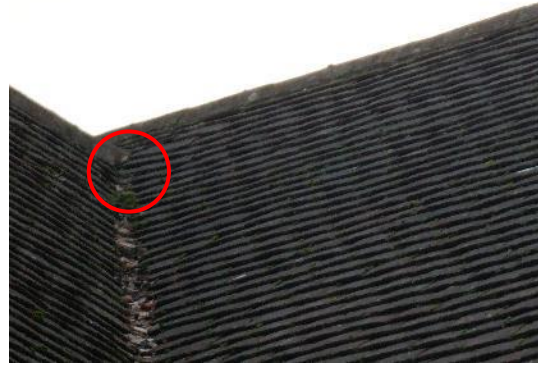
8. Lifted roof tile below ridge tiles of pitched roof.

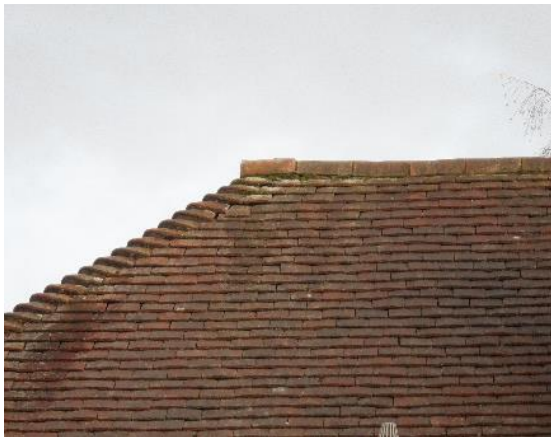
9. Gaps between roof tiles near corner of ridge and hipped tiles.

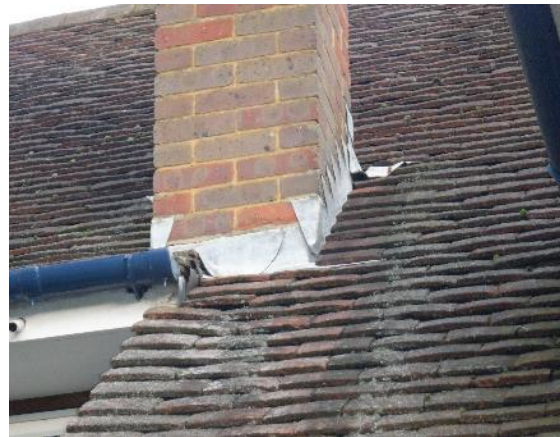
10. Lifted roof tiles and lifted lead flashing around the base of the chimney.

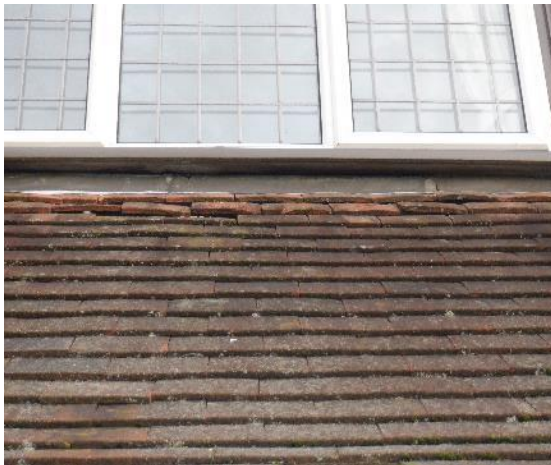
11. Lifted roof tiles below rear dormer window.

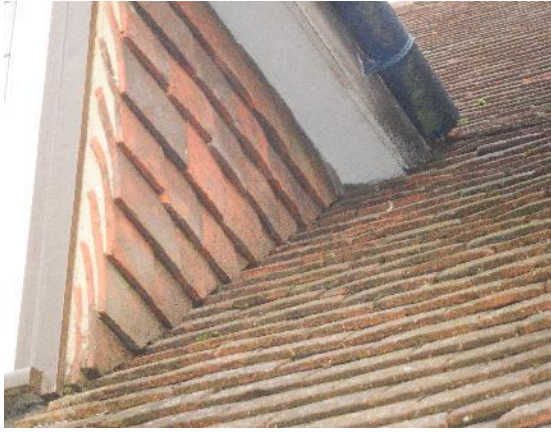
13. Occasional lifted hanging tiles around dormer window on rear elevation.

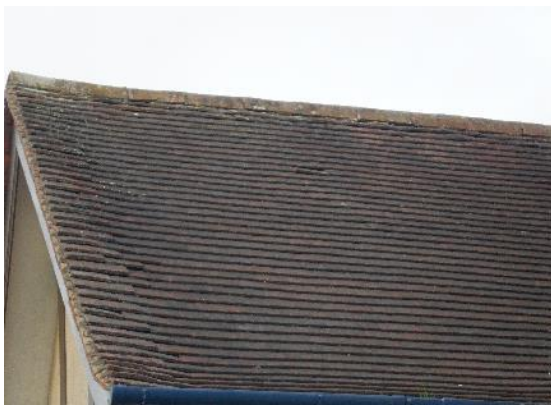
**3.2.1** The detached house was of brick cavity wall construction, with a complex roof including a hipped roof running the length of the house, with pitched roof gables to the front and the rear, and multiple pitched roofed dormer windows on both the front and rear elevations (**Photographs 1 & 2**). There was a double garage attached to the house on the north-eastern corner of the property (**Photograph 3**). The house had multiple lifted roof tiles on the front elevation (**Photograph 4: Target note 1**). The dormer windows on the front elevation featured hanging tiles on the sides of them, which were mostly tight and lifted in places (**Photograph 5 & 6: Target note 2**). There was a wooden soffit flush to the wall along the front elevation (**Photograph 7: Target note 3**). There was a lifted roof tile on the northern side of the pitched roof, and lifted tiles on the southern side where the roof join the hipped roof (**Photograph 8: Target note 4 & 5**). On the rear elevation, there were some gaps between the hipped tiles near the ridge of the roof (**Photograph 9: Target note 6**), a lifted tile below the chimney and lifted lead flashing to the side of the chimney (**Photograph 10: Target note 7**). There was a dormer window on the cat slide section of the hipped roof, that had lifted roof tiles below it, with waney-edged board cladding above the window and hanging tiles on both sides of the dormer, which was all tight and no visible gaps (**Photograph 11, 12 & 13: Target note 8 & 9**). There was a tight wooden soffit along the rear elevation, including the gable of the pitched roof (**Photograph 14: Target note 10**). The southern side of the pitched roof featured multiple gaps below the ridge tiles and some gaps between the verge tiles where they had moved apart (**Photograph 15: Target note 11 & 12**).

15. Lifted roof tiles below ridge tiles; gaps where verge tiles have moved apart.

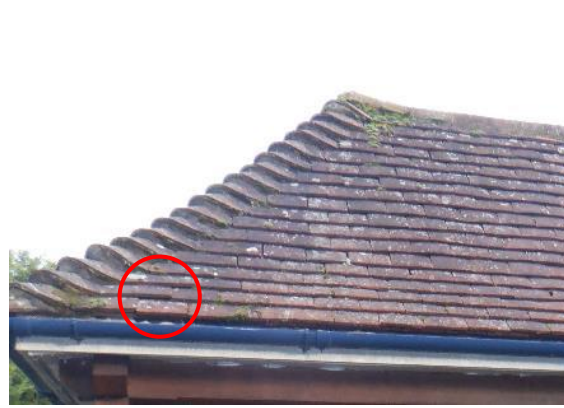
to the wall around the garage (**Photograph 17: Target note 13**). There were slightly lifted roof tiles on the eastern and southern side of the roof (**Photograph 18 & 19: Target note 14, 15 & 16**), which when inspected closely with the use of an endoscope showed no evidence of use by bats.

18. Lifted roof tile on western elevation of the hipped edge of the garage roof.

**4.2.3** Bats are highly mobile and roosting within the house, therefore it is possible that bats could be found within the garage in the future. Care must therefore be taken during the work to remove the small number of tiles by gloved hand and if bats are discovered, work must stop immediately, and a licensed ecologist called to site to attend to the bat(s) and provide further advice. Work must only recommence once further written advice has been received; a mitigation licence or confirmation of the site's registration under the Bat Mitigation Class Licence (if applicable) may be required for the work to go ahead lawfully.

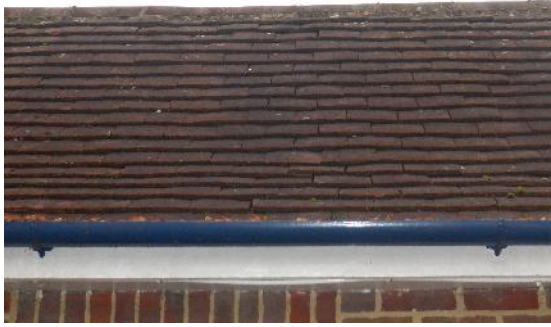
19. Occasional lifted roof tiles on southern elevation of the garage roof.

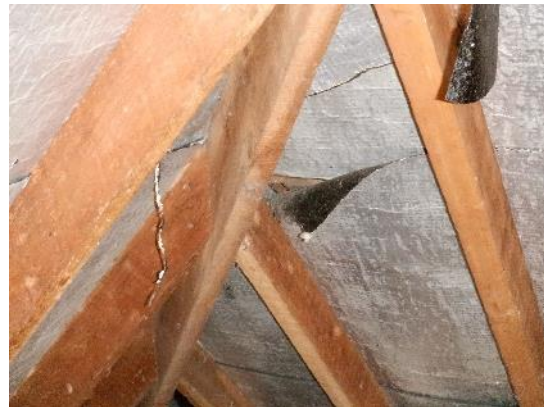
22. Tear in foil covered bitumen felt roof lining.

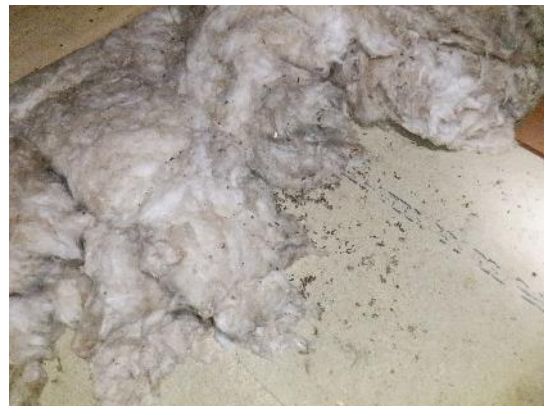
**4.1.1** The finding of approximately 1000 medium-sized bat droppings scattered through-out the void below the central ridges, at the western gable wall and below the northern and southern hipped roof, indicates that the house is being used by void-dwelling bat species, considered likely to be a long-eared bat species (*Plecotus* sp.), as a day roost used regularly by small numbers of non-breeding adult bats. The number of droppings is unlikely to be consistent with the roof supporting a maternity colony.

24. High concentration of bat droppings adjacent to the loft hatch at the northern end of the void.

**4.2.2** The house supports a bat roost for a species likely to be brown long eared bat and may support crevice dwelling species. Care must therefore be taken to ensure that the building work does not block access to the house roof e.g., by scaffolding.

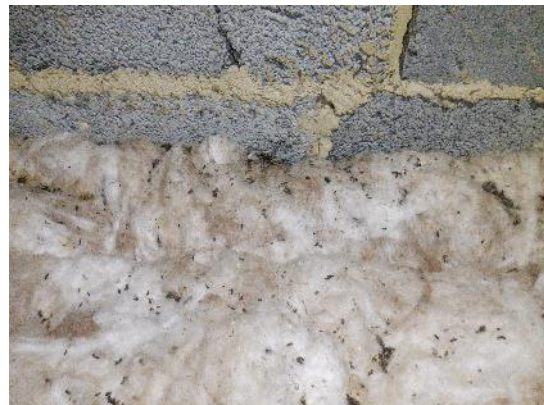
25. High concentration of bat droppings below ridge in the central part of the roof void.

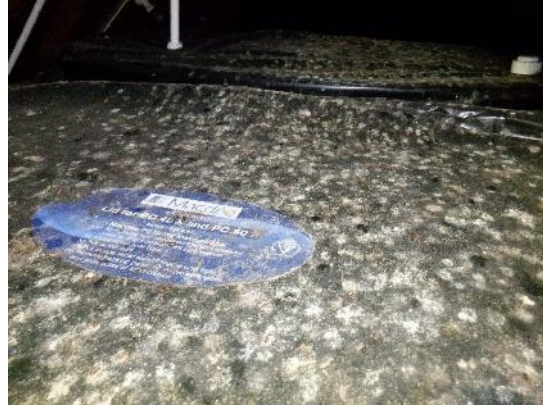
27. Bat droppings and urine spots on raised, covered water tanks under the central ridge.

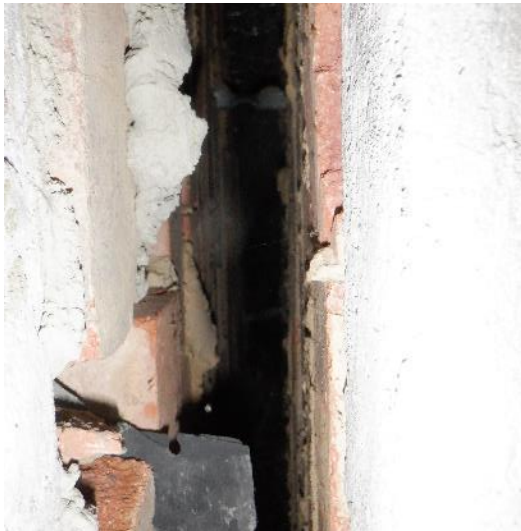
30. Gaps around blockwork on western gable; scattered bat droppings on gable wall.

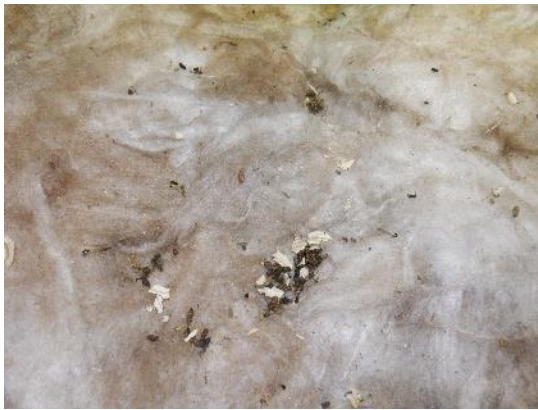
33. Scattered bat droppings on fibreglass across the southern section of the void.

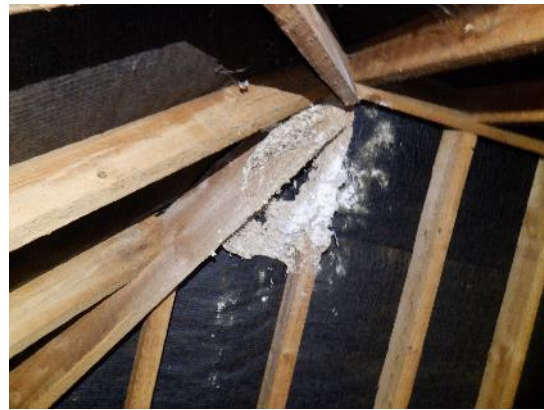
34. Destroyed wasp nest on the hipped ridge on the southern side of the void.

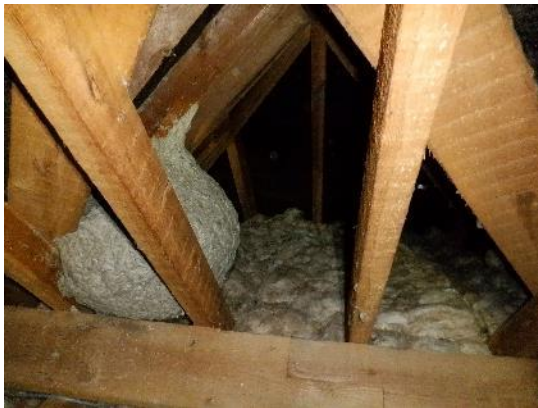
35. Large wasp nest above the front pitched dormer window.

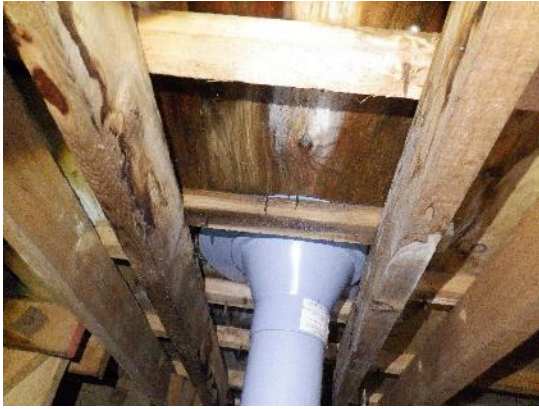
39. The westernmost drainage pipe on the flat roof, with water damage on the boarding around the top.

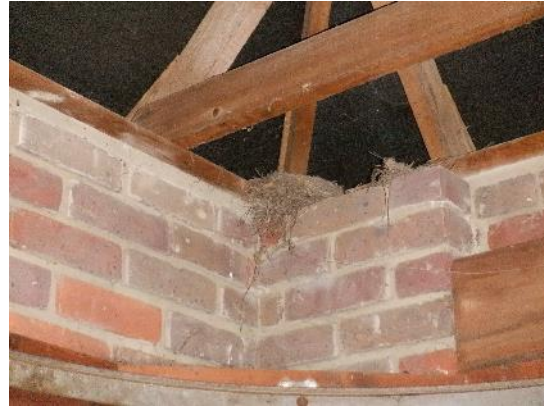
40. Old birds' nest on top of the wall plate in the south-eastern corner.
