# Bickleigh House

## 2. Photos of Interior

Living Space Architects - 4 September 2020

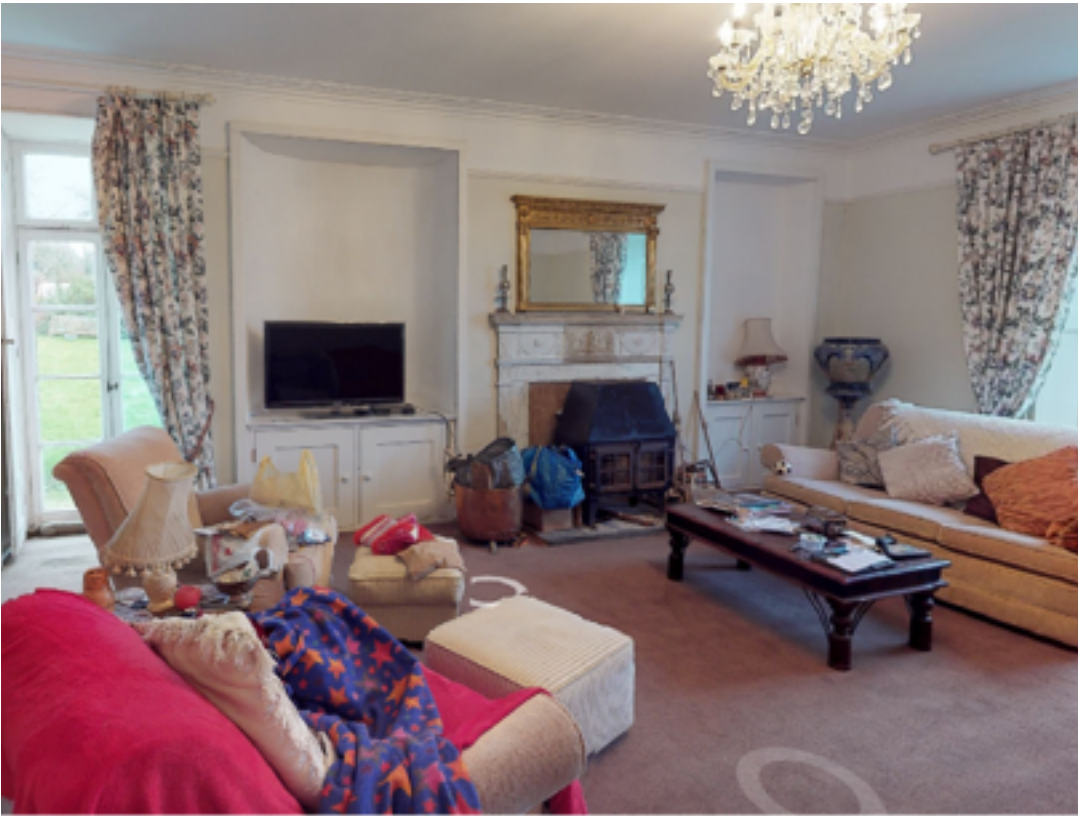
2.1. Interior view of sitting room facing south - note C20 joinery to alcoves and original door to left.

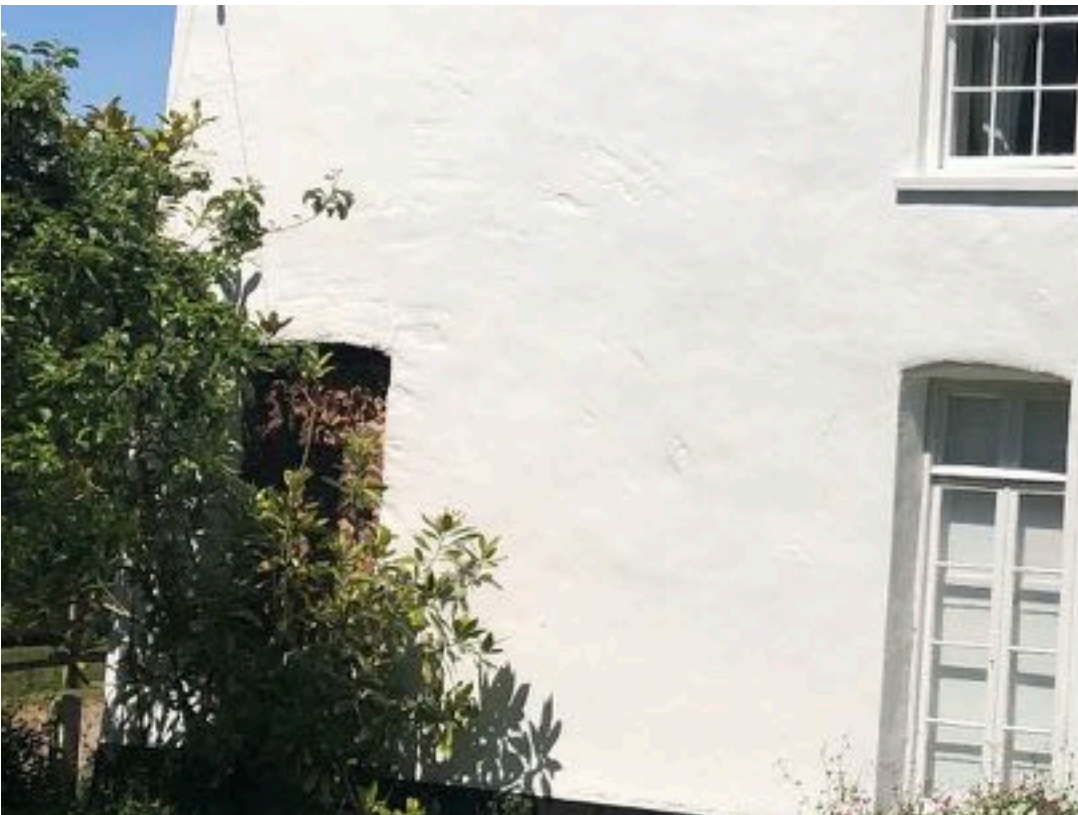
2.2. View of exterior wall to sitting room facing north - original door opening can be seen on left (infilled with stone)1a. Interior view of sitting

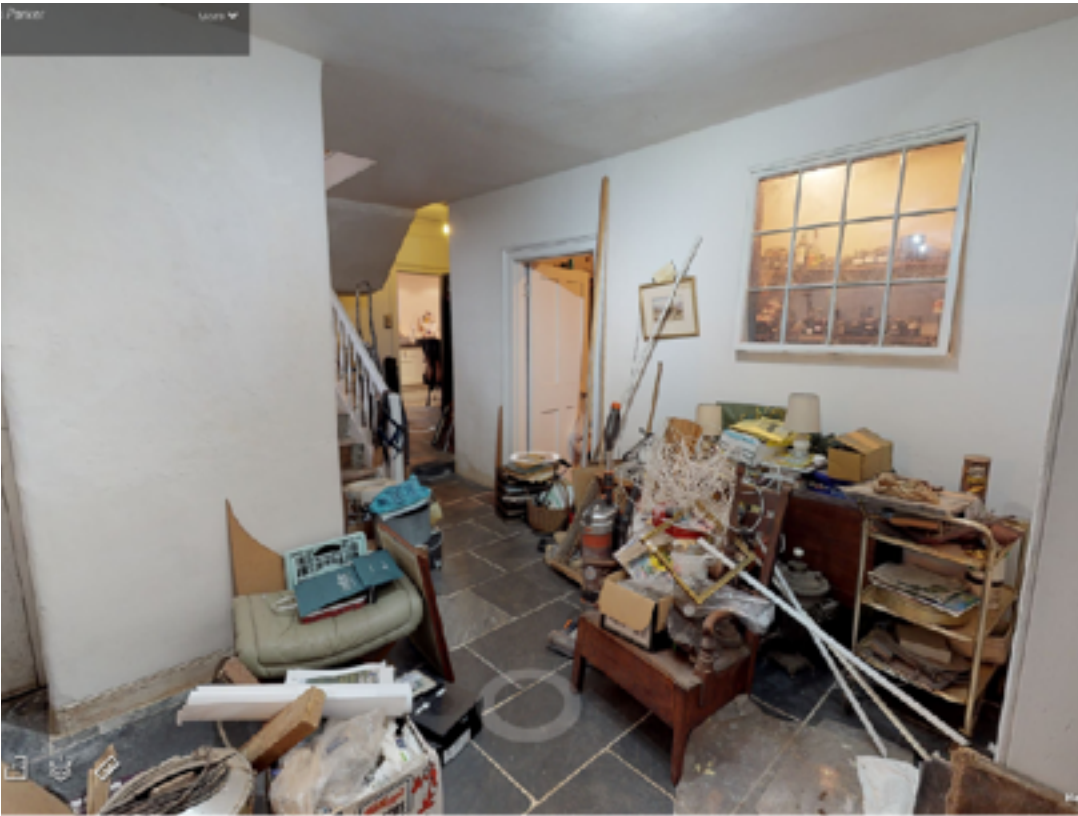
2.3 Internal corridor looking towards pantry (right) and kitchen beyond.

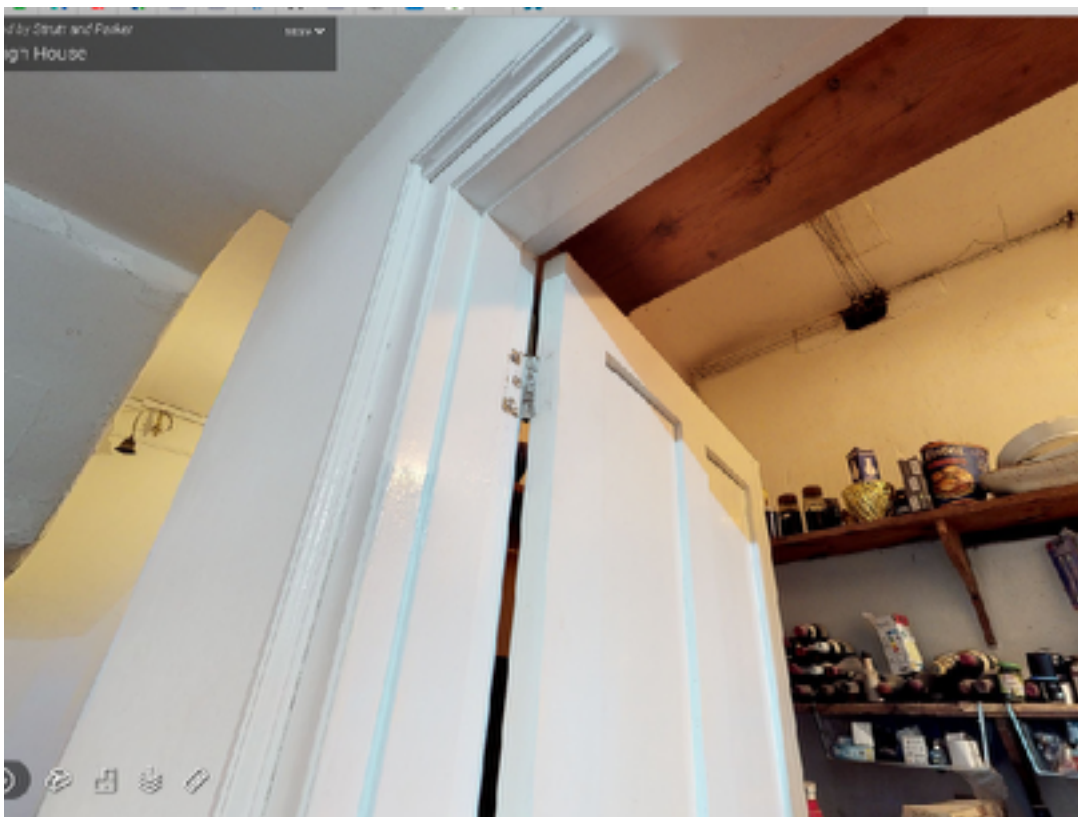
2.4 Frame of door to pantry is C20 although door is C19. Pantry was likely inserted or enlarged during C20 (utilising an existing window and door) creating a pinch point under the stairs adjacent).

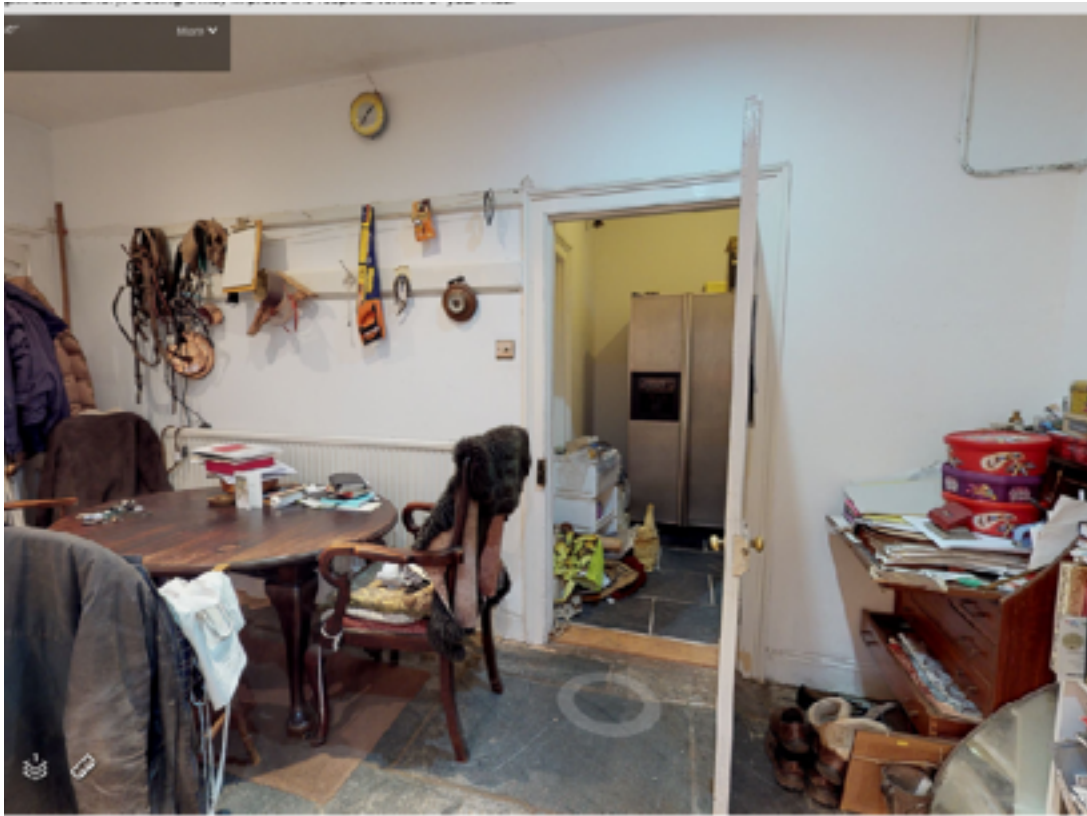
2.5. Wall between kitchen and store room.

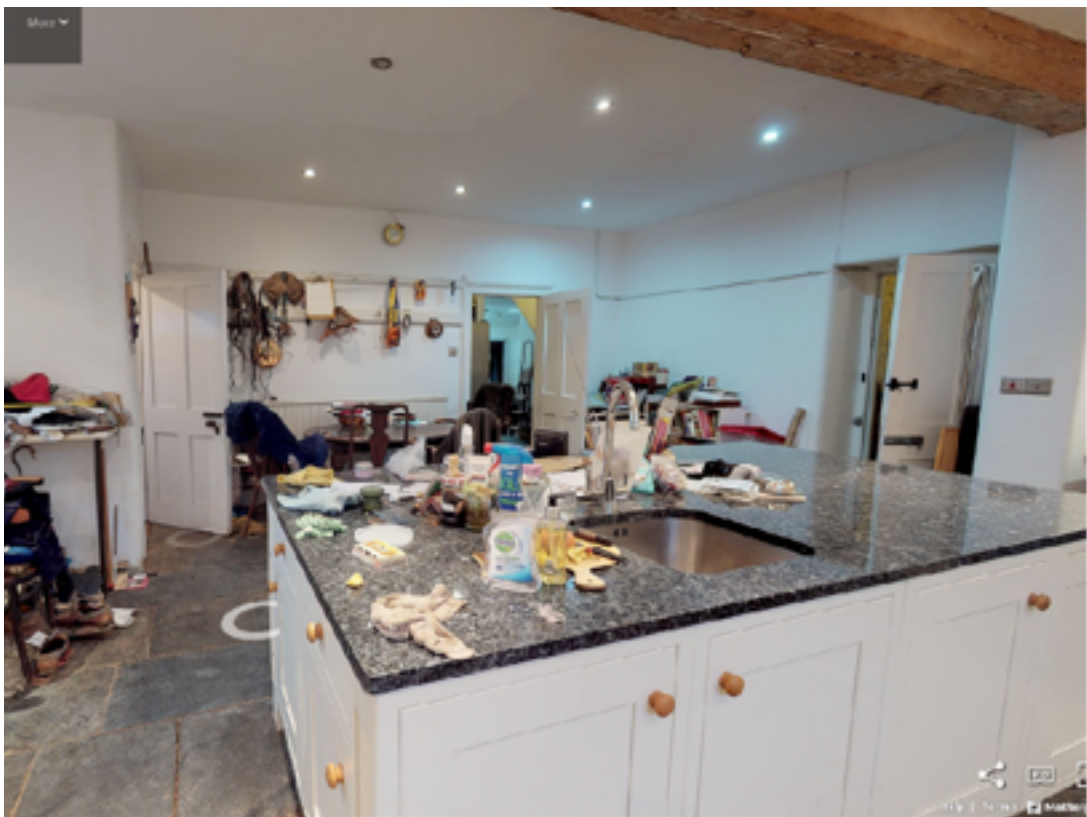
2.6. Wider view of kitchen

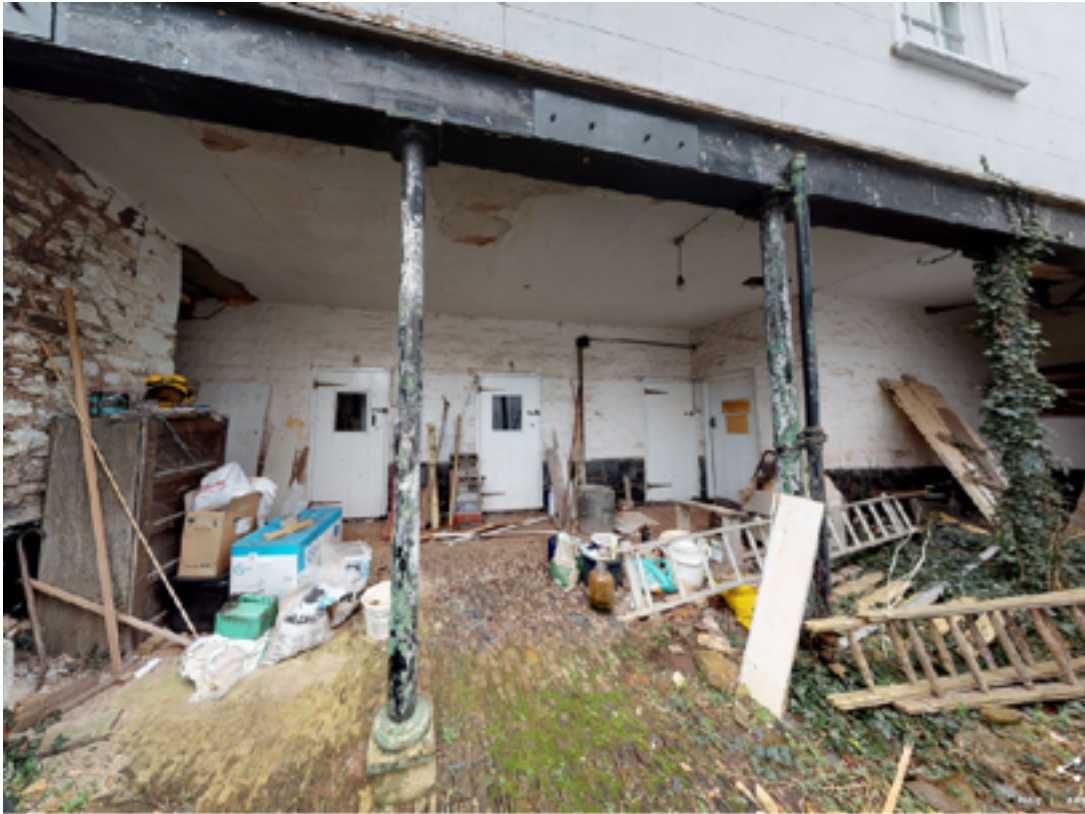
2.7 Existing wrought iron columns within central service yard - glazed screen to be inserted behind.

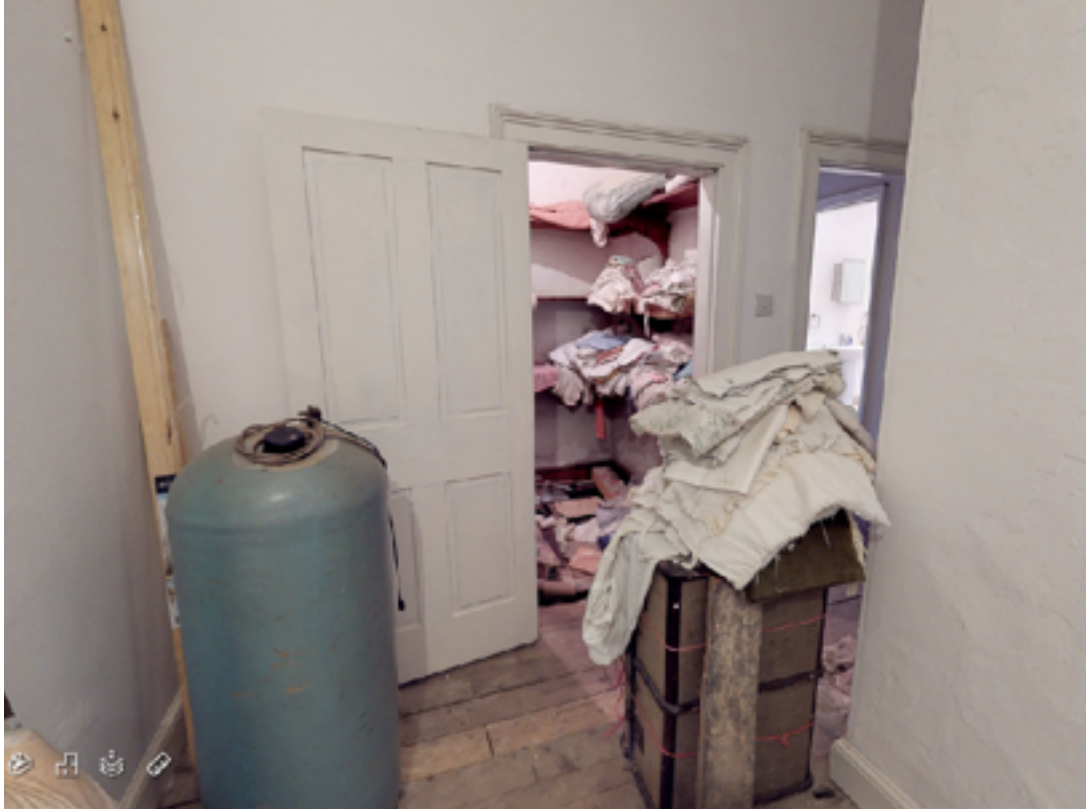
2.8. Part of partition walls to be removed. floor boards in this area are narrower and door frames inconsistent.

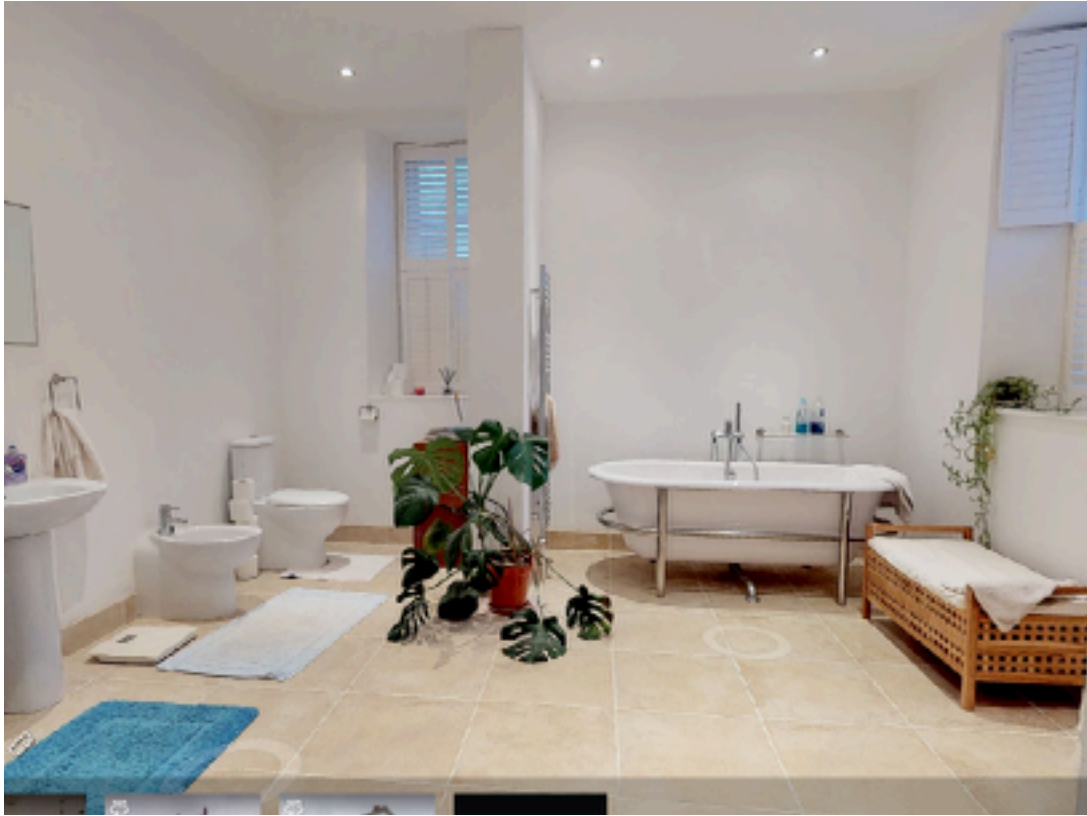
2.9. Bathroom to be subdivided by glass screens - no historic details are present in this room.
