Ashington

Arboricultural Impact Assessment
Northumberland Line

Northumberland County Council

December 2020

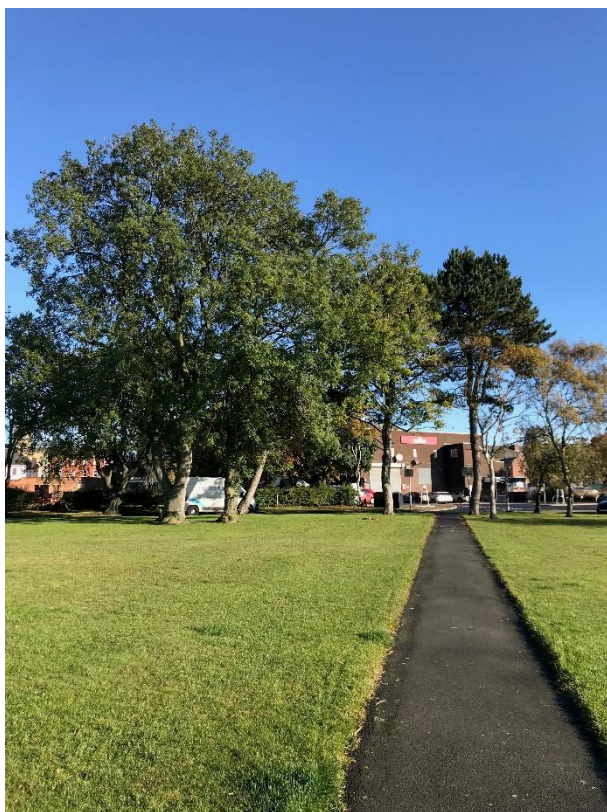
The most significant tree included within the survey is T31 a mature ash, established to the north of an area of formal grassland and dominant within the surrounding landscape and tree canopy. This tree has been identified as high quality due to its prominence in the local landscape, with a high amenity value whilst showing signs of ecological niche habitat (such as a hazard beam), typically only provided by mature and older trees. At the time of surveying, T31 did not show any obvious symptoms of chalara ash dieback (such as a deviation in branching pattern, lesions or browning of young shoots), or other signs (such as fungal fruiting bodies).

Figure 1. T31, visible left, dominant in tree group.

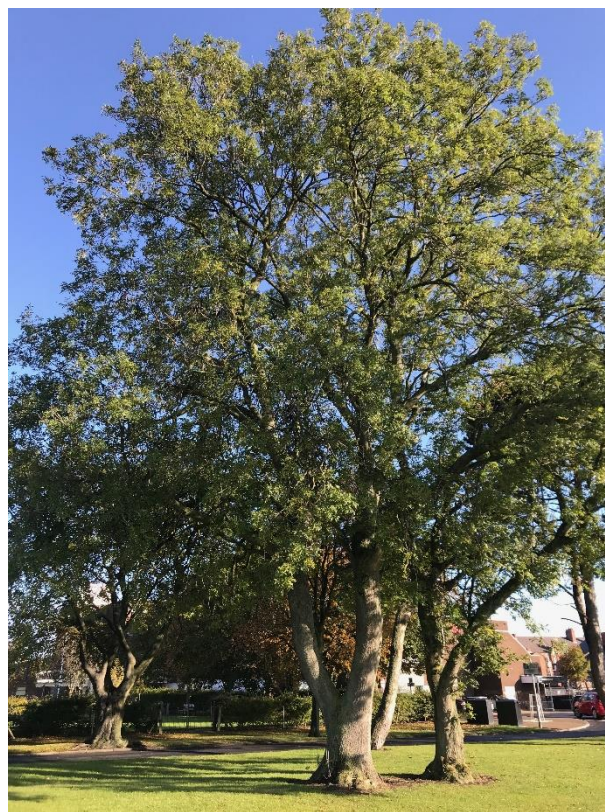
Figure 2. T31, looking north.

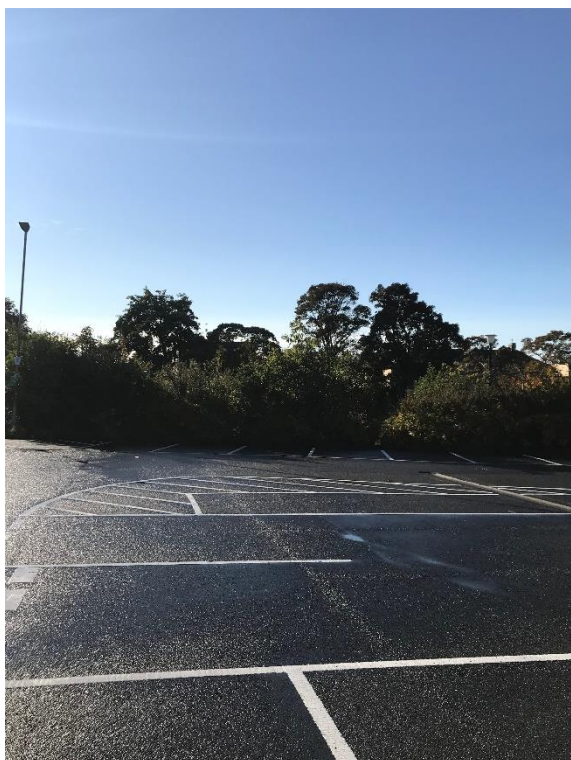
Figure 3. G68 in foreground with T86-T89 in background.

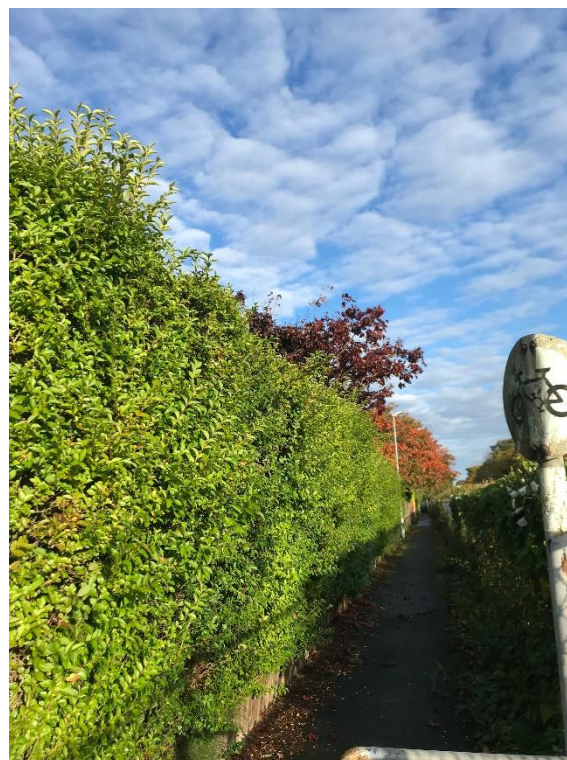
Figure 4. Showing alleyways with boundary hedgerows and small third party trees.

South of the public areas are various alleyways bordered by managed hedgerows and trees established in third party land. Predominantly, these trees and hedgerows are of low arboricultural value, either due to previous poor management practises or due to their overall size and therefore age, meaning replacement utilising like for like planting is likely achievable.

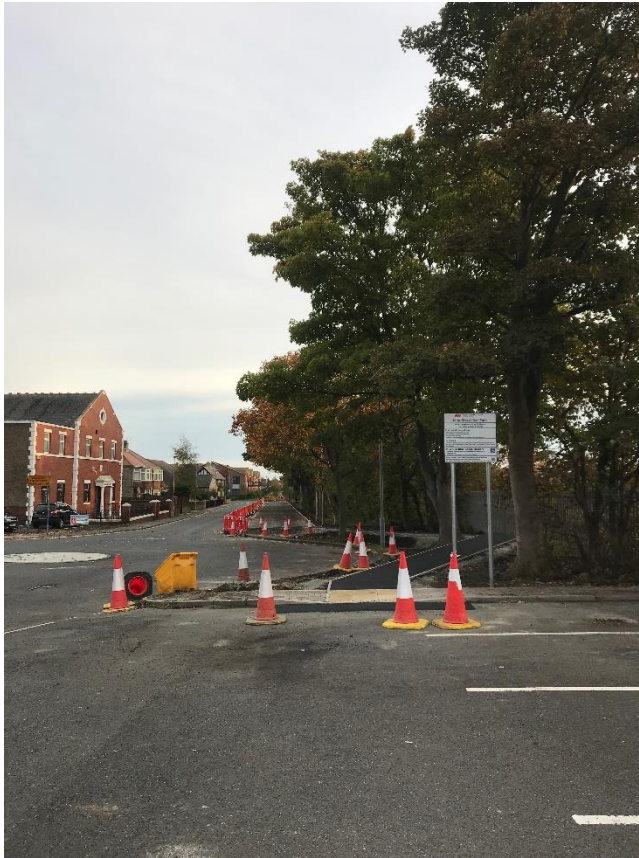
East of the railway, the trees form an avenue to the west of John Street. The majority of the trees situated in the avenue are of moderate quality. A number of ash trees within the avenue (namely T50, T51 and T54) were noted to be in severe decline, likely due to ash dieback. Due to the condition, position and size of these trees, they were categorised as unsuitable for retention and are recommended for removal.

During the survey, it was noted within this area that development works were recently undertaken, including the installation of hard surfacing immediately adjacent to the tree avenue. Mounded soil and concrete at the base of trees and severed roots present on the ground were noted. It is recommended that the extent of potential damage resulting from these works is investigated utilising hand excavation techniques only to determine the potential extent of root severance.

Figure 6. View south down John Street.

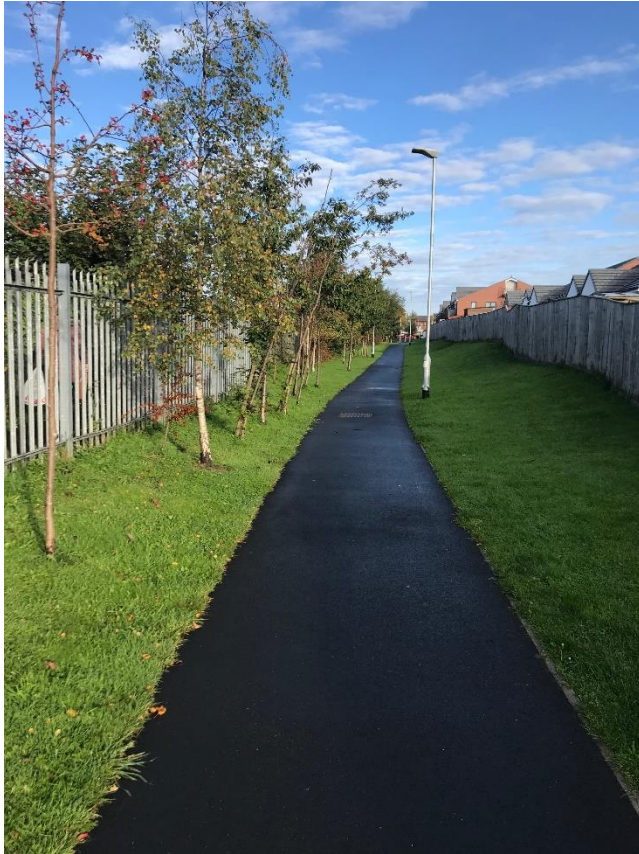
To the south of the avenue is a large group of new tree planting, comprised of a large variety of tree species, identified as low quality (Category C) due to their overall age and size and therefore their replaceability. This tree group however has high future potential and will likely provide good screening of the railway.

Figure 10. Showing new tree planting, G119.
