# Arboricultural Impact Assessment BS5837:2012

Epsom Lodge, 1 Burgh Heath Road, KT17 4LW

Ref: AEL-18298-AIA

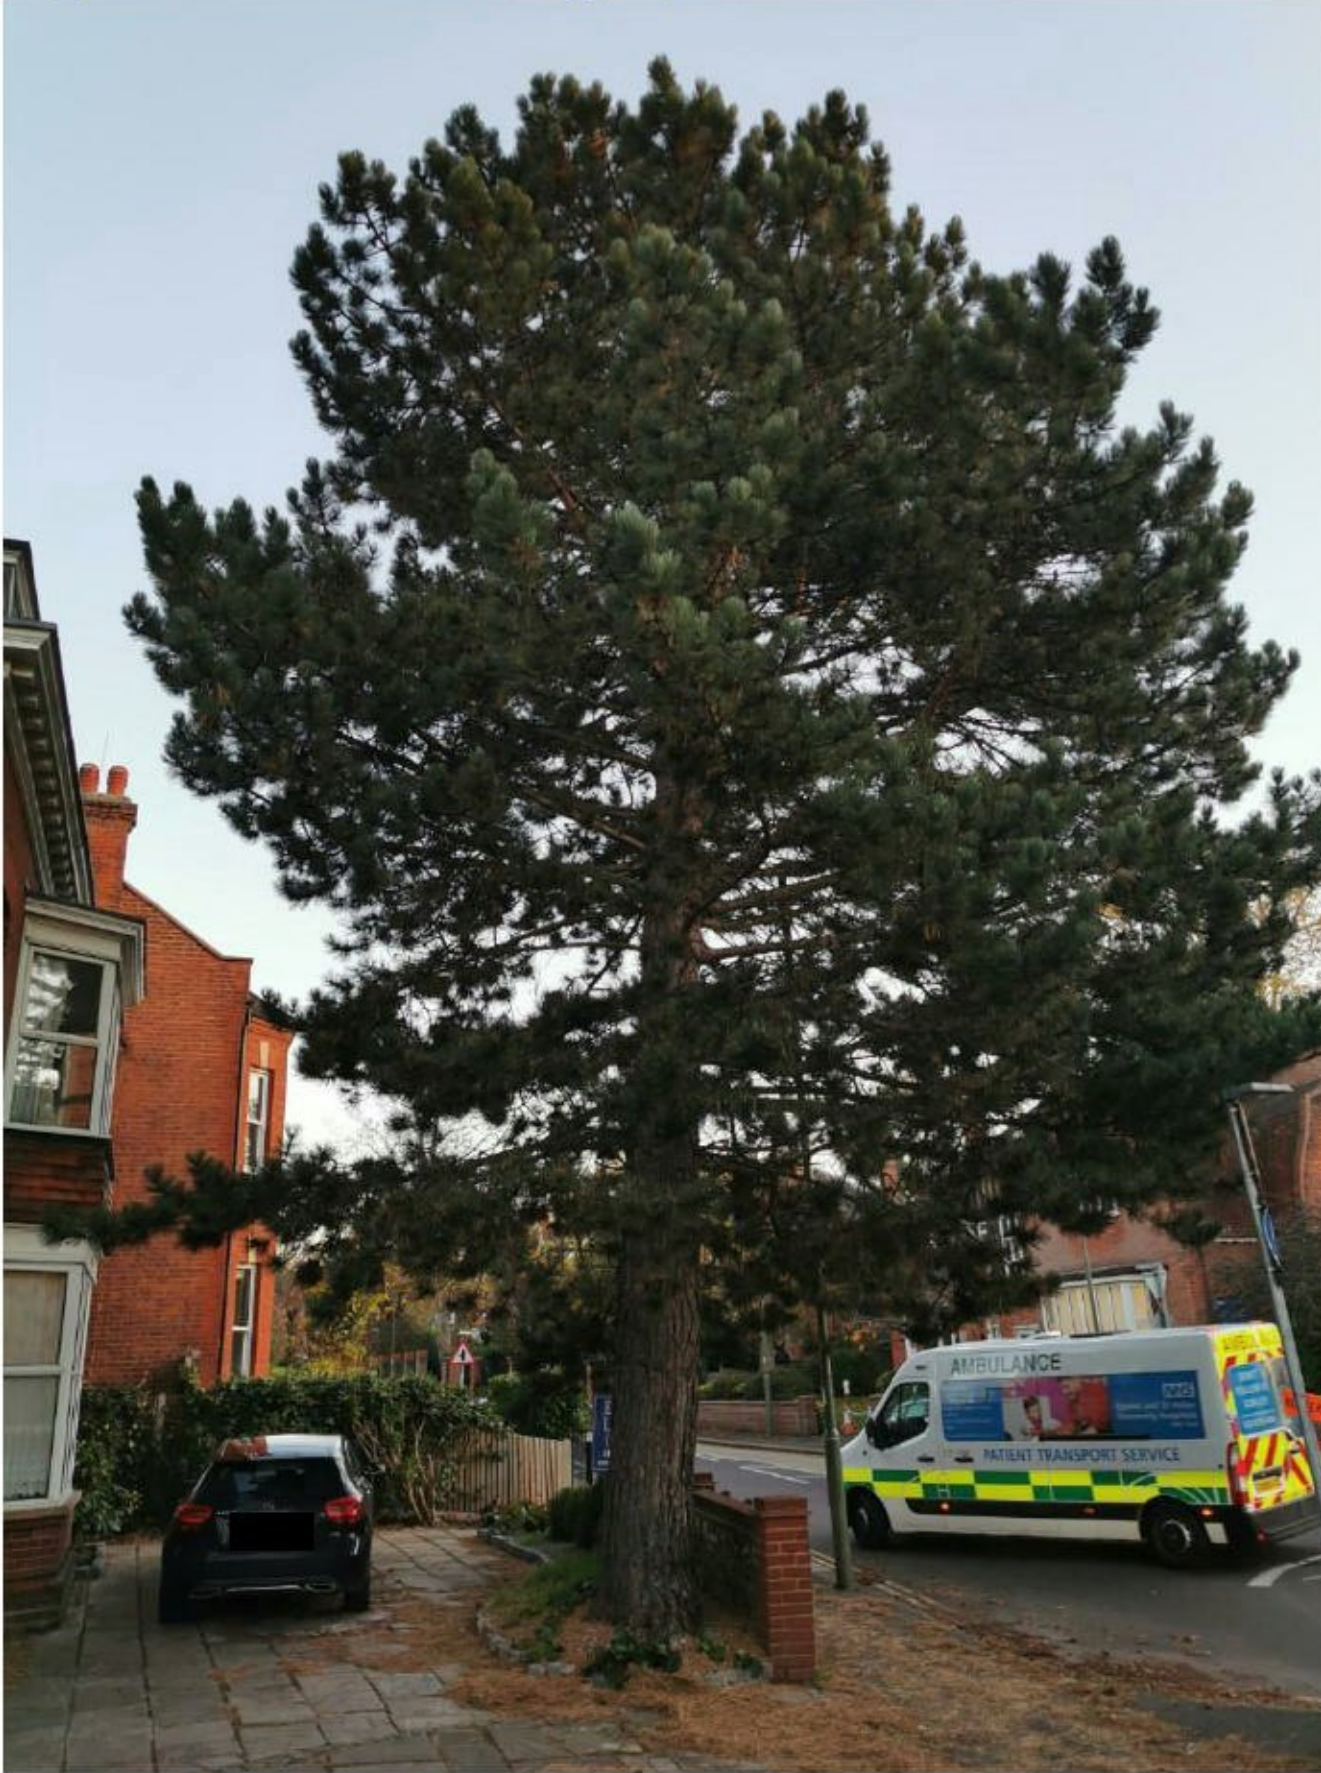
The only tree of value is T.1 to the front of the property, and this has some localised damage to the hardstanding.

There is current direct damage to the hard standing and lifting of the paving slabs. It is likely that the roots will be directly underneath the paving and will hinder any future landscaping. There will also be a significant root severance for the new driveway to the underground car parking area.

AEL-18298-PIC1 – Showing T.1 to the front of the house.

Tree Ref:	Category	Works required	Development	Arboricultural
T.1	B1	Fell to ground and remove stump	Yes	Likely

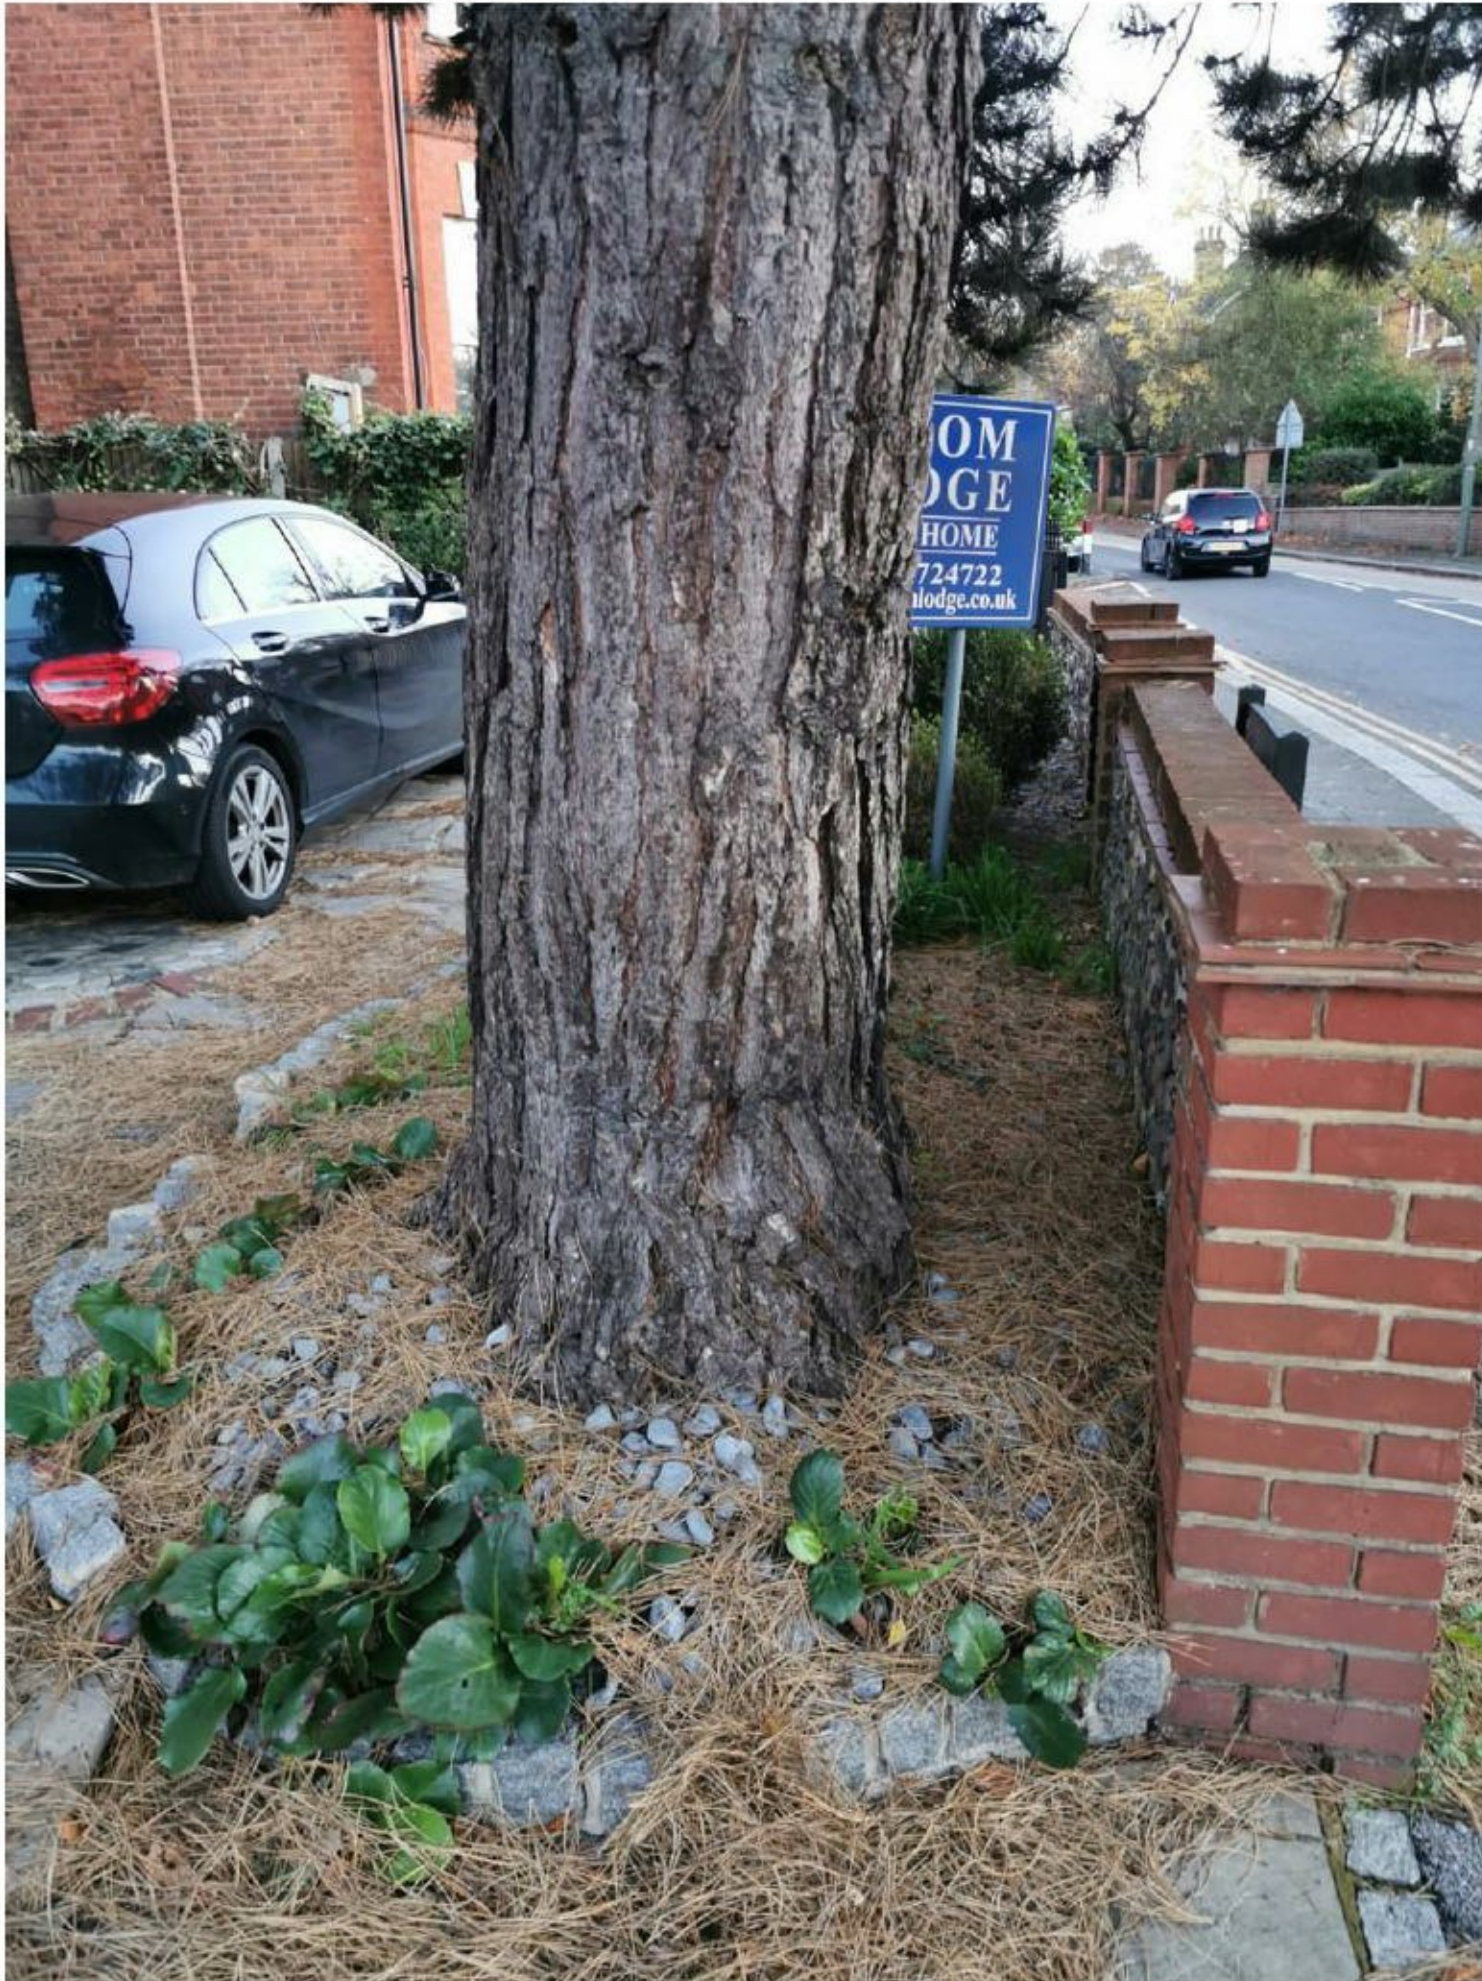
2. The tree has been planted to the front of the property and is currently causing localised direct damage to the hardstanding and to the boundary wall. If this is not addressed, then this damage will only continue, and future management of the area will require patching of the driveway and wall. This may be an adverse effect on the tree, or cause damage to the roots. There were no obvious signs of damage to the main building at this stage. The bedrock is showing as a chalk formation so there is a very low likelihood of shrinkage within the soils from the tree.

The tree is close to the front boundary wall and causing some damage. The tree is also low over the pavement and the road and this will need to be crown lifted under the Highways Act to 3m over the pavement and 5.2m over the road. This would change the visual value of the tree.

AEL-18298-PIC2 – Showing tree in proximity to the wall.
