PRELIMINARY BAT HABITAT ASSESSEMENT AND
EMERGENCE SURVEY,
45, MANOR GREEN ROAD,
EPSOM,
SURREY, KT19 8RN.

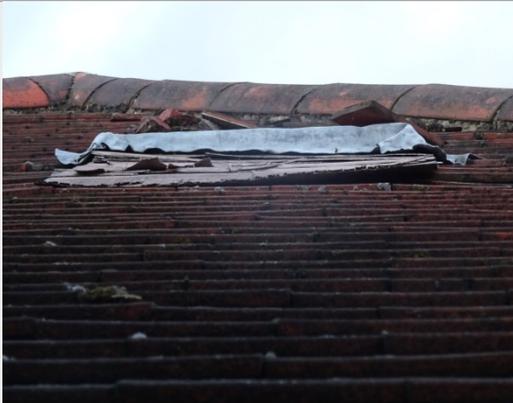
3.9 Daylight could be seen through the roof where an old roof light/flue had been removed and covered, leaving gaps with suitable potential for bat ingress.

Photograph 1. Hole in roof

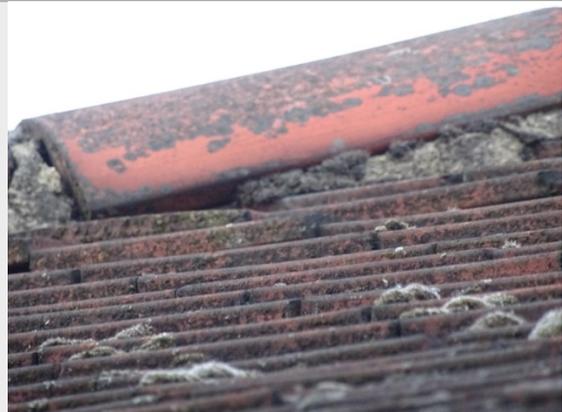
3.3 A hole was located in one of the ridge tiles, the rest were sound. There was a patched hole in the roof, where they may have been a projecting flue or roof light. This had been covered to prevent rainwater ingress.

Photograph 2. Hole in ridge tile, west facing slope

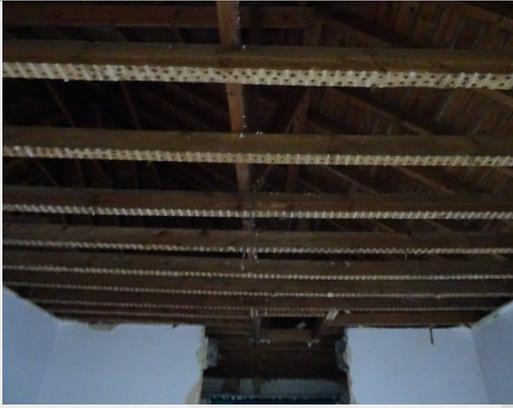
3.8 The ceiling has been removed and the trusses are exposed. The sarking board could be seen. There were no droppings located on the concrete floor indicating that any bats have been flying around the internal void.

Photograph 3. Exposed truss work as viewed through ceiling

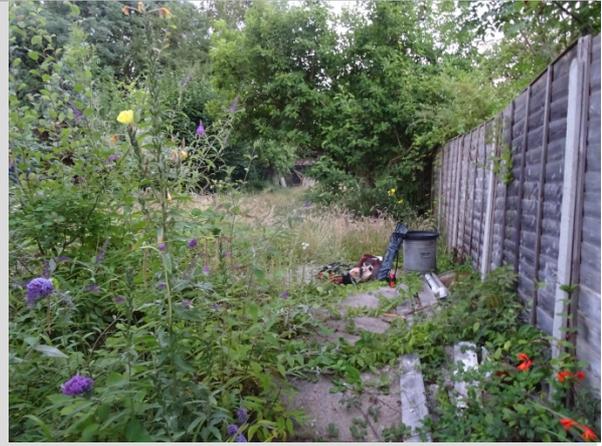
3.10 Vegetation links were poor, although there is a fruit tree in the front garden and a magnolia and fruit trees some 20m from the bungalow at the rear.

Photograph 4 Trees at the rear of the garden
