3.7 Link Entrance—

4.1 External Repairs: Findings & Recommendations

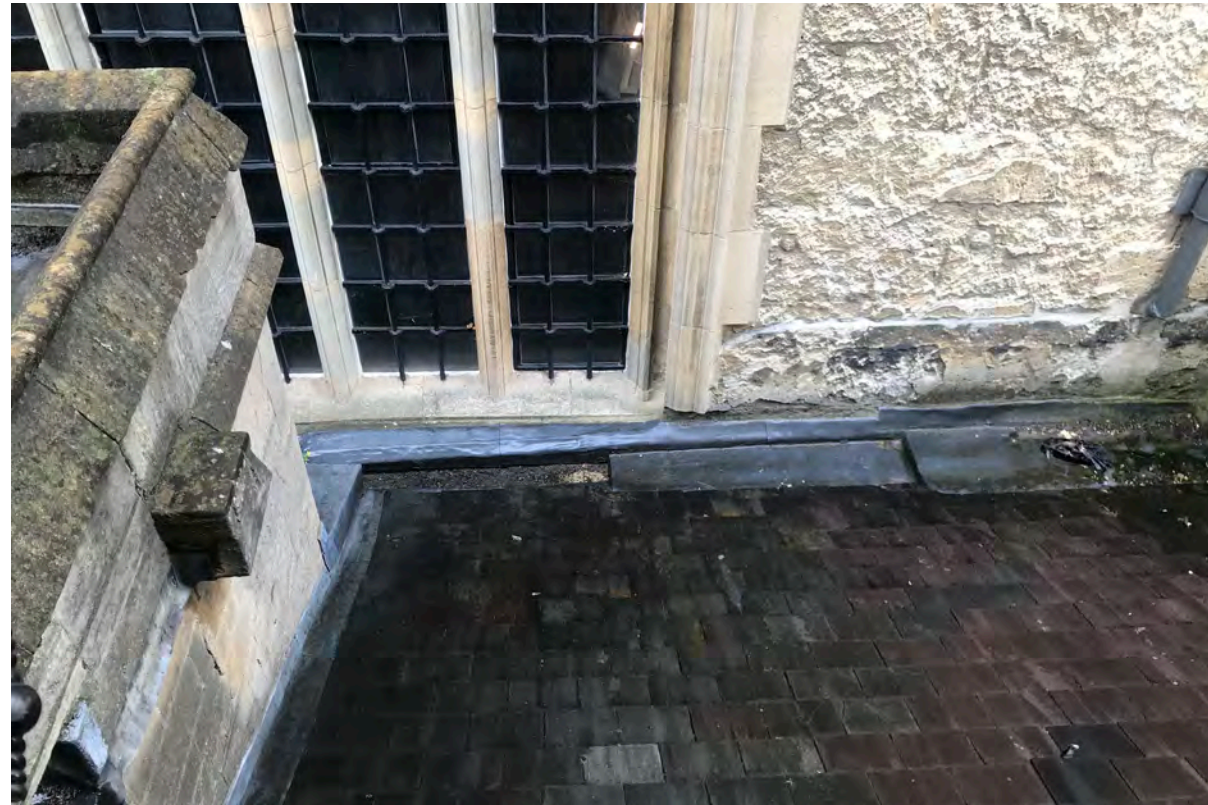
The current junction with the Bodleian is dressed unevenly into the wall and appears to have required the destruction of much of the original window cill.

Existing condition showing leadwork abutting bodleian cill

Our proposal seeks to improve on the existing interface by lowering the junction with the Bodleian to beneath the cill. The work offers the opportunity to repair the damaged cill or at least protect the window surround from further deterioration.

Beyond the window, leadwork will be flashed into mortar joints within the Bodleian wall. Further site surveys to determine the remaining extent of the Bodleian cill profile and mortar joint positions will allow working details to be developed during Stage 4.

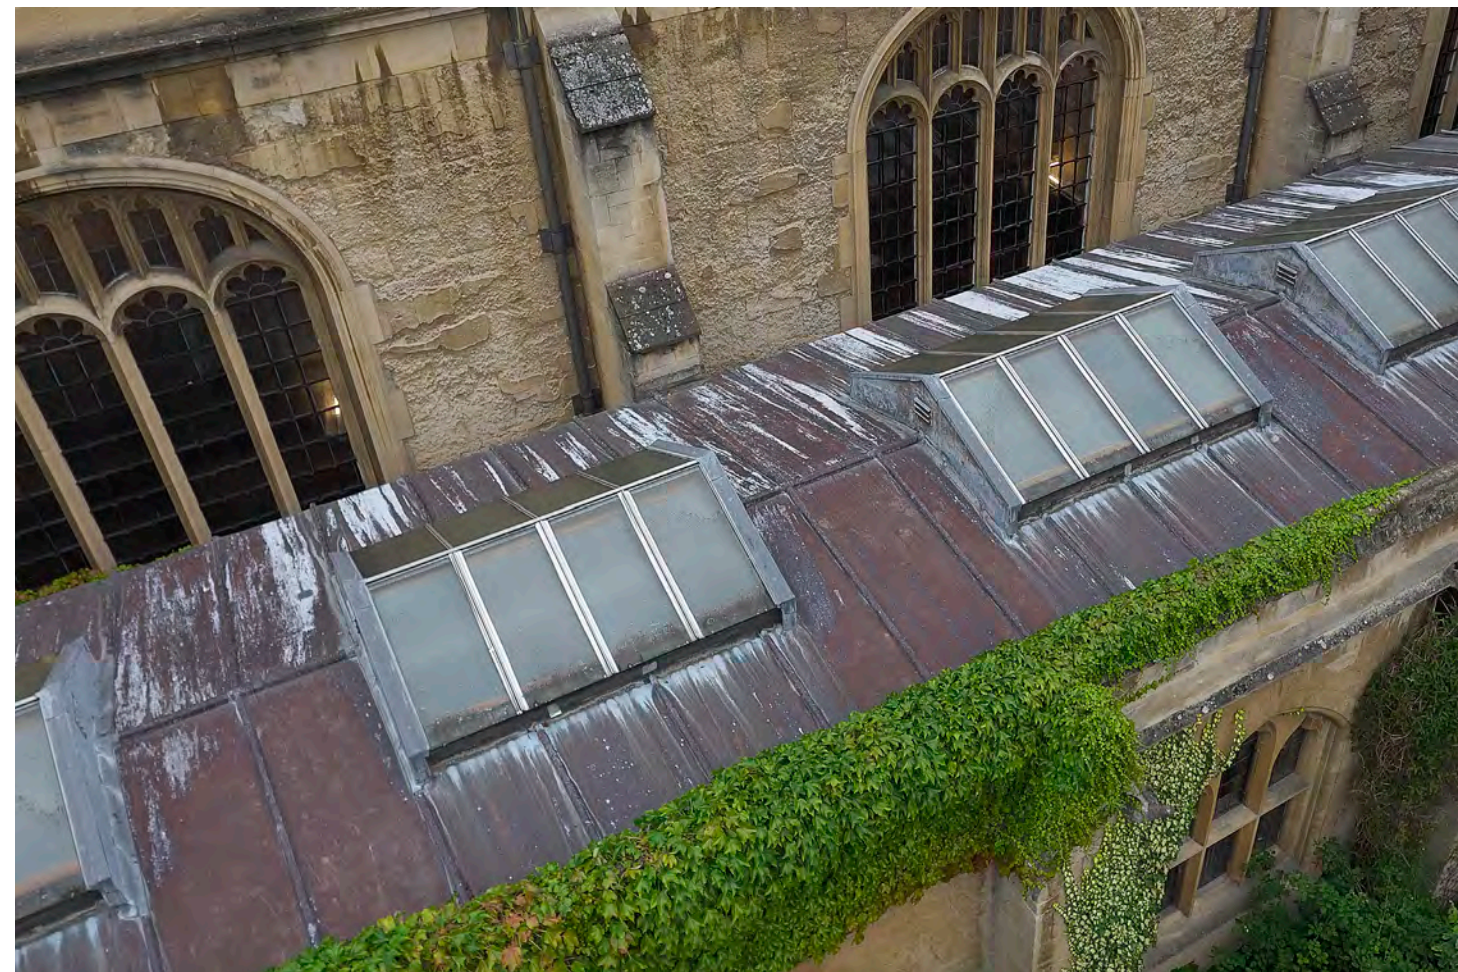
The present condition of the roof-lights is poor. Upstands are not insulated and the wired single glazing contributes to heat loss and condensation. Frames around the glass panes have leaked in places and some are in an advanced state of decay.

Aerial view of existing roof-lights installed in 1957

Our proposals for the annexe roof-lights replace the 1957 alterations with two parallel ribbons of clerestory windows that extend the length of the mezzanine balcony. These will be covered by a lead lantern cap that should extend no higher than the ridge of the existing roof-lights.

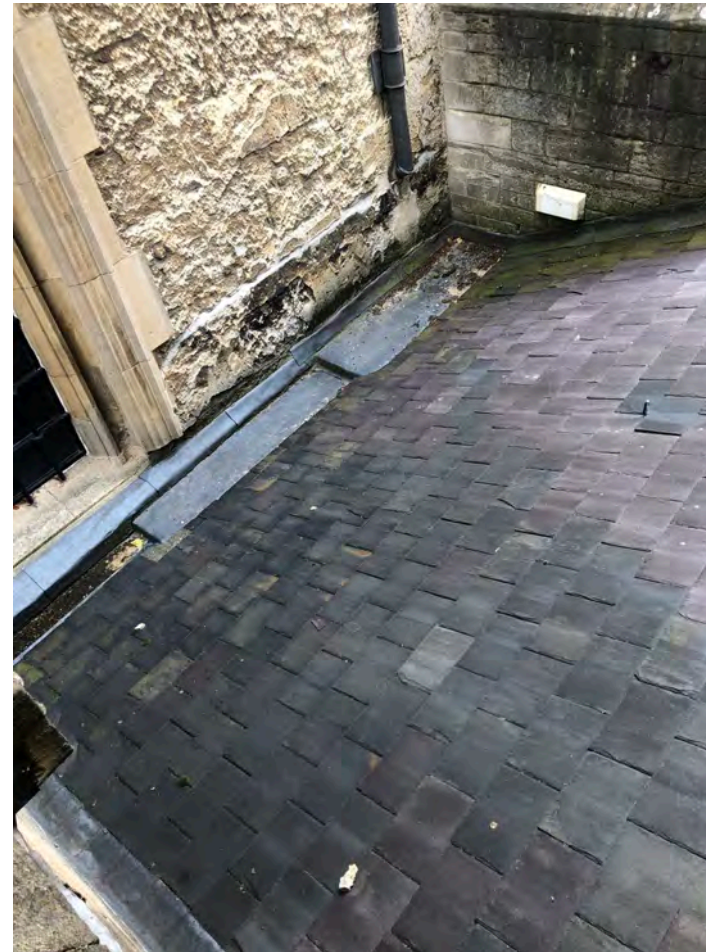
01. Flat lead roof to link block
02. Sloping slate roof above safe room and gardener's store

With the internal reorganisation of the library, the slate roof is now not fit for purpose, offering limited head room beneath. It is therefore proposed that this roof be replaced, salvaging any slates for the main roof where possible, with a series of lead bays with rooflights to provide daylight to the rooms below.

A new lead flashing would be created to the Bodleian, ensuring a minimum of 150mm below the existing cill. The vertical face of the drop in height between this gutter and the higher roofs to the west will be lead lined. The existing lead roof will be relaid to new falls to the east to also drain into this gutter, with a new hole created through the parapet to allow for this, and the existing hole repaired.

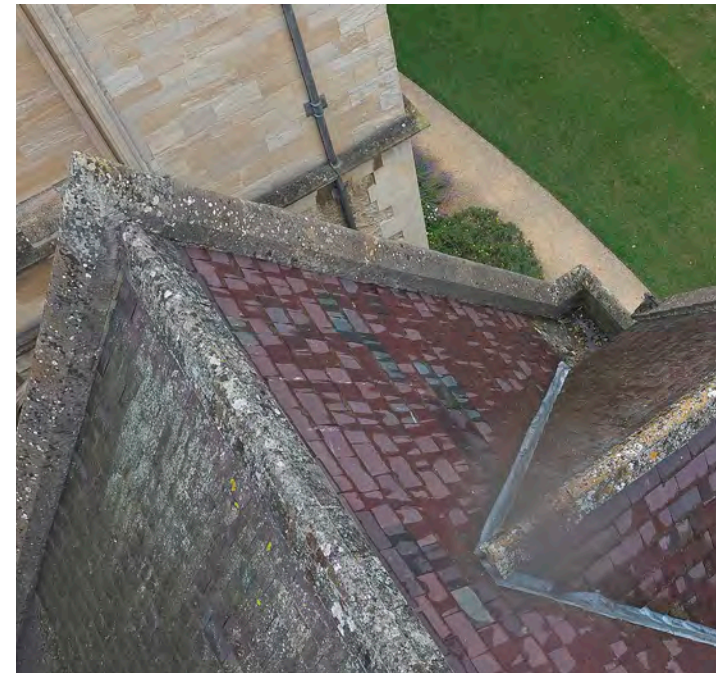
The slates to the south slope are of a different nature to those at the rear, except to those areas beneath the dormers.

The mix of blue and grey slates to the south slopes is visually unappealing, while those to the north slope are far more consistent, apart from one small area behind the tower.

01. Bird's eye view of southern side of main library
 02. Annexe
 03. Junction at Main Library, Tower, Annexe and Link buildings
 04. Main Library
 07. Main Library - difference in slates
