DESIGN, ACCESS, SIGNIFICANCE AND JUSTIFICATION STATEMENT September 2020 rev A

Replacement windows and doors at 4 Counters Court, Mill Street, Sidmouth, EX10 8DW.

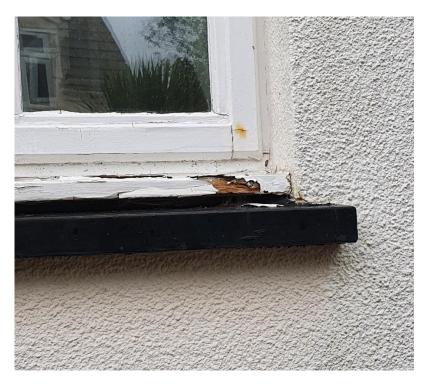
Cill rotten and casement joint defective and repaired

The proposal is replace the existing defective softwood double glazed stormproof windows and doors with hardwood to match existing.

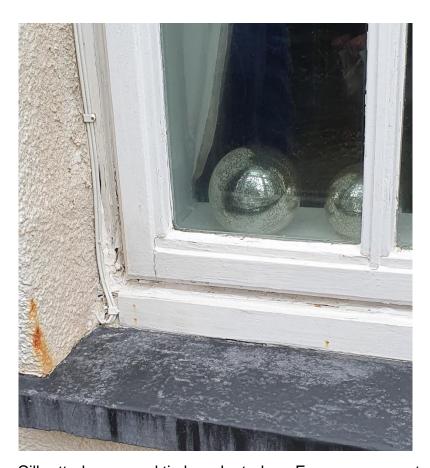
Cill rotted away and timber planted on, Frame, casement and beading rotten.
