DESIGN, ACCESS & HERITAGE STATEMENT IN RESPECT OF  
RE-ROOFING AND ASSOCIATED WORKS  
AT  
No 11 WALMGATE, YORK YO1 9TX

MARCH 2021 – REF 21/00529/LBC

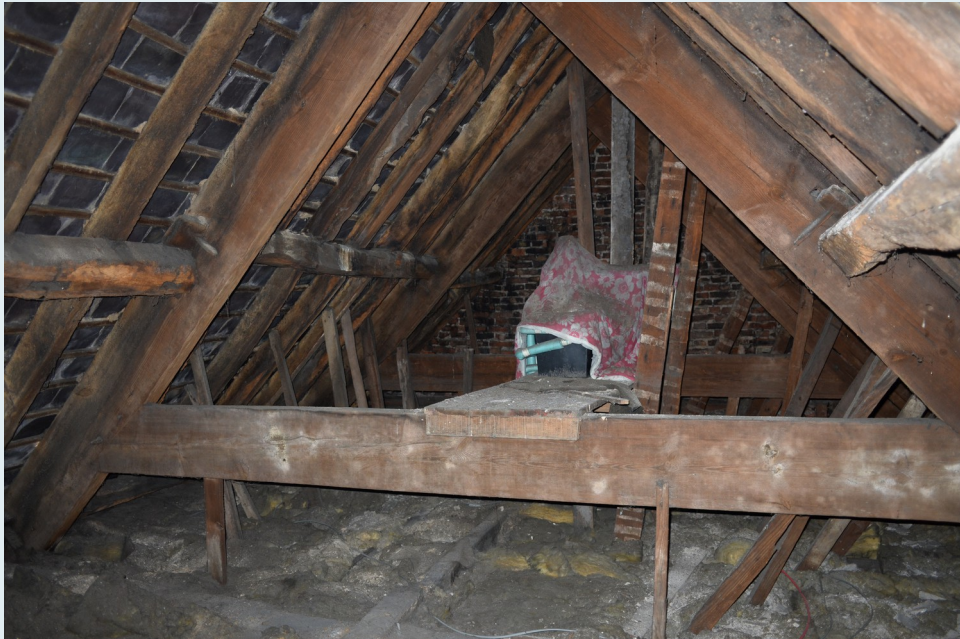
*Roof structure viewed from centre of property facing rear – note redundant galvanised tanks to be removed during works*

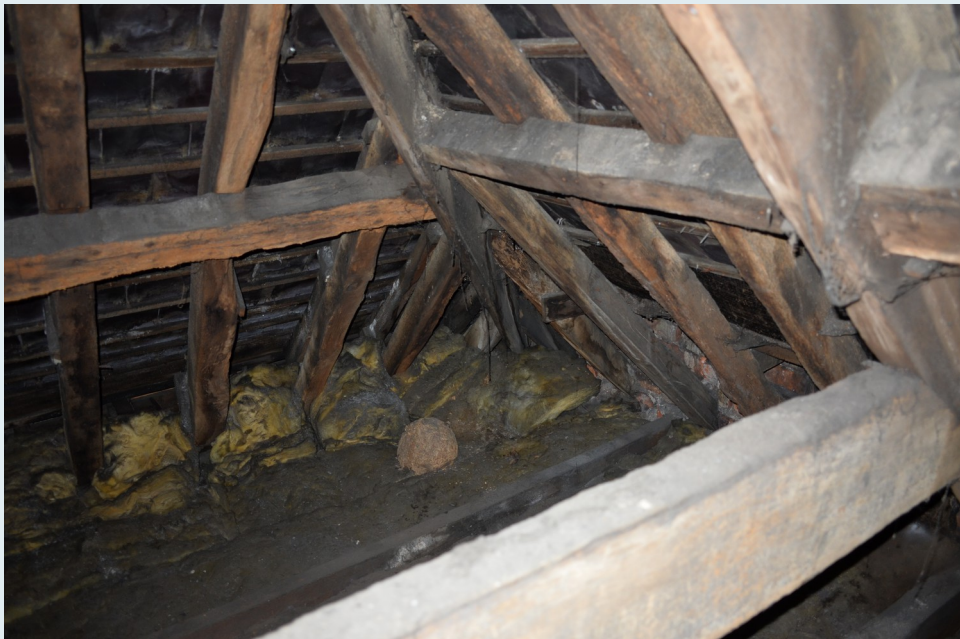
*Roof structure viewed from centre of property facing front – note staining and evidence of rainwater penetration to rafters*

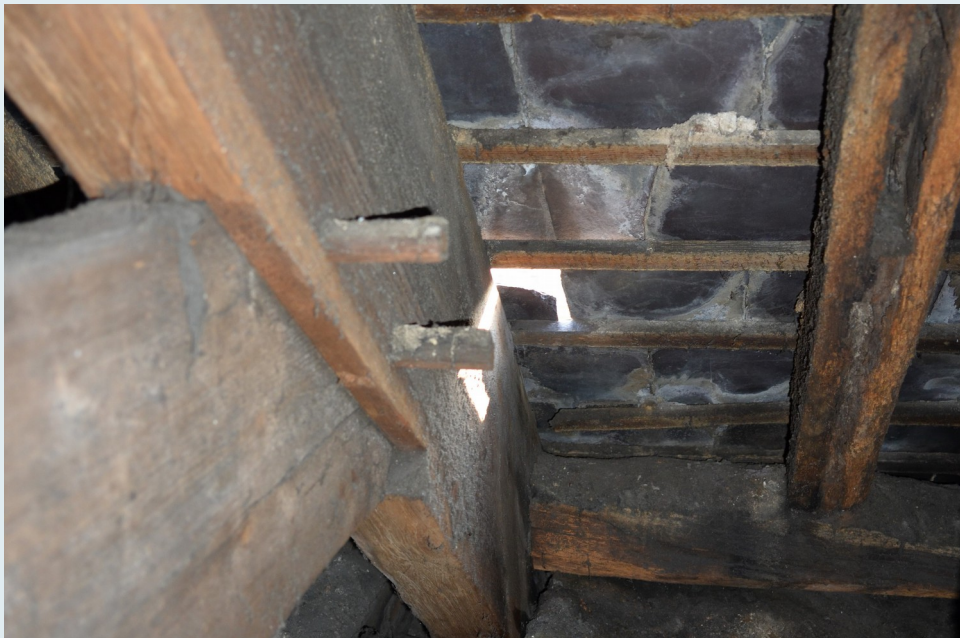
*Slipped and missing slates visible from within loft-space. Note also isolated infestation to rafters, which are to be treated with an organic paste, such as boron or similar to mitigate the risk of further damage.*
