Bat Roost Report

**Global Centre for Rail Excellence
(GCRE)**

Bat Roost Survey Report

Rev A | 18 June 2020

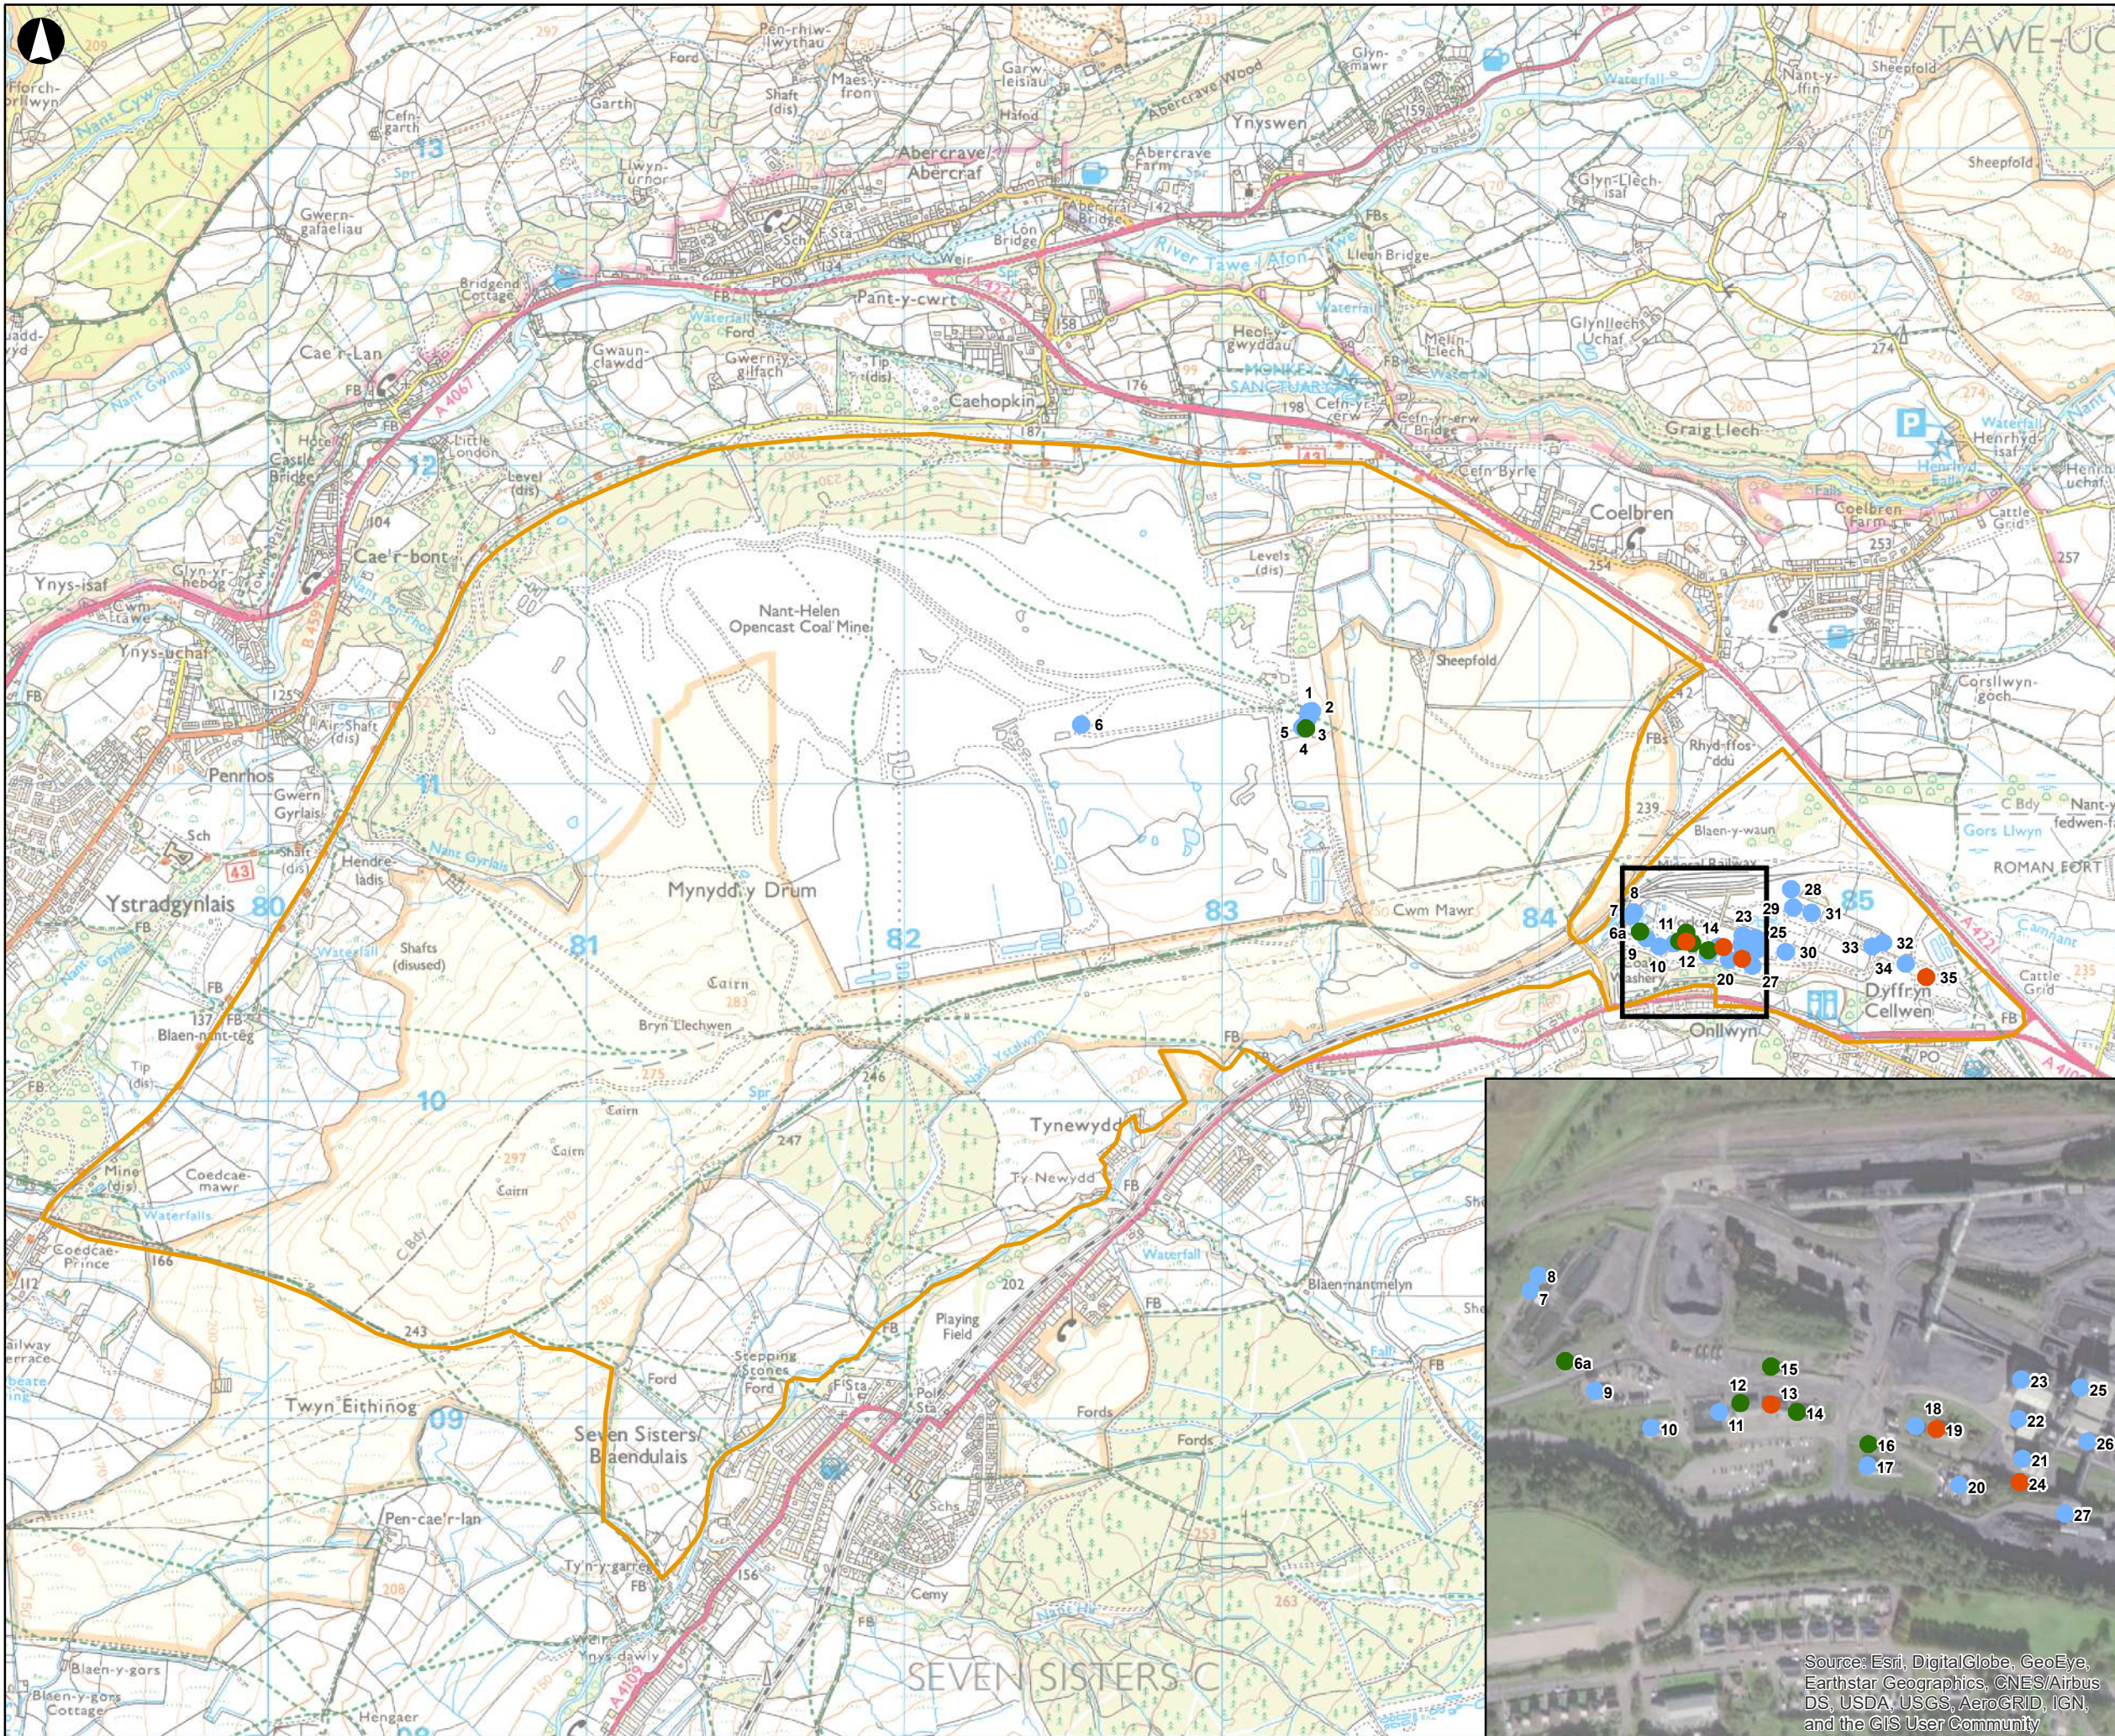
**Figure 2
Building/Structure Survey Results**

The results of the PRA and nocturnal surveys are presented within Table 8 below, with building/structure locations shown on Figure 2. A bat roost was confirmed within a stone tunnel (No. 36), at the western end of the study area. No other evidence or roosts were found within any buildings/structures in the study area.

The comprehensive suite of bat roost potential surveys in relation to buildings and trees within the study area did not identify any bat roosts. One of the structures – an old stone railway tunnel, was found to support a bat roost however. It is not anticipated that this roost will be affected by the Project. However, if this roost were to be disturbed by any works, a European Protected Species (EPS) mitigation licence application would be required to ensure compliance with legislation.

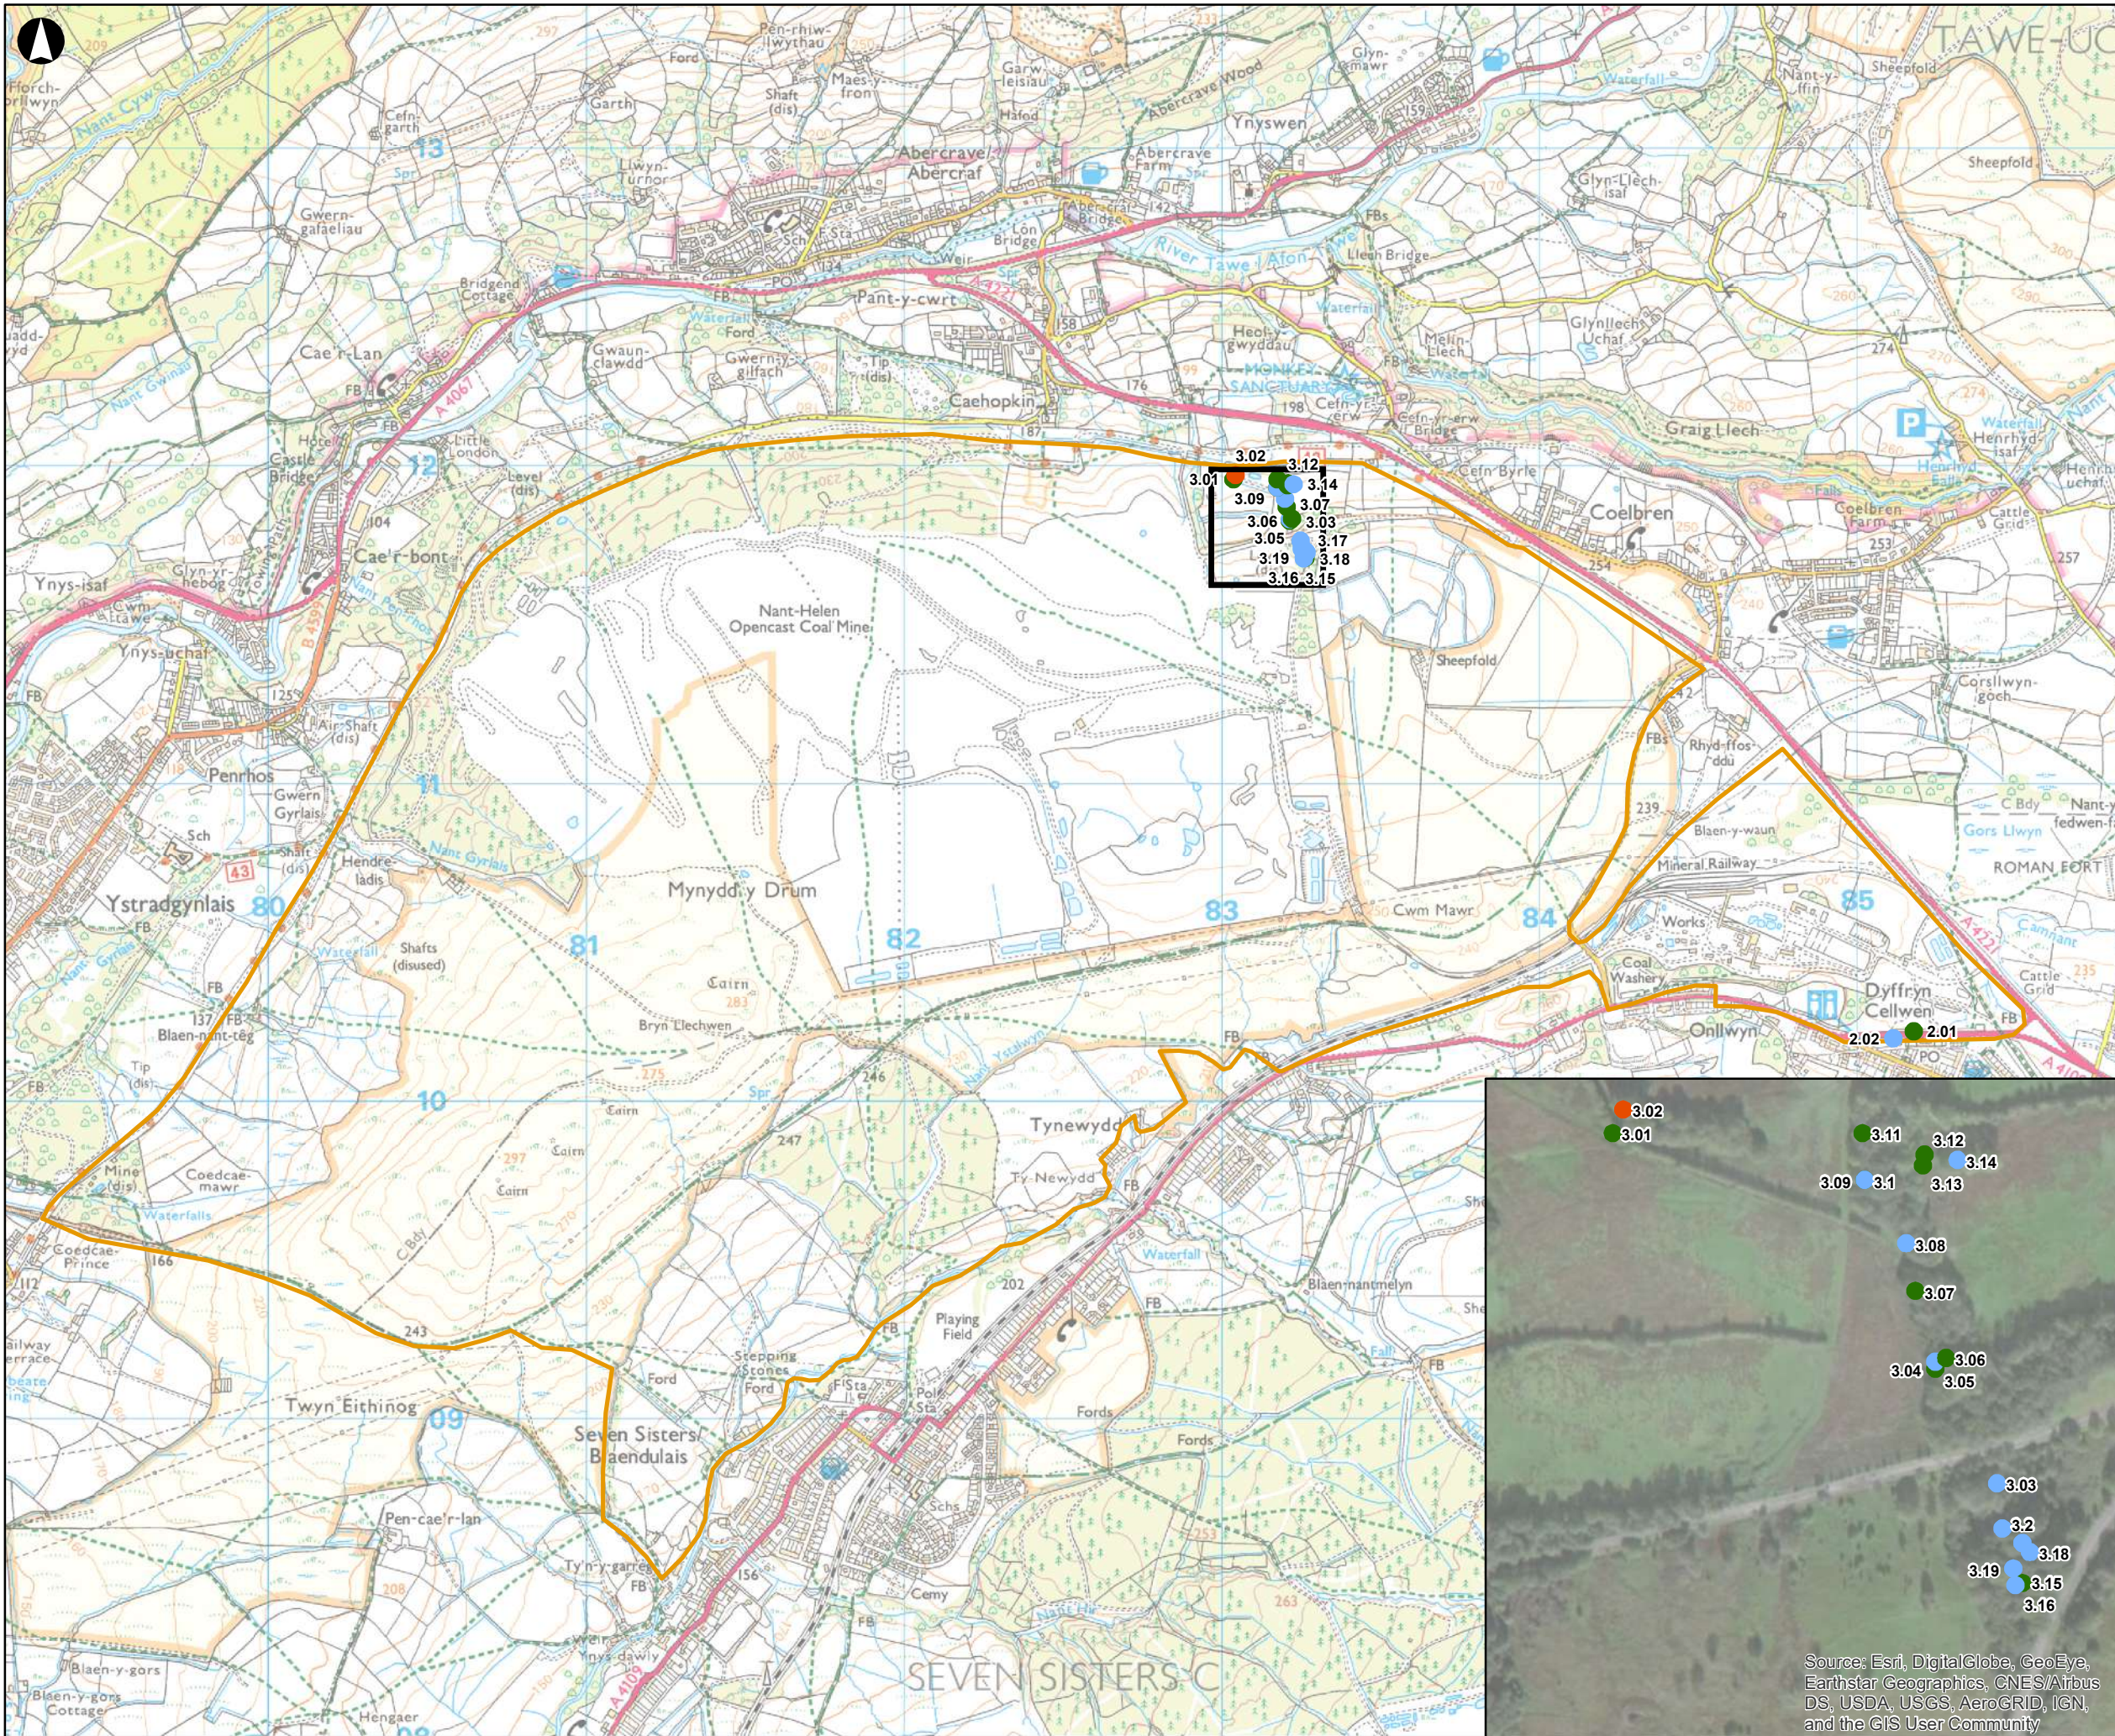
The results of the ground level inspection and tree climbing assessment surveys are presented within Table 9 below, with tree locations shown on Figure 3. No bat roosts were identified within any tree within the study area.

In addition, following a tree climbing assessment, 12 trees (Table 9, Figure 3) still retained bat roost potential (having low or moderate bat roost potential). As such, these 12 trees should be retained if possible. However, if removal/works are required these trees should be subject to updated tree climb inspections immediately prior to removal/works (if required), and only be felled/pruned if confirmed as being clear of any roosting bats.
