DESIGN AND ACCESS STATEMENT and HERITAGE STATEMENT

Poplars Farm, Lower Road, Hardwick, Aylesbury, Bucks HP22 4DZ

March 2021

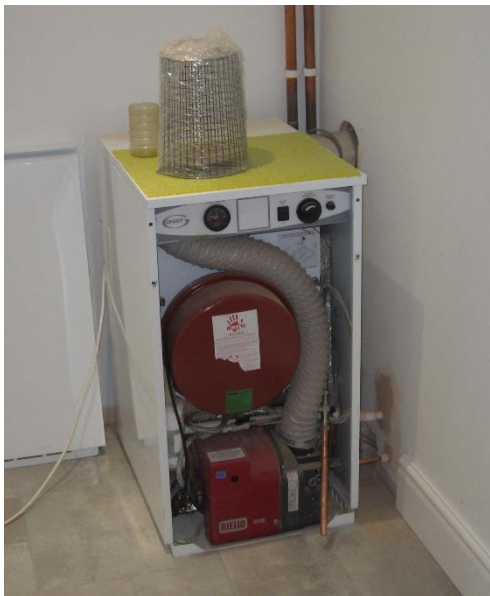
New boiler located in the utility room of The Farmhouse.

Provide new oil-fired boilers to each dwelling as shown on the plans.

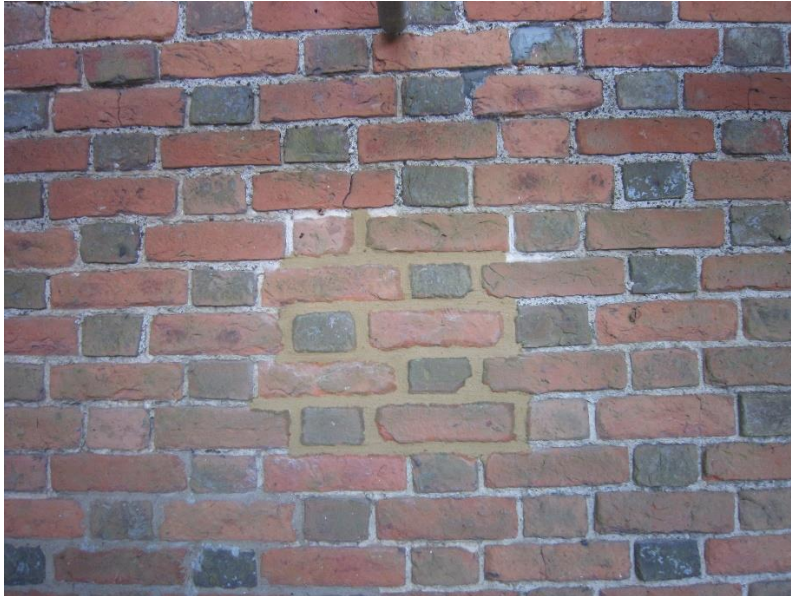
Small sample area of repointing taken shortly after its application

The owner has employed the services of Gunpoint Ltd who specialise in repointing brickwork, in particular lime mortar in historic buildings. While the specialist equipment used to rake out the old mortar avoids any damage to the brickwork, it also penetrates deeper than normal raking out enabling a more comprehensive and longer lasting pointing. The pointing mix is well established and commonly accepted by heritage organisations and supplied by Secil Natural Hydraulic Lime certified to the current version of EN 459-1 (100% burnt limestone) 1:4 Natural Hydraulic NHL 3.5 (moderately hydraulic) bedding and pointing mortar with >3.5 to <10 MPa strength @ 28 days.

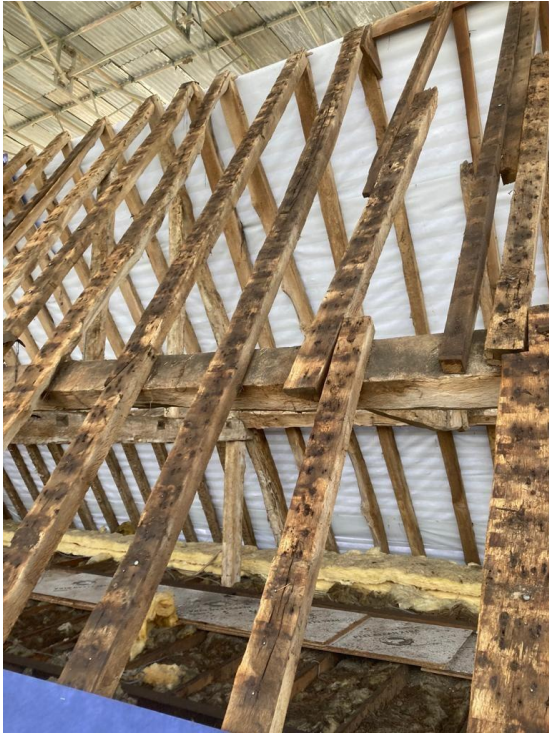
Exposed roof structure over The Range showing poor and inadequate repairs and reinforcement undertaken in the past.

Carefully remove all existing roof tiles, brush clean and remove all moss and other debris. Stack all sound tiles for re-use. Carefully remove existing felt and battens, brush clean the exposed roof timbers and treat for woodworm and rot. Repair all damaged timbers by reinforcing the existing timber rather than replacing.

Line the rafters with lapped 'Cromar' Vent 3 premium performance breather membrane fixed with 38mm x 25mm treated timber battens. Re-lay the original tiles where possible to

the elevation open to public view and provide new handmade clay tiles where necessary. Spray two applications of soot wash to the new tiles to increase the ageing process.

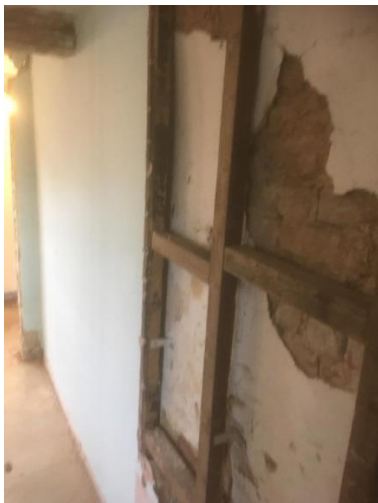
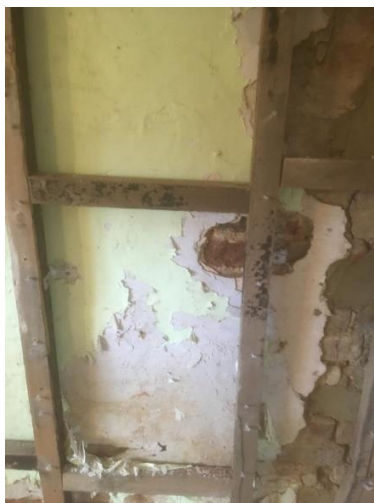
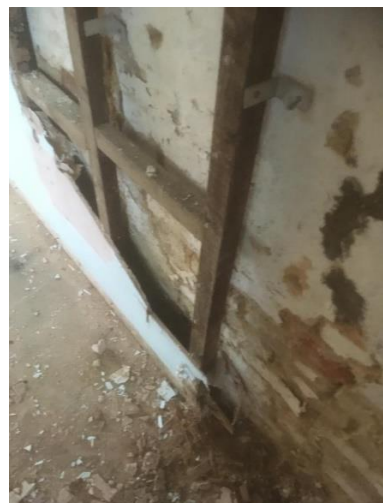
The main defect of the building related to rising damp, both through the floors and the internal and external walls. Ill-advised attempts had been made by previous owners to rectify the problem by lining the walls with stud framework, plasterboard and skim attached directly to the walls and the floors laid with concrete and old plastic fertiliser bags used as a damp proof membrane. Not surprisingly, these futile attempts to resolve the situation only resulted in the problem continuing to cause further deterioration and damage to other parts of the building.

Examples of earlier remedial work and the extent of rising damp

Take up existing concrete floors down to the existing hardcore base, level and apply sand blinding to avoid any sharp corners puncturing the polythene damp proof membrane. Replace and lay concrete oversite over newly laid damp proof membrane. Lay 80mm Celotex GA400 insulation boards and fix 16mm underfloor heating pipes encased in 50mm self-levelling liquid screed.

Remove modern stud framework and plasterboard, strip back plaster to 1m above floor level and inject a chemical damp proof course into the brickwork. Scrape off all loose plaster and line the walls with plain Triton P8 cavity dram system wall tanking fixed with 38mm x 25mm battens. Line throughout with 50mm Celotex insulation and 12.5mm plasterboard and skim. Please note the Triton P8 system is specifically designed to allow the brick wall and remaining plaster to breath freely, thus avoiding any potential lack of ventilation problems.

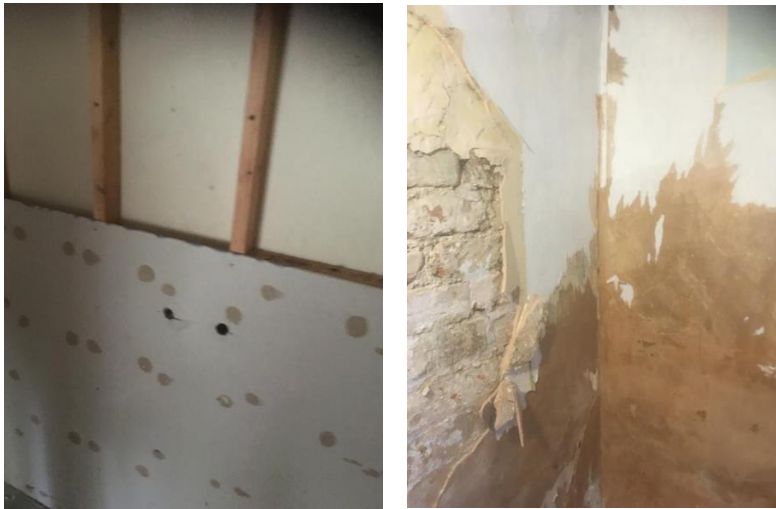
Examples of earlier remedial work and the extent of rising damp

On further investigation, it was evident that the earlier makeshift approach was common throughout the entire building and minimal, incremental works or repairs on a like for like basis would not be cost effective or make any meaningful contribution to resolving the fundamental problem in the long term. Therefore, it was necessary to take a more comprehensive method.

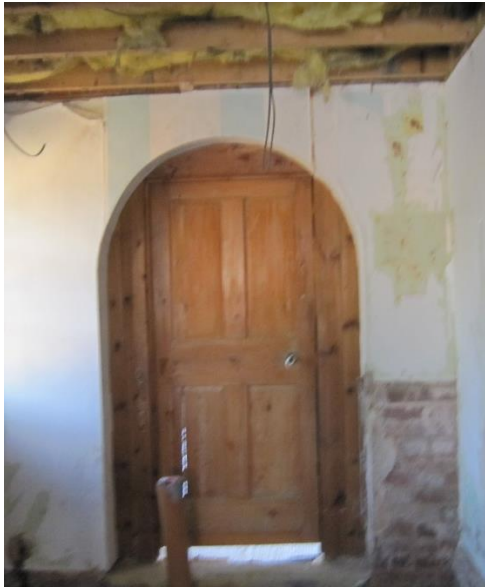
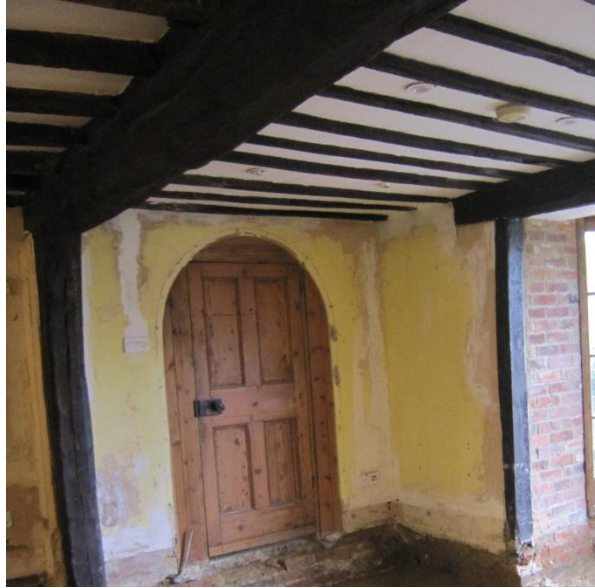
Door 'A' linking The Farmhouse and The Range removed and blocked in.

Three relatively new door openings linking The Farmhouse with The Range have removed and blocked up providing the necessary fire separation between the dwellings.

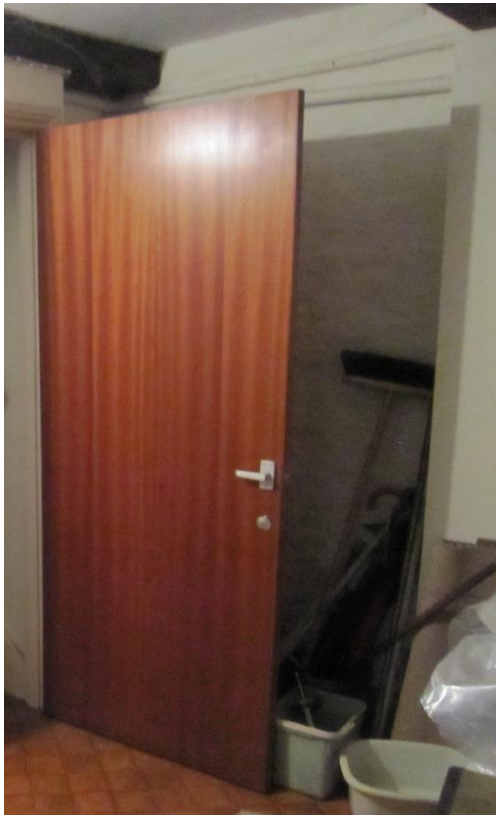
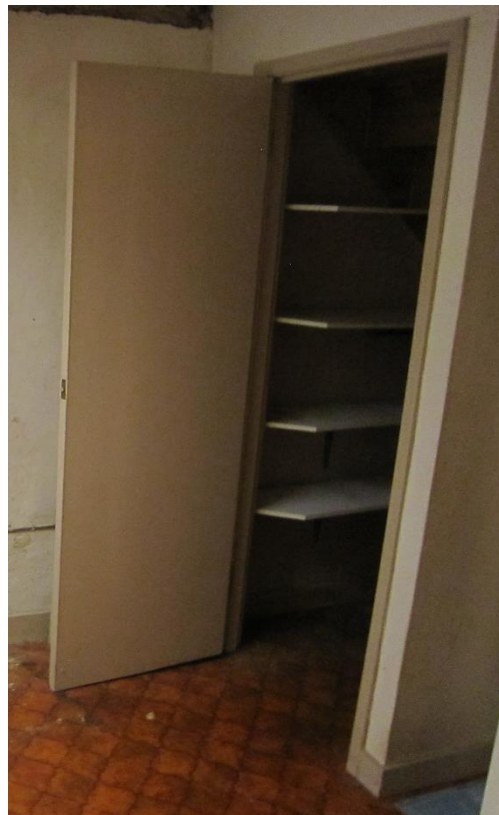
Typical modern post 1948 doors replaced by oak ledged doors

All other modern post 1948 doors and architraves have been removed and replaced with oak ledged doors with traditional latch and strap hinges.

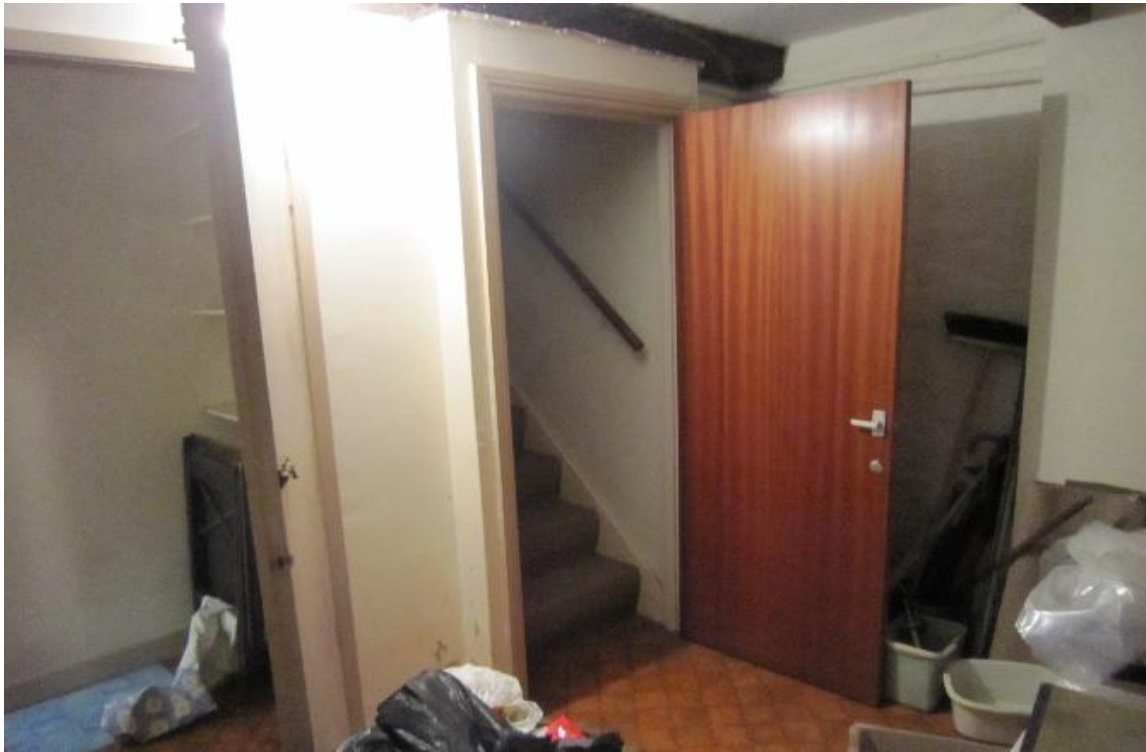
A modern post 1948 staircase had been introduced in the recent past to gain access to the first-floor bar and snooker room to avoid access through the bedroom area in The Farmhouse. The staircase was enclosed by modern partitioning and flush doors as shown in photograph TH5.

TH5 – original staircase

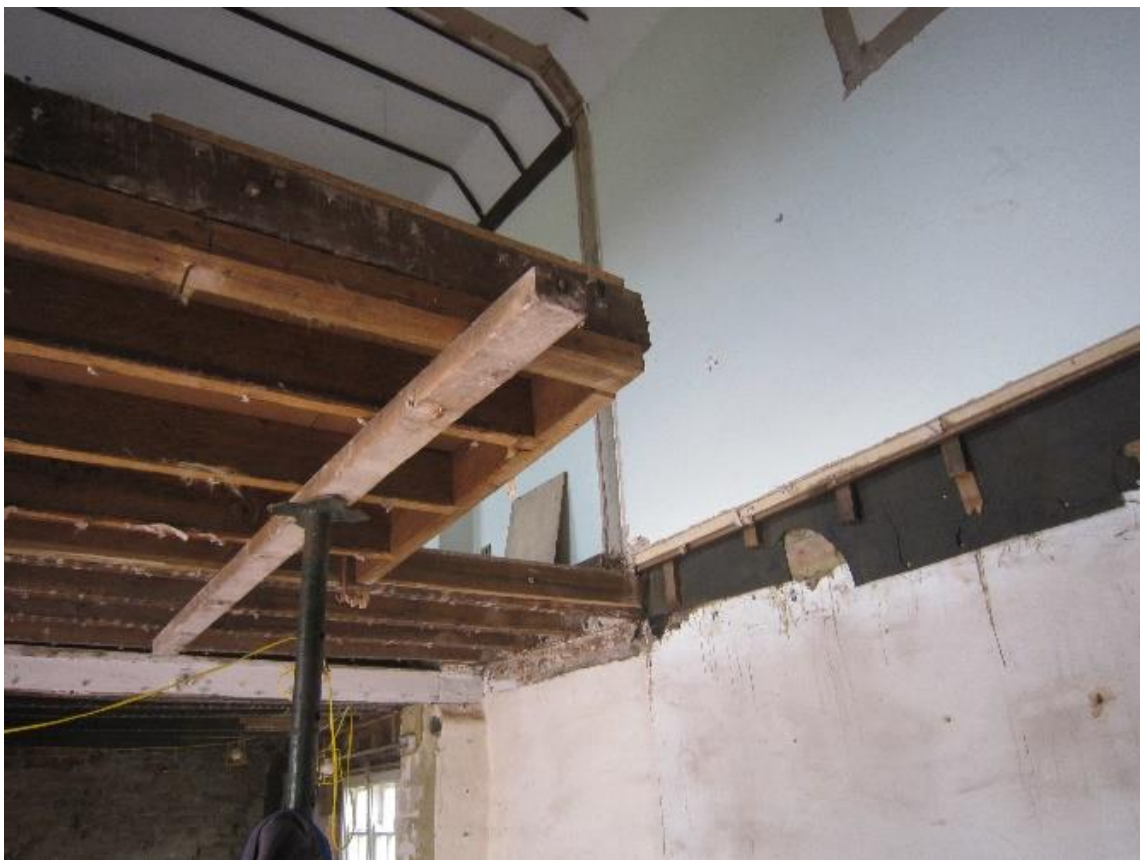
Having removed the staircase and the ceiling plasterboard the floor joists were exposed revealing what can best be described as a makeshift 'L' shaped stairwell with no reinforced trimmers or supporting structure as shown in photograph TH6.

TH6 – the original stairwell

A new staircase was designed in accordance with Part K of the Building Regulations to fit within the original stairwell with a new floor structure and floor structure was introduced in accordance with the specification shown below.

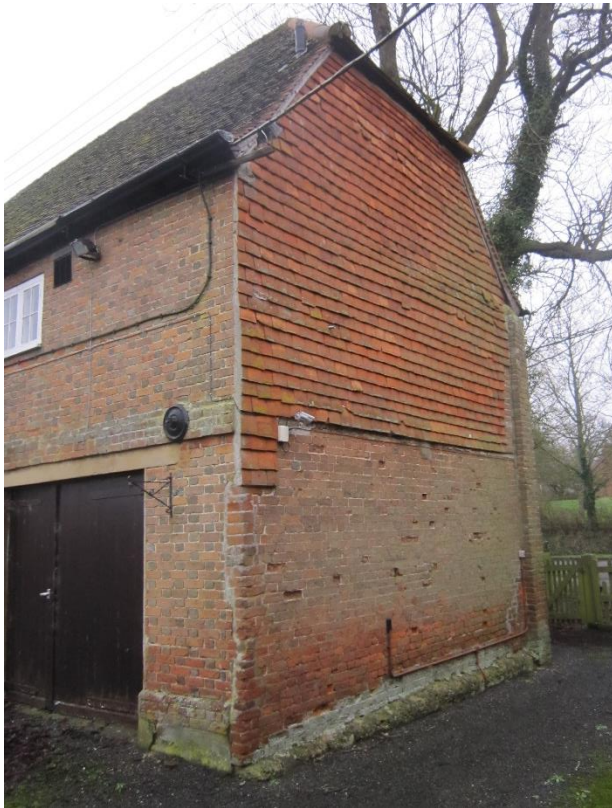
The photograph of the west gable end elevation shown below provides evidence of the general condition of this part of the building. Tiles had fallen from the tile hung wall and some were hanging precariously, having been dislodged from their fixings. The fascia board and soffit of the Dutch hip was irreparable and required replacing on a like for like basis.

The Range west gable end elevation

It was necessary to carefully remove the vertical tiles and battens to expose the structure behind and any repair work necessary to make it sound. The structural integrity of this part of the structure is particularly important because it supports the tile hanging, which, if not correctly constructed, will jeopardise the safety of anyone below. Accordingly, any rotten timbers were either replaced or repaired and all timbers treated for infestation or rot.

Vent 3 breathable membrane was fixed together with 38mm x 25mm battens and handmade clay tiles fixed with galvanised double nailing to the battens.

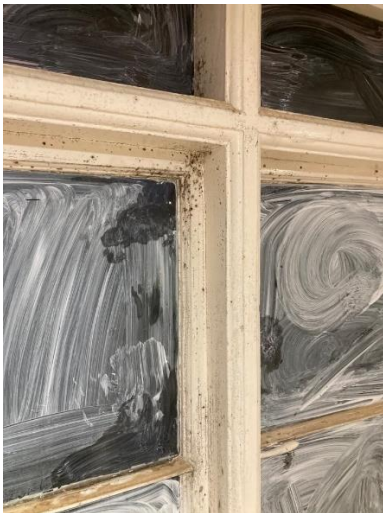
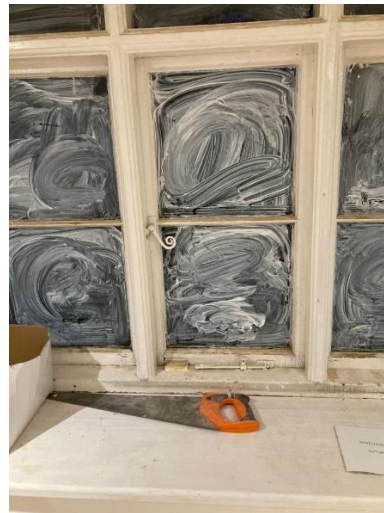
Typical ground floor windows prior to refurbishment

All windows have been meticulously refurbished to weatherproof working order, replacing hardware as necessary, with brass hinges, traditional black iron 'monkey tail' latches and handles.

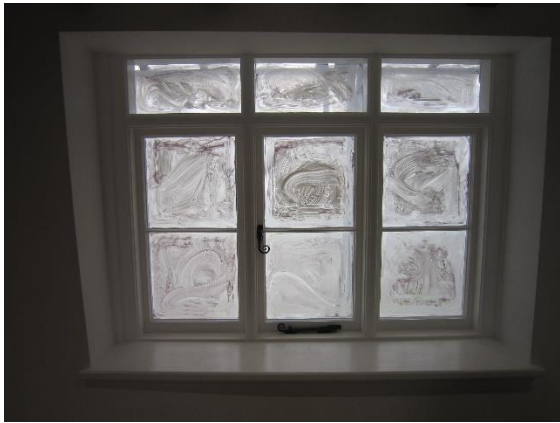
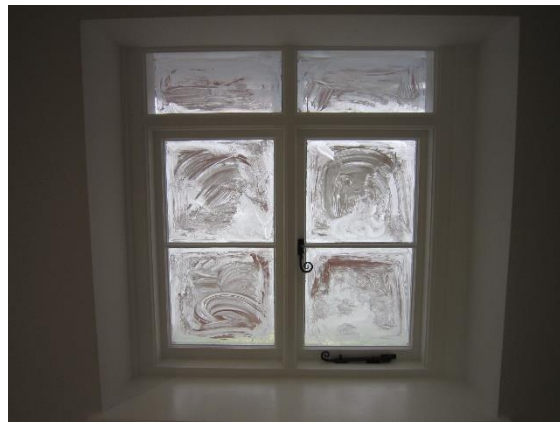
Typical ground floor refurbished windows

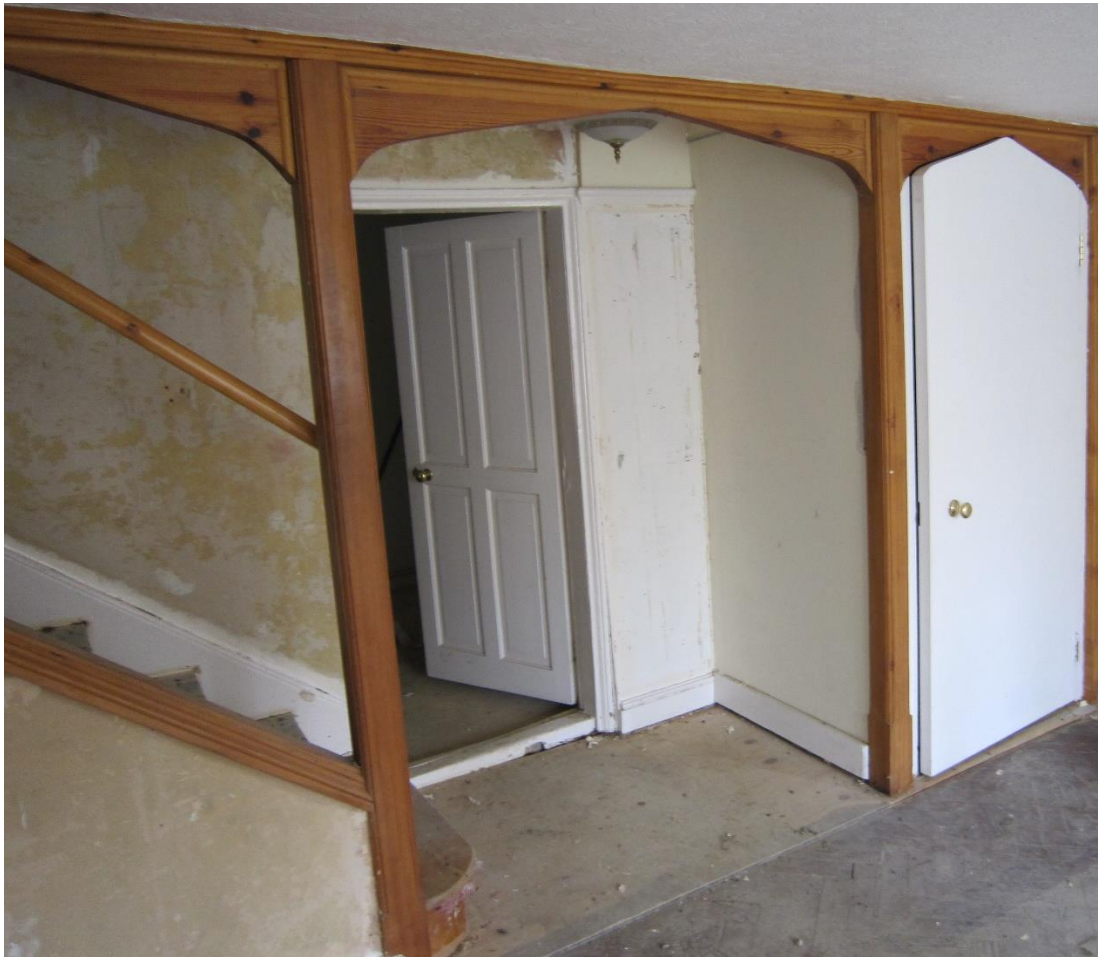
FH1 – showing the modern framework, door and partition – now removed.

Photographs FH1, FH2 and FH3 show how the recent modern doors and partitions have been removed and the plasterwork above the staircase has been removed to expose the original brick and framework of the early C18 outer wall. New oak post and beam have also been introduced to support the first-floor structure, previously unsupported.

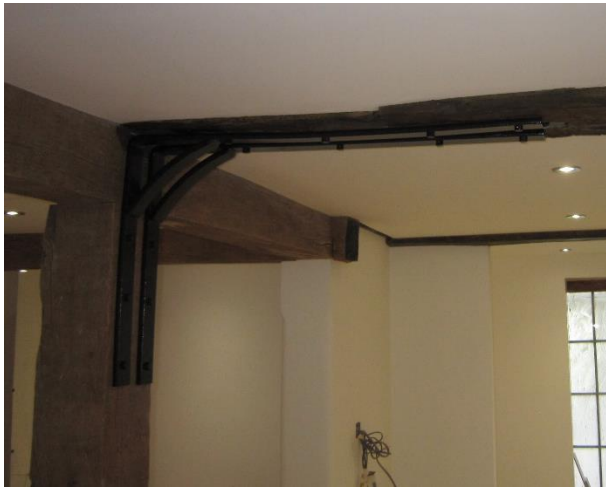
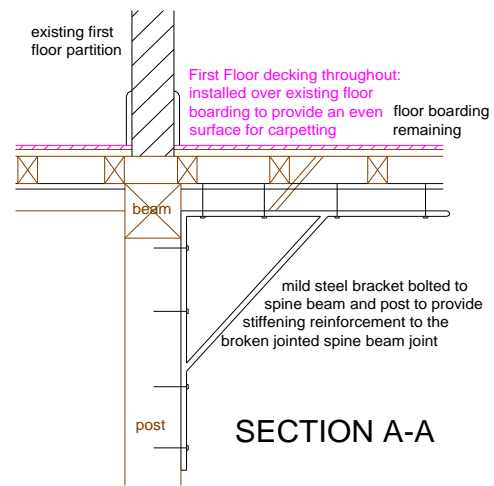
FH4 – showing the steel bracket reinforcing the broken spine beam.

Photograph FH4 and Section A-A shows how the broken spine beam joint was repaired using a purposely fabricated mild steel angle iron and bracket bolted to the oak post and spine beam resulting in stiffening the structure and avoiding any major intervention to the original structure. No attempt has been made to hide the renovation that is considered better seen as demonstration of the works undertaken.

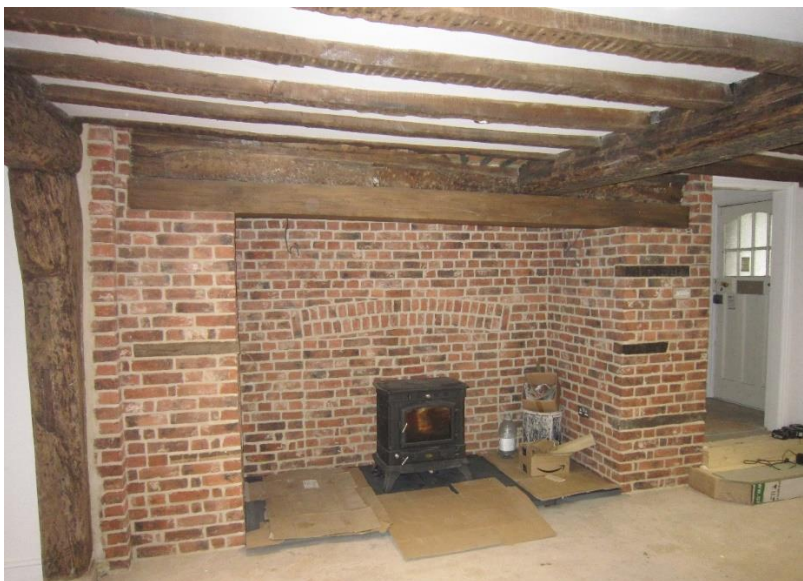
FH5 – showing the refurbished open fireplace and new log burner.

Photograph FH5 shows how the fireplace has been renovated, including:

- exposing the C19 brickwork of part of the chimney complex in the centre of the building,
- the cleaned brickwork, repointed using lime mortar,
- a new stone slab hearth is presently covered with protective cardboard,
- a newly installed log burner and
- a new oak lintel covering a previously installed RSJ.
