ARBORICULTURAL IMPACT ASSESSMENT & TREE RETENTION PLAN

FORT HALSTEAD, KENT

**ARBORICULTURAL IMPACT
ASSESSMENT**

Report No: RT-MME-128206-02

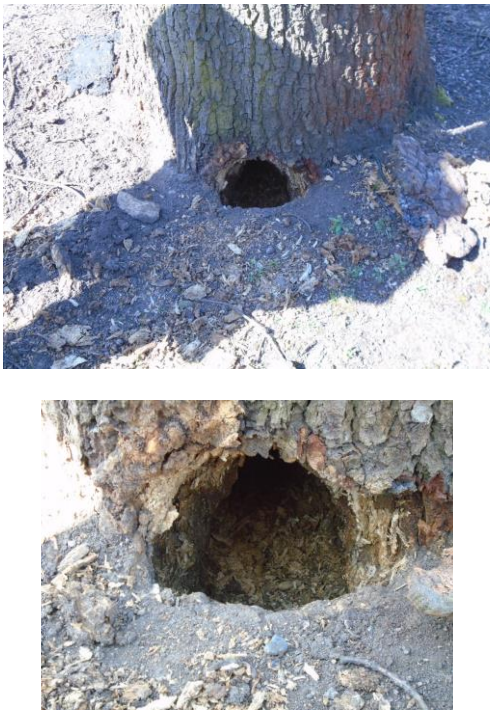
<p>Figure 1 & 2: Showing T1567 being colonised by a decay fungus called Ganoderma, and the extent of cavity caused by the fungus. The tree was recently reduced but the decay was not spotted at the time.</p>

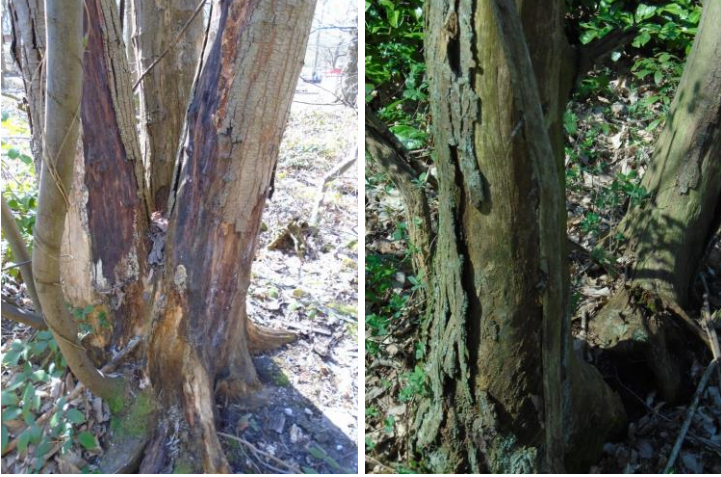
The other disease which is also wildly spread is *phytophthora* affecting the vast majority of the sweet chestnut trees onsite. The disease is known as a large group of pathogens which causes diseases in plants, including many species of trees, hence the given name which derives from Greek meaning plant destroyer from "*python*" plant and "*phthora*" destroyer.

<p>Figure 3 & 4: Showing two stands of sweet chestnut both suffering from <i>phytophthora</i> causing bark necrosis at lower stem.</p>

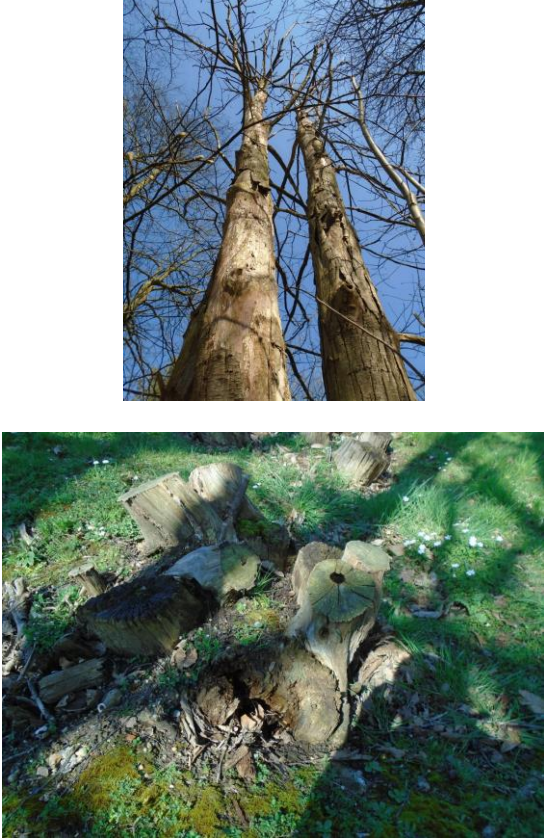
<p>Figure 5 & 6: Showing a dead standing twin stem of sweet chestnut being killed by <i>phytophthora</i> and old stump of sweet chestnut removed in the past due of being affected by the same pathogen. Many of these stumps can be found throughout the site, suggesting that <i>phytophthora</i> has been an issue for quite some time.</p>
