PRELIMINARY BAT ROOST ASSESSMENT

FORT HALSTEAD, KENT
PRELIMINARY BAT ROOST
ASSESSMENT

A Report to: CBRE Ltd

Report No: RT-MME-127947-02 Rev B

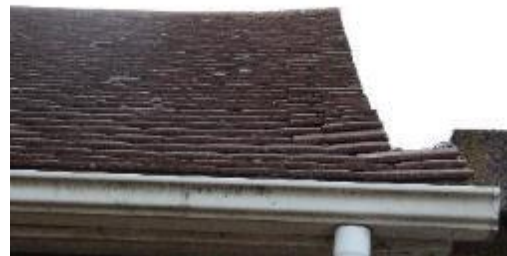
Plate 4.6: Dislodged roof tiles

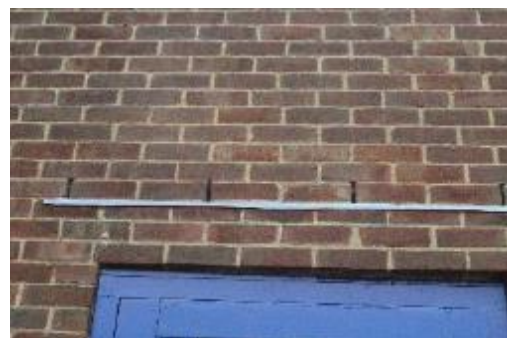
Plate 4.8: Weep holes in brickwork

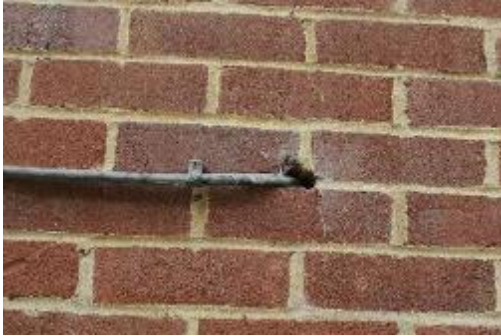
Plate 4.9: Hole in brickwork around cable inlet

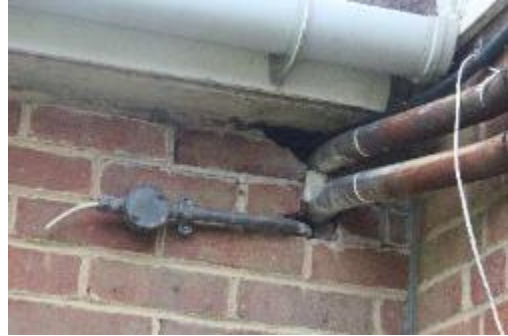
Plate 4.10: Hole in brickwork around pipework

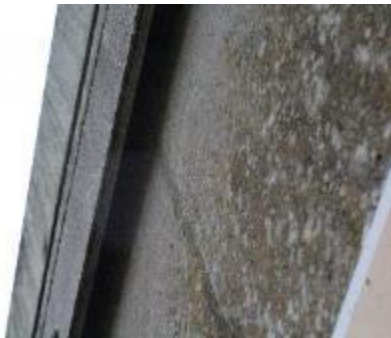
Plate 4.11: Gap behind fascia board

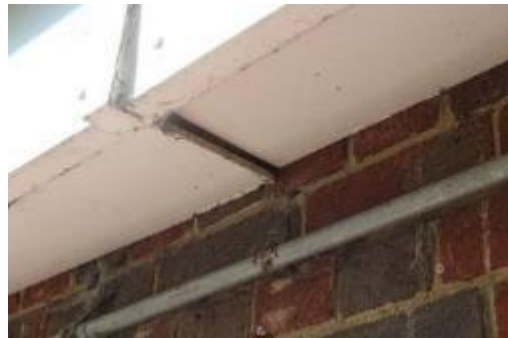
Plate 4.12: Gap in soffit

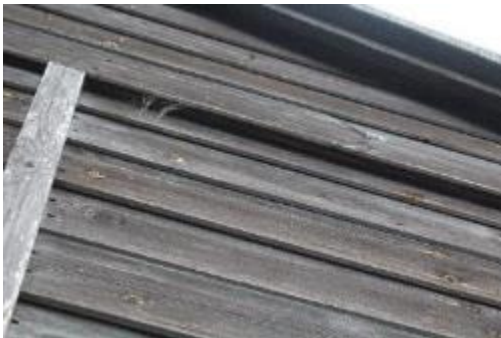
Plate 4.13: Gap in wooden cladding

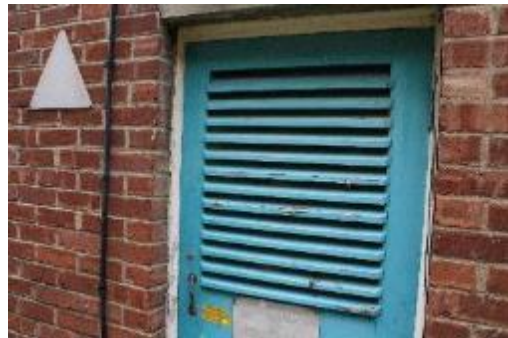
Plate 4.14: Louvre door with large gaps

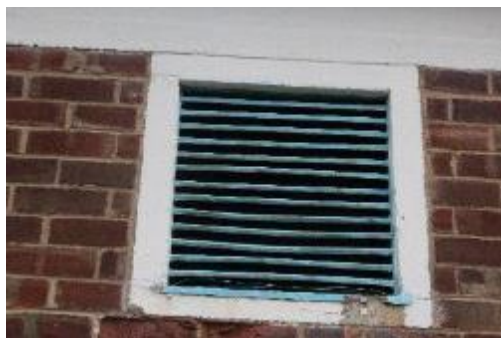
Plate 4.15: Vent with large gaps

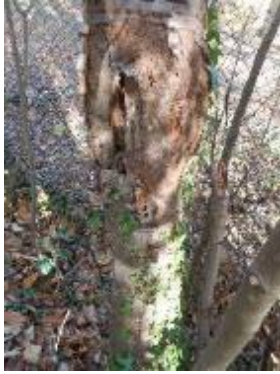
Plate 4.16: Tree 1498

| Tree No. | Species | Description | BCT Suitability Class |
|---|---|--|---|
| 1498 | Cherry | Tree measures approximately 14 m in height and 0.4 m in stem diameter at chest height. There was a lot of damage to the main stem at low level (Plate 4.16). The cracks and crevices were inspected with an endoscope and torch and none of them extended to any significant depth. They were found to offer only limited roosting opportunities for individual bats. | Low |

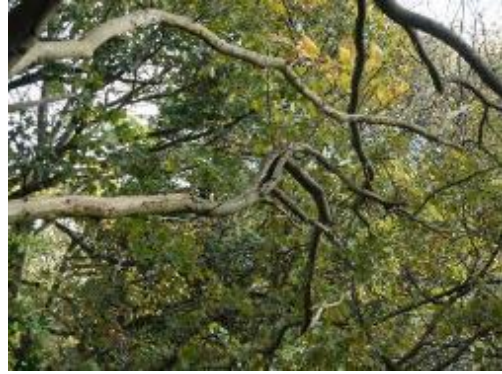
Plate 4.17: Tree A

| Tree No. | Species | Description | BCT Suitability Class |
|---|---|--|---|
| A | Sweet chestnut | Tree measures approximately 16 m in height and 0.8 m in stem diameter at chest height. There was a large tear-out wound on the main stem, extending from 2-4 m above ground level, with cracks around it which lead into cavities. Hazard beams were also present on lateral branches at approximately 10 m above ground level and there was a broken limb with lateral cracks extending towards the main stem (Plate 4.17). This tree could not be climbed as it was deemed unsafe. | High |

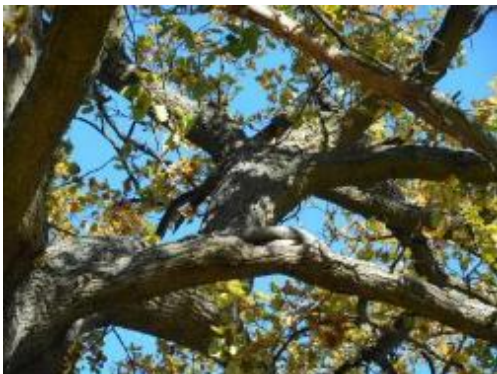
Plate 4.20: Tree 1528

| Tree No. | Species | Description | BCT Suitability Class |
|---|---|--|---|
| 1528 (Tag 658) | Oak | Tree measures approximately 14 m in height and 0.7 m in stem diameter at chest height. There was a scar with a hole in it on the eastern aspect at approximately 8 m above ground level (Plate 4.20). There was also a hole on the northern aspect at 8 m above ground level. These holes were found to ingress 20 cm and they narrowed. Some debris and cobwebs were present, but no evidence of bats was recorded. | Moderate |

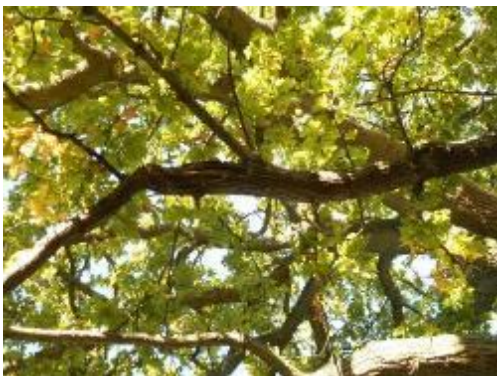
Plate 4.22: Tree 1535

| Tree No. | Species | Description | BCT Suitability Class |
|---|---|--|---|
| 1535 (Tag 663) | Oak | Tree measures approximately 14 m in height and 0.7 m in stem diameter at chest height. There was a split limb on the southern aspect at approximately 5 m above ground level (Plate 4.22). This split was found to ingress 20 cm and it contained a few cobwebs with a small amount of debris. No evidence of bats was recorded. | Moderate |

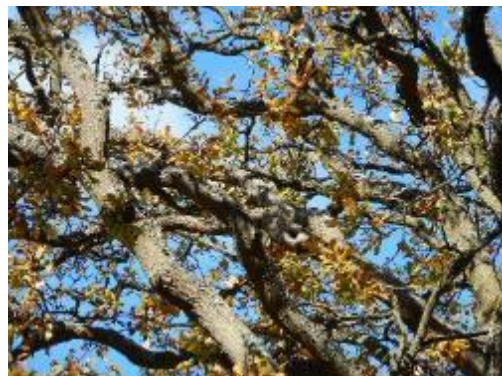
Plate 4.23: Tree 1543

| Tree No. | Species | Description | BCT Suitability Class |
|---|---|---|---|
| 1543 (Tag 679) | Oak | Tree measures approximately 12 m in height and 0.4 m in stem diameter at chest height. There was a hole on the eastern aspect at 8 m above ground level (Plate 4.23). This was inspected and found to ingress 15 cm. It had smooth sides and was clear of cobwebs and debris, possibly indicating frequent and recent use by fauna. | High |

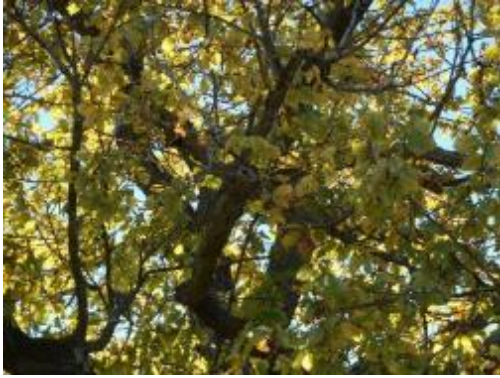
Plate 4.24: Tree 1566

| Tree No. | Species | Description | BCT Suitability Class |
|---|---|---|---|
| 1566 (Tag 822) | Oak | Tree measures approximately 12 m in height and 0.5 m in stem diameter at chest height. There was a scar and rot hole at 10 m above ground level and multiple splits were present at the end of lateral branches (Plate 4.24). The rot hole extends 20 cm downwards and 20 cm upwards, creating suitable roosting opportunities for bats. Debris was present in the bottom of the feature, but there was no smoothing or staining. No evidence of bats was recorded. | High |

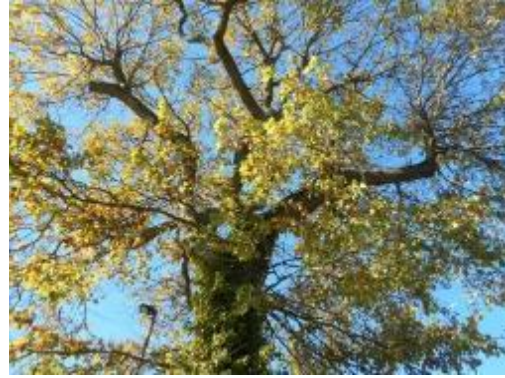
Plate 4.25: Tree 1568

| Tree No. | Species | Description | BCT Suitability Class |
|---|---|---|---|
| 1568 (Tag 824) | Oak | Tree measures approximately 15 m in height and 0.7 m in stem diameter at chest height. Rot holes were present at the end of branches on the western aspect at approximately 12 m above ground level. There was also a split in a branch stump on the northern aspect at approximately 9 m above ground level. A light covering of ivy was present on the main stem, but this did not create any potential roosting features (Plate 4.25). Due to the position of the tree next to the main entrance of a car park and close proximity to a building, the tree could not be climbed. | Moderate |

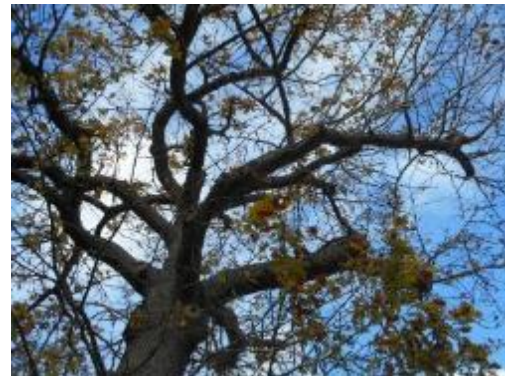
Plate 4.27: Tree 1572

| Tree No. | Species | Description | BCT Suitability Class |
|---|---|---|---|
| 1572 (Tag 848) | Oak | Tree measures approximately 12 m in height and 0.6 m in stem diameter at chest height. There was a scar on the eastern aspect at approximately 6 m above ground level and a hole on a lateral branch (Plate 4.27). The scar did not ingress to any significant depth, offering only limited roosting opportunities for bats. The hole in the branch was found to ingress 10 cm, but it was wet inside with no signs of being used by fauna. No evidence of bats was recorded. | Low |
