**1967 - Statement of Significance & Heritage Statement**  
for application to vary condition of planning consent reference and Listed Building  
Consent reference  
Great Barton Cyst St Lawrence  
March 2020

**Application for variation of planning condition and listed building consent:**

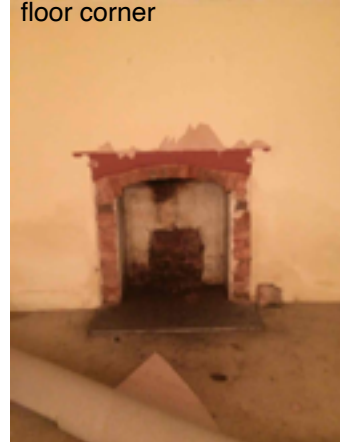
Fire surround torn off in Siting Room 1

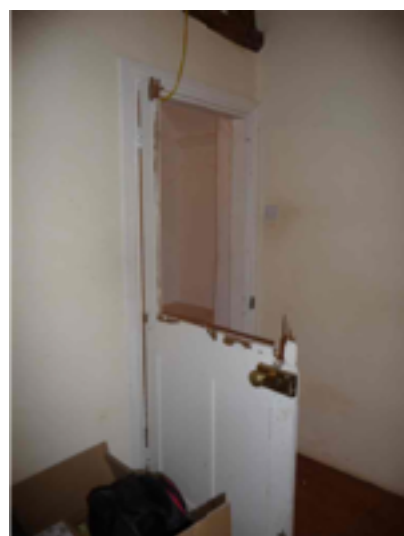
Vandalised door frame, Bathroom 1

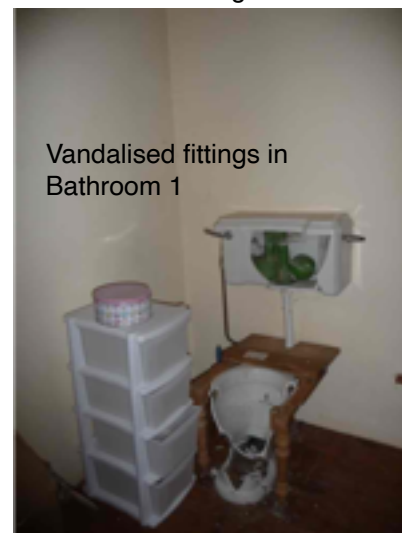
Vandalised fittings in Bathroom 1

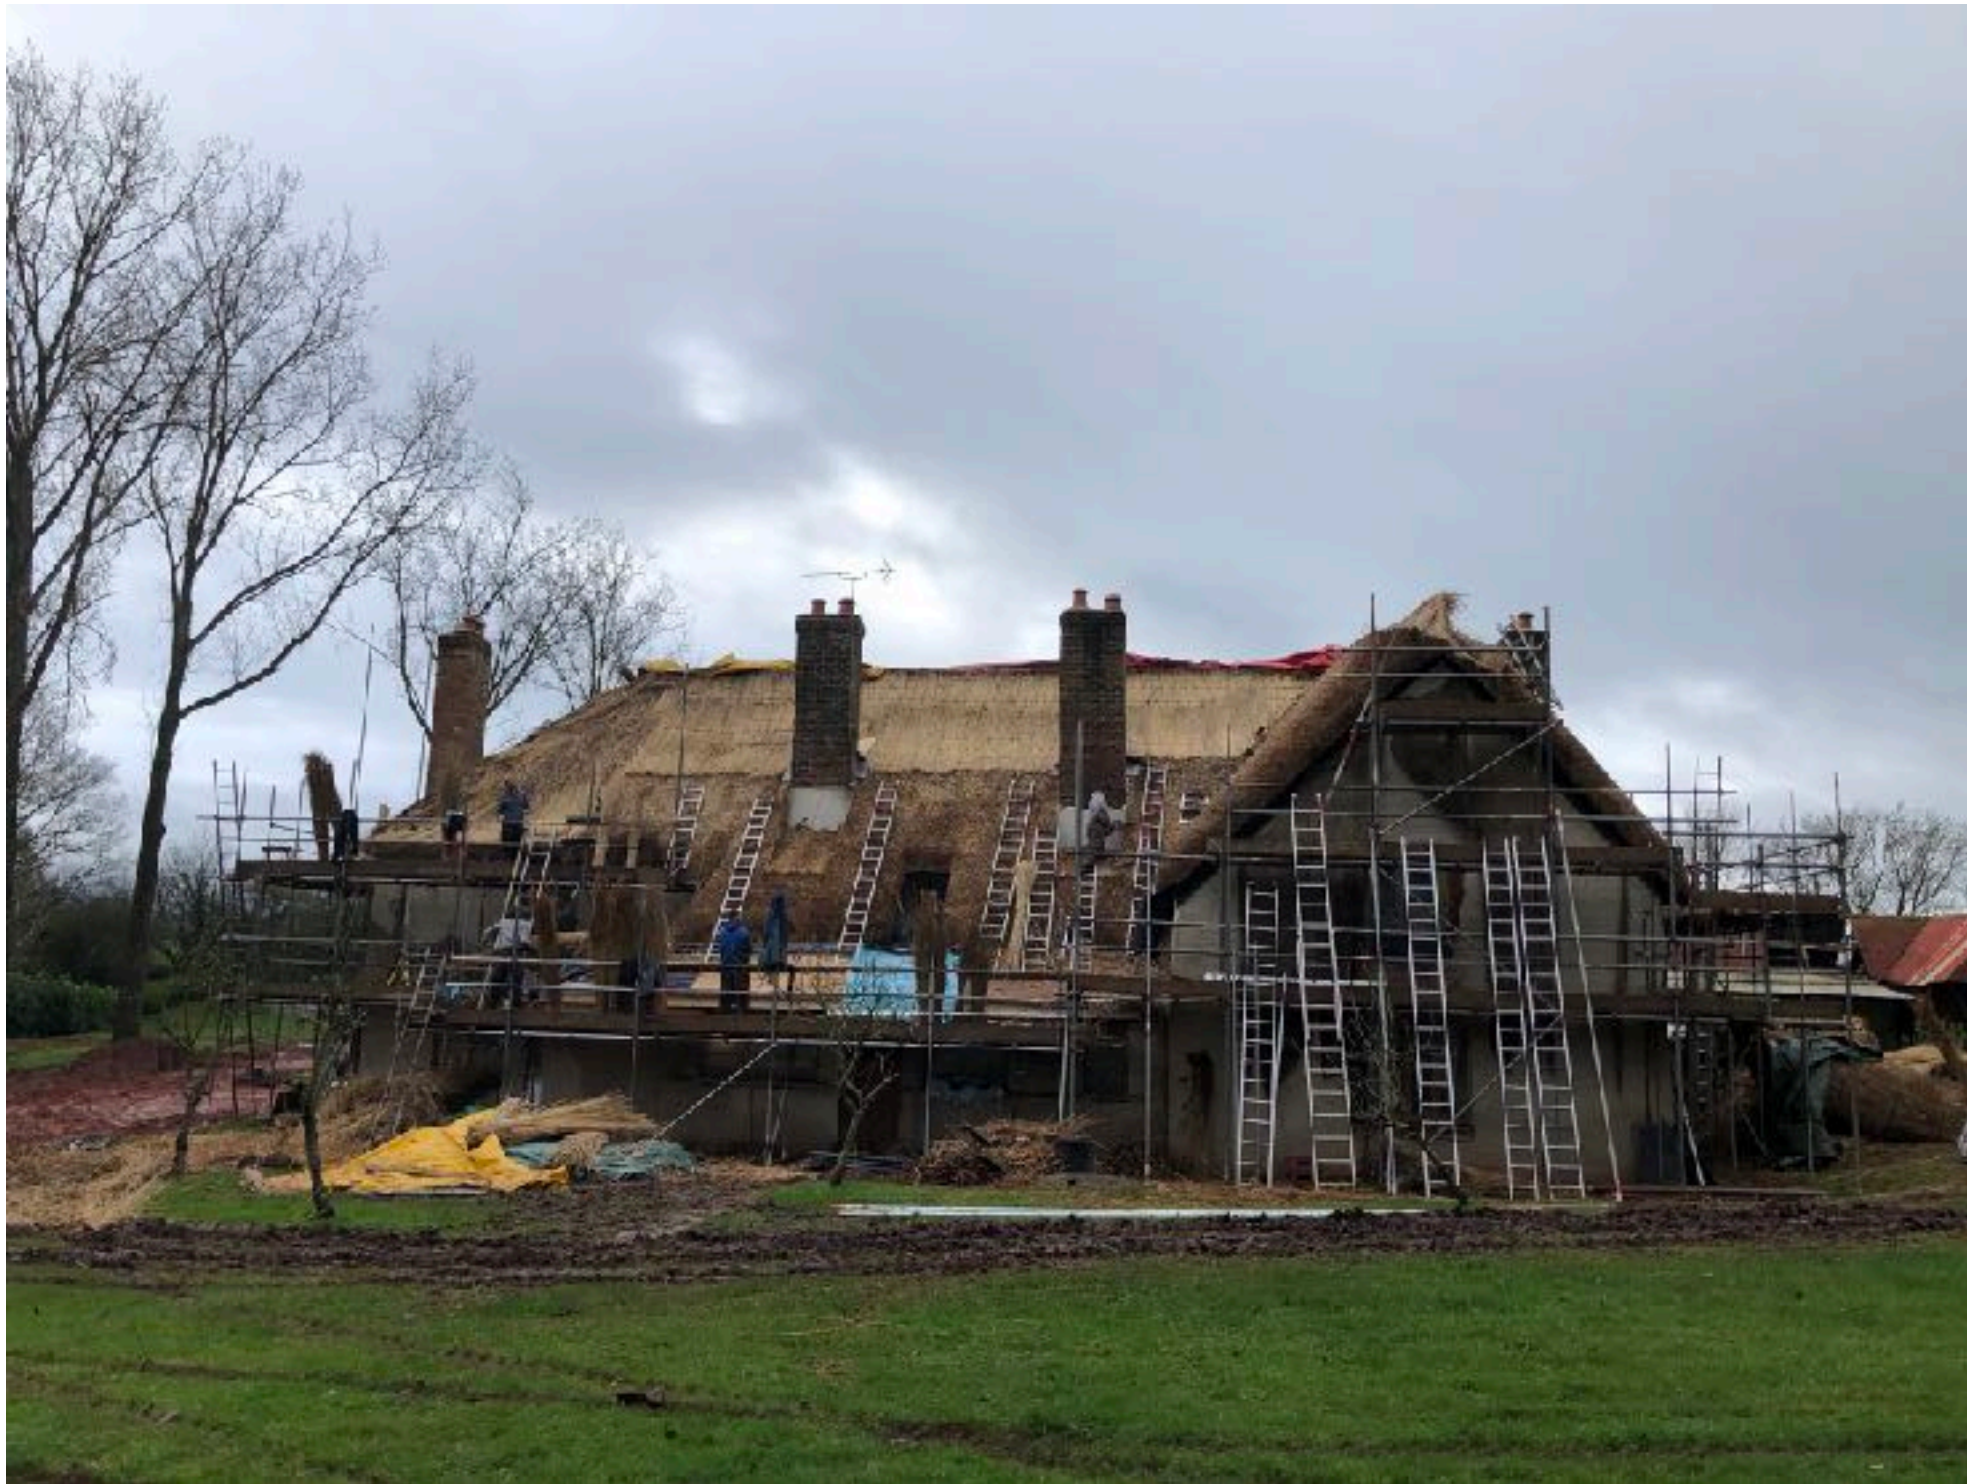
Thatching work in progress December 2020

As discussed and further to our recent correspondence re- lower section of roof at the rear of the property (Great Barton) I would strongly advise that this lower section of out shot roof to be slated with a lead soaker ran along the top course of slates for our first course of thatch to sit on. Although it is possible to thatch the section in question I could not guarantee this sections longevity as the minimum gradient for thatch to work is forty five degrees.

1. **Significance of heritage asset:** Alteration carried out to rear outshut largely rebuilt during 2000's renovation and repair, although the overall massing and form of the outshut followed that of the earlier structure.
2. **Proposal:** Following advice from the Master Thatcher, Leigh Selby, the lower portions of the hipped outshut were slate covered as that would provide a more effective weather covering. Slate covered lower skirts to thatched roofs is a traditional local detail where weathering of the thatch is a concern.
3. **Analysis of the impact of the proposal:** The amendments, whilst being applied for after work has been carried out has resulting in building fabric with better long terms integrity and weather proofing that originally proposed.

For the benefit of the roof I would advise slating this lower section and replacing the main roof with Turkish water reed.

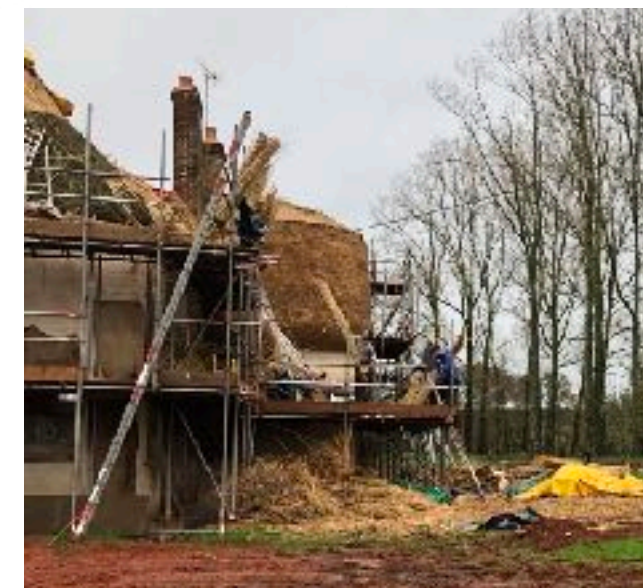
Side view of outshut from south. Thatching work in progress December 2020

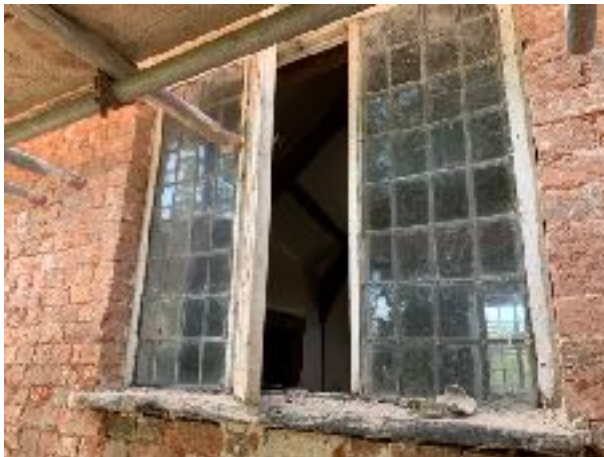
FFW09 Bedroom 1 Northeast Elevation

1. **Significance of heritage asset:** Fenestration throughout general 2 or 3 light casements .. mainly of 19 or early 20C date, heavily renovated or replaced in 2000's (Dr Blaylock) The exceptions highlighted below are FFW09 a 3 light casement that retained leaded lights and saddlebars and the originally unglazed 4 light window GFW06. Following opening up both windows where found to have had chills cast into their bottom rails causing rot and deterioration of the frames.

Previously: Cast cill inserted into window frame, causing rotting of frame. Bottom rail of soft wood frame has not

2. **Proposal:** Following assessment of their condition it was decided that the windows would be replaced with equivalent in oak, style and detail as agreed for replacement of the 20C replacements elsewhere.

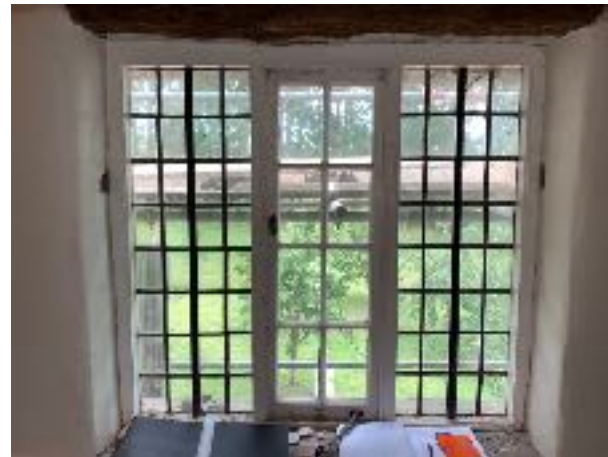
Now: New three light oak framed window and cill installed in place of previous window, leaded casements retained on

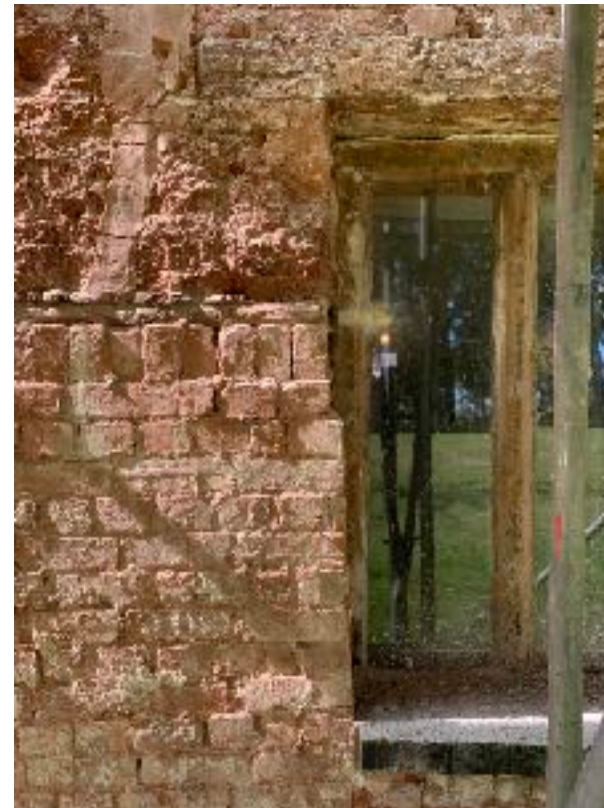
GFW06 Study/Home office Northeast elevation

Previous: 4 light window frame with 20C panes inserted. Bottom rail of frame submerged by cast inset cill

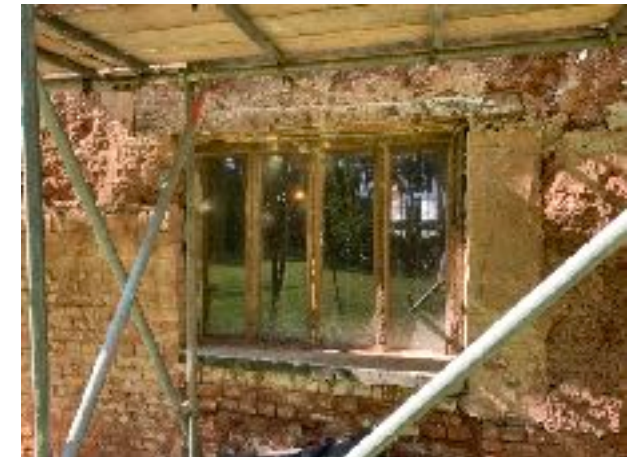
Now: New four light oak framed window and cill installed. Historic frame retained on site.

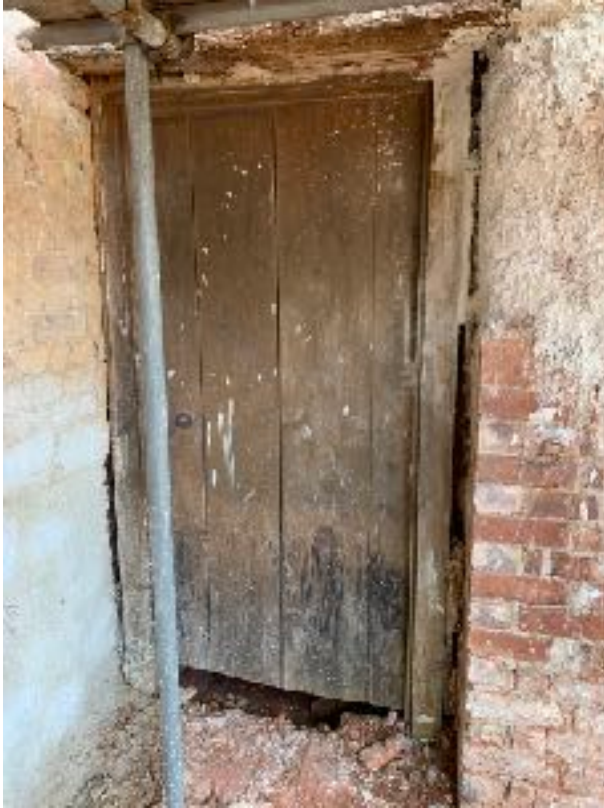
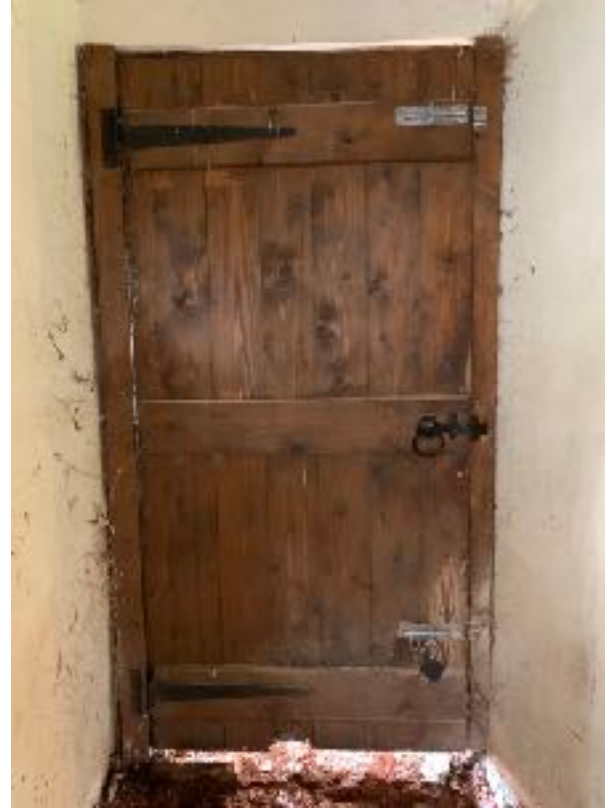
1. **Significance of heritage asset:** Side door openings in east and west gables are not considered original to the house ( Dr Blaylock 2017), with 20th c brickwork evident in north west wing. However these openings contribute to the uniform frontage of the farmhouse as subsidiary doorways. The vertically boarded doors and door frames are 20C and ill-fitting with tile or no threshold, and previous repairs particularly to the lower sections.

2. **Proposal:** Following assessment of their condition it was decided that the doors and door frames would be replaced with equivalent in oak, constructed to provide better fitting and a secure installation.
