Heritage, Design & Access Statement
Osbournby House, West Street Osbournby.

Window Replacement.

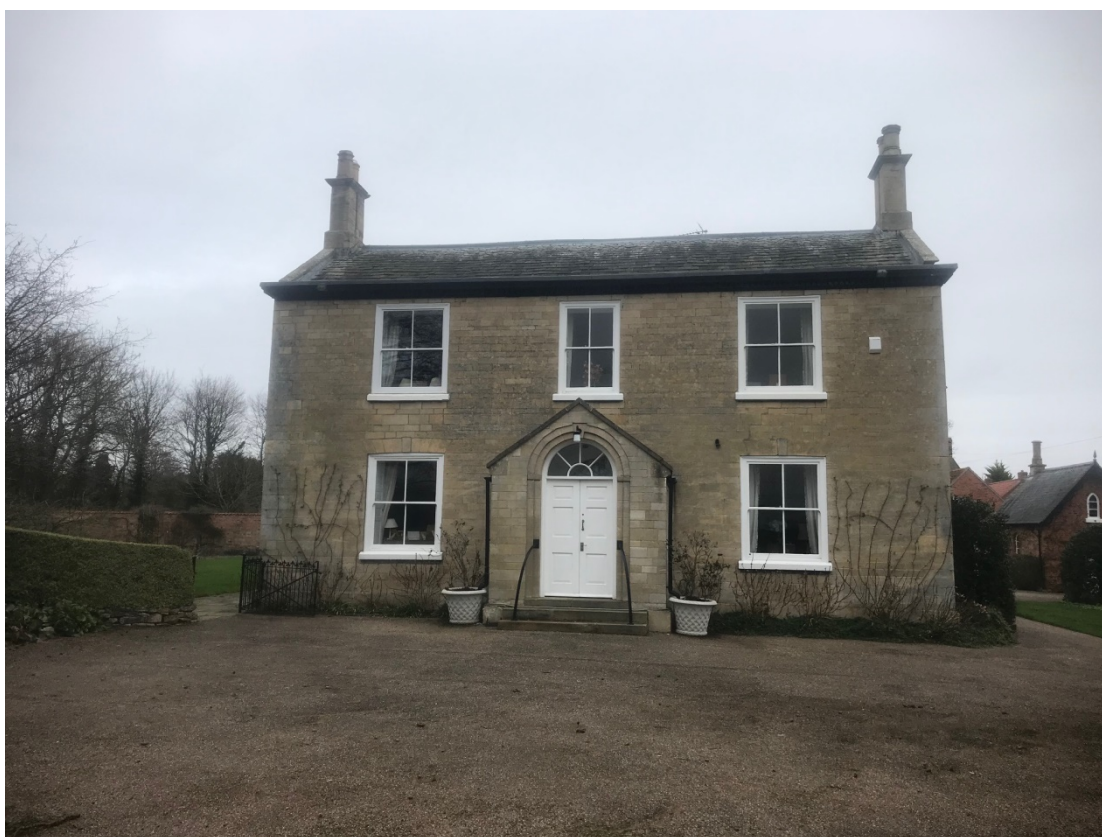
(Photograph of West Elevation 5 x main windows)

West Elevation - Windows to the west elevation have deteriorated and are in urgent need of replacement. Following an onsite meeting with the Conservation Officer in 2020 (pre Covid) it was agreed that works to replace the windows should be programmed.

Whilst on site, it was agreed with the Conservation Officer that replacement windows should be manufactured from hardwood to match the existing Georgian style windows, copying details such as mullion and transom designs. The west elevation consists of five sash windows plus 2 casement windows to the front porch.

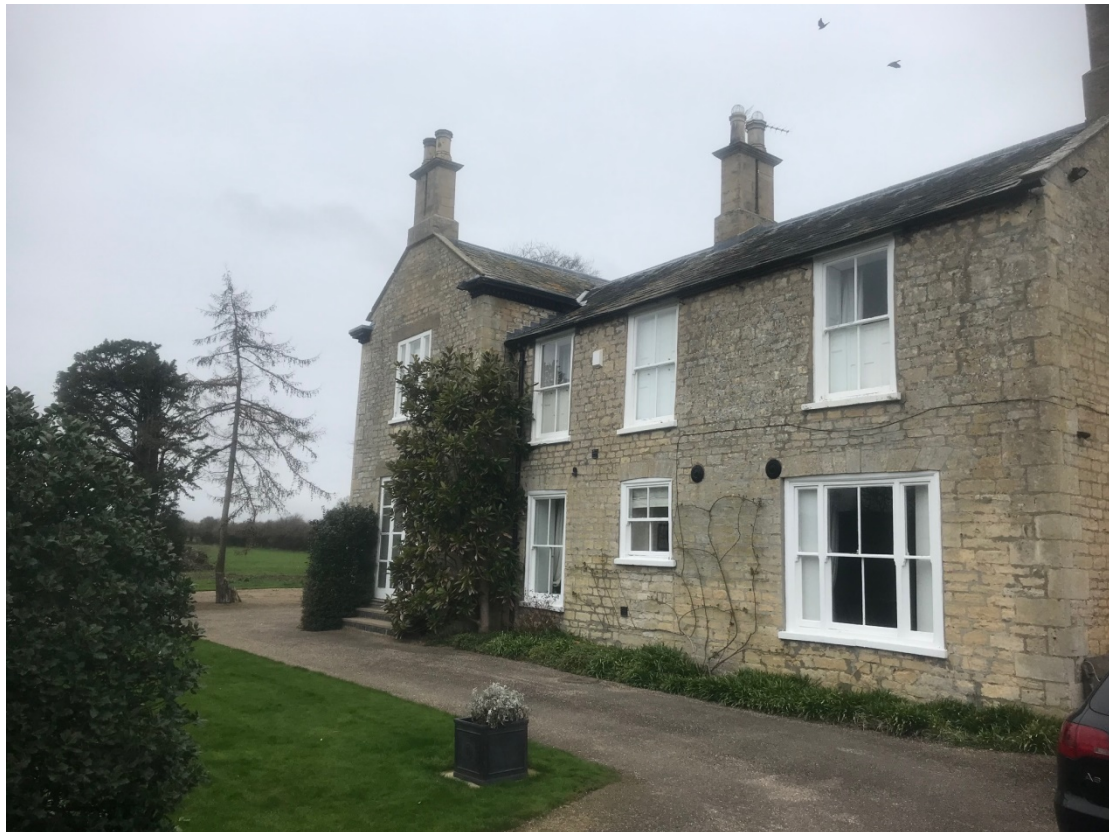
(Osbornby House – South elevation)

South Elevation –the south elevation comprises seven sash windows and a door with side panel arrangement located on the ground floor of the south facing gable elevation. Both the door and window to first floor (directly above) are more recent replacements (pre listing) and are of different design to the original style sash windows.

Our proposal is to initially replace the 7 sash windows, all to be manufactured to the same sash design to match original window details (albeit with 14mm double glazed units) to include mullion and transom designs, rebates and profiles.
