Report : Bat and Nesting Bird Assessment:
House and Garage at Kingswood,
Kingsland Road, Shrewsbury SY3 7AF

Reference : CP/2515/20.1

Date : 15th March 2021

Proposed : Remodelling of the House and Garage.
development

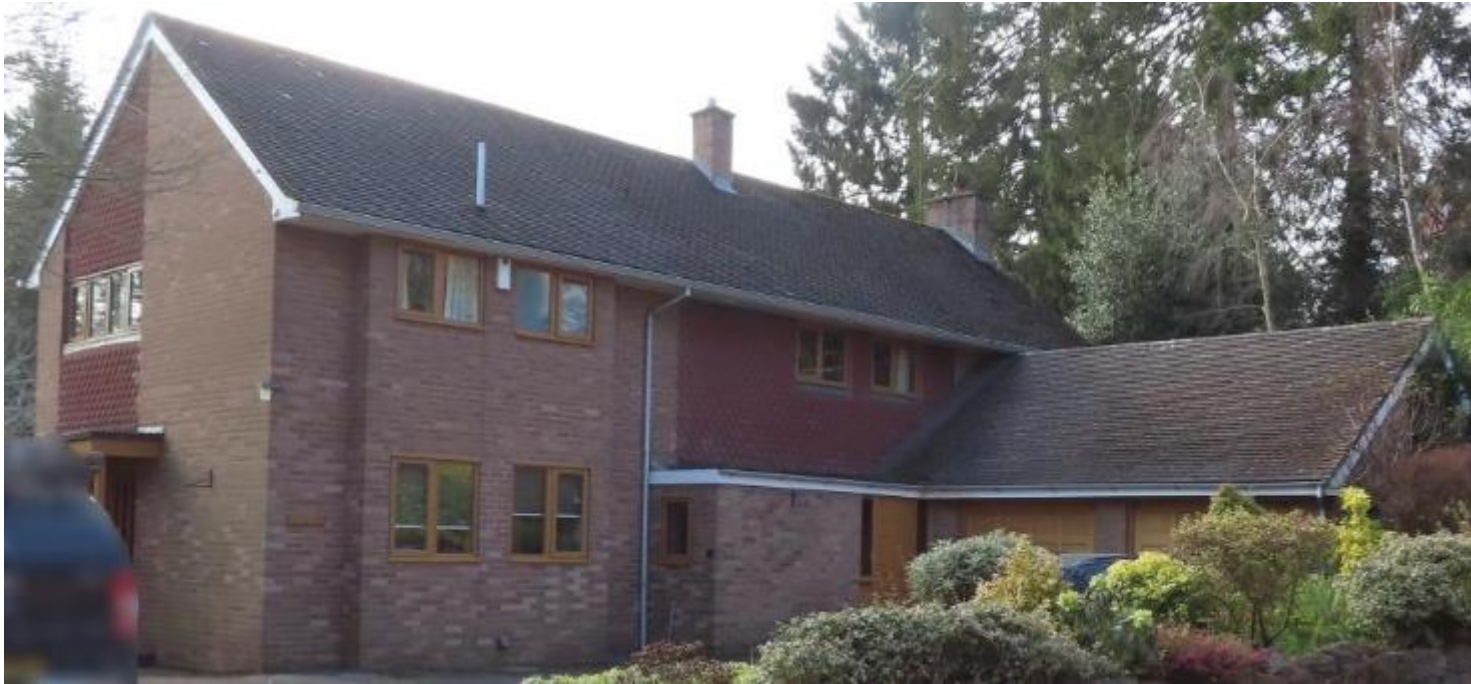
Photograph 1.

Far left: part of the East elevation of Section A.
Lower far-left: part of the North and East elevations of Section E.
Left and upper centre: North elevation of Section A.
Lower centre: North and East elevations of Section D.
Right: part of the East elevation of Section B.
Far right: part of the Section B North elevation.

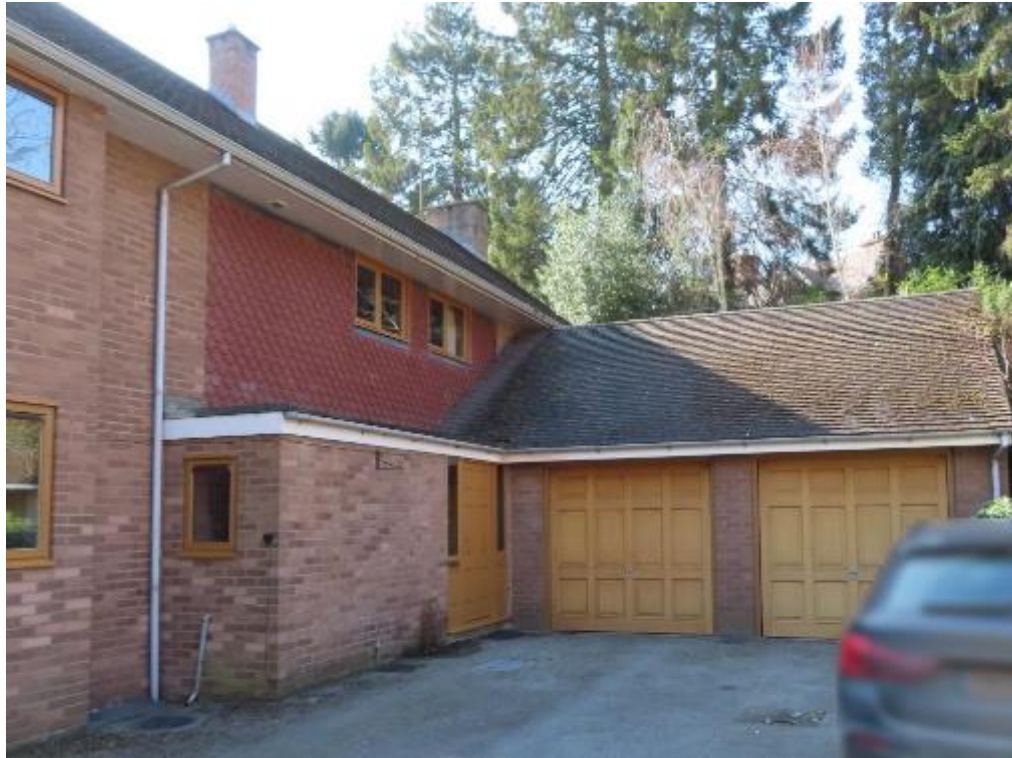
Photograph 2.

Far left and upper left: part of the North elevation of Section A.
Lower left: North and East elevations of Section D.
Centre and right: part of the East elevation of Section B.

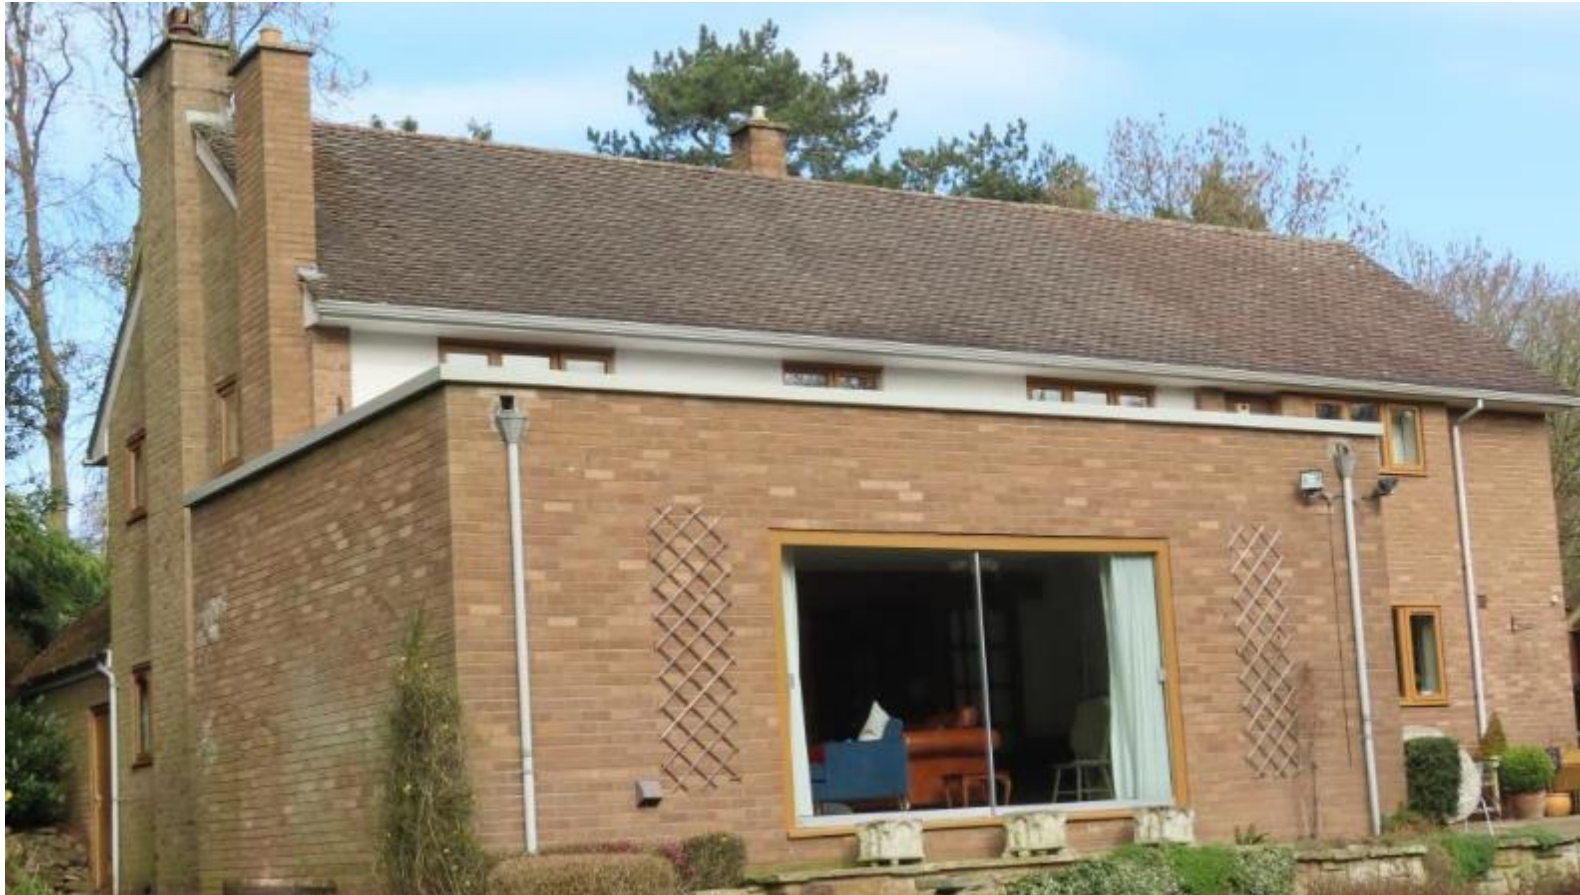
Photograph 3.

Extreme lower left: part of the West elevation of Section B.

Far left: part of the West elevation of Section A.

Lower left: West elevation of Section C.

Lower centre and lower right: South elevation of Section C.

Upper left, upper centre and right: part of the South elevation of Section A.

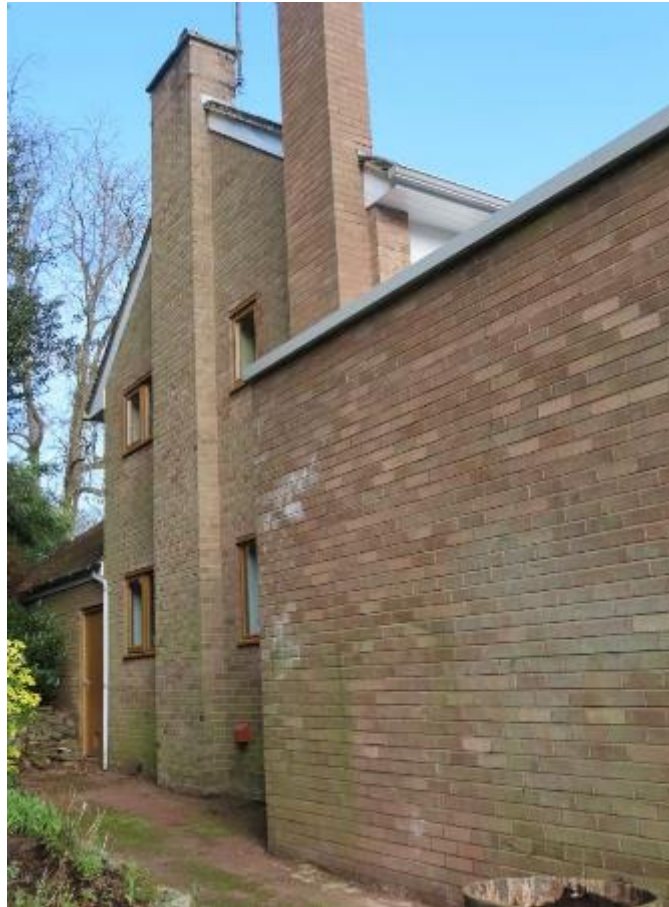
Photograph 4.

Far lower-left: part of the West elevation of Section B.

Left: part of the West elevation of Section A.

Upper right-of-centre: part of the South elevation of Section A.

Lower centre and lower right: part of the West elevation of Section C.

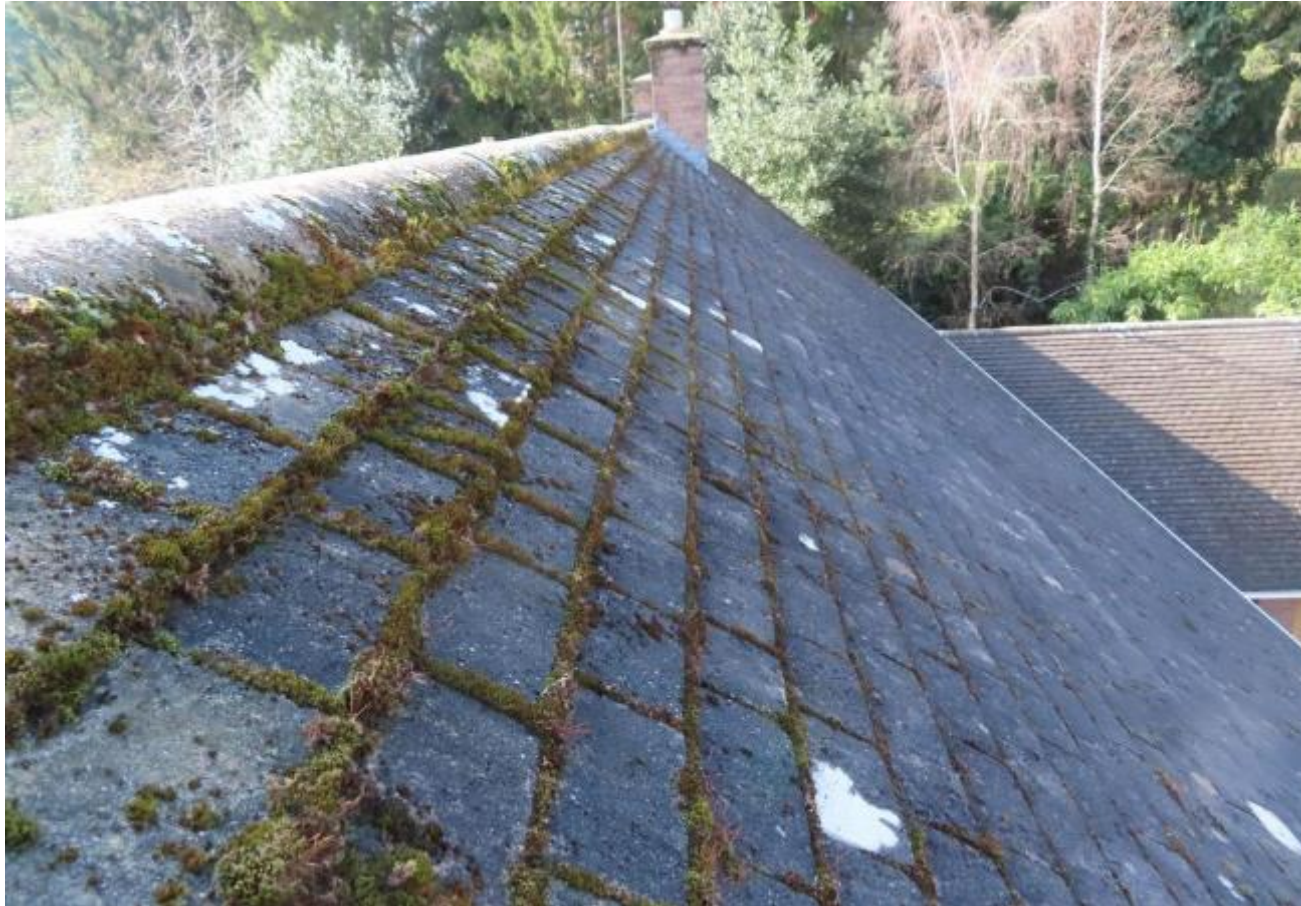
Photograph 5.

Left, centre and lower right: part of the North elevation roof-slope of Section A.
Mid-ground right: part of the East elevation roof-slope of Section B.
Looking west from east.

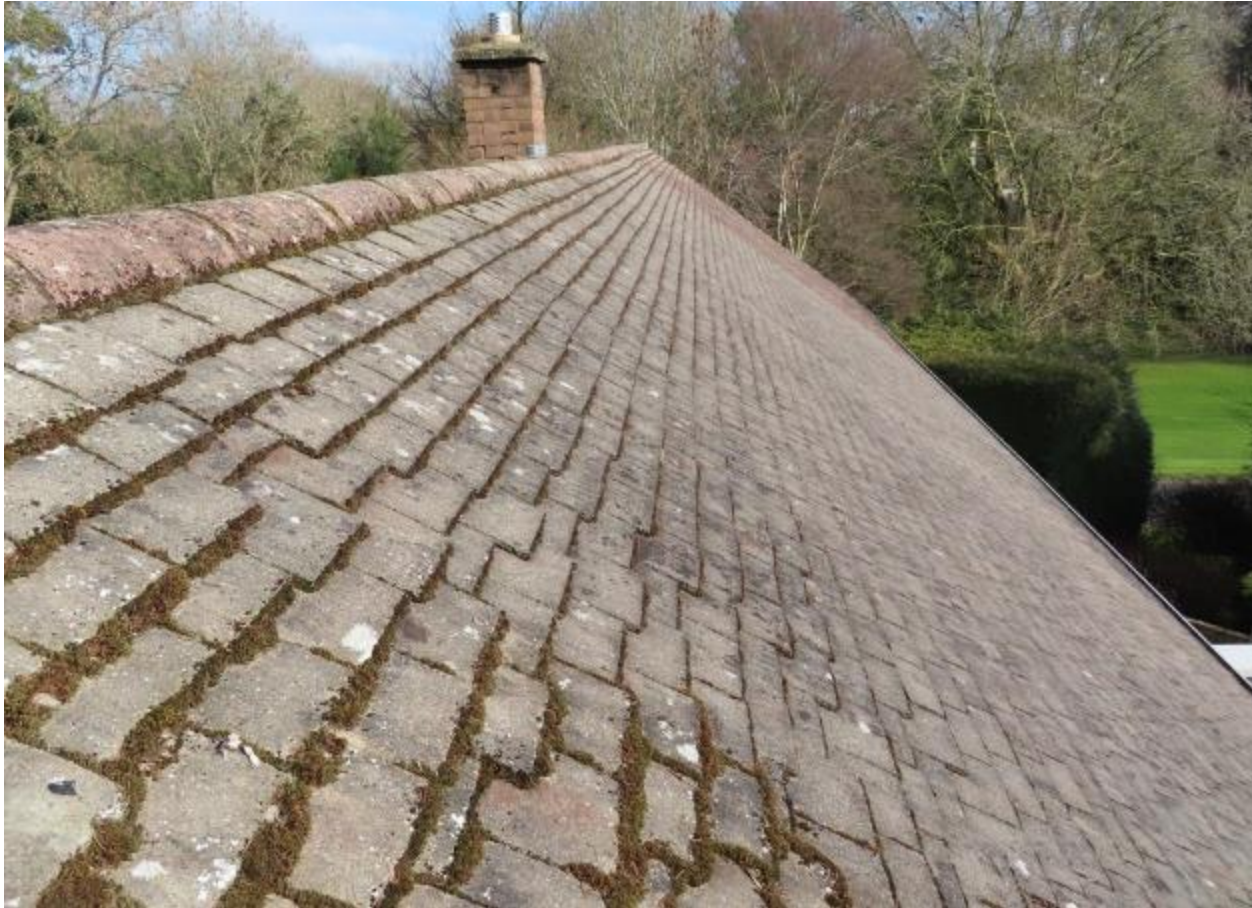
Photograph 6.
View of part of the south elevation roof-slope of Section A.
Looking east from west.

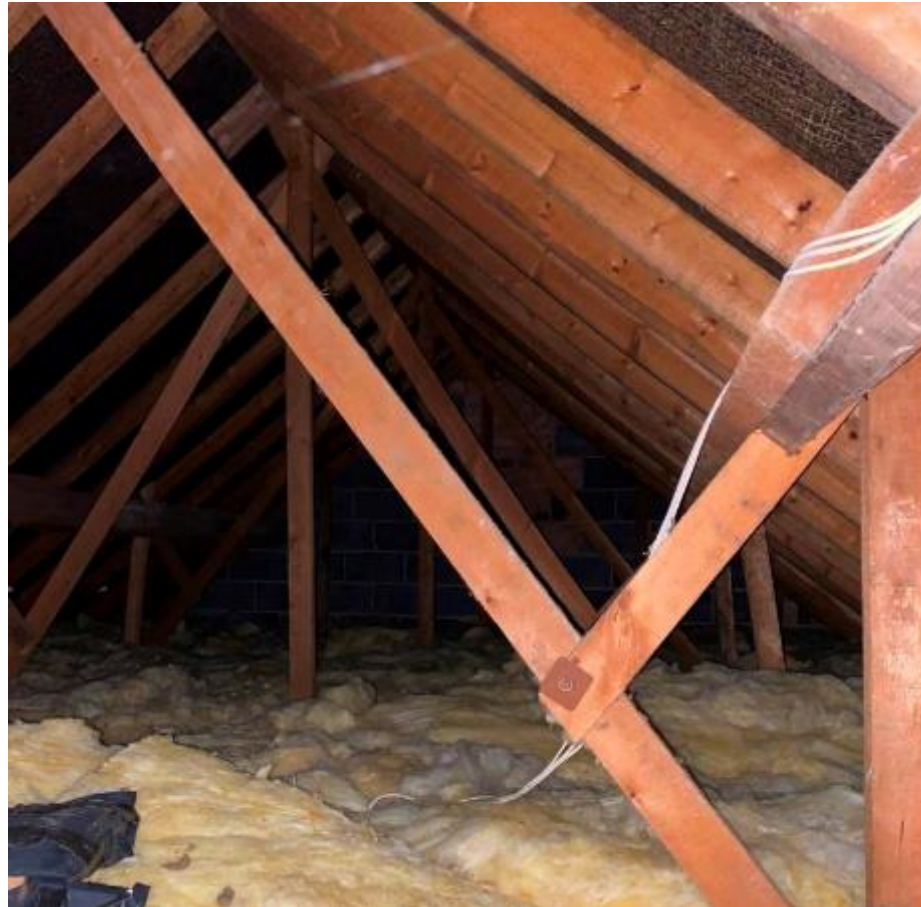
Photograph 7.
View of part of the Section A roof-space.
Looking west from east.

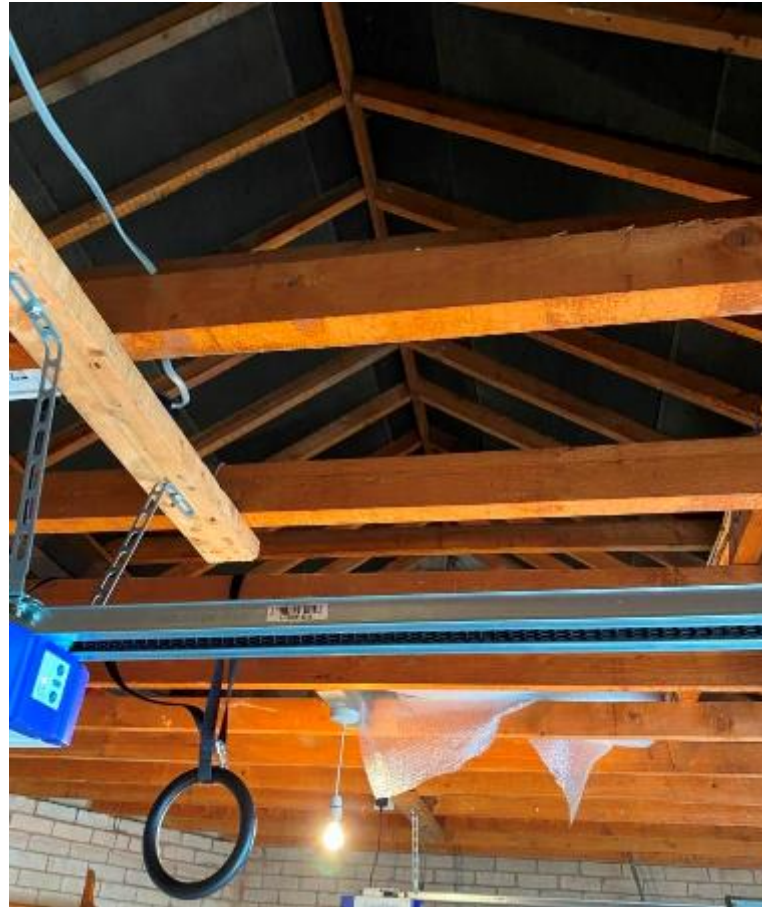
Photograph 8.
View of part of the Section B roof structure.
Looking north from south.
