BS5837 Arboricultural Report,	
Arboricultural Impact Assessment	
and Method Statement

OUR REFERENCE	AC.2020.429
CLIENT	Mr Rakesh Patel
SITE	23 Norbury Road, Thornton Heath, Croydon, CR7 8JP
REPORT BY	I S Thompson (known as Tom) M. Arbor. A., BSc. (Hons) Arb,
	MSc. eFor
DATE	2 nd November 2020
DATE OF SITE VISIT	16 th October 2020

Conversion of a public house to residential dwellings

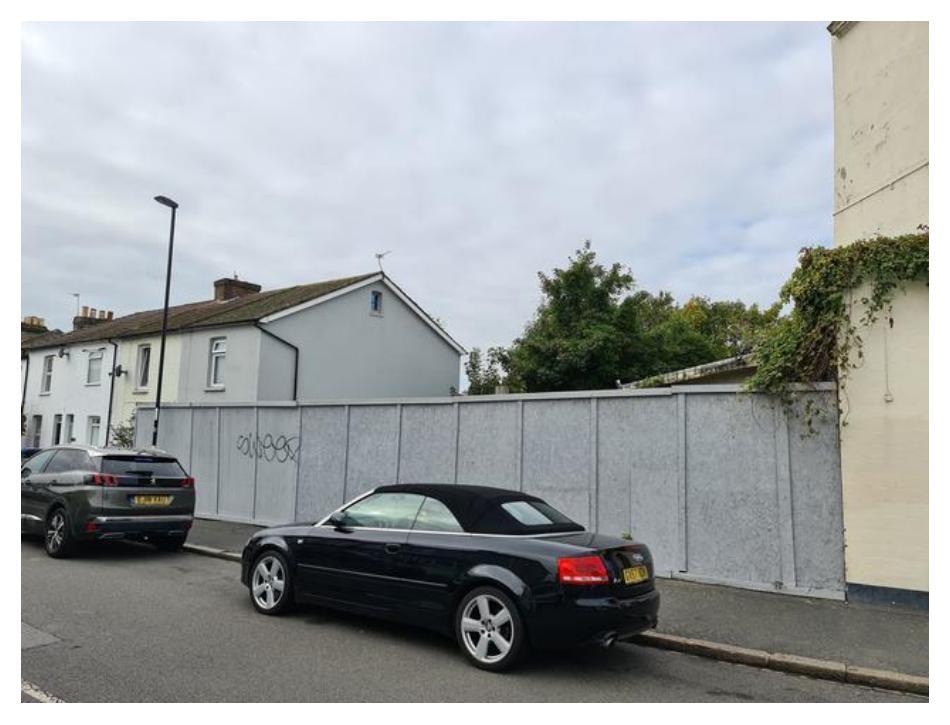
Image 1 Blocked off driveway to the pub car park

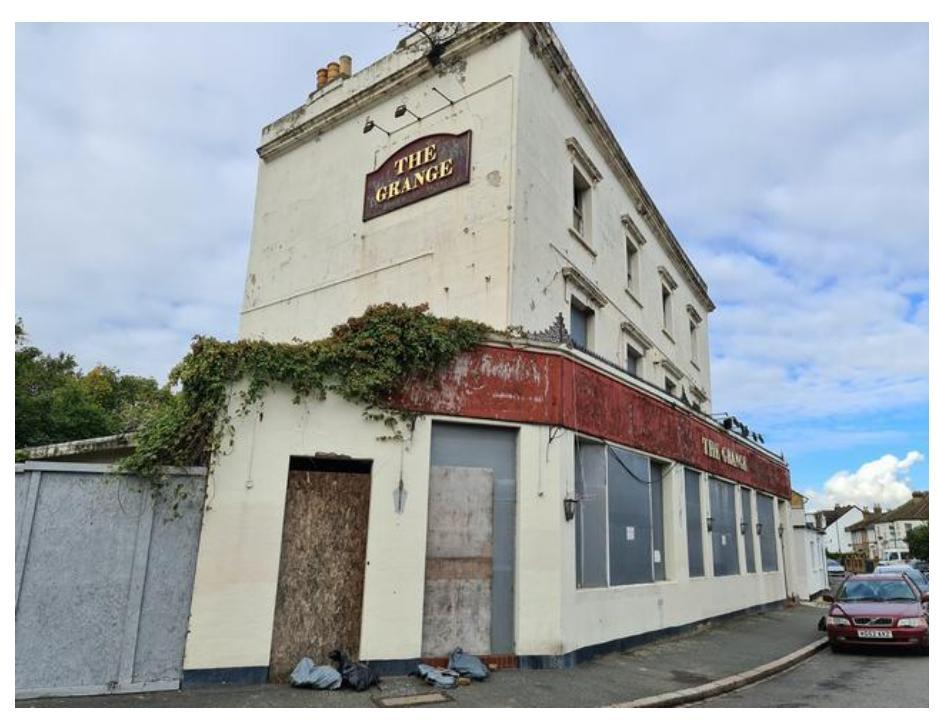
Image 2 The former public house

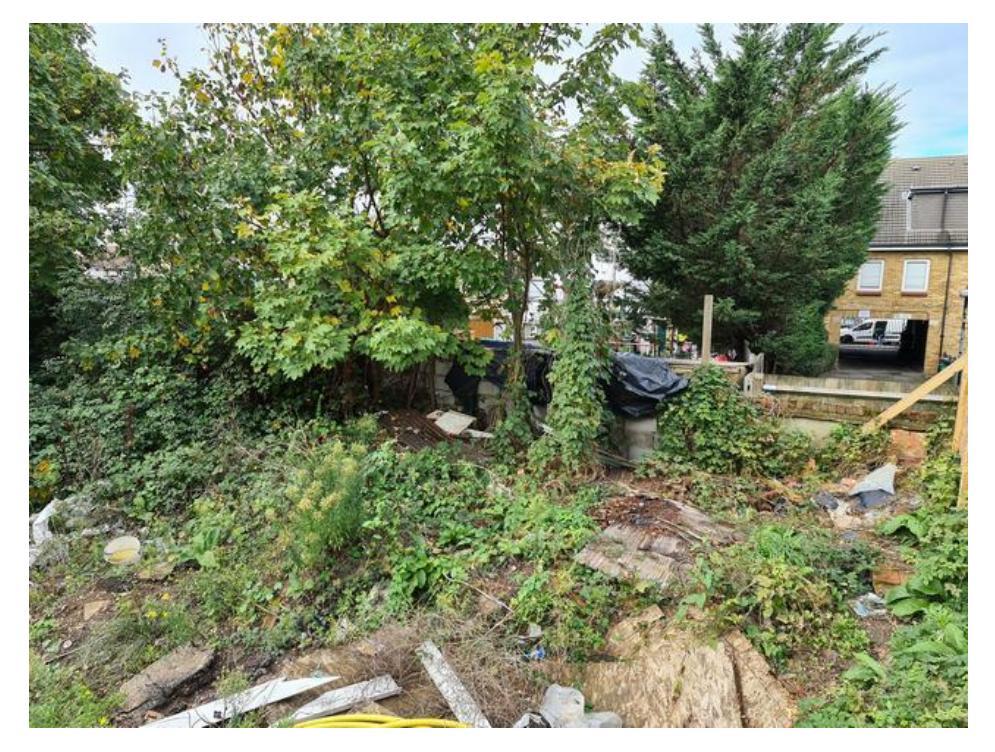
Image 3 Rubble pile at the rear of the site with T6 and T7 growing in it

3.2.1 There are six trees and seven saplings that are proposed for removal as part of this application. The trees are T1-4, and T6 and T7. These are mostly small trees with the two plums T3 and T4 being more mature but both in poor condition. Consequently, there will be a minimal effect to their amenity value of the area.

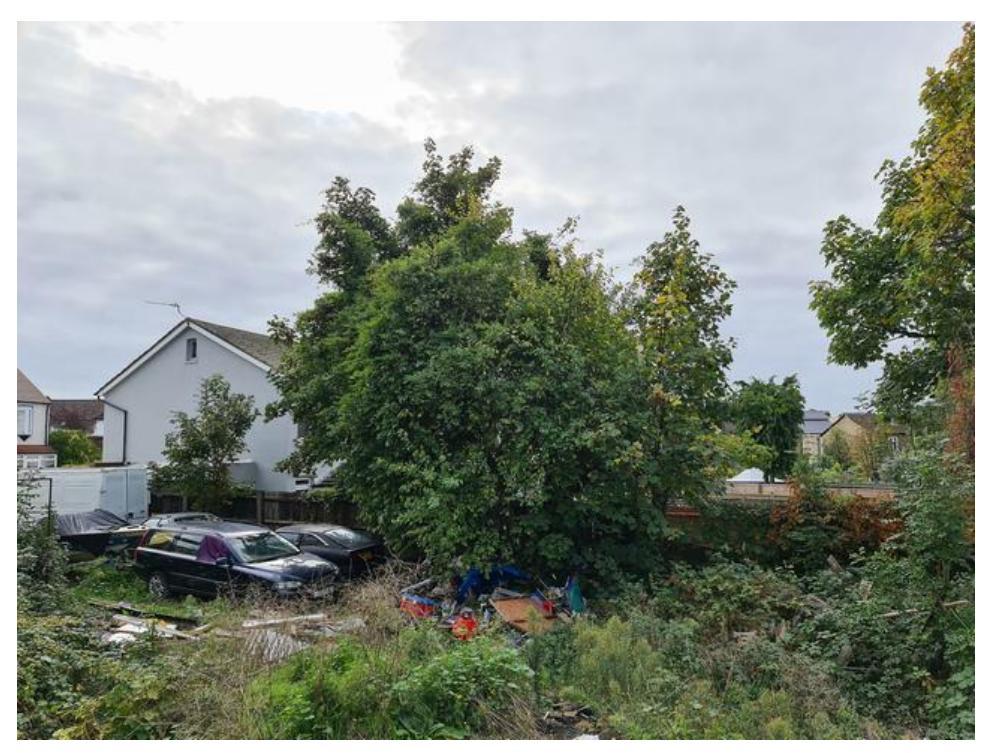
Image 4 T1-4 on the southern side of the site, all to be removed

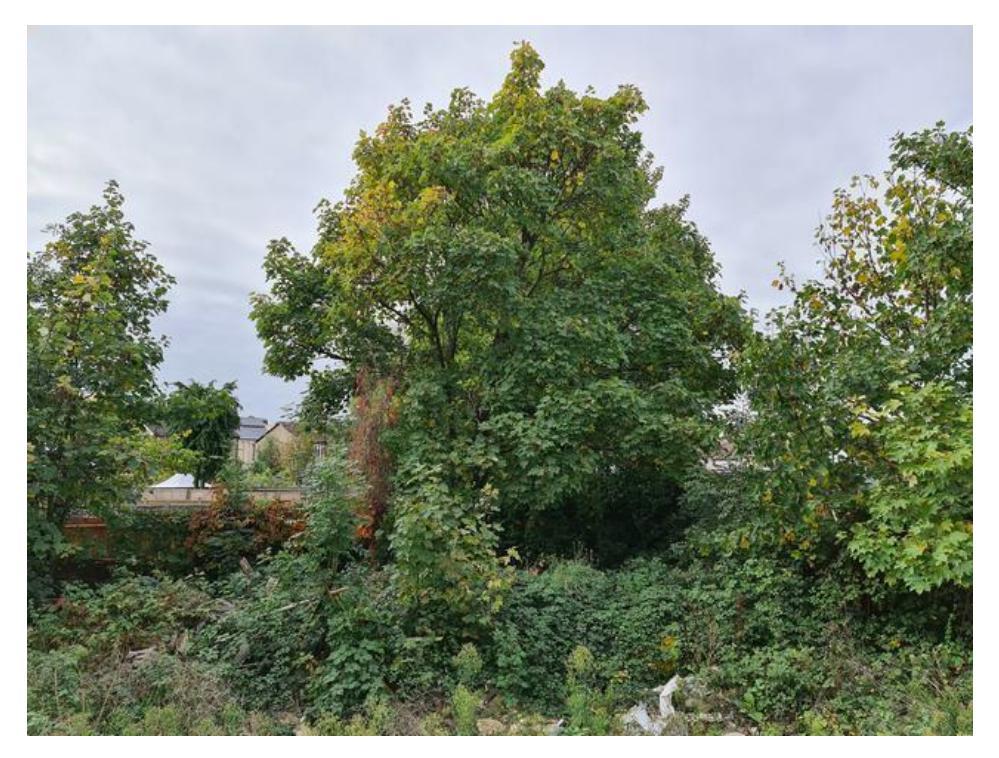
- The driveway where it is being extended to the proposed new garages, will run through the root protection area (ROPA) of T5 a sycamore. This is addressed in Section 9 Hard Surfaces within the RPA.
- The garages will be partially within the RPA of T5. This is addressed in Section 110 of the AMS Foundation Design.

T5 located in the adjacent property Image 5

11.1 As there is construction in close proximity to T5 a retained sycamore on the adjacent property some form of tree friendly foundation will be required to minimise the root disturbance. This could involve the use of a slab or mini piles or screw piles.

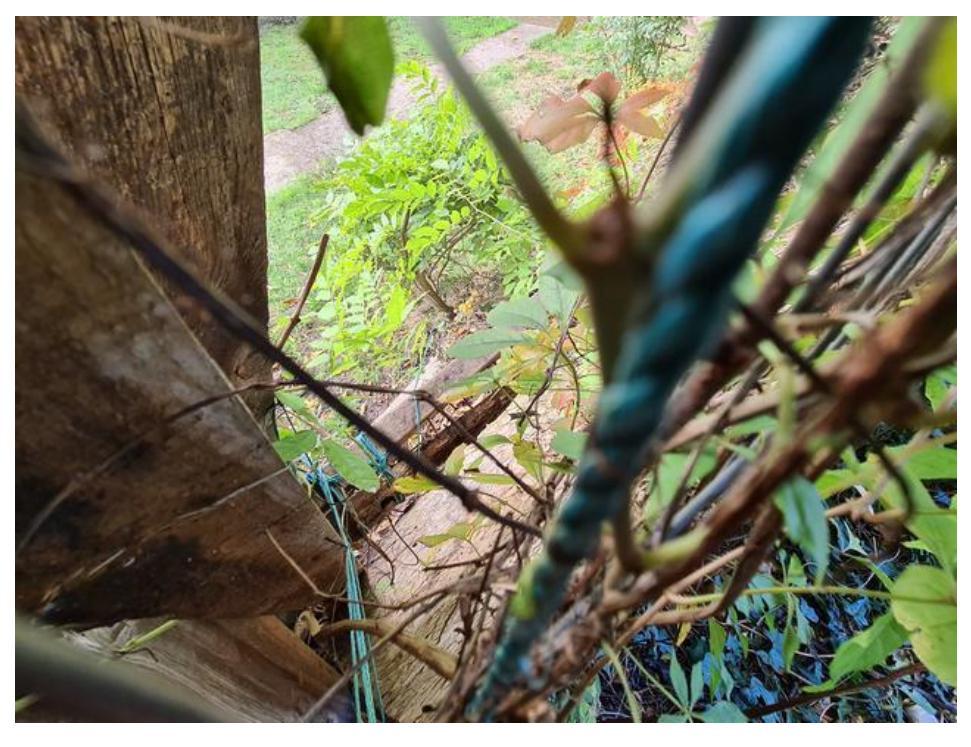
Change in level along the southern boundary Image 6

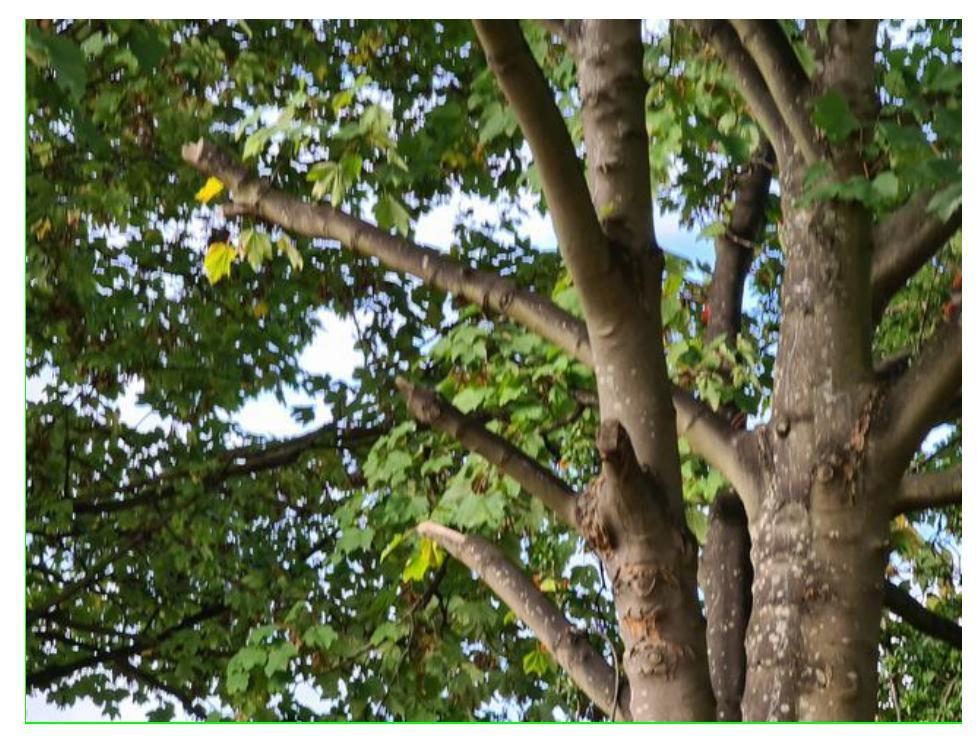
Branche son the owner's side of T1 have been previously hacked back, see stubs Image 7

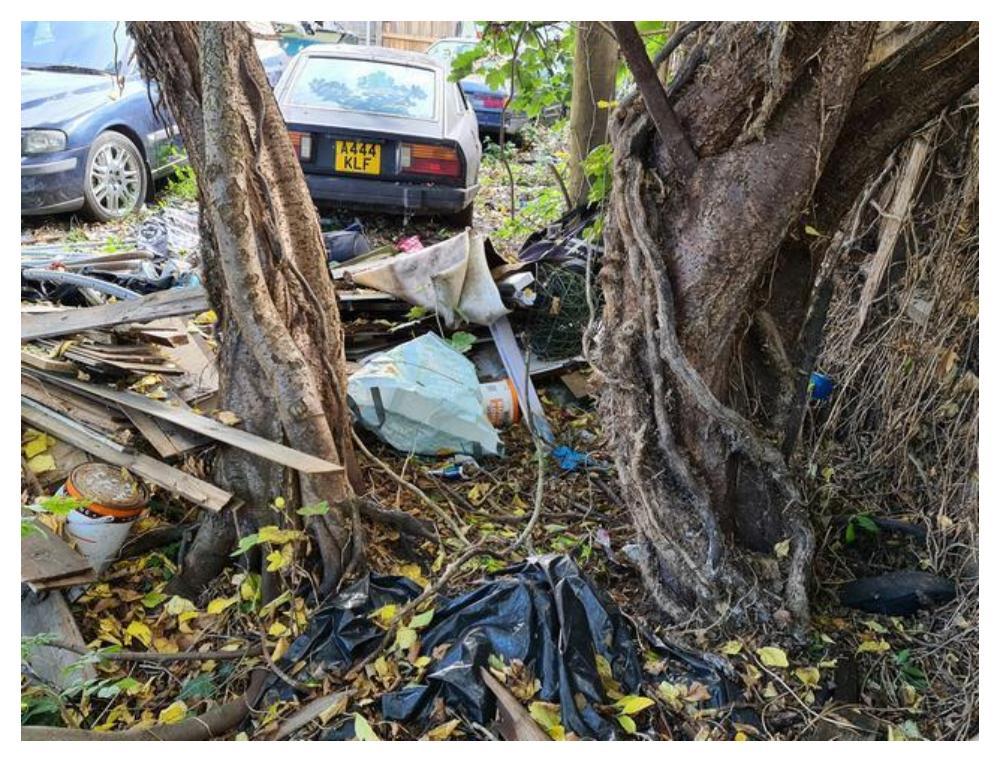
Base of T2 and T3 both poor quality plum trees Image 8
