Arboricultural Survey to BS5837 2012

Arboricultural Impact Assessment

Site	1 Walnut Close, Eynsford
-------------	---------------------------------

Date of Report	V3 16th April 2018
-----------------------	--------------------------------------

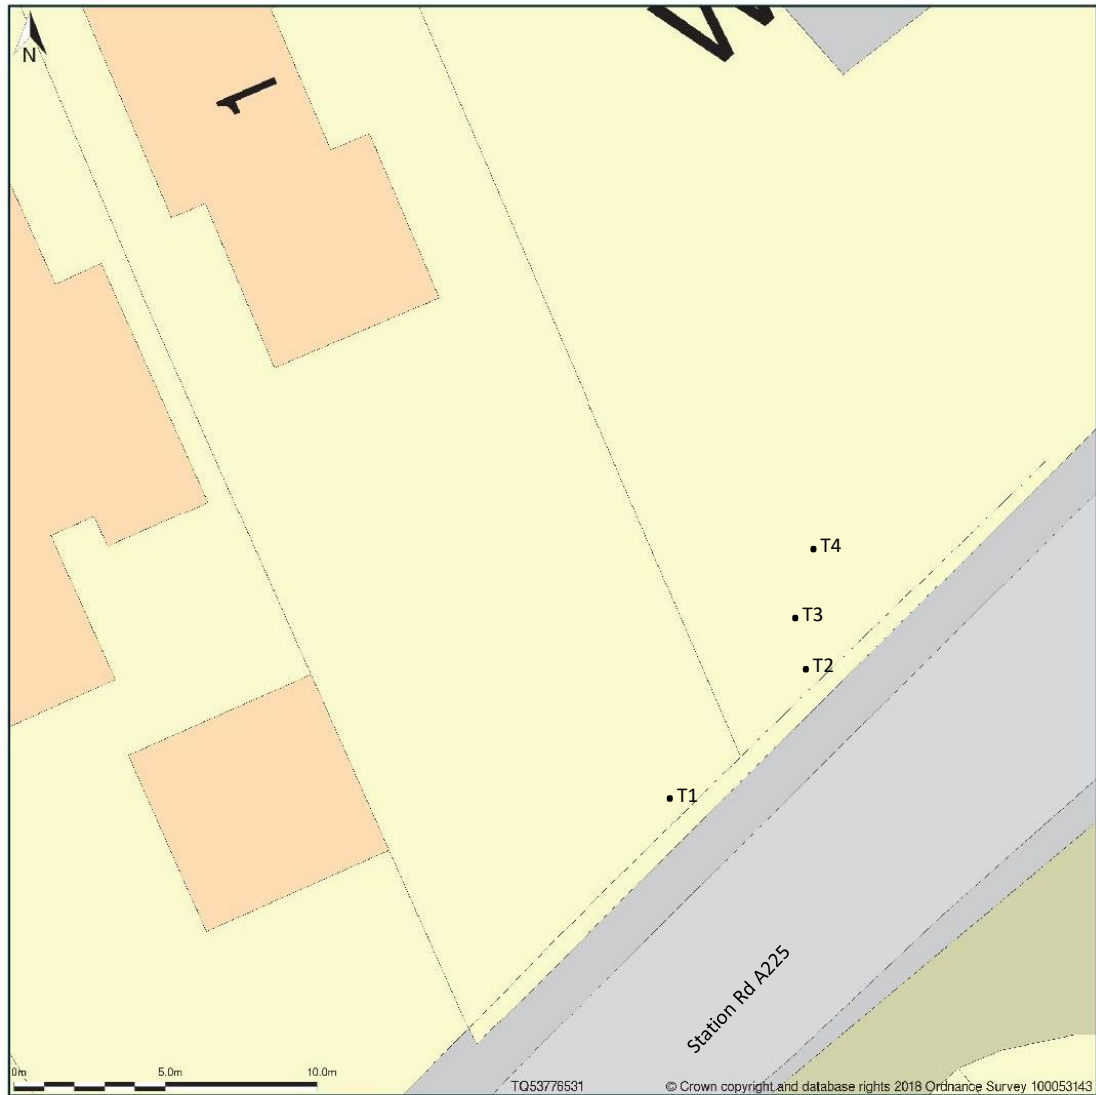
Site Plan with tree locations

- 6.2 The site has four main trees and some shrubs along the roadside boundary of the property. The trees individually are poor specimens but collectively they provide screening from the road.

- 7.4 There is not much evidence of tree management on the site as the trees are quite young. Ivy is heavily affecting several of the trees and it has been severed on some of the trees.

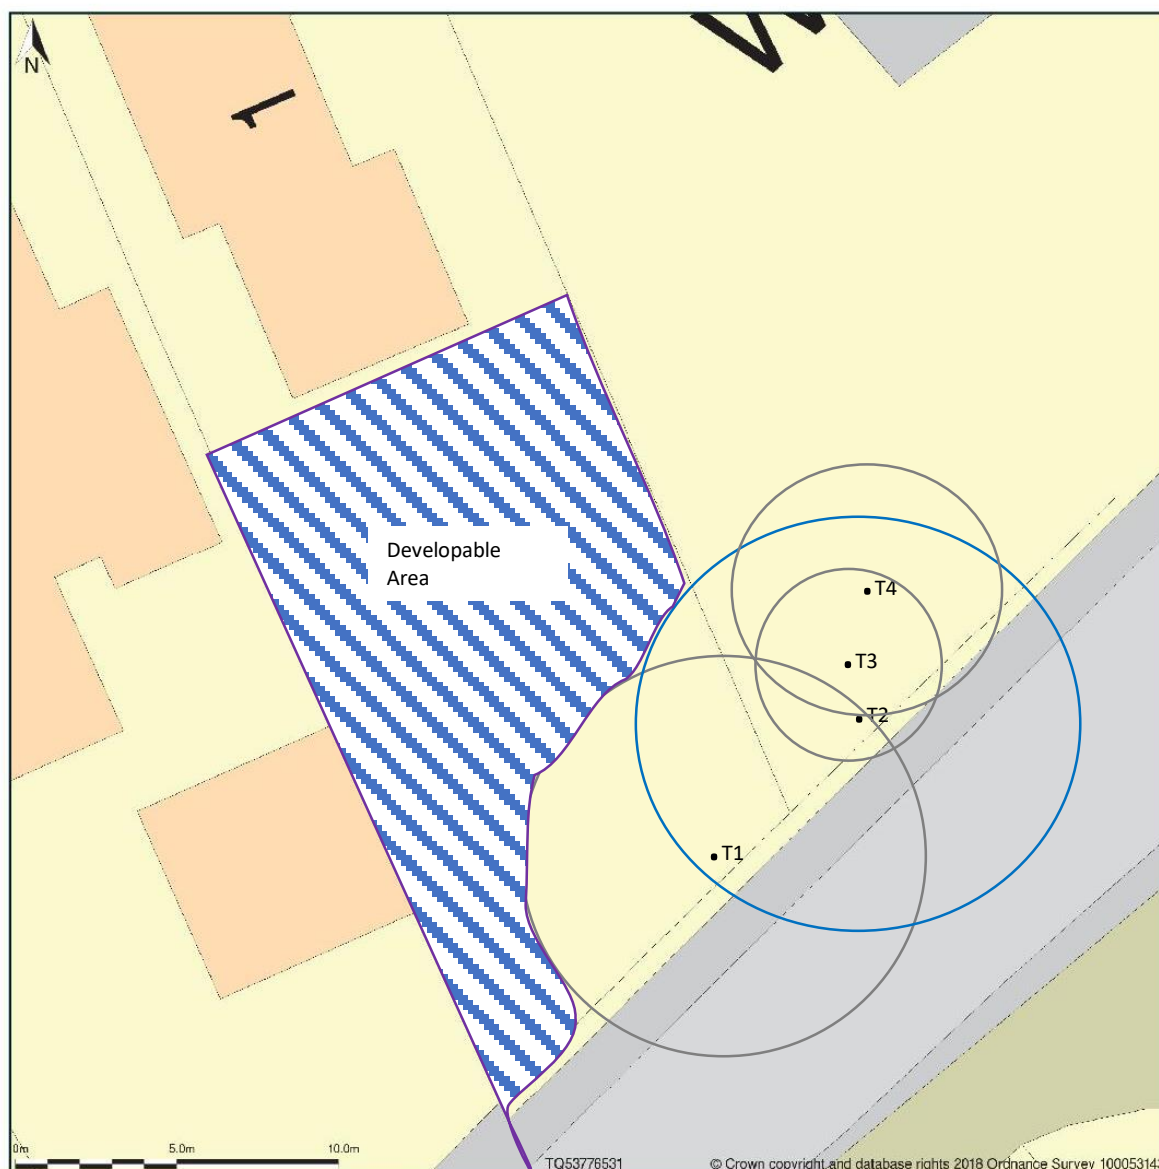
**Tree Constraints Plan with tree
root protection areas shown**

- 8.5 The road and paving will possibly have reduced the root growth of the trees to the south sides.
- 8.6 The tree root protection areas form a roughly parallel block running along the side of the pavement extending approximately 7m into the site. Beyond that there is developable space and also a developable corridor approx. 2.5m wide along the western boundary free of RPAs which could potentially be used for access.

Please note tree locations are not guaranteed to be exact so site measurements should be undertaken before any designs are drawn up. RPA measurements are in the Tree Survey Schedule, Appendix 1, of this report

- 8.7 No unauthorised construction work should take place inside the Root Protection Areas (RPA). These are plotted on the Tree Constraints Plan.
- 8.8 Machinery and plant equipment movement will be necessary for the works. I would advise that where possible protective fences are used during development to protect the RPA of the trees during any works.

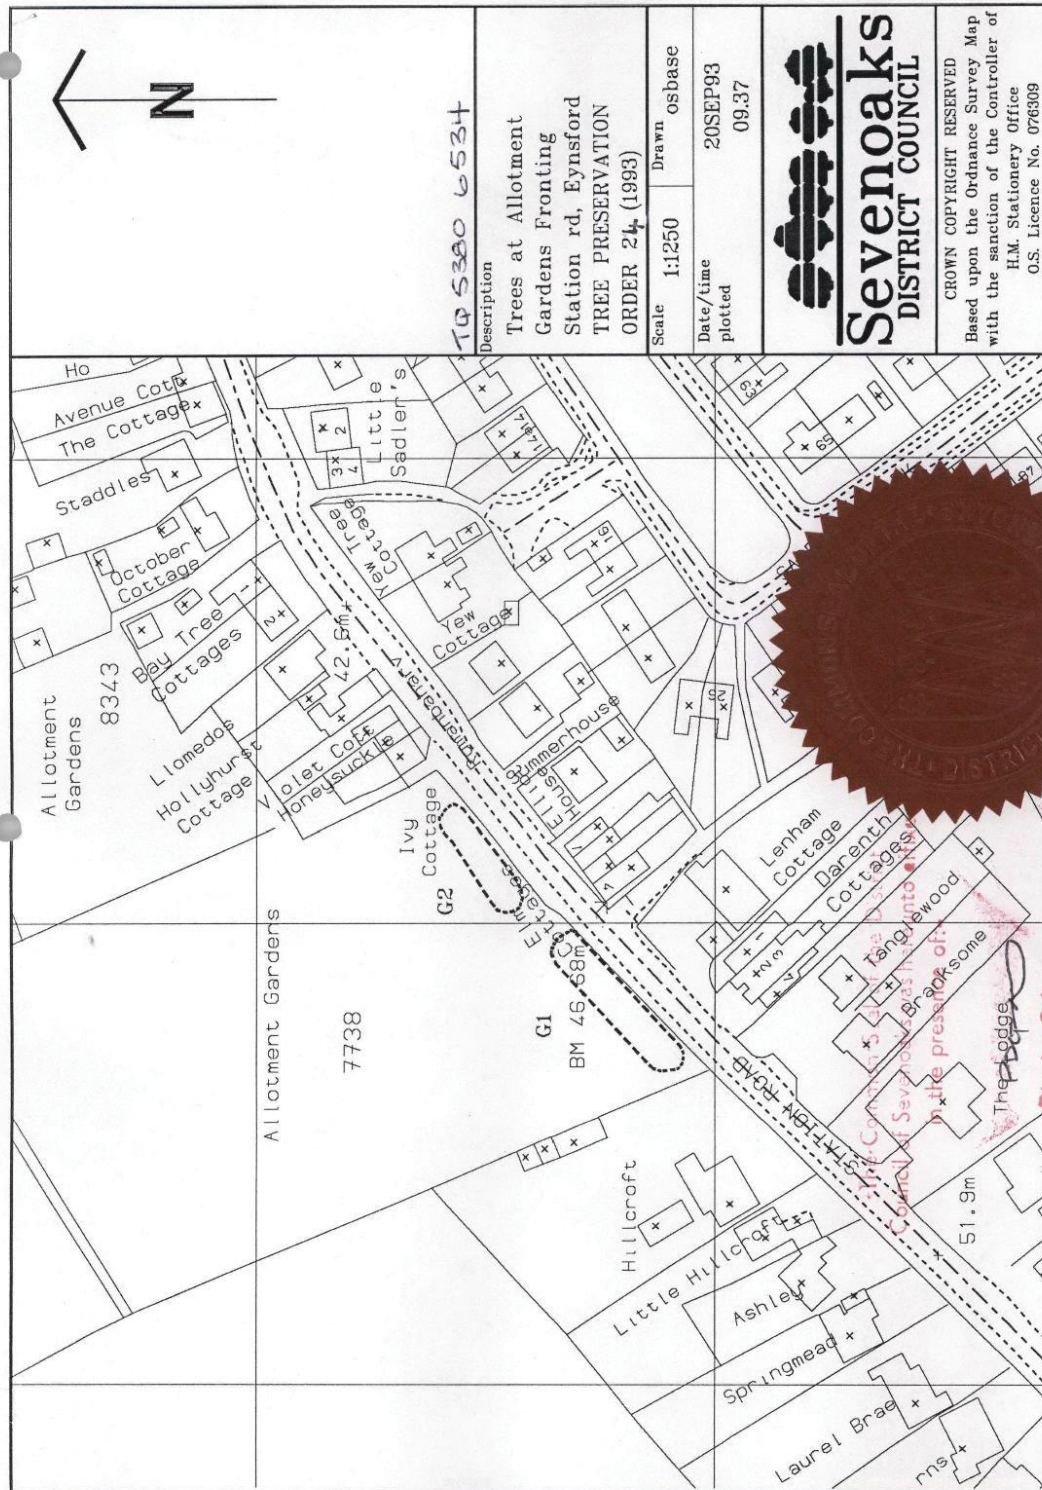
TPO Area Map

- 6.1 The house is in a close off the A225. There is a group TPO (Tree Preservation Order) on the trees running along the side of the A225, see map in appendix 4. The TPO was placed in 1993 before Walnut Close was built. The trees concerned are in G1 on the TPO plan.
