Arboricultural Impact Assessment & Method Statement

Harrison Home, Liverpool Rd South, Maghull, L31 8BS

Our Ref: 21/AIA/SEFTON/22

March 2021

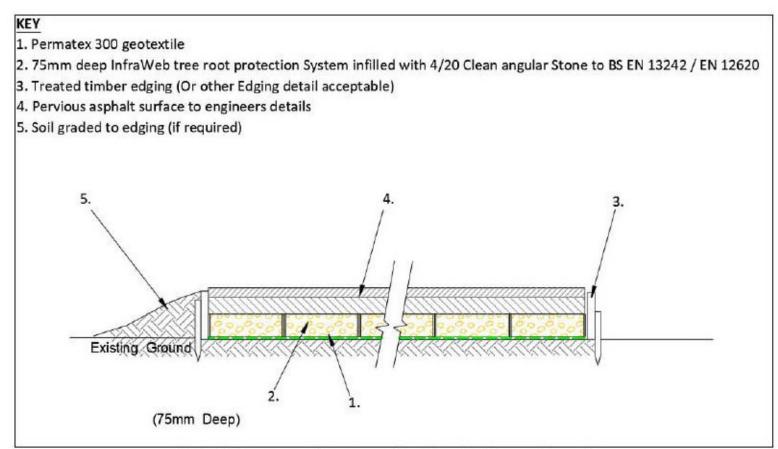
Plate 1- Cross section example of no-dig footpath section

- 8.3 There are two construction impacts to retained trees as detailed below:
 - The proposed car park encroaches within the RPA of tree numbers 17, 20 & 50 and the realigned pedestrian footpath encroaches within tree number 8 & 9. This incursion is less than the 20% tolerance specified at 7.5.3 of the BS and the trees are of good vigour such that these works are possible with no long-term adverse impact to their health and vitality. In order to comply with the requirements of the BS and ensure no damage to any underlying tree roots these sections will be installed to a no-dig design specification using a three-dimensional cellular confinement system such as 'Infraweb' or 'Cellweb' which will involve the installation of a layer of plastic cells laid above the existing ground level. The cells will be back filled with a free draining washed stone that contains no fines in order to help maintain adequate gaseous diffusion for tree roots below. Surface dressing will be a porous material to be agreed with the LPA. A full specification will be supplied by the project structural engineer and will comply with recommendations contained within para. 7.2 of BS5837: 2012. Details are included within an Arboricultural Method Statement.

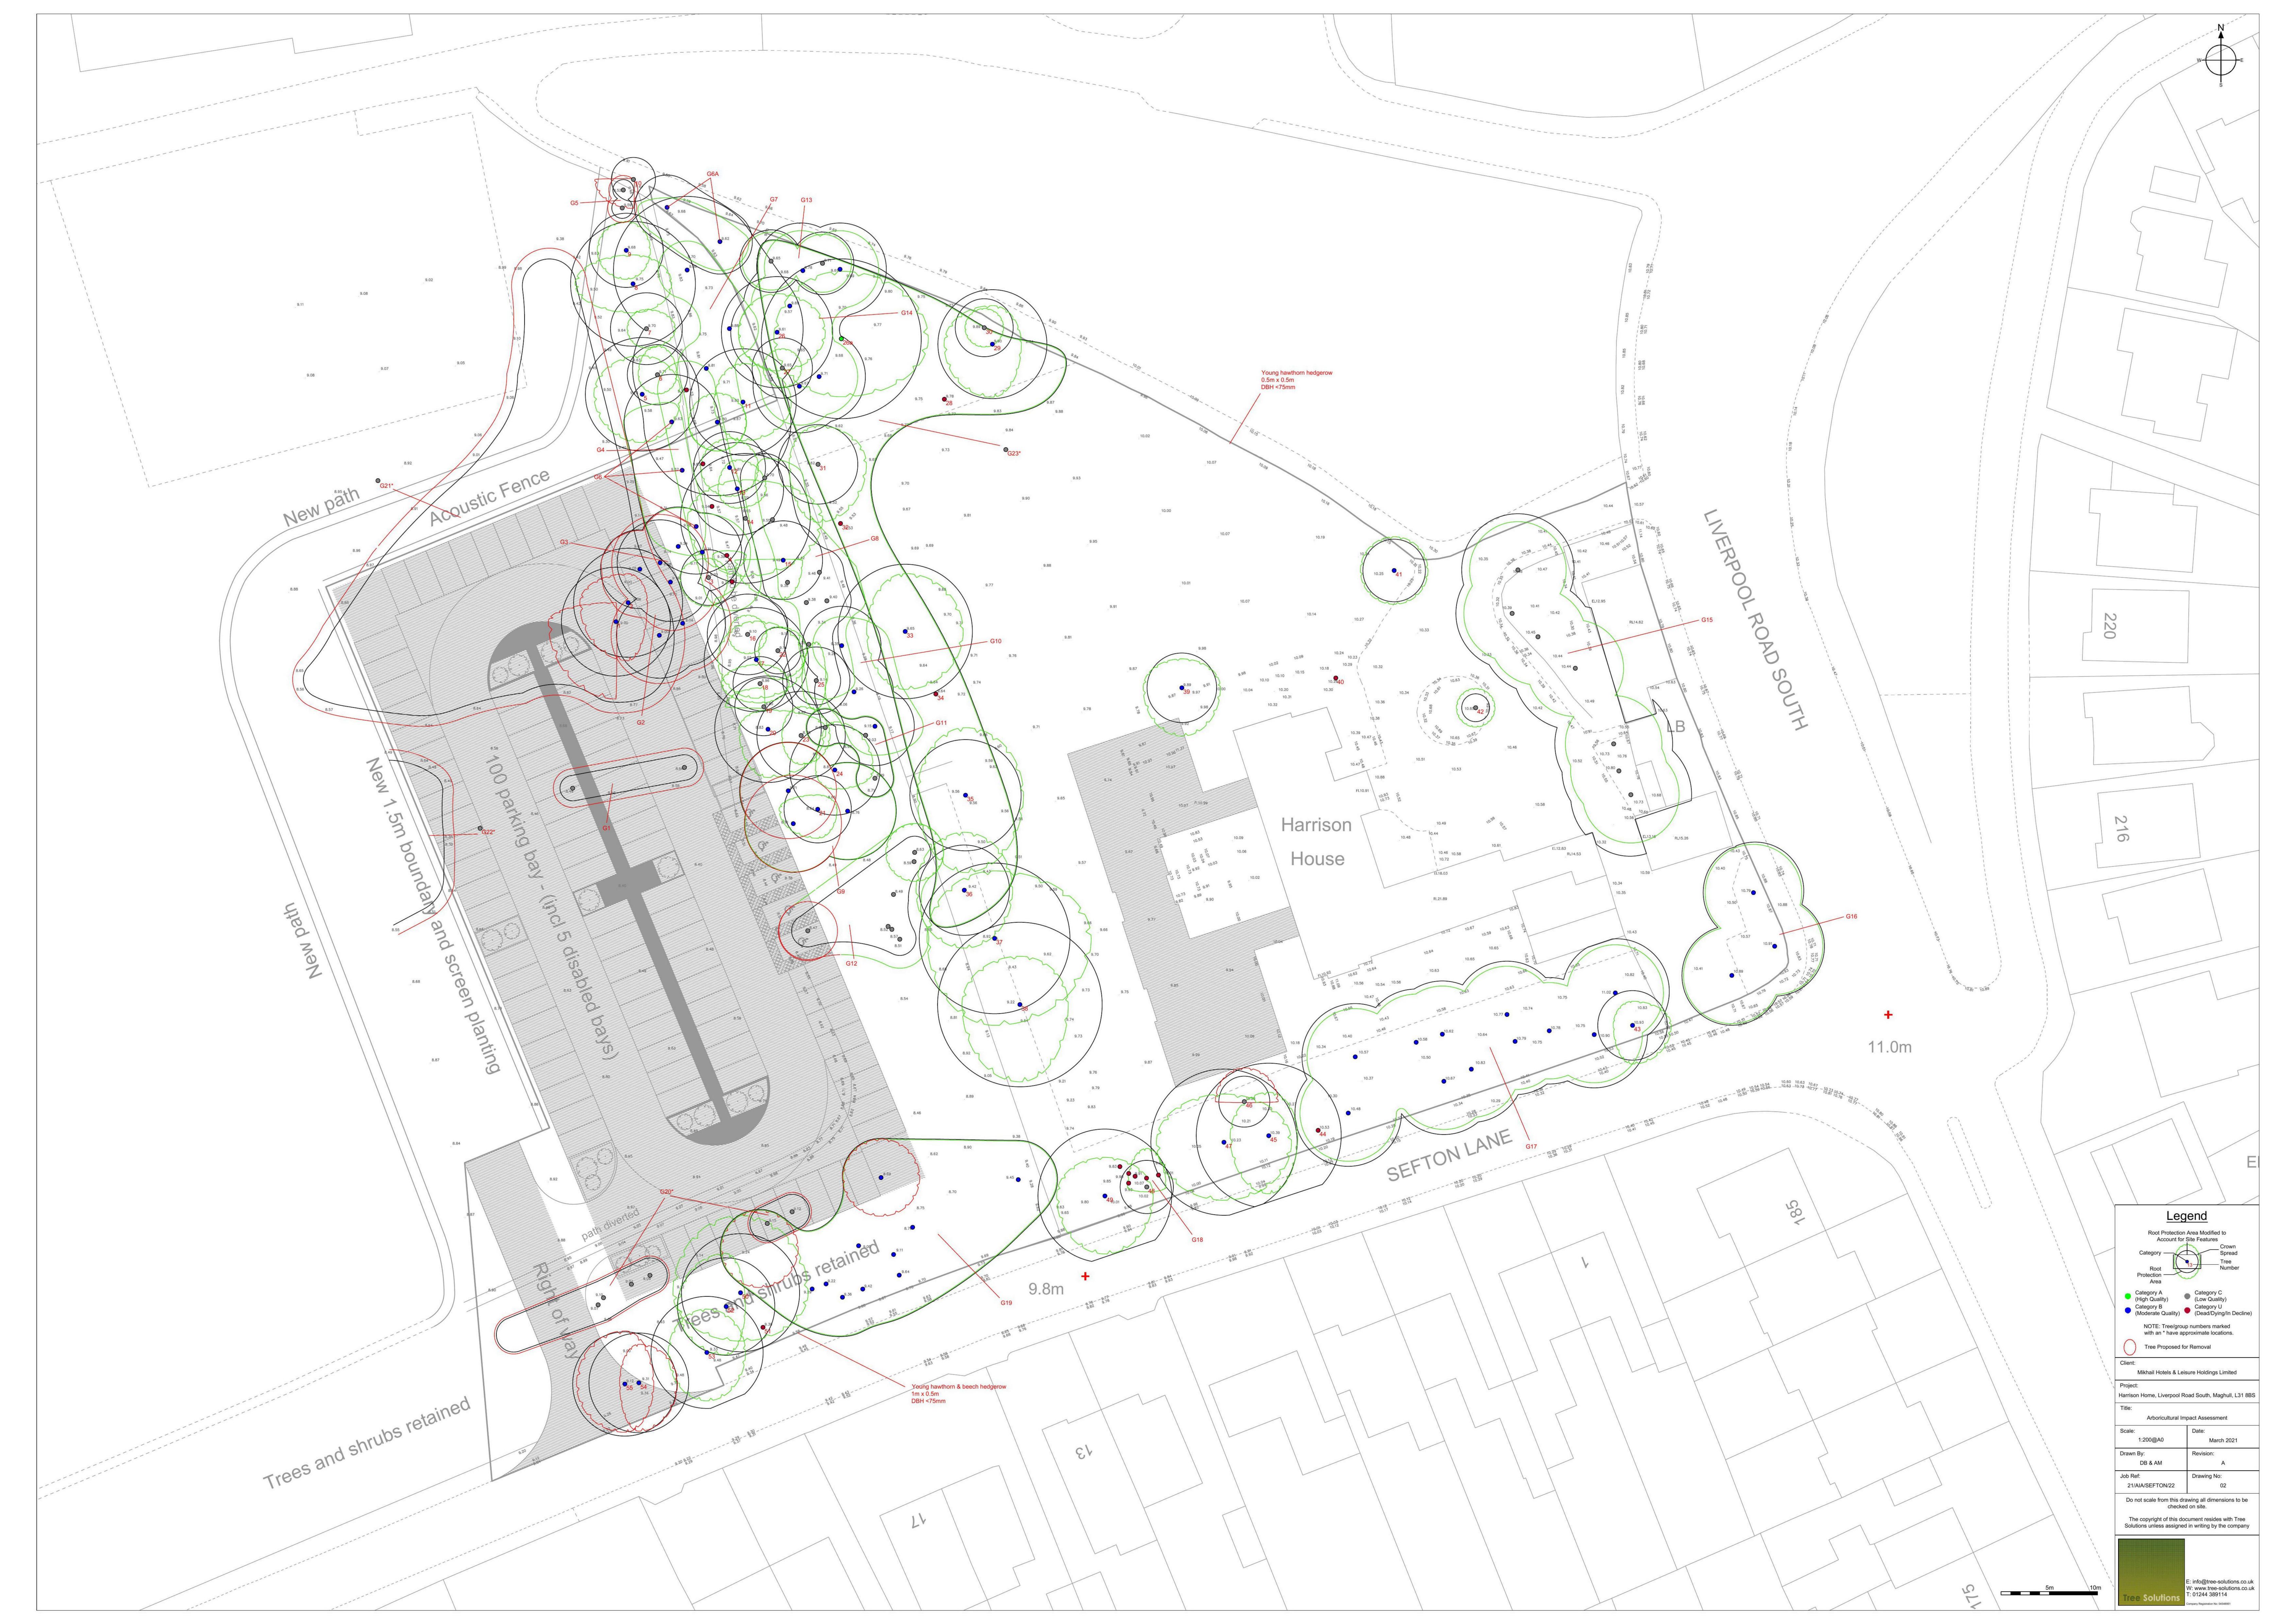
Impact Assessment Plan

- 8.2 In order to accommodate the proposed development it will be necessary to remove the following trees as detailed within the survey schedule:
 - > Tree numbers 1, 2, 46, 54 & 55

- ➢ Group Numbers 1-3, 9 (2 trees), 12 (2 trees), 19 (2 trees), 20, 21, 22 (east side)
