# BS5837 Arboricultural Impact Assessment

**6 The Oaks, Fleet, GU51 4HQ**

Job Reference: **03559R**

**May 2021**

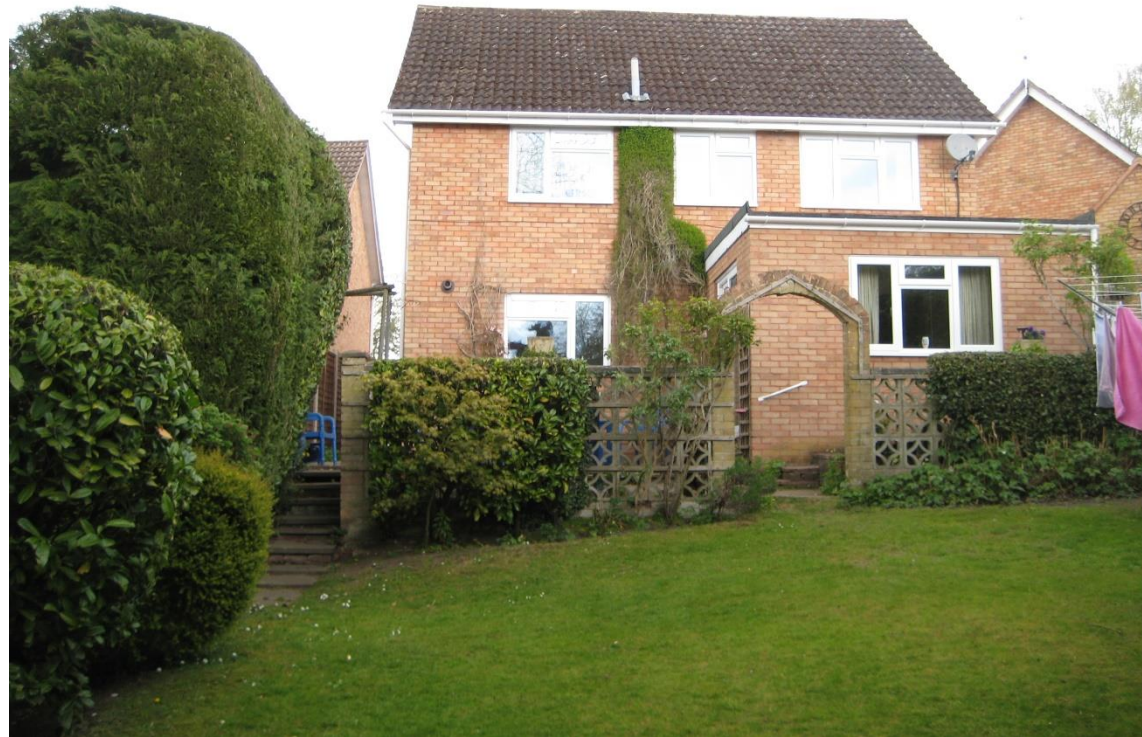
**Image 1** – Looking towards the property (rear) with H2 visible (left)

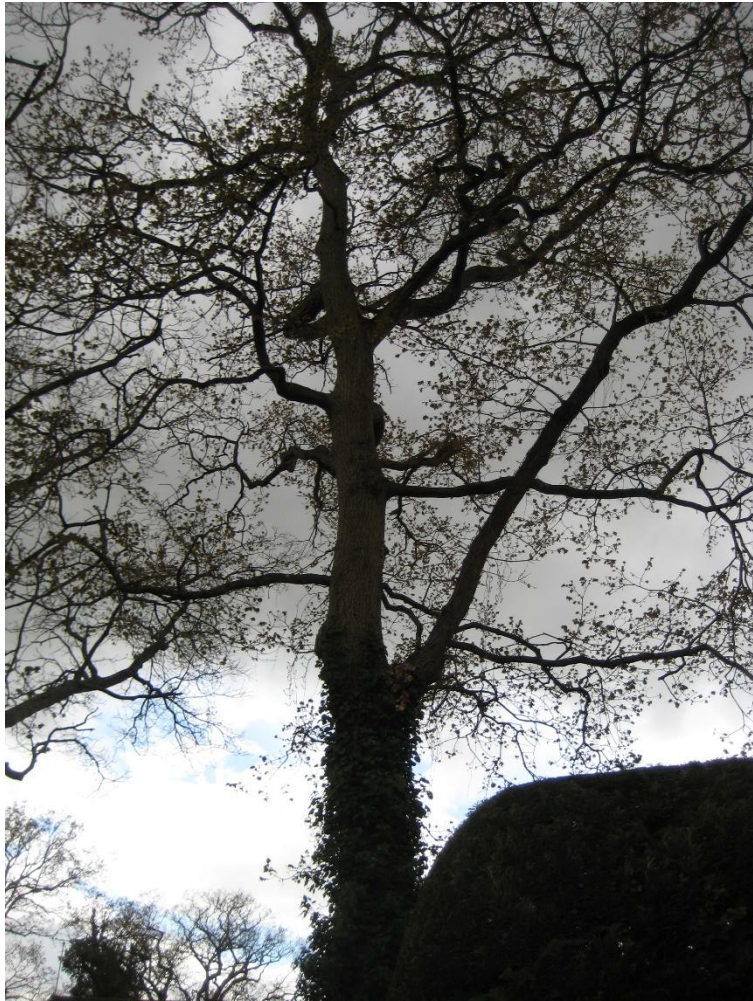
**Image 2 – T1 3<sup>rd</sup> party Oak**

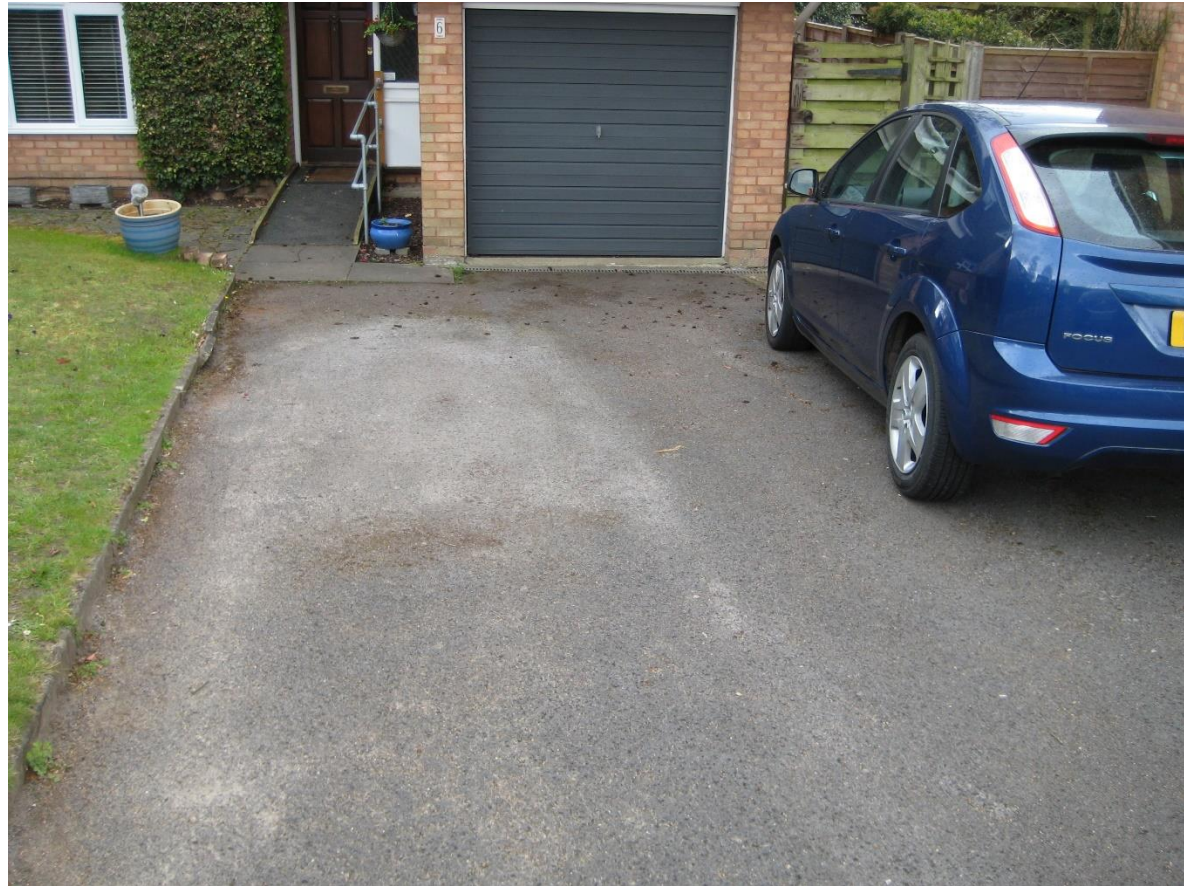
**Image 3 –Site storage (front)**
