12 Glovers Place
Hexham
NE46 3QN

Application for
Listed Building Consent

Additional supporting Information

Summary of work requiring Consent.
12 GLOVERS PLACE, NE46 3BN

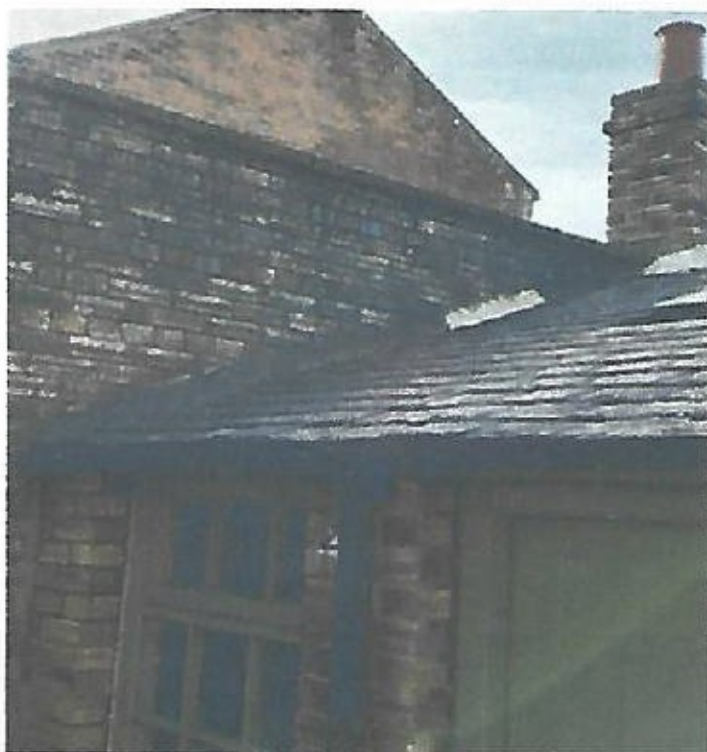
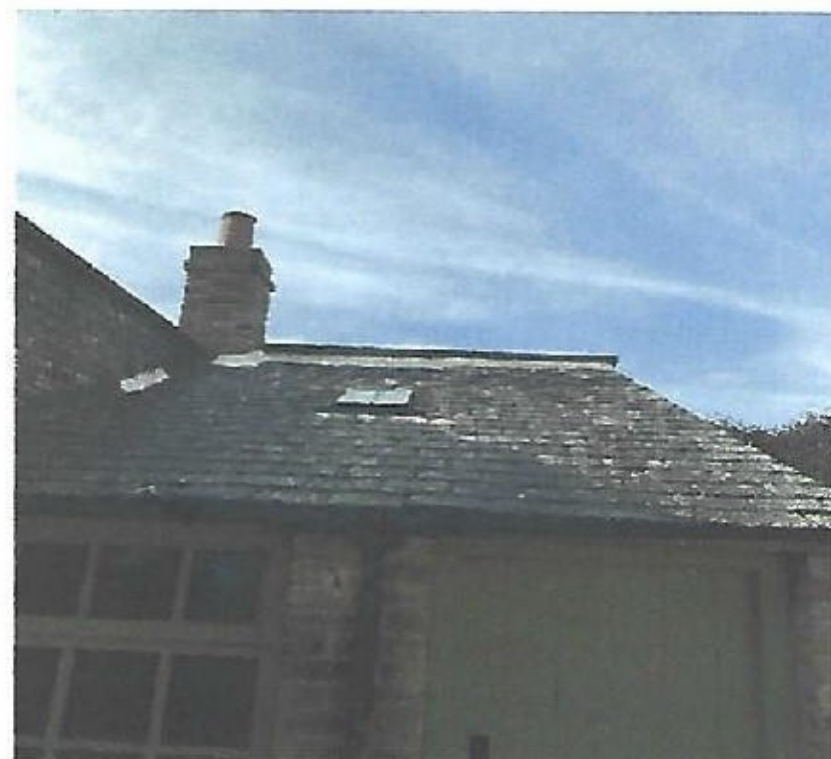
OUTBUILDING ROOF

The Building Survey identified damp staining to the sarking boards to the underside of the roof slope. The adjacent purlin also shows similar staining - likely to be caused by poor /degraded flashing to the left hand side of the slate roof attached to the adjoining building, and the concrete flashing along the roof ridge.

Remove the existing degraded 'mortar' flashing adjacent to the left hand wall.
Install a lead soak using Code 3 lead under the slate tiles
Install step flashing using Code 4 lead to the adjacent wall and over the slate tiles, including the base of the chimney stack.

Install Code 4 flashing over the existing concrete along the roof ridge, and secure in a chase just underneath the water table.

This remedial work will ensure that the outbuilding is watertight in the short term

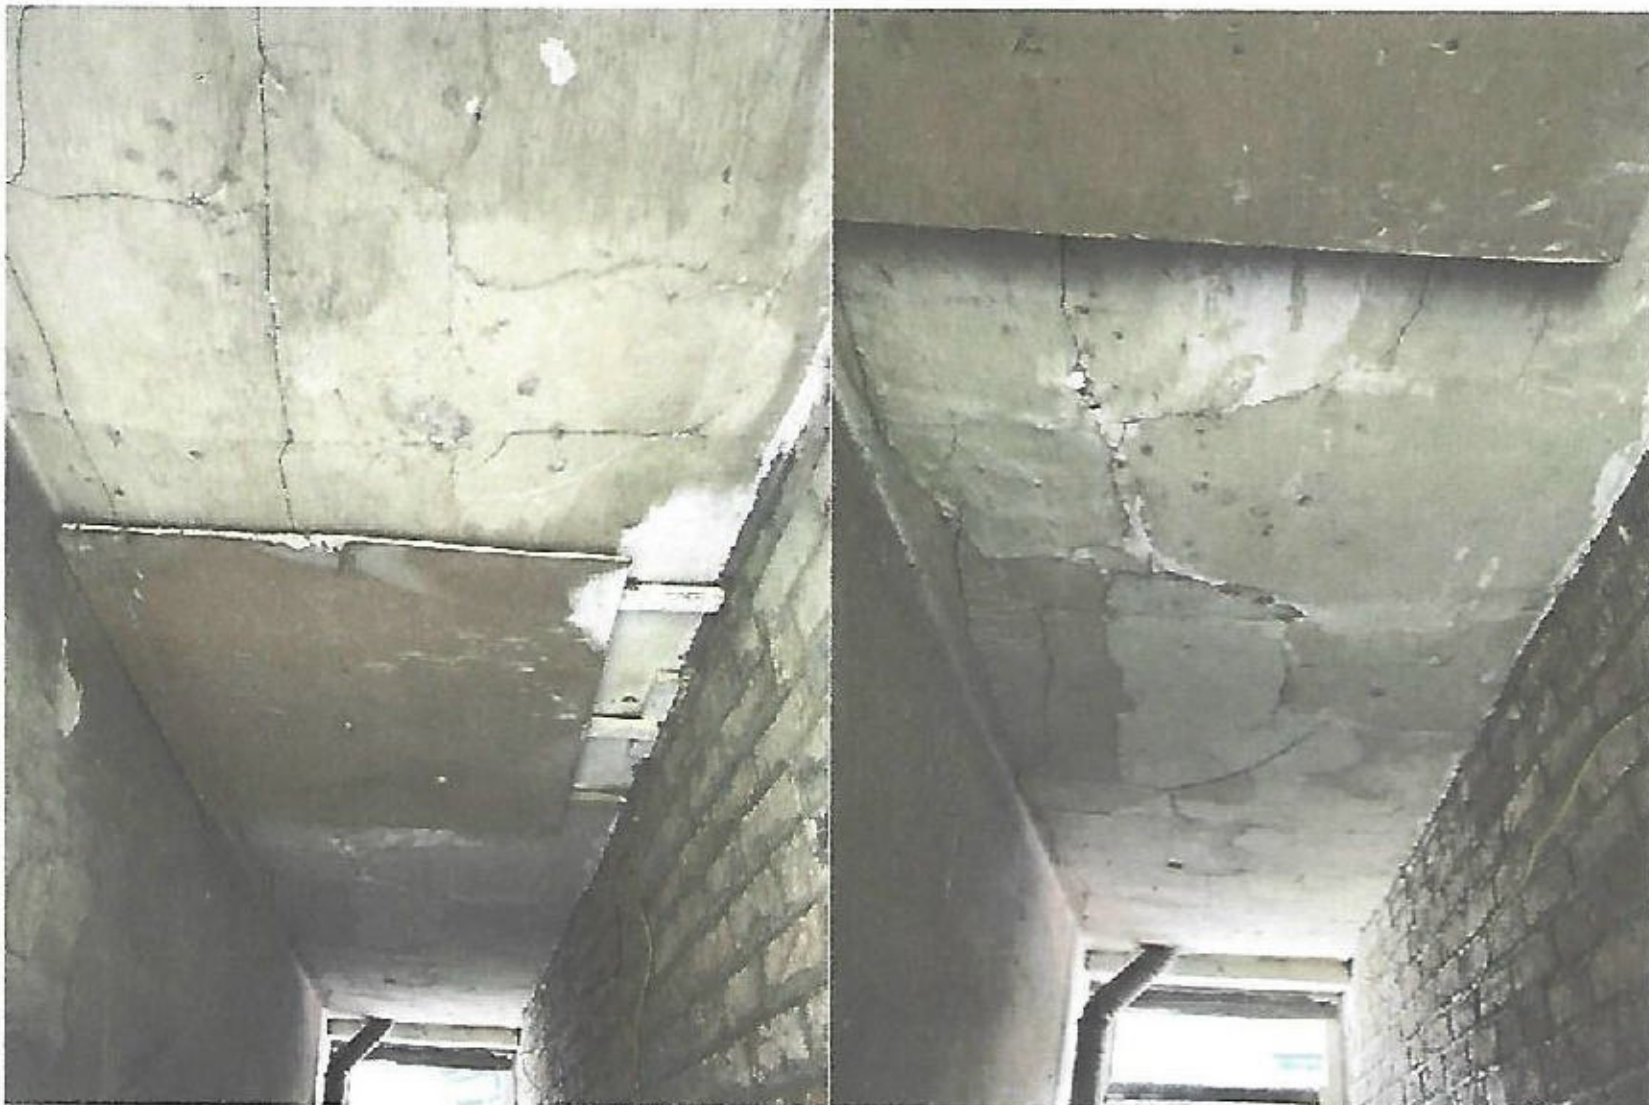
ALLEY CEILING

The Building Survey pointed out the very poor condition of the Alley ceiling, which is heavily cracked and deflected. In its current state, there is the possibility for further debonding to occur, incurring more damage and a potential safety hazard when using the Alley.

- Plasterboard and skim the ceiling which would keep in character with the exposed brickwork of the properties either side of the alley
- Overboard the alley with marine plywood and then paint a neutral colour.

It is considered that either option would halt the deterioration and make safe the alley. We will accommodate any preference by the Conservation recommendation.

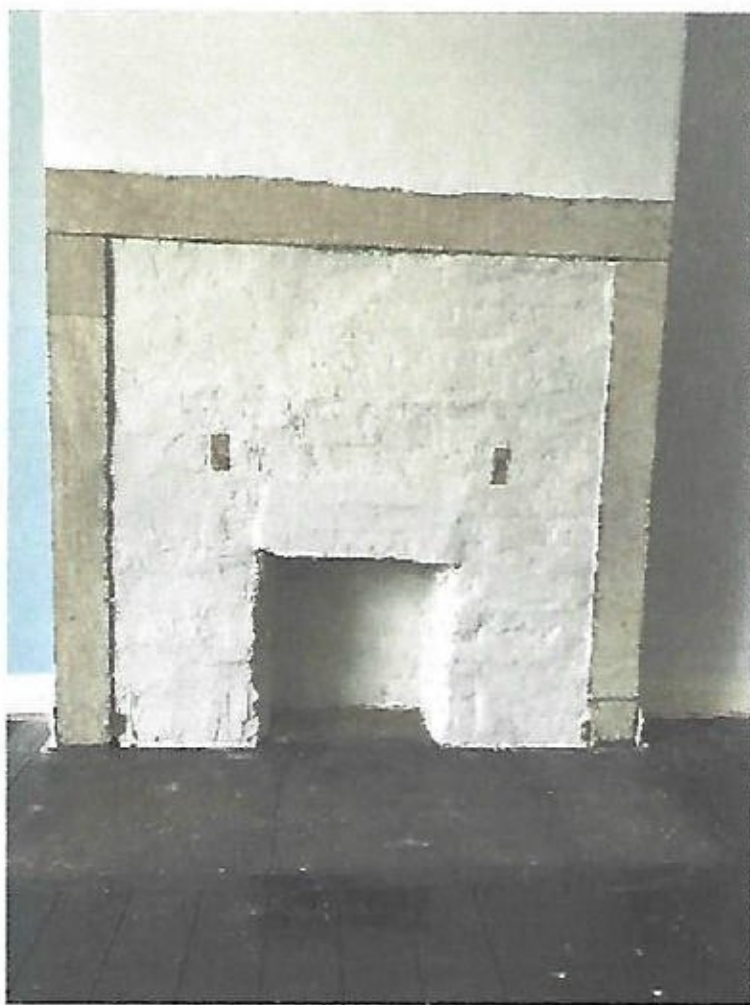
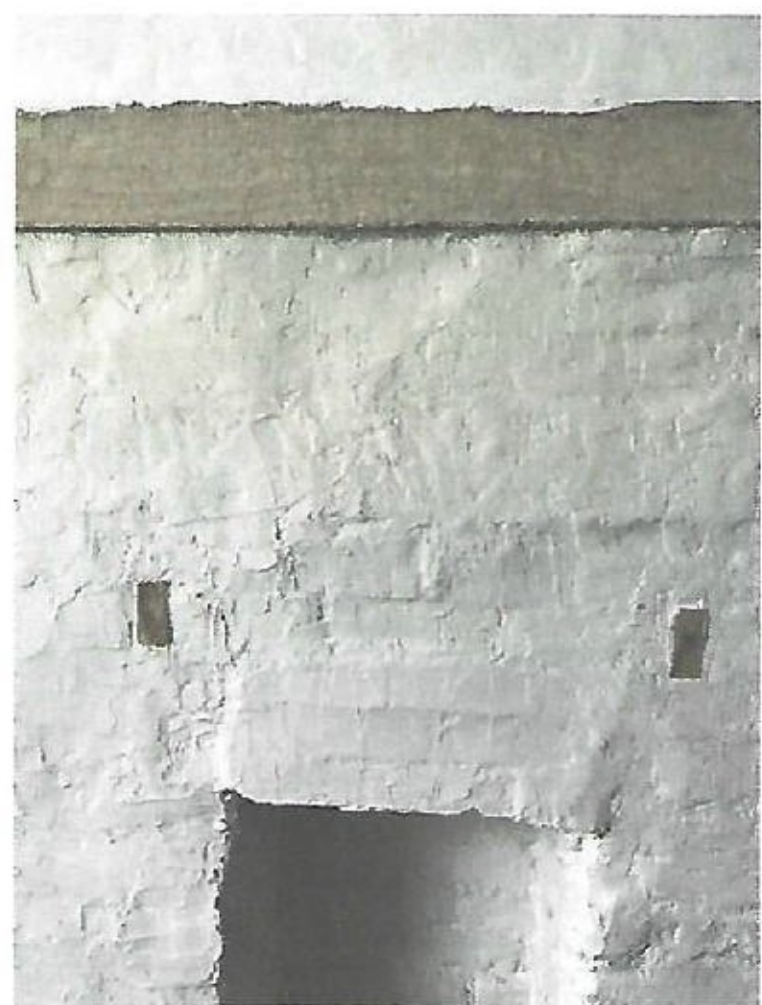
FIREPLACE

There is an equivalent fire surround in the Living Room directly above, which is intact and in good condition. However the entire fireplace itself has been bricked in and roughly plastered, but for a small opening where normally a fire would sit. It does not look as though it has been used as an open fire for quite a while.

Remove the plaster covering the bricks

Inglenuok the Fireplace, cleaning the brick work if it is ok or rendering inside the nook

line chimney with 9-meters of Flex liner

new pot hanging cowl and register plate

carbon monoxide alarm

signed off with HETAS.

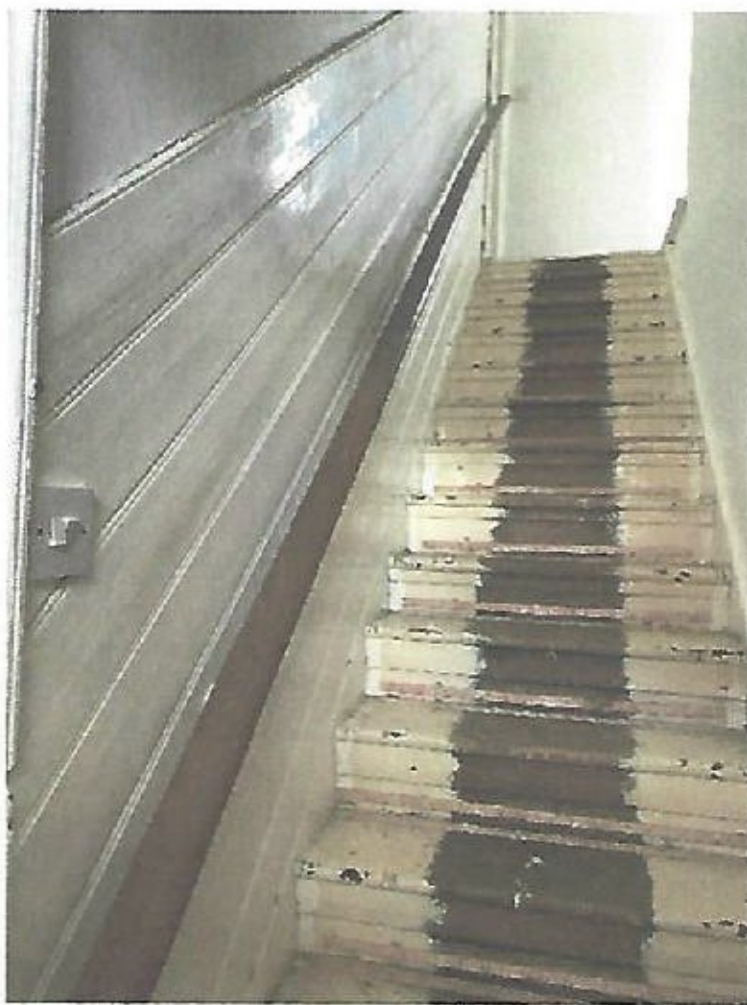
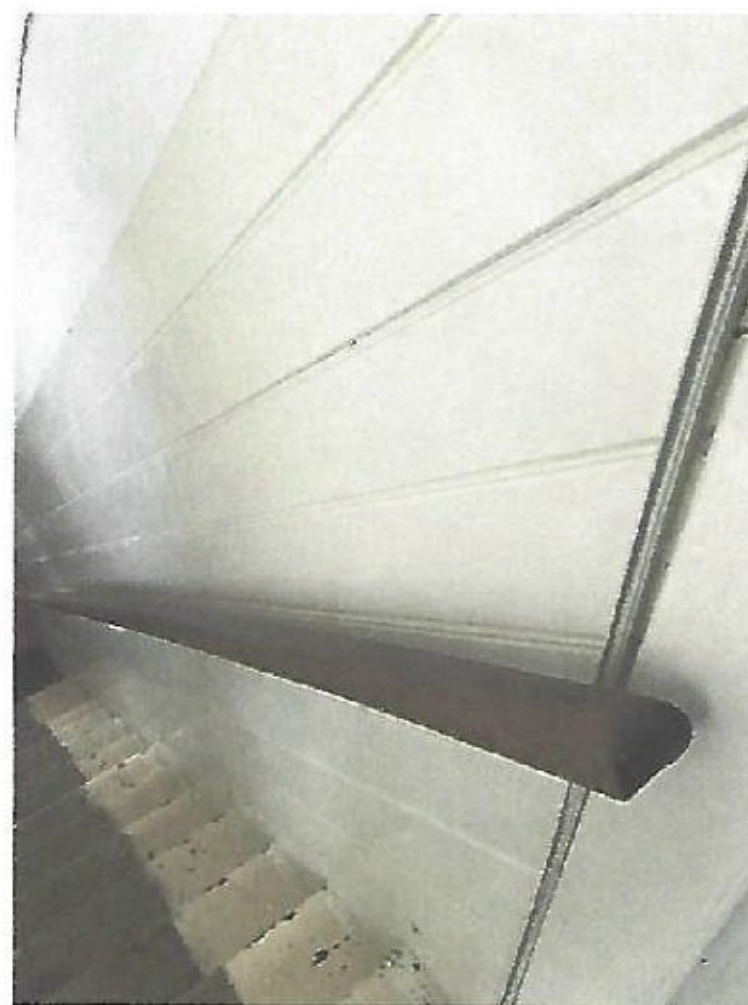
RESTORE STAIRCASE WALL

The front door leads into a very small 'vestibule' with a door off to the left, into the kitchen. A set of stairs leads up to the first floor, and to the left hand side, two thirds of the lathe and plaster wall has been fitted with broad sheets of cladding. The right hand wall is finished as you would expect with plaster.

Apart from being a bit of an eyesore, it is certainly not in keeping with the character of the property and detracts from the beautiful hand rail attached to the cladding.

Remove the pine cladding

Restore the original wall with lime mortar to the existing lathe and plaster

Refit the handrail

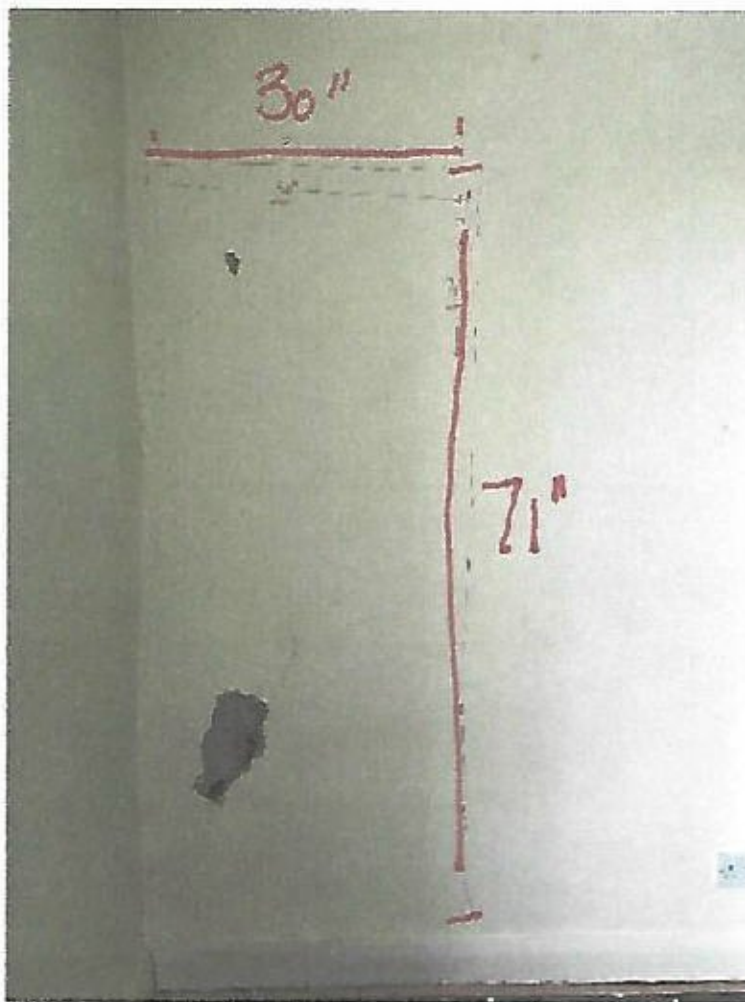
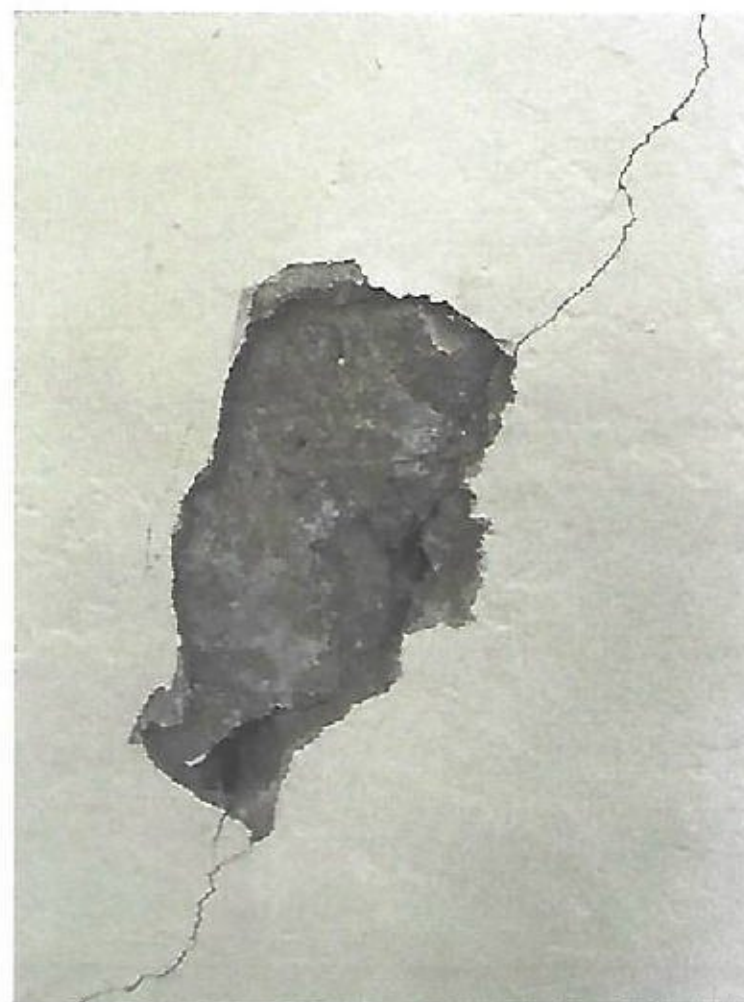
RESTORE SOME OF THE DEBONDED WALL

The Building Survey commented on a crack on the wall facing you as you enter the main Bedroom. This is a party wall with Number 10 Govers Place. The Surveyor reported that there is no structural issue causing the crack, but debonding of the original plaster to the party wall.

Their recommendation was to attend to the crack to prevent the crack extending and causing more debonding of plaster. The picture shows the extent of wall which will need to be replastered. The current plaster is applied directly to the stonework.

- Remove the debonded plaster in the area indicated on the photograph
- Clean up the exposed stonework
- Replaster with lime based mortar

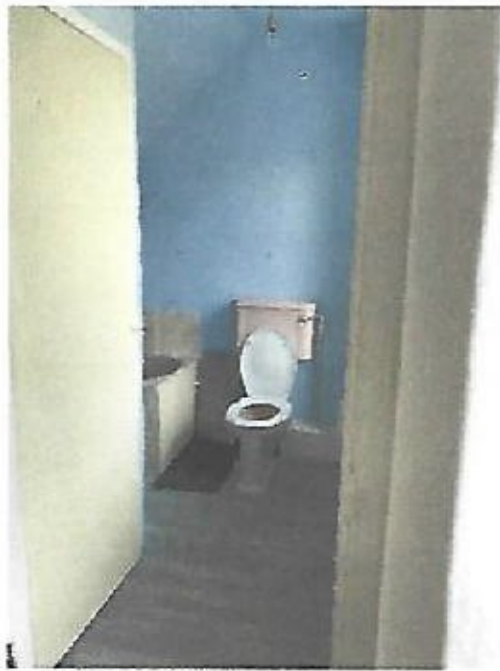
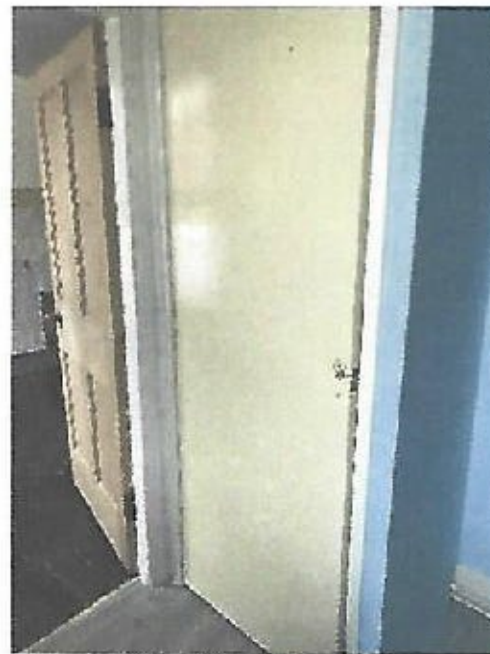
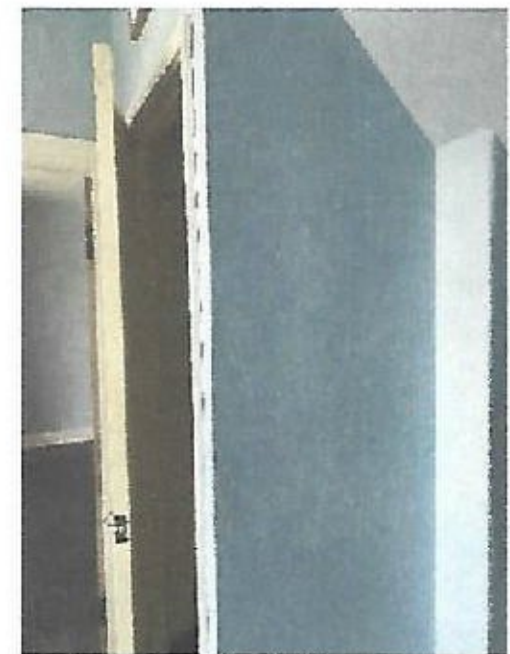
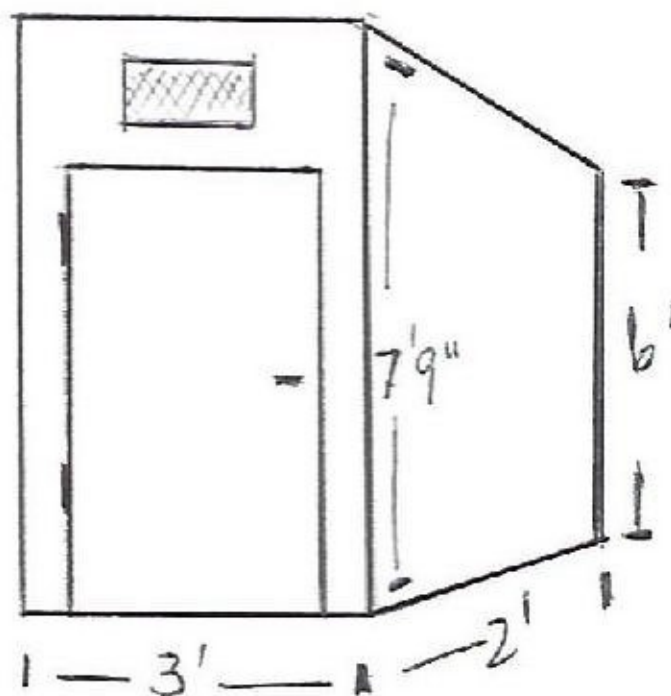
BATHROOM AIRING CUPBOARD

A combi boiler now provides the hot water for the property, and the water tank has been removed, so this space is now redundant.

The intention is to restore the original dimensions by removing the airing cupboard, leaving more space when the bathroom is upgraded.

The airing cupboard consists of a stud plaster wall to one side and access to the cupboard via a plywood door. There is an air vent positioned just above the door.

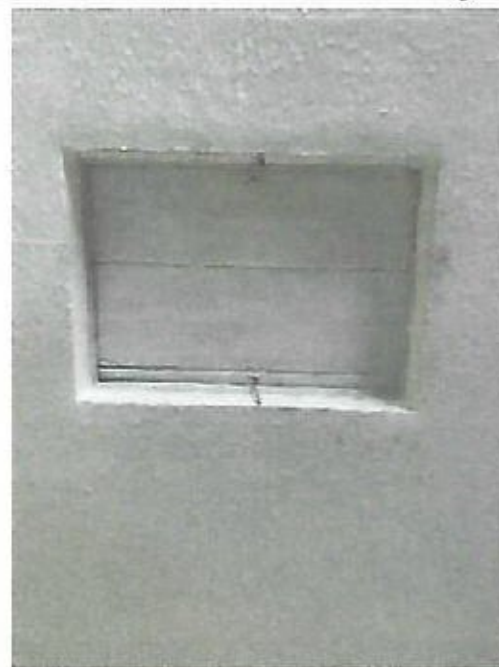
current hatch

The current loft hatch is located in the larger bedroom toward the rear on the left side. It measures 450mm x 330mm (18" x 13"). The joists in the loft run across the length of the property and the narrow width of the hatch – 330mm – accommodates the gap between the joists.

'Back in the day', the hatch might have been an adequate opening for people to get in and out of the loft, however the current size and location presents a few issues:

- The size limits practical access for the purpose of maintenance and any potential repairs. (for example the Building Survey highlighted that there was insufficient loft insulation relevant to current regulations)
- The location means that any furniture in the room – i.e. a bed – would need to be moved each and every time access was required.

The two issues raised above could be resolved with the relocation of the loft hatch to the entrance of the smaller bedroom.

The sketch illustrates the size and location of the current hatch, and the potential location and size of the new one. The direction of the joists means that only one joist would need to be removed (Shown in red on the sketch)-approximately 600mm in length – in order to fit the new loft hatch. To maintain the strength and stability of the roof structure, once trimmed, the joists would be tied into other joists using similar timber.
