# Ampney Park

## Preliminary Bat Roost Assessment and Survey

April 2021

Client: Simon Morray-Jones  
Architects Ltd  
Report Ref: SEB2429\_01  
Author:  
Kate Hayward MCIEEM  
[www.seasonsecology.co.uk](http://www.seasonsecology.co.uk)

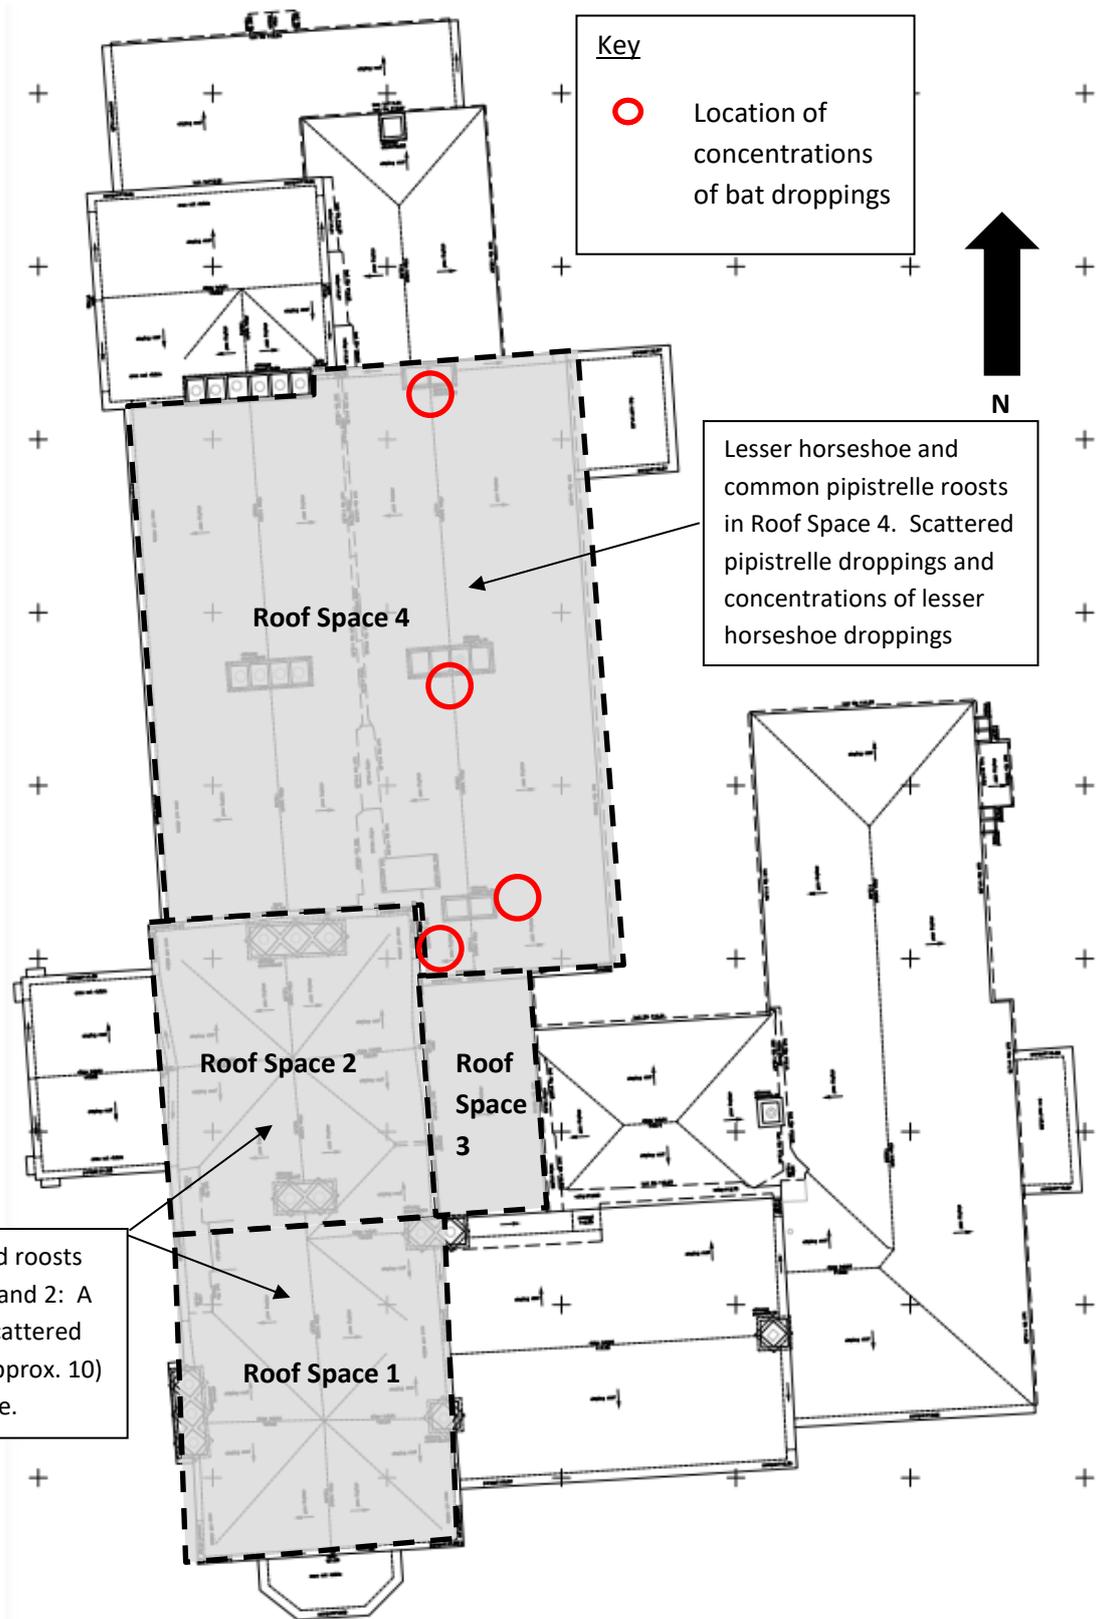
## Annex 2: Main House Roof Layout and Survey Results (April 2021)

- 4.2.6 Internally, the Main House contains four accessible roof spaces. These are numbered 1-4 and are shown on the plan at Annex 2. Roof spaces 1-3 are located in the three-storey South Wing. Roof Space 4, the largest of the four roof spaces, is located in the two-storey North Wing.

- 4.2.7 The roof spaces are dark and undisturbed. They have traditional Bitumen-type liners and wooden roof supports.
- 4.2.8 *Roof spaces 1 and 2*, both accessed from the second floor of the South Wing, are approximately 1.7m high to the apex, and 8m width and length. They are cluttered and contain water tanks. Evidence of bats was found in both roof spaces in the form of a low number of scattered bat droppings.

- 4.2.10 *Roof space 4* is accessed off the first floor of the North Wing and is located beneath the M-shaped, slate-tiled roof and occupies both sides of the valley. Only the eastern half of the roof space was accessed, to the east of the valley, due to the small gap between the two spaces. This eastern half of the roof space is approximately 2.5m high to the apex, 6m in width and 15m in length. There is a door at the southern end, which opens out onto the lead valley roof. Evidence of bats was found in the form of bat droppings, located in four distinct piles near to the chimneys, as well as scattered bat droppings throughout, numbering several hundred (refer to Photograph 3, Annex 4).

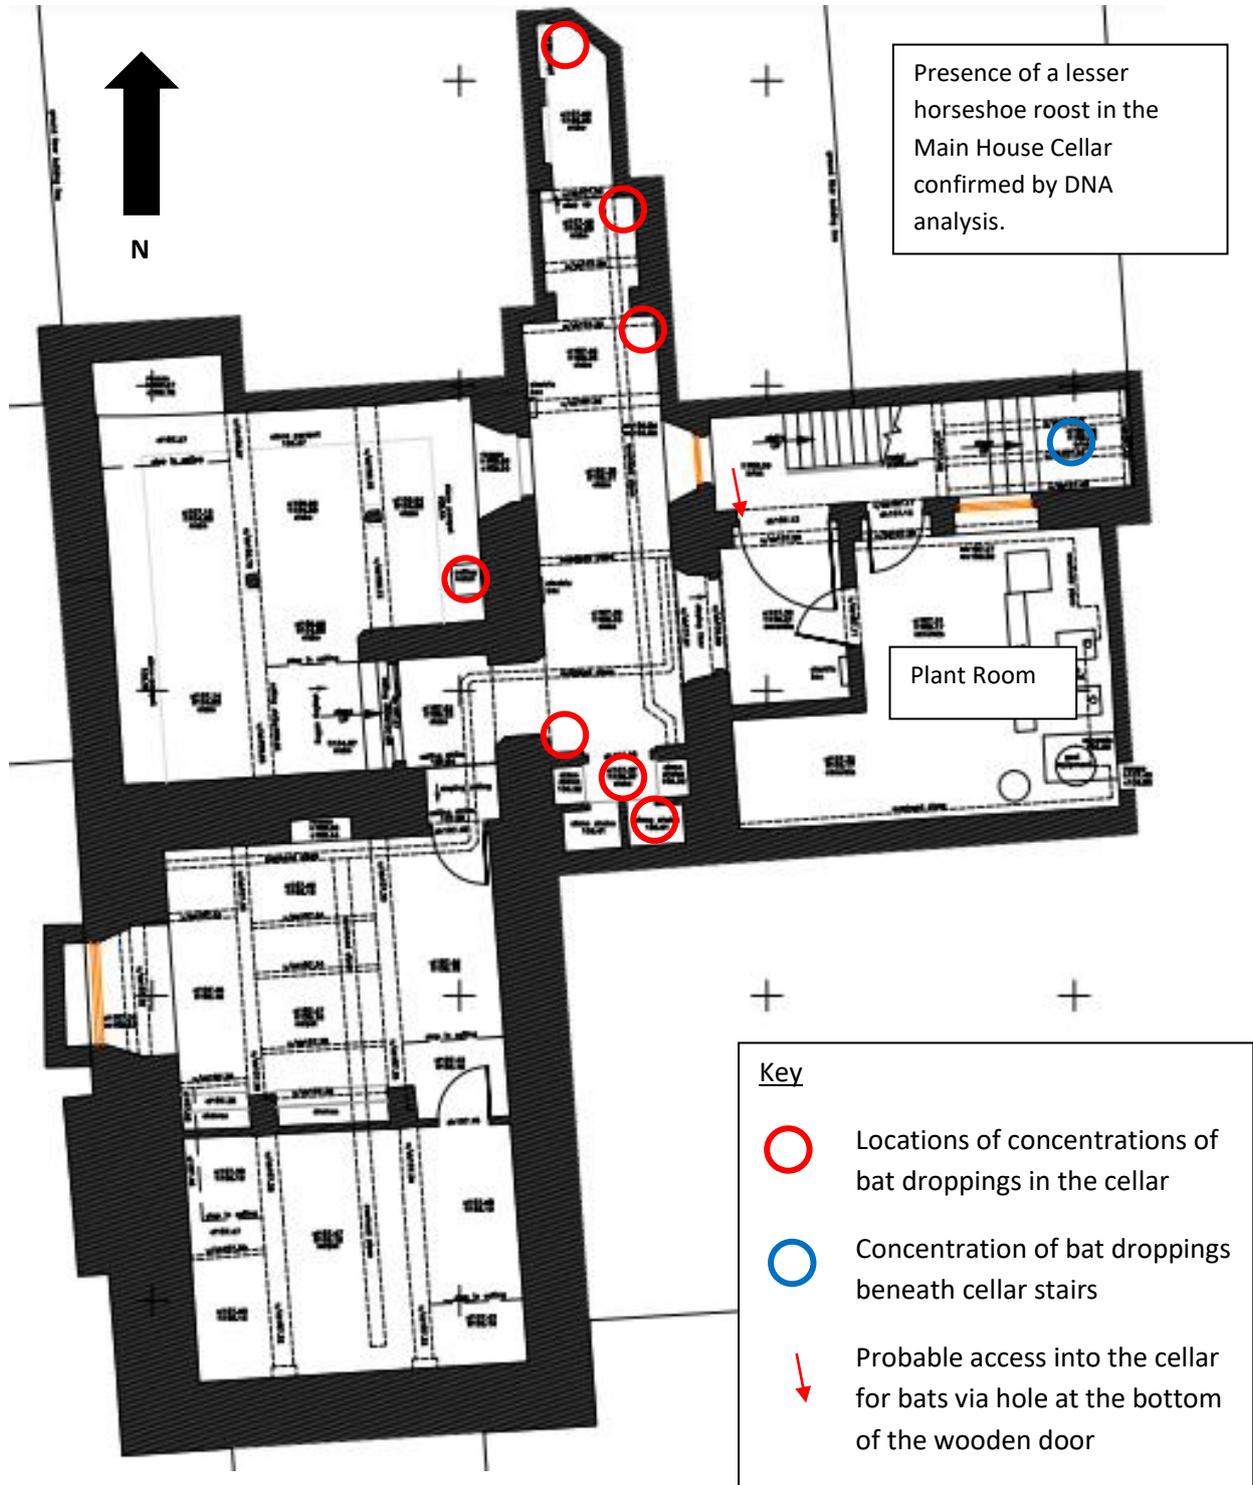
### Annex 3: Main House Cellar Layout and Survey Results (April 2021)

- 4.2.14 Seven distinct piles of bat droppings were identified within the cellar rooms (shown on the cellar plan at Annex 3 and Photograph 5, Annex 4). Bat droppings were also found beneath the stairs leading down to the cellar (Photograph 6, Annex 4). The piles of droppings number between approximately 30 and 100. No bats were present in the cellar at the time of the survey.

- 5.1.9 **Occasional access to the plant room in the cellar is required for maintenance purposes. It is recommended that the door between the plant room and the rest of the cellar is blocked off to prevent access to areas where lesser horseshoe bat is roosting.**

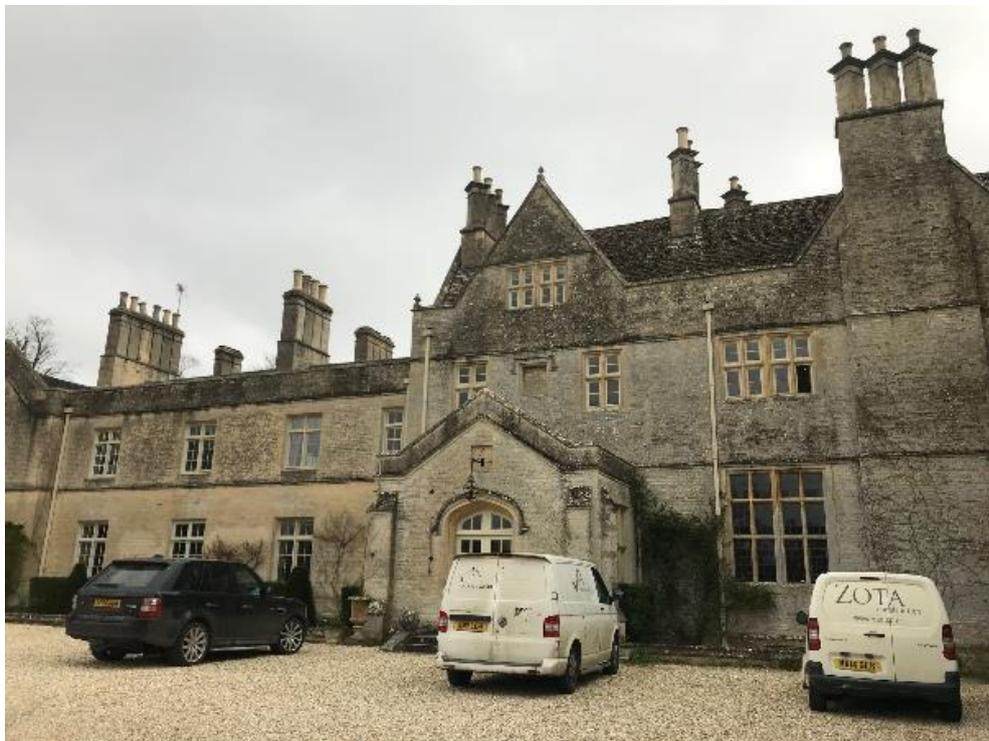
- 4.2.2 The Main House is a large period property, constructed of Cotswold stone with slate and stone-tiled gabled roofs and multiple chimneys (refer to Photographs 1 and 2, Annex 4). There is a North Wing and a South Wing. The two-storey North Wing has an M-shaped, slate-tiled roof. The three-storey South Wing has a gabled, stone-tiled roof with a slate-tiled roof to the two-storey element attached to the east (rear) elevation. There are single-storey sections attached to the north elevation (North Wing) and east elevation (South Wing), all constructed of Cotswold stone with slate-tiled roofs with shallow pitches.

- 4.2.4 The slate tiles on the North Wing roofs have few gaps evident and there are few gaps in stonework evident on the external walls. The north aspect of the North Wing has several gaps in coping stones and stonework near the roofline.

- 4.2.5 The stone tiles on the South Wing roof feature several gaps beneath and there are a number of gaps in the stonework on the external walls, mainly on the east and west aspects.

Photograph 1. The front (west) aspect of the Main House, showing the two-storey North Wing and three-storey South Wing.

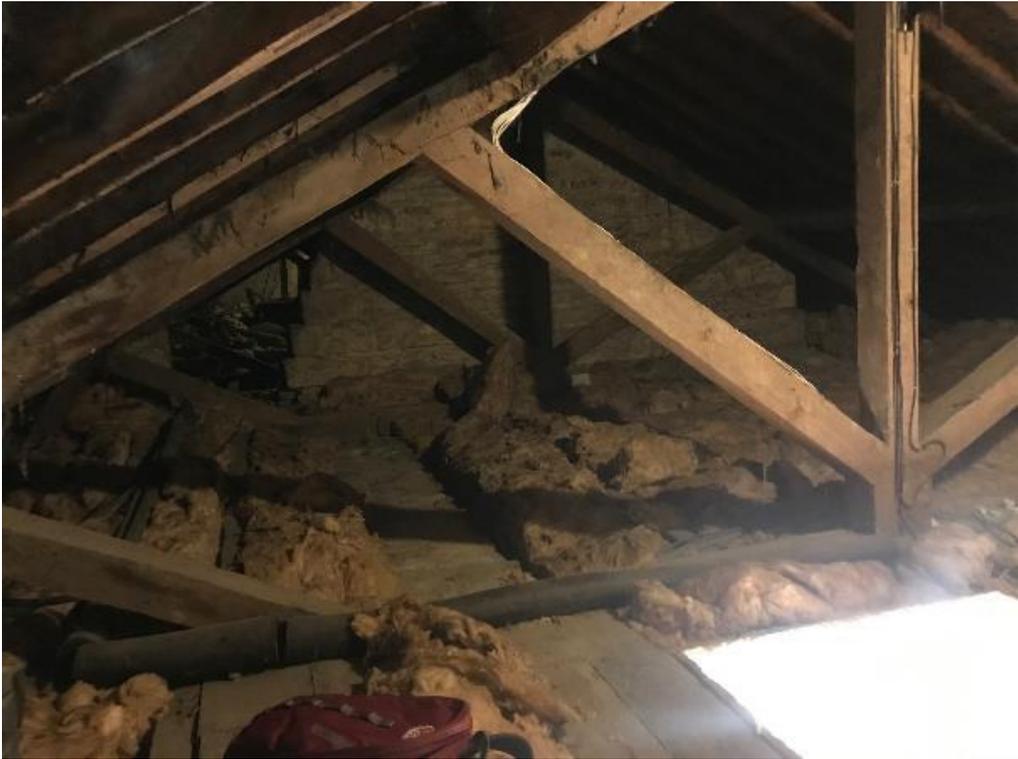
Roof Space 4, North Wing – Lesser horseshoe and common pipistrelle

Photograph 3. Part of Roof Space 4 of the Main House (North Wing). Confirmed lesser horseshoe and common pipistrelle roosts.

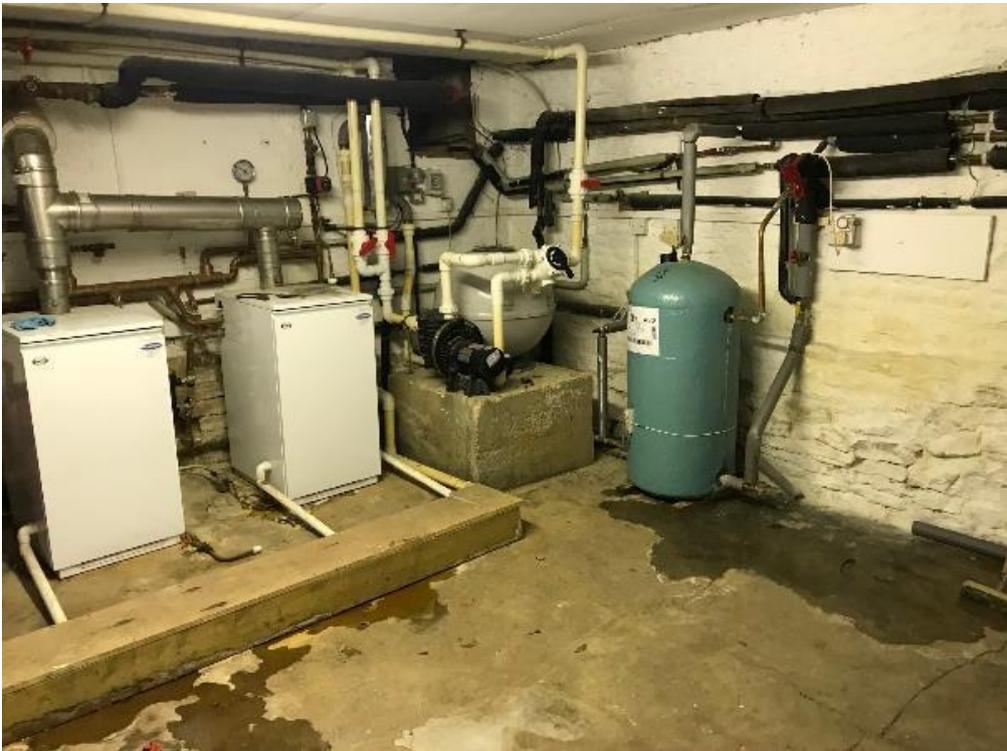
- 4.2.12 The plant room contains the heating system for the Main House (refer to Photograph 4, Annex 4). It has a warm and stable environment but is heavily disturbed from noise and vibration from machinery. It is well-lit from one window opening onto the stairwell. No evidence of bats was found in the plant room.

Photograph 4. View of the Main House Cellar, Plant Room.

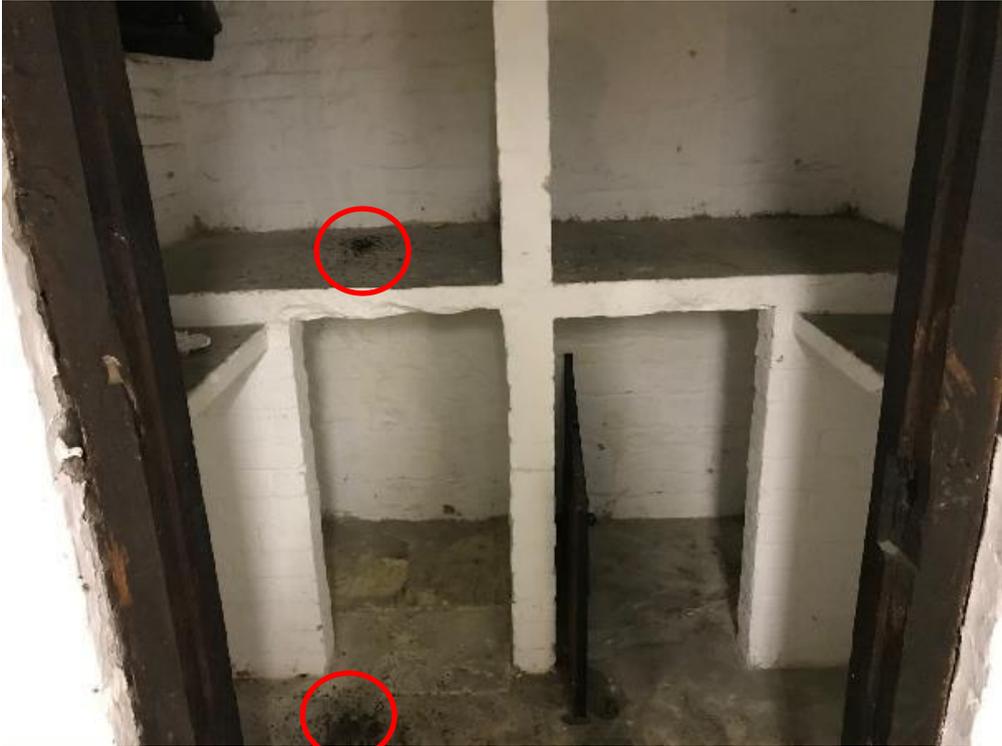
Cellar – Lesser horseshoe

Photograph 5. Main House Cellar showing concentrations of lesser horseshoe bat droppings (circled).

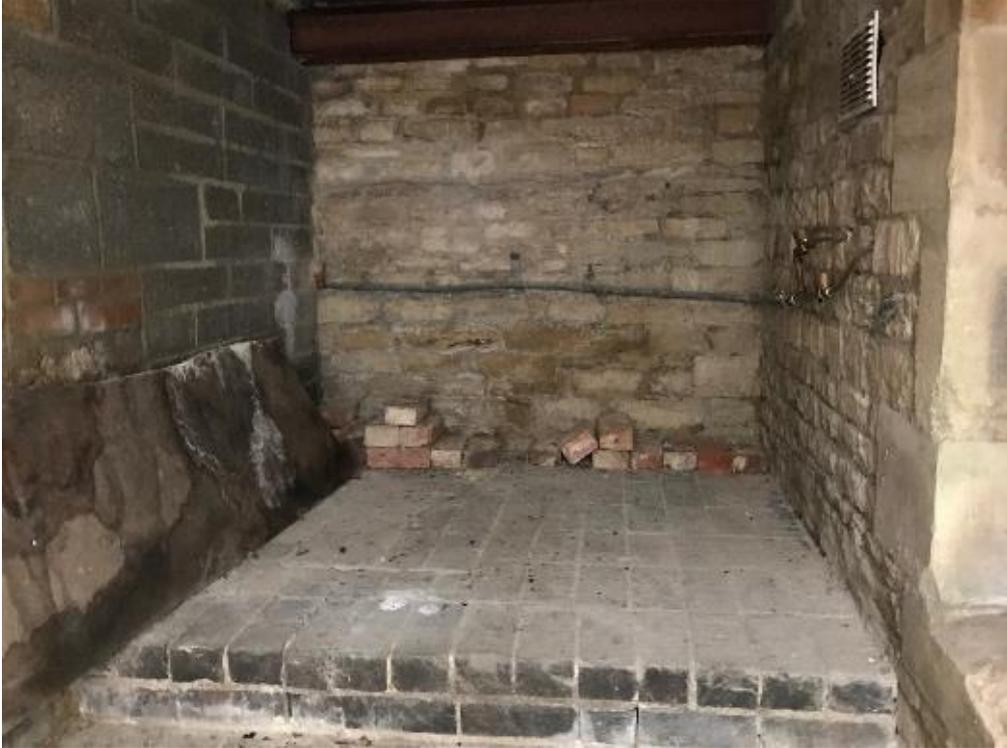
Photograph 6. Area below the Cellar stairs with lesser horseshoe droppings.

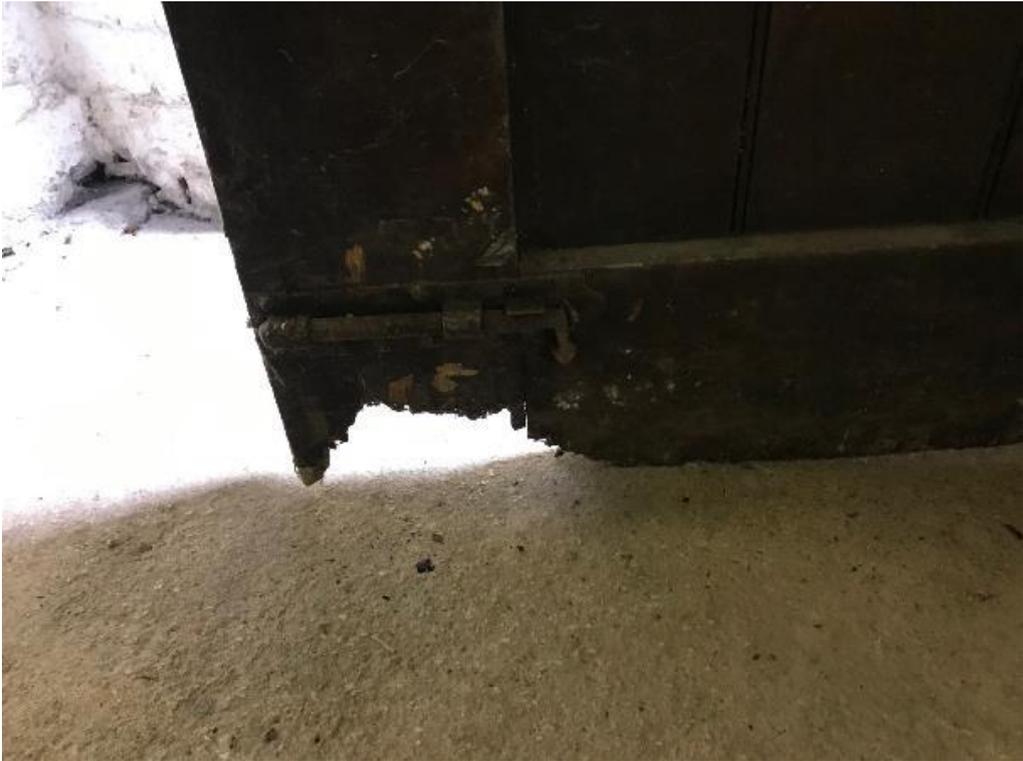
Photograph 7. Probable access point for lesser horseshoe at base of the Cellar door.

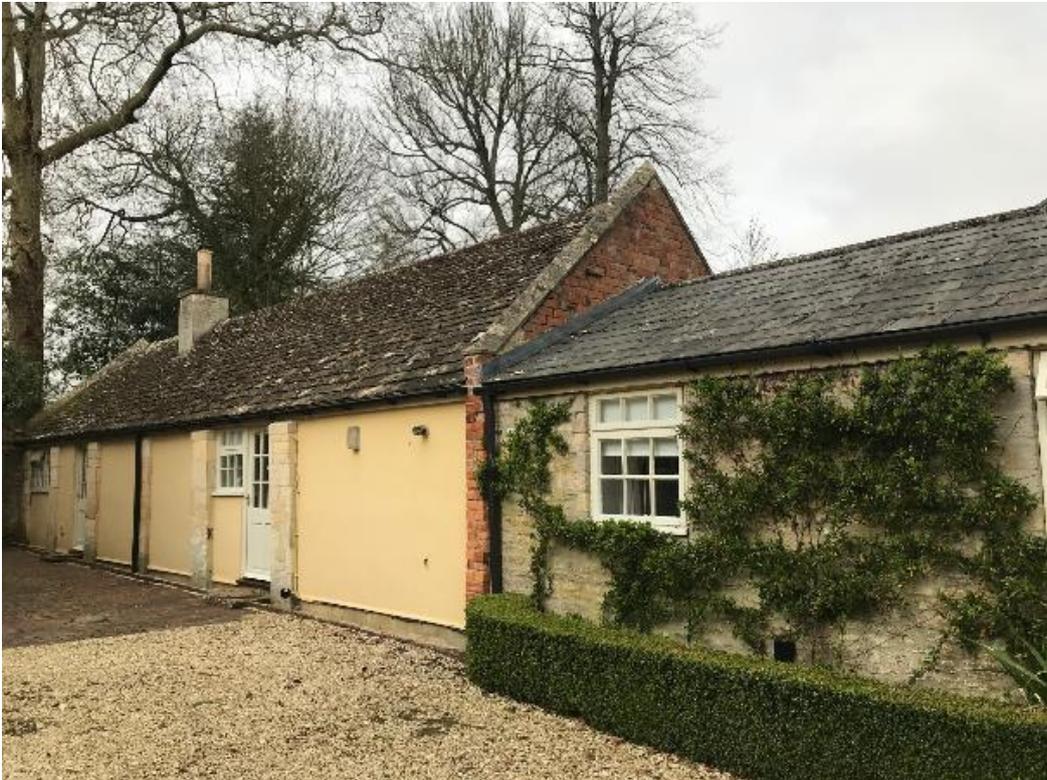
- 4.2.19 The Stable Cottage is a single-storey building, formed of two sections. The western section is has rendered stone walls and a gabled stone-tiled roof. The eastern end has stone walls with a gabled, slate-tiled roof (refer to Photograph 10, Annex 4).
- 4.2.20 There are several gaps evident under stone tiles on the western section. The slate tiles on the eastern section are in good condition and appear tight and well-sealed.

Photograph 10. The south aspect of the Stable Cottage. The area beneath the slate-tiled section contains a roof space. The stone tiles have occasional gaps beneath.

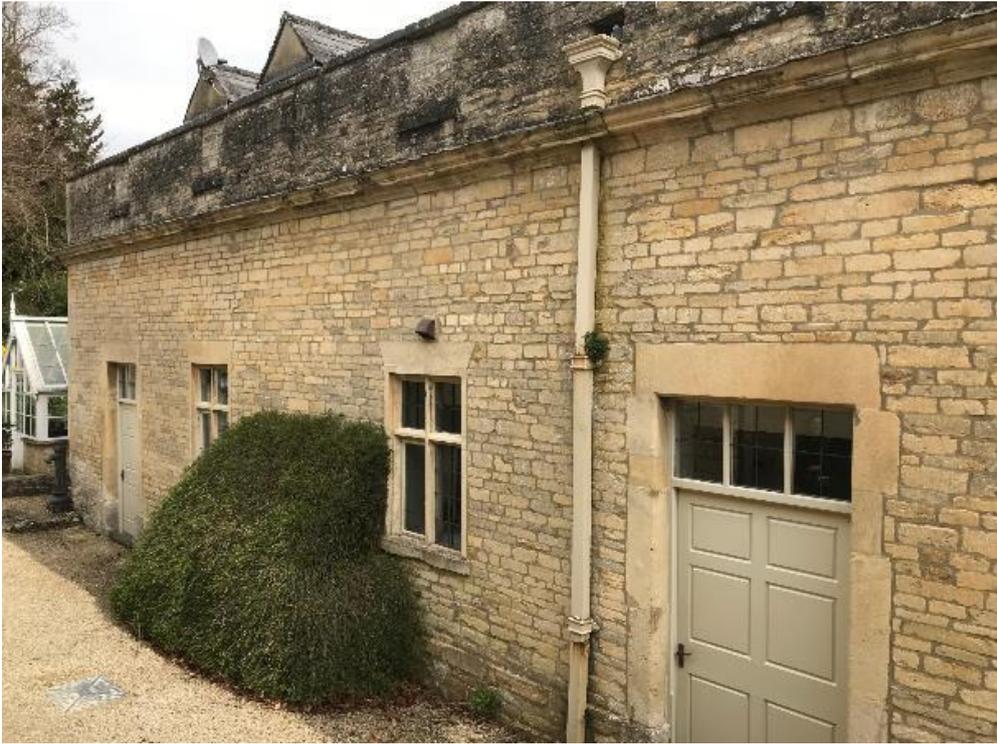
- 4.2.23 The Stone Barn is a two-storey building constructed of Cotswold stone, with stone parapets and a pitched, slate-tiled roof with dormers on the west and east aspects (refer to Photograph 11, Annex 4). The stonework is in good condition with no obvious gaps or cracks. Much of the roof could not be seen from ground level due to the parapets obstructing views, but where slate tiles were visible, these appear in good condition with gaps evident.

Photograph 11. The west aspect of the Stone Barn.

- 5.2.4 Stone Barn – This building will undergo internal alterations and roof repair/re-roofing. It is assessed as *Low* suitability to roosting bats. Therefore, **one dawn re-entry survey is recommended**. A re-entry survey of this building is preferable as there is limited views of the roof structure and bats returning to their roosts at dawn tend to exhibit swarming behaviour, which is often easier to observe.

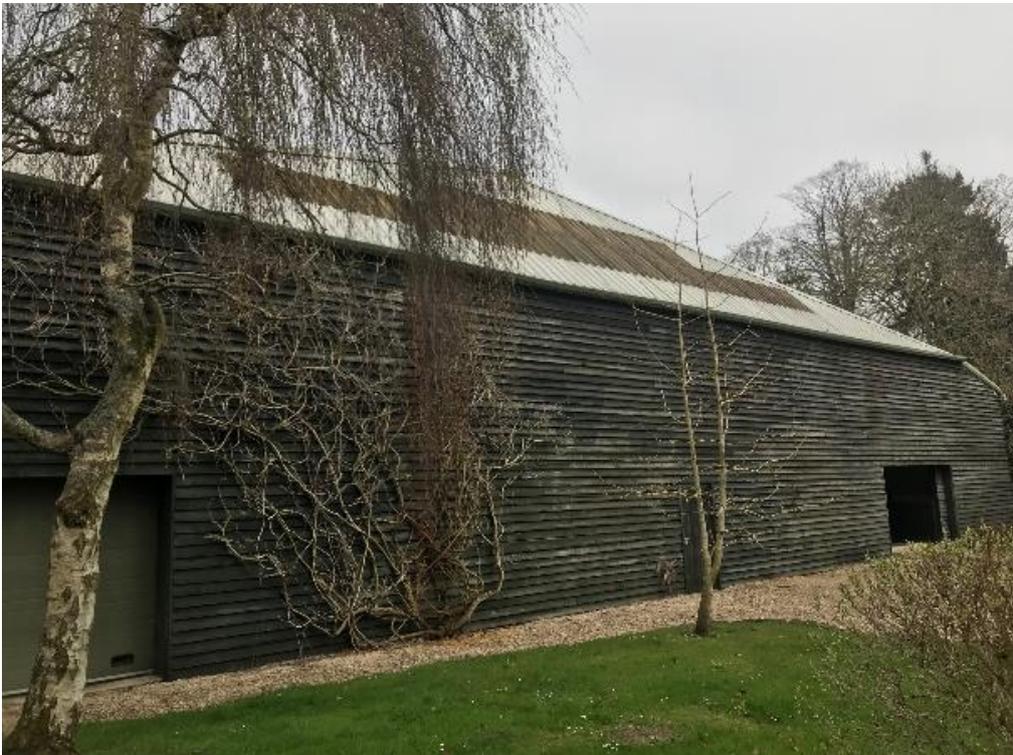
- 4.2.25 The Indoor Horse Arena is a large, steel-framed, wooden-clad structure with a corrugated metal roof (refer to Photograph 12, Annex 4). There are numerous gaps behind the wooden cladding on all aspects. Attached to the building's western elevation is a lean-to structure, also wooden-clad with windows on the east aspect. On the building's eastern elevation is an open-sided machinery store/car port. There is one large metal door on the south aspect, which provides access into the internal area of the arena.

Photograph 12. The Indoor Horse Arena.

- 5.2.5 Indoor Horse Arena – This building will be demolished. It is assessed as *Low* suitability to roosting bats. Therefore, **one dusk emergence or dawn re-entry survey is recommended**.

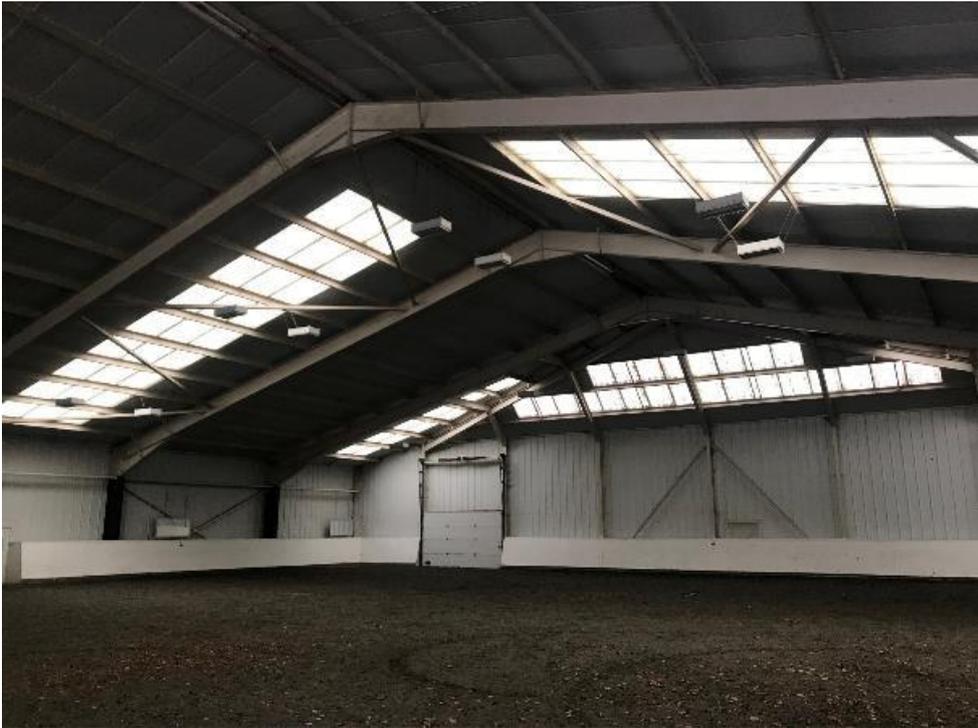
- 4.2.26 Internally, the arena is entirely open to the metal roof and the steel frame is visible (refer to Photograph 13, Annex 4). There are no enclosed spaces and no visible crevices. The interior is well-lit owing to sections of clear corrugated roof panels. One bird's nest was noted to be present on an internal beam.

Photograph 13. The interior of the Indoor Horse Arena.
