## **Tree Survey**

**Planning Consent UK Ltd**

Sutton United Football Club

**16 April 2021**

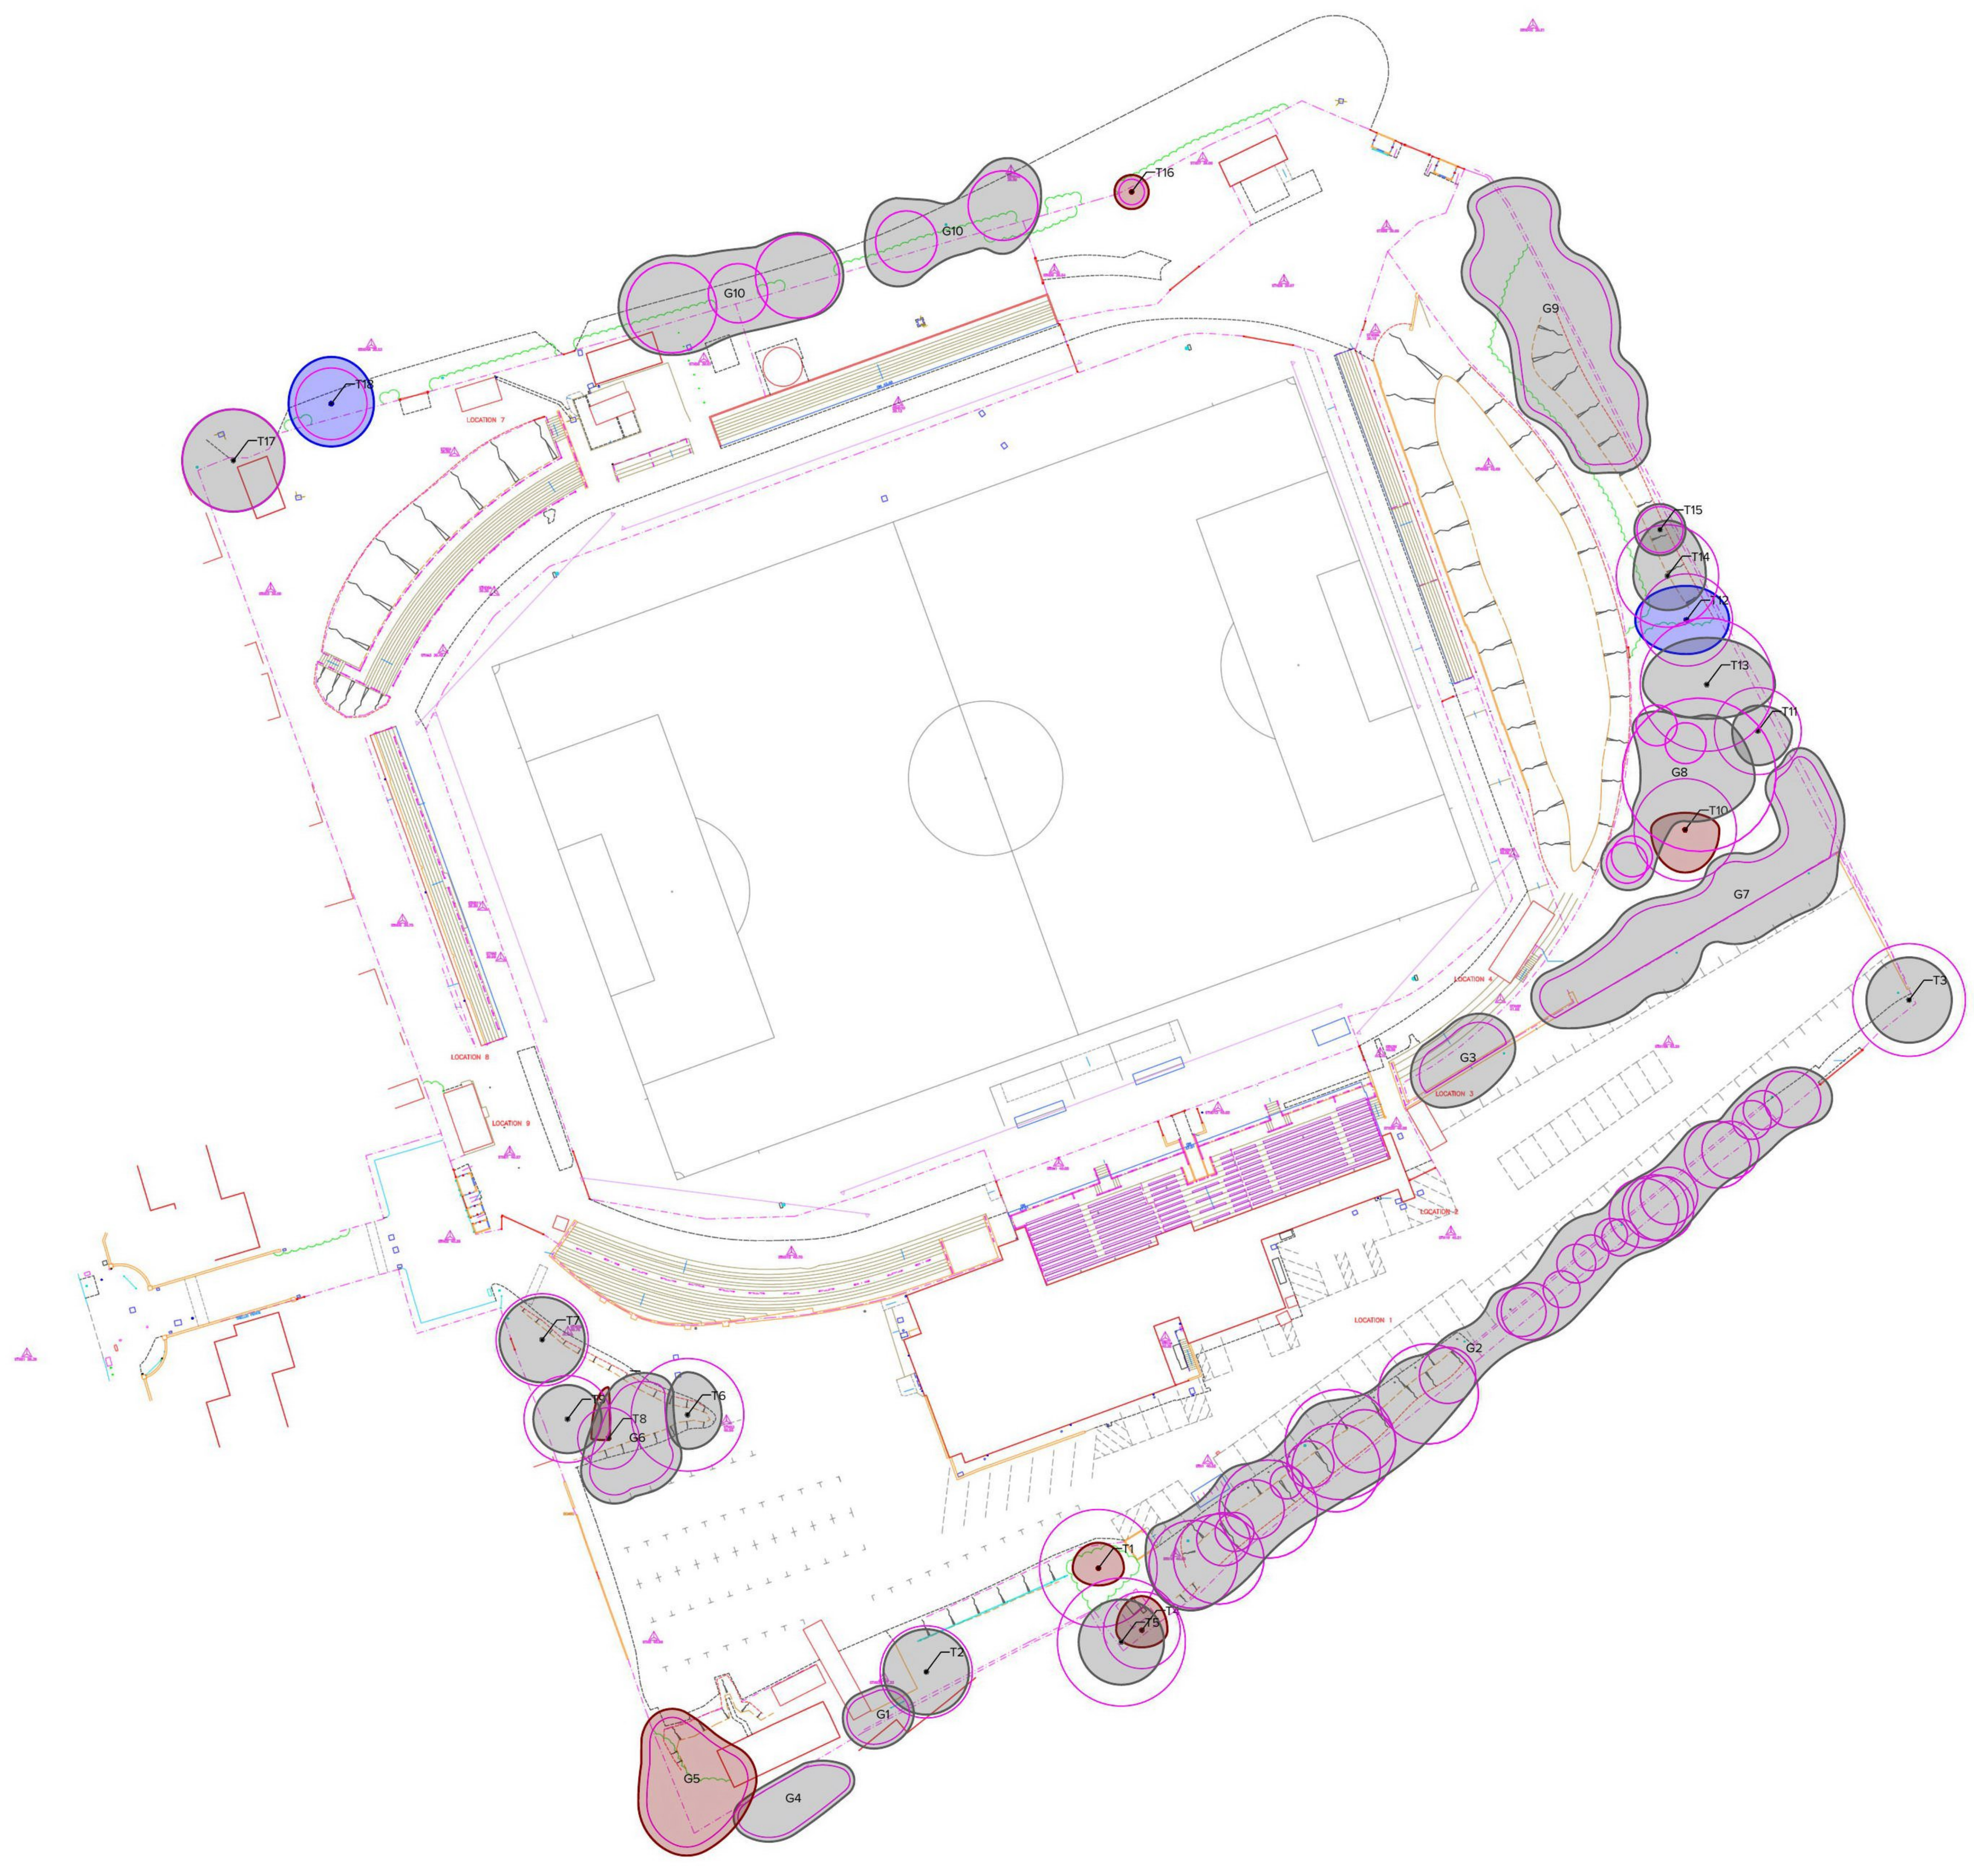
**TREE CONSTRAINTS PLAN**

Tree No.	Common Name	Botanical Name	Height (m)	Stem Dia (mm)	Crown Spread (m)				Height of Crown Clearance (m)	Age Class	Phys Con	Struc Con	Additional notes	Preliminary recommendations	BS5837 Retention Category	RPA (m <sup>2</sup> )	RPA Radius (m)
					N	E	S	W									
T1	Common ash	<i>Fraxinus excelsior</i>	12	580	3	3	2	3	5	E/Mat	Poor	Poor	Large ash tree on raised bank at edge of site. Heavily decayed with Inonotus hispidus brackets present. Previously been topped with very limited regrowth. Large stem wound on south side resulting from lost limb. Very limited future value.	Consider removal in the interests of general good management	U	150	6.90
T2	Black locust	<i>Robinia pseudoacacia</i>	13	450	5	5	5	5	3	Mat	Fair	Fair	Large tree on embankment at edge of site. Heavily clad in ivy. Tree forms codominant stems at 3m. Located on embankment approx 1m higher than hard surfacing car park underneath canopy.	No work required at time of assessment	C1	92	5.40

T3	Sycamore	<i>Acer pseudoplatanus</i>	14	550	5	5	5	5	5	Mat	Fair	Fair	Large tree at corner of site, located less than 1m away from hard surface car park. Heavily clad in ivy restricting assessment of main stem and canopy. Canopy is heavily encroaches on car park lighting.	No work required at time of assessment	C1	137	6.60
T4	Common ash	<i>Fraxinus excelsior</i>	13	367	4	3	2	3	4	E/Mat	Declining	Declining	Poor quality ash tree which is twin stemmed at base. Tree has signs of ash dieback present and a very poor vigour in canopy. Tree is growing into old rail fencing on eastern base. Very limited future value.	Consider removal in the interests of general good management	U	64	4.50
T5	Common lime	<i>Tilia x europaea</i>	14	633	5	5	5	5	5	Mat	Good	Fair	Large boundary/screening tree located next to electrical transformer. Tree is multistemmed from base with heavy epicormic growth. Unable to survey south and east side of trees due to fencing. Tree has very limited future value due to location.	No work required at time of assessment	C1/2	177	7.50

T6	Sycamore	<i>Acer pseudoplatanus</i>	9	539	5	4	4	3	4	E/Mat	Fair	Declining	Canopy previously reduced to 5m with some regrow this. Main stems decayed around reduction points and some medium deadwood within canopy. Low quality tree limited current or future value.	No work required at time of assessment	C1	137	6.60
T7	Horse chestnut	<i>Aesculus hippocastanum</i>	11	450	5	5	5	5	3.5	E/Mat	Fair	Fair	Horse chestnut located towards entrance to site. Hcbc prevalent with severe bark cracking and bleeding. Limited future value.	No work required at time of assessment	C1	92	5.40

Tree No.	Common Name	Botanical Name	Height (m)	Stem Dia (mm)	Crown Spread (m)				Height of Crown Clearance (m)	Age Class	Phys Con	Struc Con	Additional notes	Preliminary recommendations	BS5837 Retention Category	RPA (m <sup>2</sup> )	RPA Radius (m)
					N	E	S	W									
T8	Sycamore	<i>Acer pseudoplatanus</i>	8	290	6	0	0	2	4	Dead	Dead	Poor	Standing dead tree on edge of group. No remaining value.	Consider removal in the interests of general good management	U	41	3.60
T9	Horse chestnut	<i>Aesculus hippocastanum</i>	8	416	4	4	4	4	2	E/Mat	Fair	Fair	Horse chestnut located towards entrance to site. Multi stemmed from base with ivy obscuring main stem. Early signs of hcbc. Limited value due to hcbc.	No work required at time of assessment	C1/2	82	5.10
T10	Tree of heaven	<i>Ailanthus altissima</i>	9	500	2	4	5	4	2	Mat	Poor	Poor	Stands within wooded area not on topo survey. Dense ivy obscuring most of tree. Tree has failed at 8m with very little remaining structure. No future value.	Consider removal in the interests of general good management	U	113	6.00

T11	Sycamore	<i>Acer pseudoplatanus</i>	17	425	3	4	4	3	4	E/Mat	Fair	Fair	Element of wooded area. Dense ivy coverage. Very low individual value. Minor contribution to group feature.	No work required at time of assessment	C1/2	82	5.10
T12	Pedunculate oak	<i>Quercus robur</i>	9	450	4	5	4	6	2	E/Mat	Good	Good	Boundary/screening tree located on embankment next to site boundary. Tree is growing into old wire tree guard which should be removed to ensure it has long term retention. Minor Secure deadwood present throughout canopy. If tree has good management then tree has long term value	No work required at time of assessment	B1/2	92	5.40
T13	Japanese pagoda tree	<i>Styphnolobium japonicum</i>	14	650	6	8	4	8	2	Mat	Good	Fair	Larger tree towards edge of wooded group. Broad canopy. Small diameter deadwood throughout. Large component of area, good screening from adjacent park.	No work required at time of assessment	C1/2	191	7.80

T14	Common ash	<i>Fraxinus excelsior</i>	11	500	7	5	4	4	3	E/Mat	Fair	Fair	On edge of wooded area. Dense ivy obscuring assessment. Low vigour in upper canopy.	No work required at time of assessment	C1/2	113	6.00
T15	Sycamore	<i>Acer pseudoplatanus</i>	8	216	3	3	3	3	2	S/Mat	Fair	Fair	Small boundary/screening tree located on edge of site. Tree has very limited long term value as tree is growing into boundary fence.	No work required at time of assessment	C1/2	23	2.70
T16	Common ash	<i>Fraxinus excelsior</i>	5	130	2	2	2	2	1	S/Mat	Declining	Declining	Ash regen growing through fence. No future value.	Consider removal in the interests of general good management	U	7	1.50

Tree No.	Common Name	Botanical Name	Height (m)	Stem Dia (mm)	Crown Spread (m)				Height of Crown Clearance (m)	Age Class	Phys Con	Struc Con	Additional notes	Preliminary recommendations	BS5837 Retention Category	RPA (m <sup>2</sup> )	RPA Radius (m)
					N	E	S	W									
T17	Sycamore	<i>Acer pseudoplatanus</i>	10	490	6	6	6	6	2	S/Mat	Good	Fair	Tree located at edge of site behind buildings. Tree is regeneration and is growing into hard surfacing. Unable to access due to location. Very limited future value due to location.	No work required at time of assessment	C1	113	6.00
T18	Norway maple	<i>Acer platanoides</i>	8	340	6	5	5	5	2	E/Mat	Good	Good	Stand within adjacent park. Canopy overhanging site.	No work required at time of assessment	B1/2	55	4.20
G1	Sycamore		Ave 16	300	See associated plans				5	E/Mat	Good	Fair	Small group of two trees alongside site edge. Located between hard surface car park and neighbouring property. Canopy has been reduced away from boundary edge to south side.	No work required at time of assessment	C2	See associated plans

G2	Sycamore, Common ash, White willow, Elder		Ave 11	350	See associated plans				0	E/Mat	Fair	Fair	Mixed boundary/screening group on edge of site adjacent to railway. Group is of poor quality and is growing into wire fencing on east side. Dense ivy obscuring many trees in the group. Group consists mainly of regenerated sycamore. Ash in the group have ash dieback present. Due to quality and location the group has limited future potential.	No work required at time of assessment	C2	See associated plans	
G3	Sycamore		Ave 7	220	See associated plans				0.5	S/Mat	Fair	Fair	Small cluster of regen above retaining wall. Very low value generally	No work required at time of assessment	C2	See associated plans	
G4	Sycamore		Ave 15	320	See associated plans				3	E/Mat	Good	Fair	Group straddles boundary, ownership unclear. Overgrown with no access to base of group. Screening/boundary group, likely self regeneration.	No work required at time of assessment	C2	See associated plans

G5	Sycamore		Ave 12	400	See associated plans				0	Mat	Declining	Declining	Poor quality group of sycamore heavily clad in dead ivy. Crown has very limited vigour with one tree already failed. Group has very limited future value.	Consider removal in the interests of general good management	U	See associated plans	
G6	Sycamore		Ave 17	400	See associated plans				6	Mat	Good	Fair	Cluster of sycamore, mutually suppressed trees on landscape edge to car park. Some medium diameter deadwood associated with canopies. Generally low value.	No work required at time of assessment	C2	See associated plans

Tree No.	Common Name	Botanical Name	Height (m)	Stem Dia (mm)	Crown Spread (m)				Height of Crown Clearance (m)	Age Class	Phys Con	Struc Con	Additional notes	Preliminary recommendations	BS5837 Retention Category	RPA (m <sup>2</sup> )	RPA Radius (m)
					N	E	S	W									
G7	Sycamore, Common ash, Black locust, Elm species		Min 3 - Max 17	70	See associated plans				4	E/Mat	Fair	Fair	Low quality, unmanaged group forming edge of wooded area adjacent to car park. Dense ivy on many trees. Many sycamore exhibiting dieback and low vigour throughout canopy. Group requires management if retained, provides screening value collectively.	No work required at time of assessment	C2	See associated plans	
G8	Tree of heaven		Min 8 - Max 16	200	See associated plans				1	Mat	Fair	Fair	Part of wooded area predominantly tree of heaven with one larger tree and numerous small trees and suckers. Larger tree obscured by ivy. Future value limited by structural condition and characteristics of species at maturity.	No work required at time of assessment	C2	See associated plans

G9	Sycamore, Horse chestnut, Common ash		Ave 13	400	See associated plans				0.5	Mat	Fair	Fair	Mixed group of poor quality trees. Heavily clad in ivy and unable to survey east side due to boundary fence. Trees overhangs Heavily used skate park used predominantly by children. Ash in the group have early signs of ash dieback and horse chestnut has hcbc present. If left unmanaged the group has a limited future potential.	No work required at time of assessment	C2	See associated plans	
G10	Norway maple, Horse chestnut, Common ash		Ave 11	350	See associated plans				2.5	E/Mat	Fair	Fair	Off site group located right next to site. Mixed group of trees forming a screening group with park. Hcnc associated with horse chestnut trees and ash dieback associated with ash trees.	No work required at time of assessment	C2	See associated plans	
G11	Leyland cypress		Ave 5	120	See associated plans				1.5	S/Mat	Good	Fair	Short section of cypress hedge between temporary building and boundary.	No work required at time of assessment	C2	See associated plans
