Date: 12 May 2021
Ref: P2291 0521 L1

Re: Inspection and Biodiversity Enhancements at Hargrave Lodge

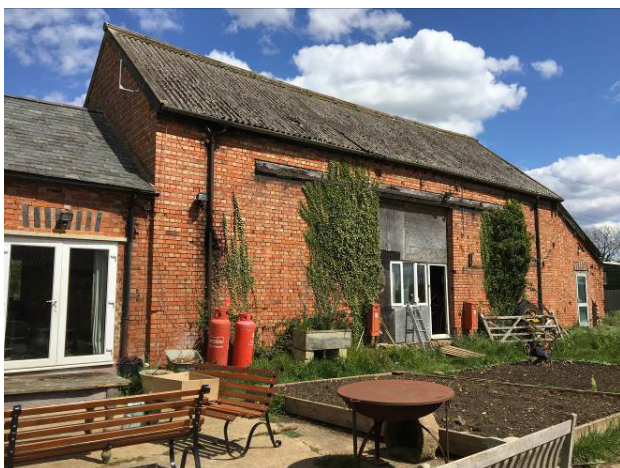
The inspection identified two redundant swallow nests within the barn interior but there is no sign that these have been occupied during the current season. On the west elevation of the building there is dense ivy and this has been colonised by a sparrow colony and is being used for nesting purposes. In addition, there appear to be one or more sparrow nests in the gap above the timber door lintel on the west face of the building. No new owl pellets are present within the lean-to extension at the south end of the building and this has presumably not been used as a feeding perch in the intervening period.

West elevation and north gable

Until the nesting activity by Sparrow has been completed and any young have fully fledged and left the nest, no work can be carried out to remove the ivy growth or disturb the door lintel.

It is recommended that as part of the proposed conversion work a number of sparrow terrace bricks are incorporated into the west elevation of the building and that at least two artificial swallow nests are affixed directly under the eaves / roof guttering on the north gable end or north east corner of the building.

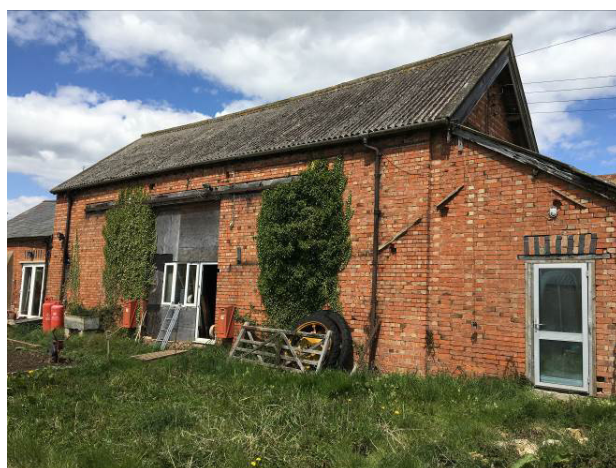
West elevation and south gable

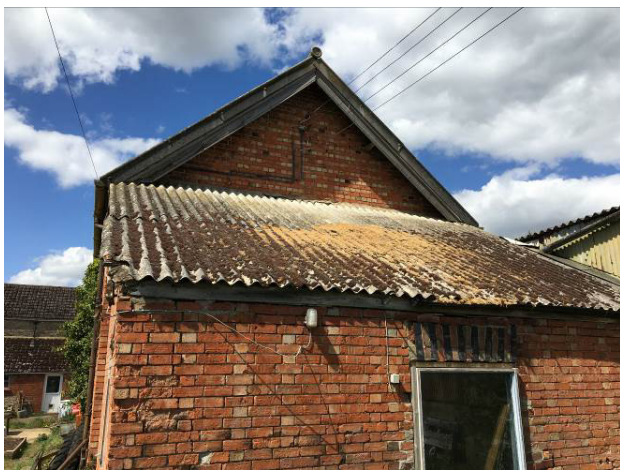
South gable

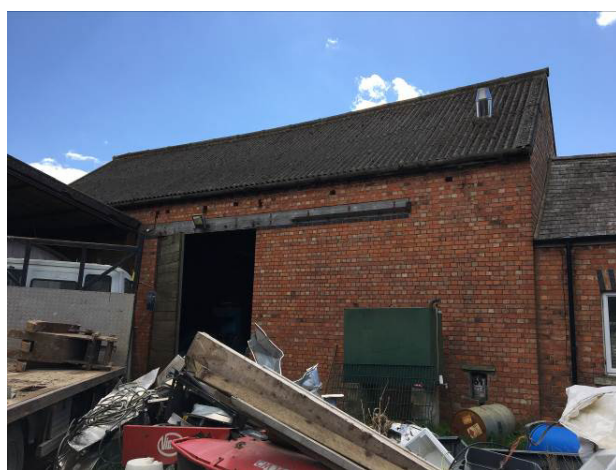
East elevation

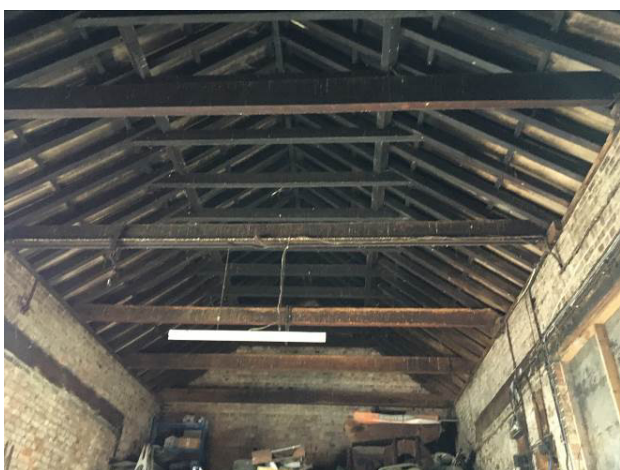
Barn B2 – the inspection of this building internally and externally searching for evidence of bat activity in the form of droppings, feeding debris etc **did not identify any evidence of bat activity in or on any part of the building structure**. The brickwork is still in excellent condition throughout and the roof is still exposed comprising corrugated sheet asbestos with no lining leaving the timber beams fully exposed. These contain no significant cracks, splits or other cavities.

Roof interior structure

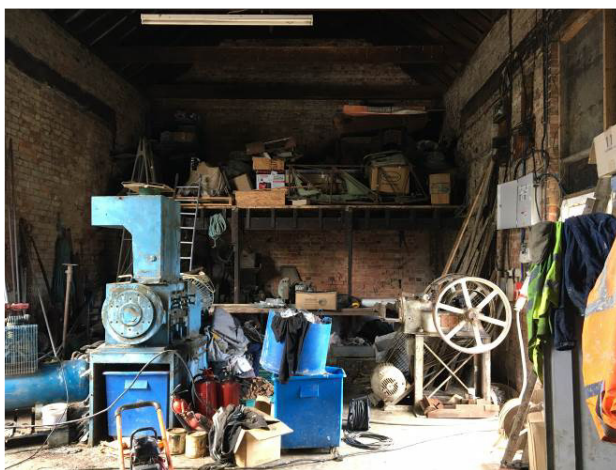
Barn interior

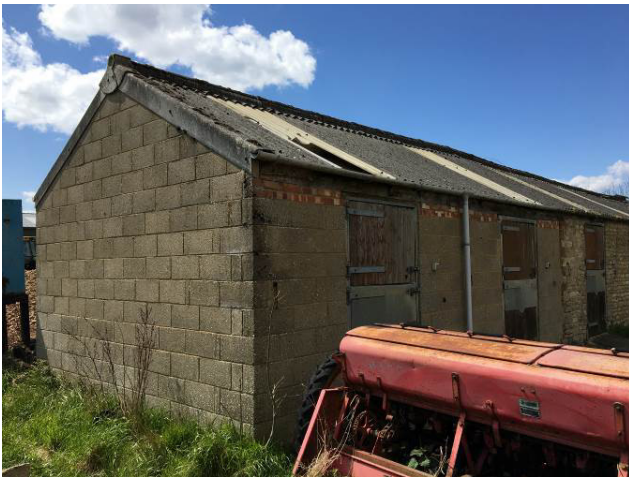
South and east elevation

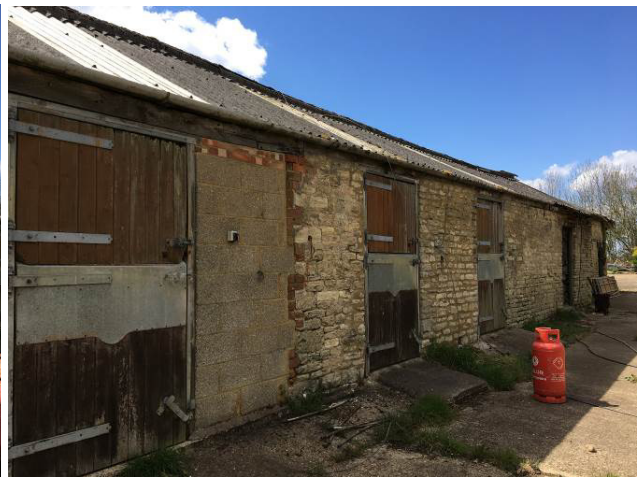
East elevation

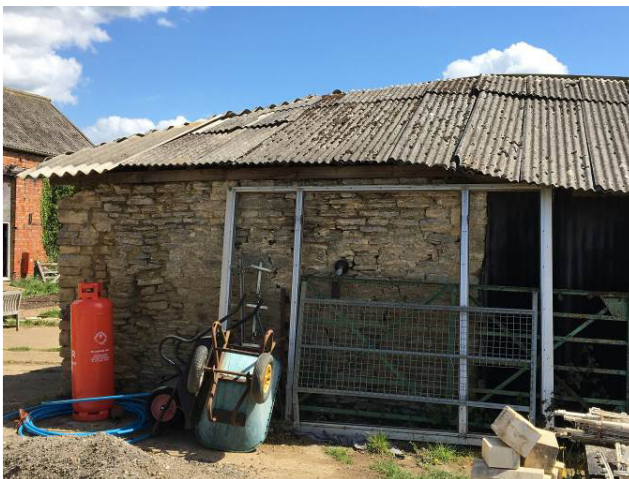
North end of stable

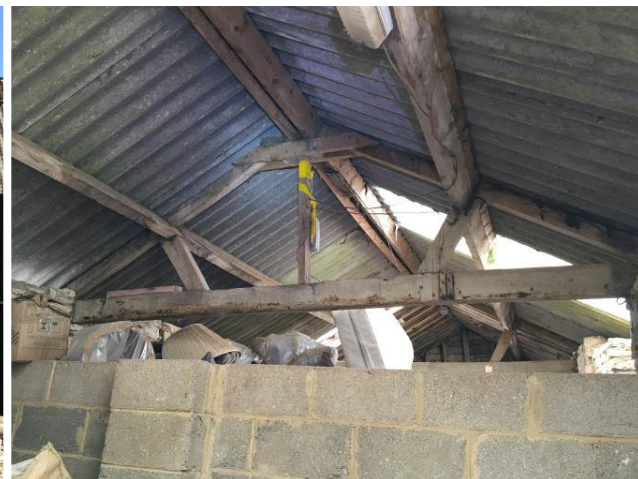
Stable B3 – the inspection of this building internally and externally searching for evidence of bat activity in the form of droppings, feeding debris etc ***did not identify any evidence of bat activity in or on any part of the building structure***. The brickwork is still in excellent condition throughout and the roof is still exposed comprising corrugated sheet asbestos with no lining leaving the timber beams fully exposed. There are light panels in the roof structure allowing high levels of natural light into the building interior. The timber roof beams do not display any significant cracks, splits or other cavities.

Stable roof interior

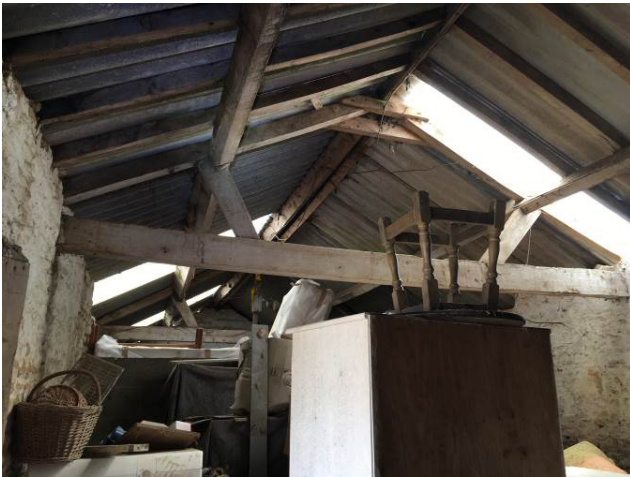
Stable roof interior

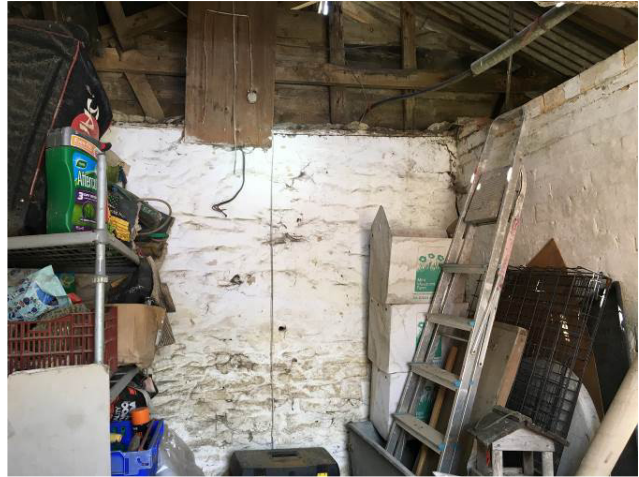
The inspection of 2017 identified three redundant swallow nests within the barn interior but only one of these is still present and there is no sign that this has been occupied during the current season. No other nests were identified within this structure.

Stable interior

It is recommended that as part of the proposed conversion work at least three artificial swallow nests are affixed directly under the eaves / roof guttering in a suitable position on the north gable end or north east corner of the building.
