Sevenoaks Wildlife Reserve, Bradbourne Vale Road, Sevenoaks, Kent TN13 3DH

Preliminary Bat Roost Assessment

Client	Kent Wildlife Trust
Site / job	Sevenoaks Wildlife Reserve, Bradbourne Vale Road, Sevenoaks, Kent TN13 3DH
Central Grid Reference	TQ52185636
Report Title	Preliminary Bat Roost Assessment
Report Reference	KWTEC/ECOSER002/SevenoaksNR

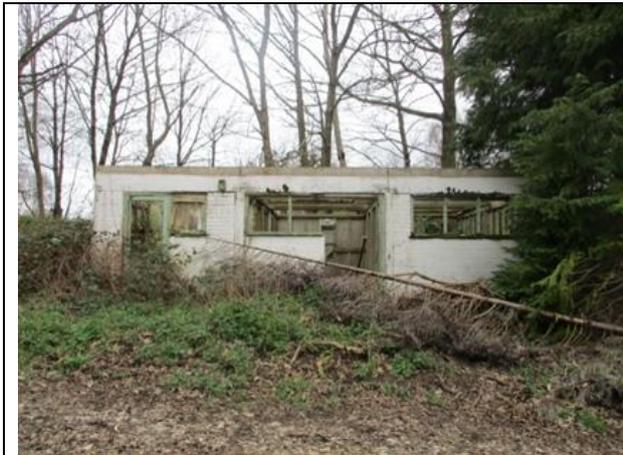
B1 – Derelict brick and concrete structure without roof, windows and doors

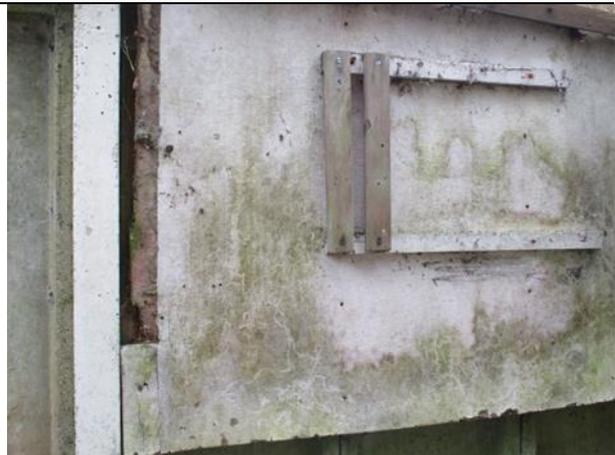
B1 – Potential for crevice dwelling species behind hanging plywood

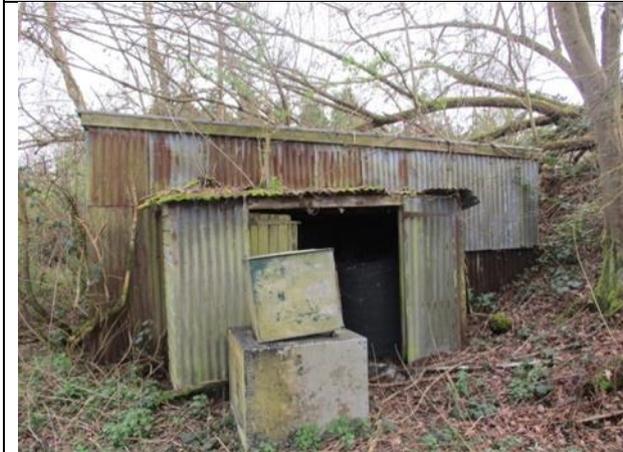
B2 - Timber framed outbuilding with corrugated metal roof and walls

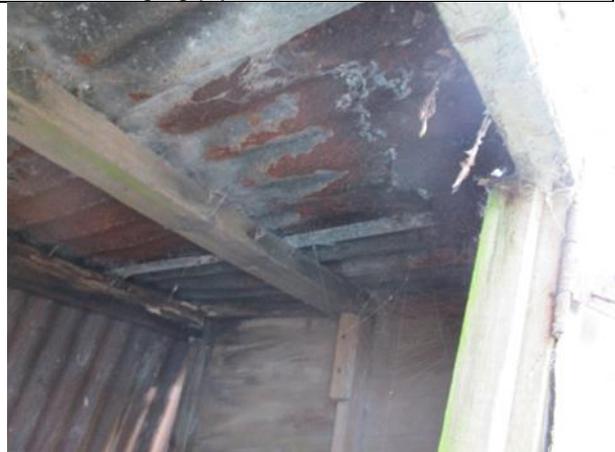
B2 - open-sided extension showing potential hanging places on timber beams

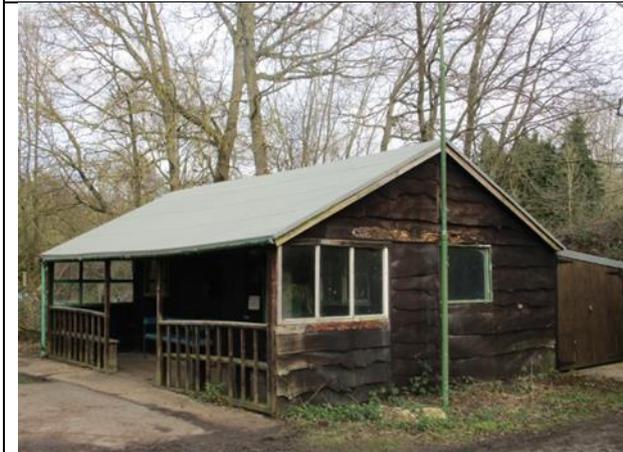
B3 - Timber construction building

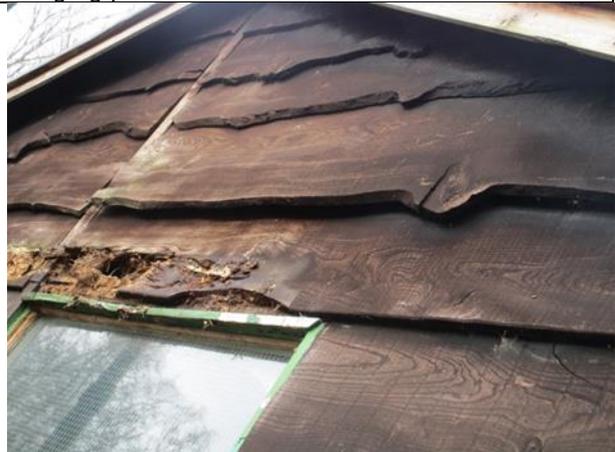
B3 - showing gaps behind timbers on western elevation

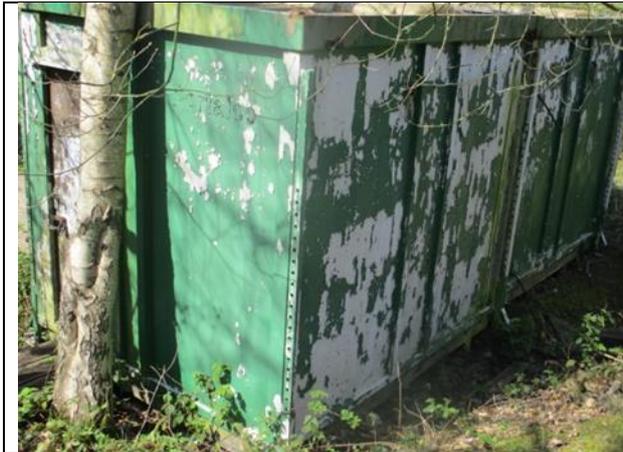
B4 - Metal container structures

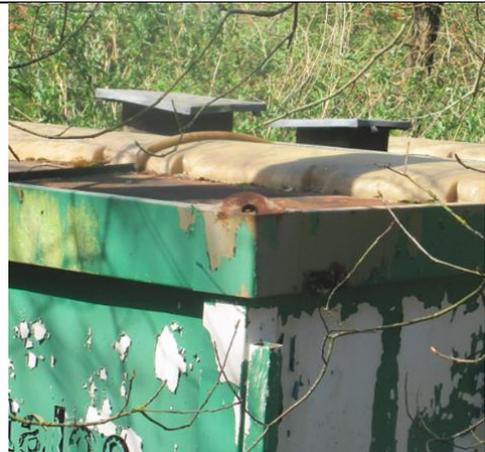
B4 - showing roof vents which have partially lifted metal on the top and sides

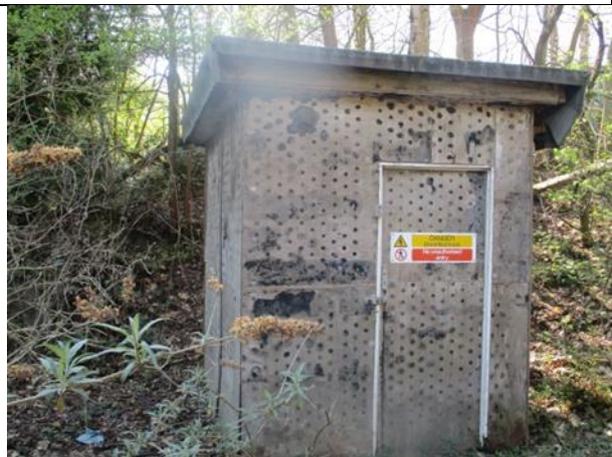
B5 - Timber structure showing overhanging felt

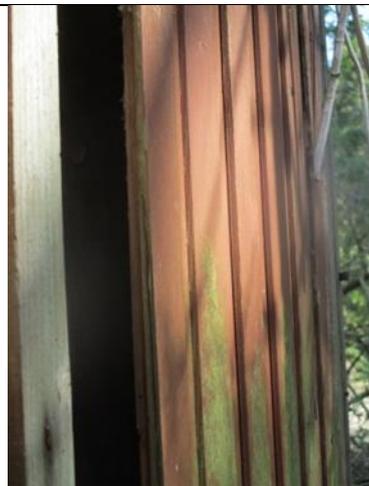
B5 - Double skin walls with access to cavity

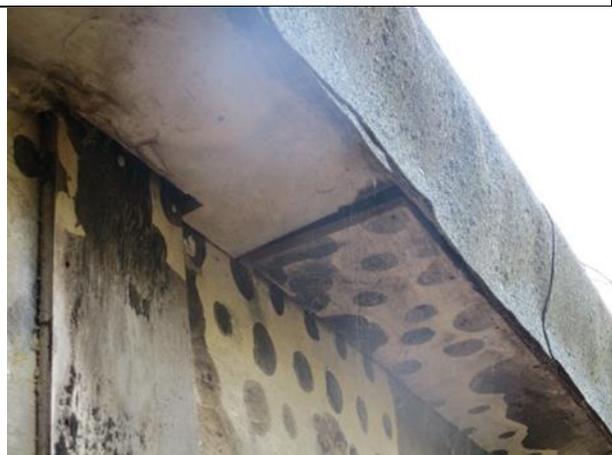
B5 - Crevice in timber soffit box

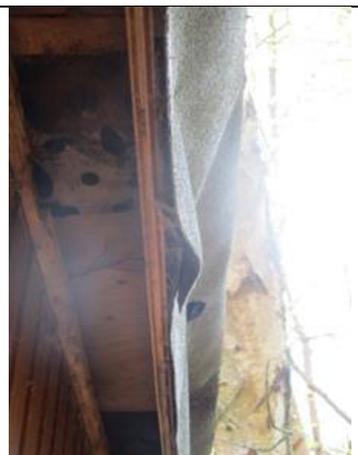
B5 - Lifted roofing felt on western elevation

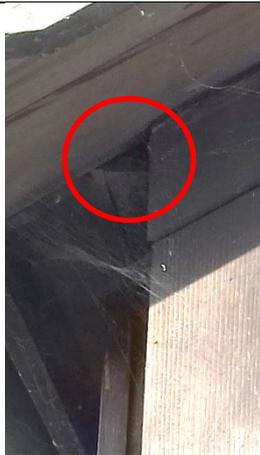
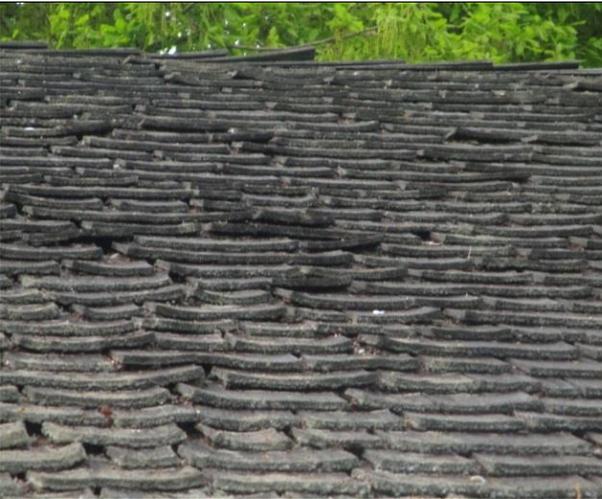
<p>B6 'Tadorna' – Hole at the end of the timber soffit on north-western corner of building</p>	<p>B6 'Tadorna' – Lifted roof and ridge tiles on southern elevation</p>

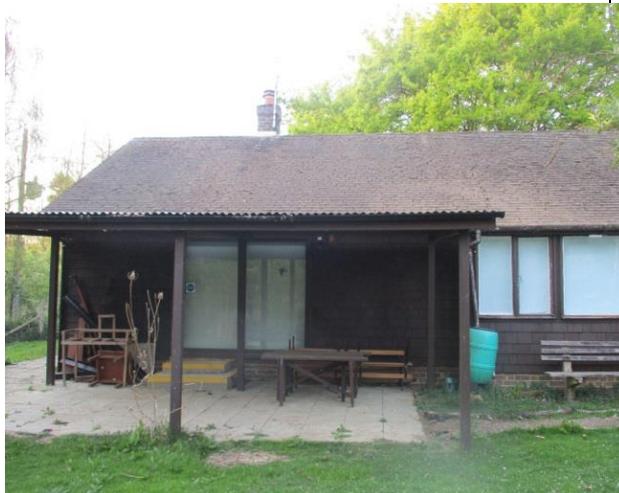
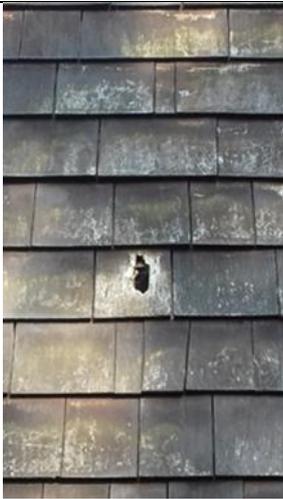
<p>B6 'Tadorna' – brick built structure with wooden tile clad walls</p>	<p>B6 'Tadorna' - Hole in tile on western elevation at c. 2.5m height.</p>

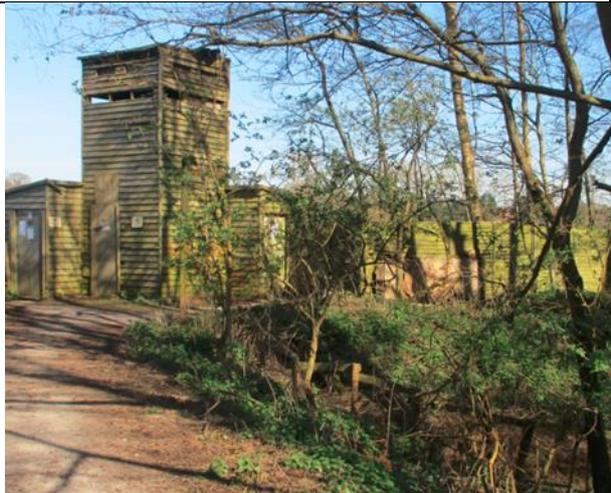
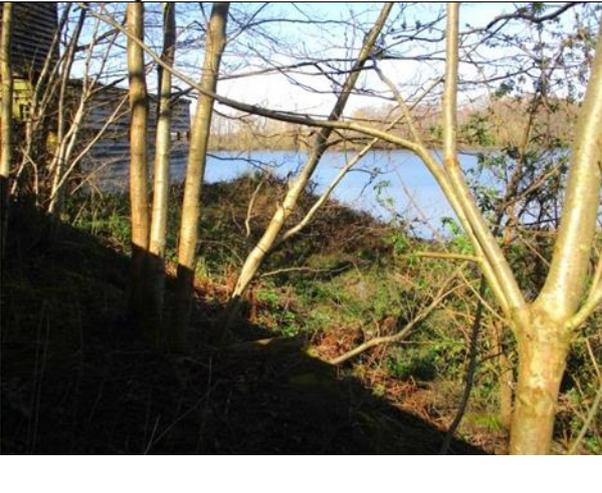
<p>B7 'Tower Hide' - showing single storey and tower sections with broadleaved woodland habitat to the south and west</p>	<p>B7 'Tower Hide' - Scattered scrub habitat to the east of Tower Hide; East Lake lies to the north.</p>

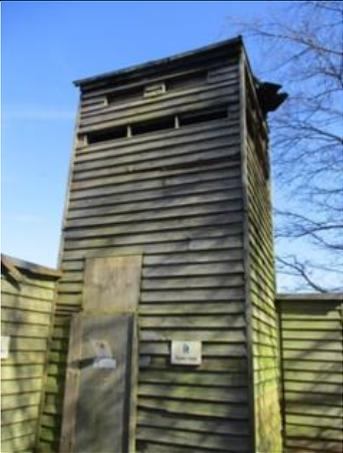
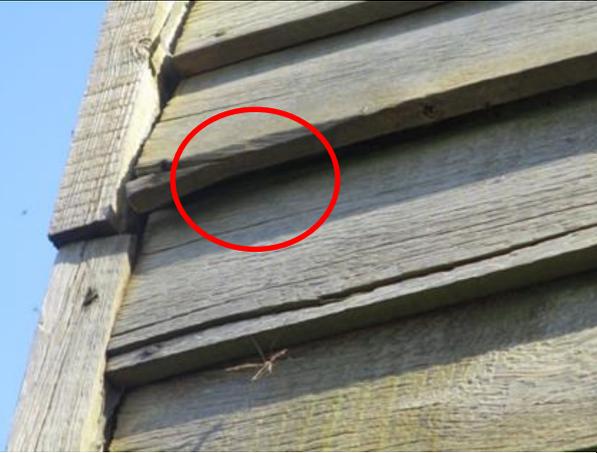
<p>B7 'Tower Hide' - showing accessible features on upper storey and boarded entrance</p>	<p>B7 'Tower Hide' - Crevices beneath lifted timbers on western elevation of Tower Hide</p>

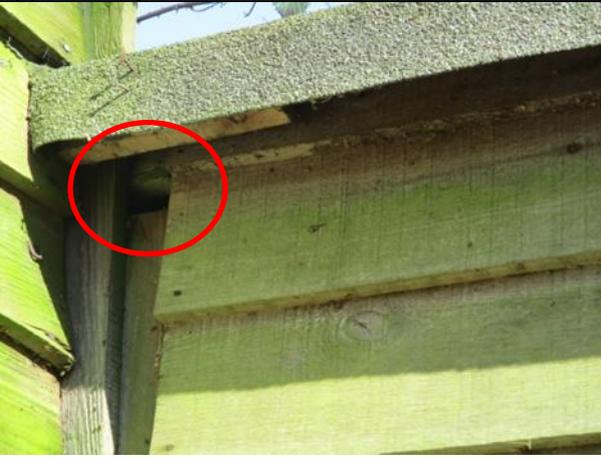
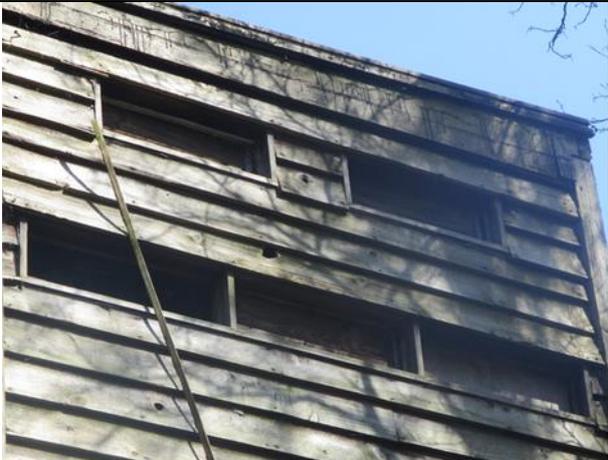
<p>B7 'Tower Hide' - Potential access point into single storey section of hide</p>	<p>B7 'Tower Hide' - Boarded viewing windows on southern elevation</p>

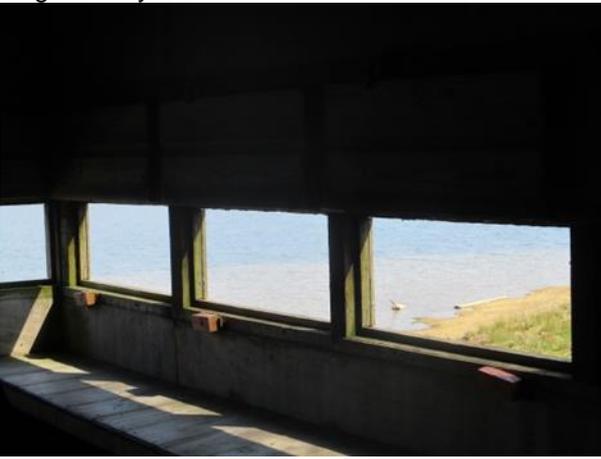
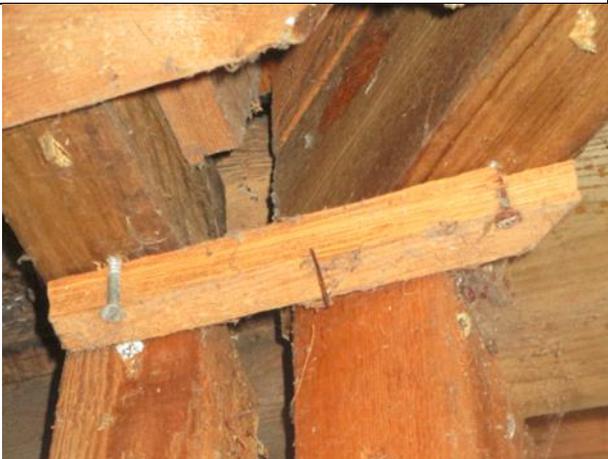
<p>B7 'Tower Hide' - Open viewing windows within the single storey section creating brightly lit interior</p>	<p>B7 'Tower Hide' - Crevices behind roof timbers within single storey section</p>

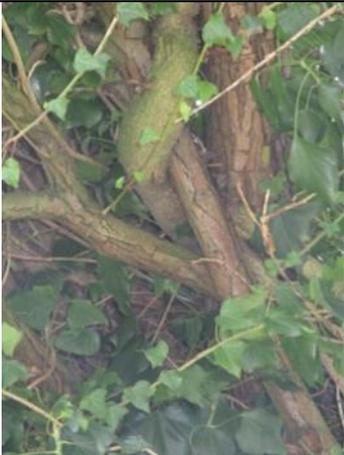
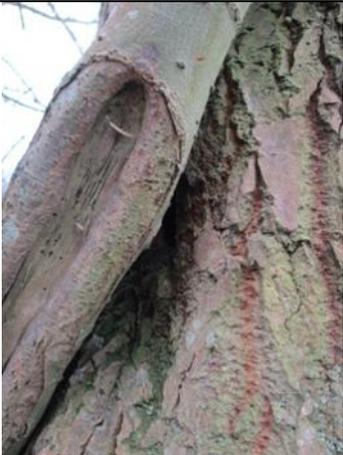
<p>T1 - showing thick stemmed ivy. Low potential.</p>	<p>T4 – Crevices between adjacent stems at low height. Low potential.</p>

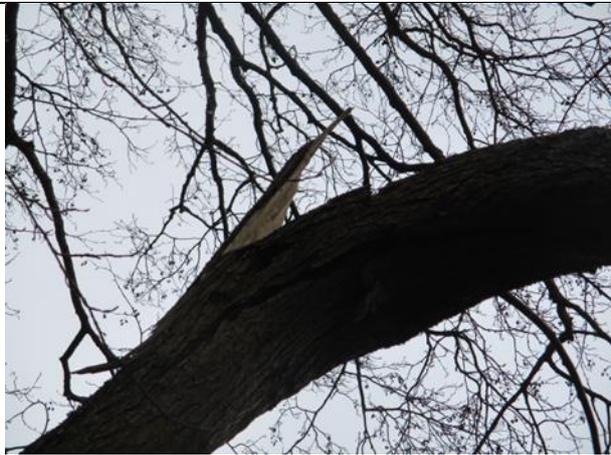
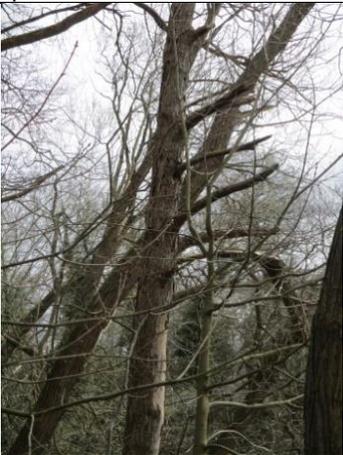
<p>T7 – Willow with split limb on southern edge of West lake – Moderate potential.</p>	<p>T10 – Standing dead wood on eastern shoreline of West lake. Hollow with holes on NW elevation. Moderate bat potential.</p>

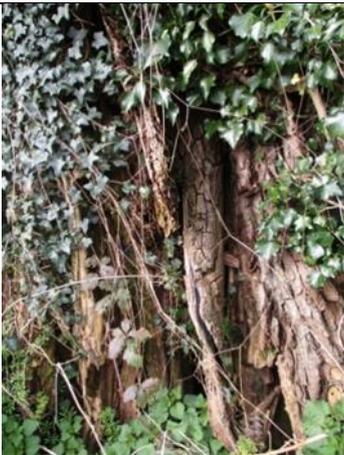
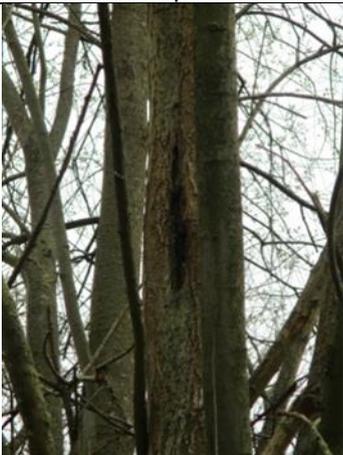
<p>T12 - Decaying elder with features at low height – Low potential.</p>	<p>T13 - Feature at 4m on southern elevation with Low potential.</p>

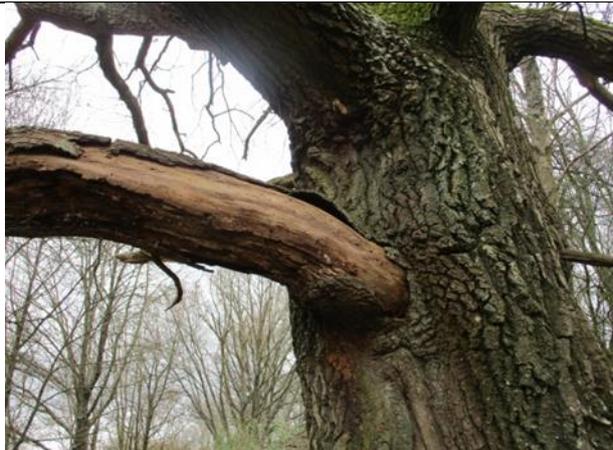
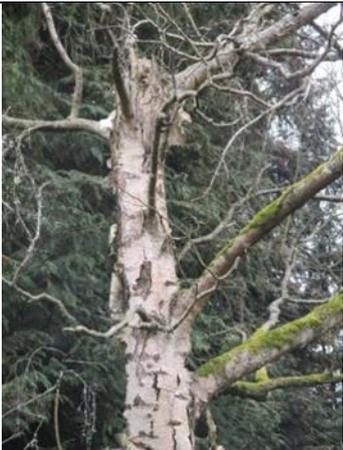
<p>T14 - Mature oak showing example of lifted bark. Low potential.</p>	<p>T17 - Decaying potentially hollow silver birch with numerous features. Moderate potential.</p>

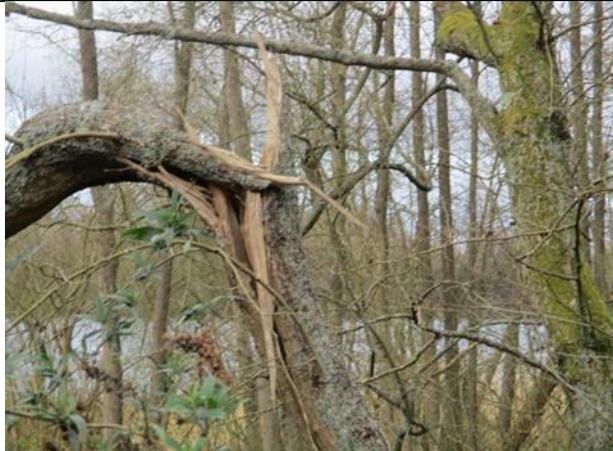
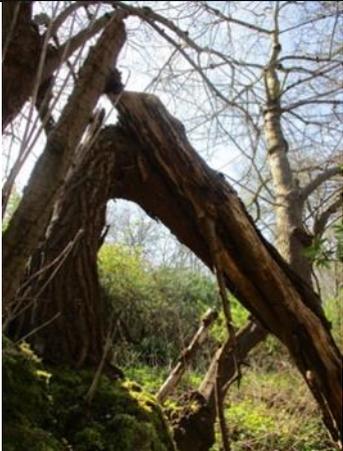
<p>T18 - Multi-stemmed alder with split limb. Moderate potential.</p>	<p>T19 - Decaying alder - limited access points. Low potential.</p>

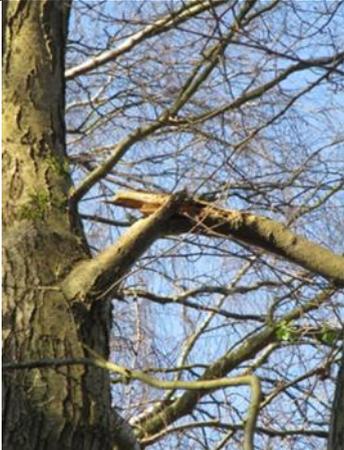
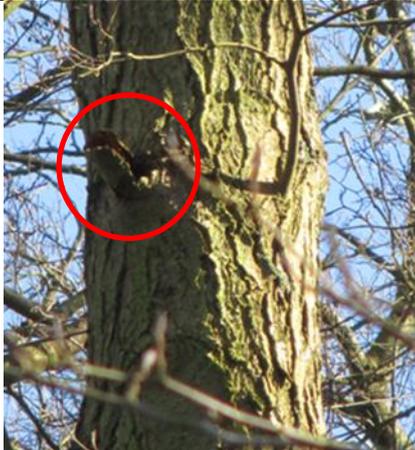
<p>T20 - Split branch on eastern elevation; numerous signs of damage, possibly hollow. Low suitability.</p>	<p>Example of Low suitability semi-mature alder within group T21 showing upward pointing features</p>

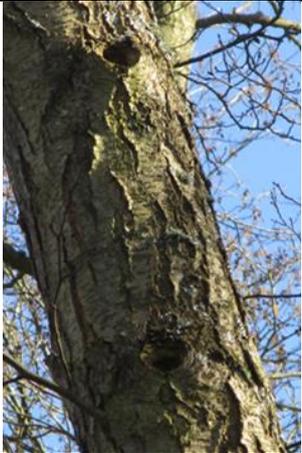
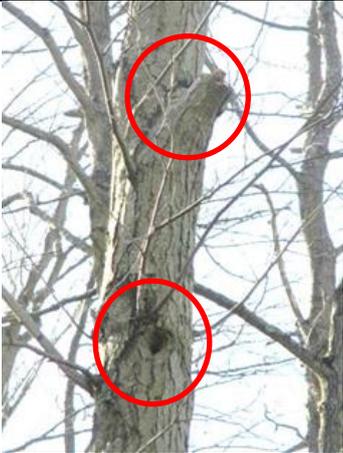
<p>T22 - Alder with holes at 10m and 12m – Moderate suitability.</p>	<p>T23 - Low suitability - Upward facing damaged branch; branch collar at 5m on southern elevation, feature does not appear to extend.</p>

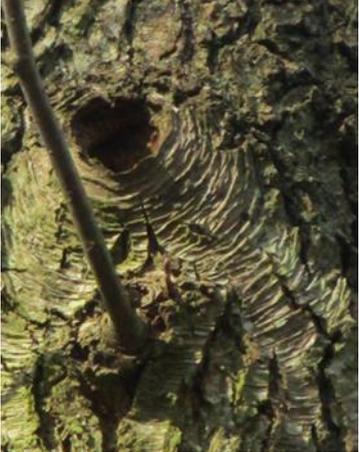
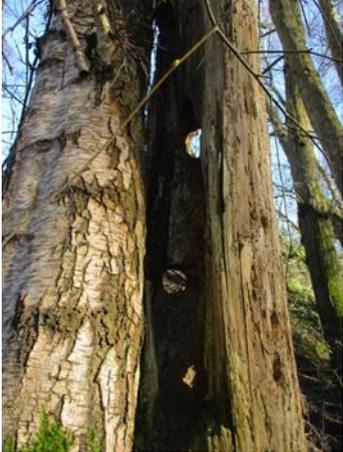
<p>T24 - Alder with hole at 9m on eastern elevation, does not appear to extend. Low suitability.</p>	<p>T25 - Standing deadwood leaning on silver birch; lack of crevices. Negligible suitability.</p>

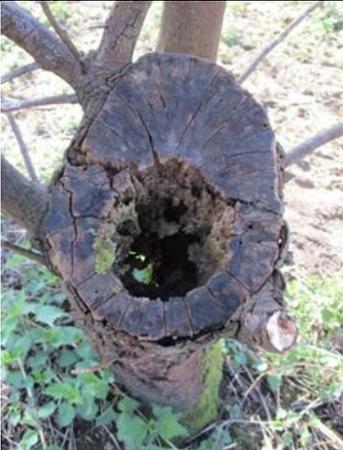
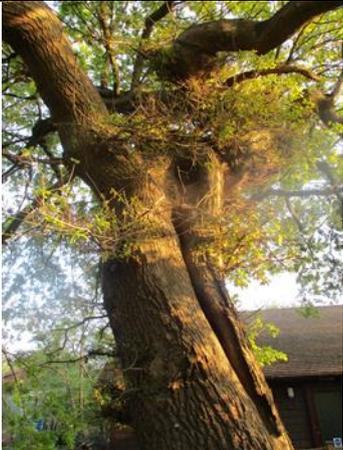
<p>T26 - Damaged alder with hollow trunk; limited crevices. Low suitability.</p>	<p>T27 - Mature/decaying Oak adjacent to building B7. High suitability</p>
