SUPPORTING STATEMENT AND REPORT

Outline Planning Application

DENSHILL

Tillydown, Marnoch, Huntly

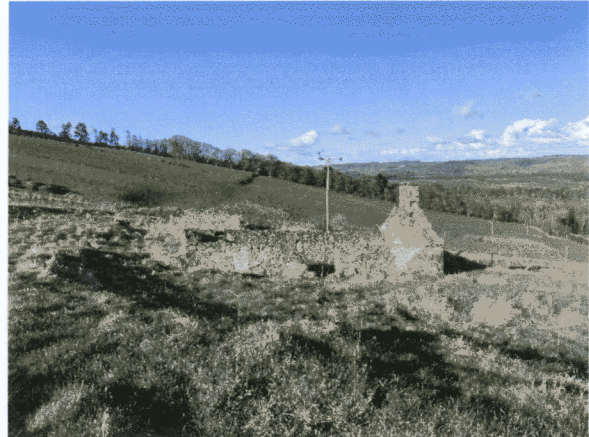
1). Towards NE. Proposed development site showing derelict old cottage to wall head level, with one remaining gable, also the remains of the old crumbled out building.

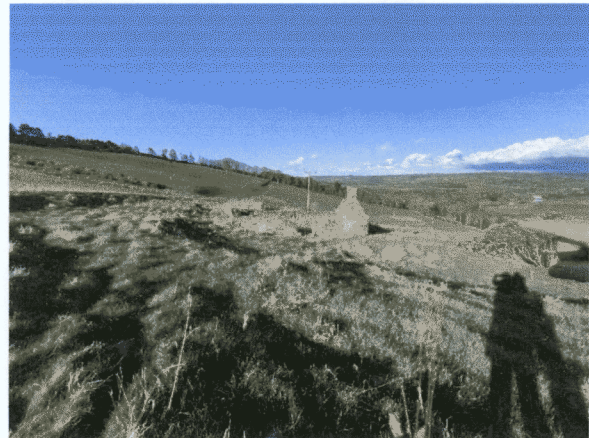
2). Towards NE. As above.

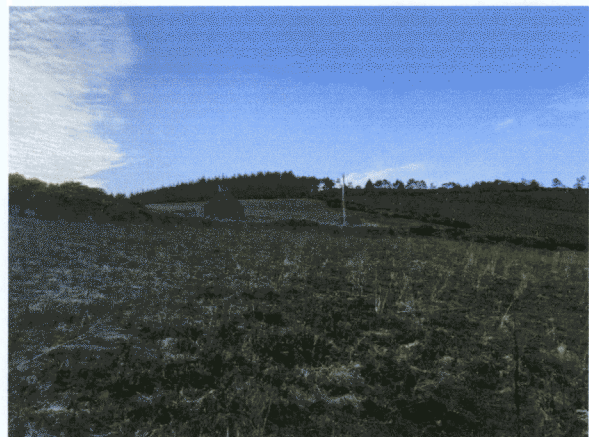
3). Towards NE. As above.

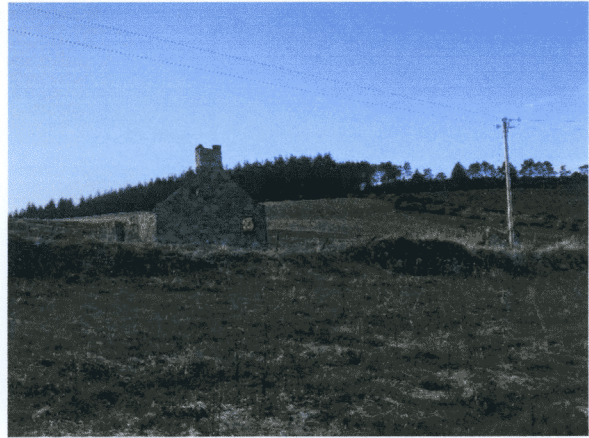
4). Towards NW. Emphasising the shallow hollow containing the proposed development site.

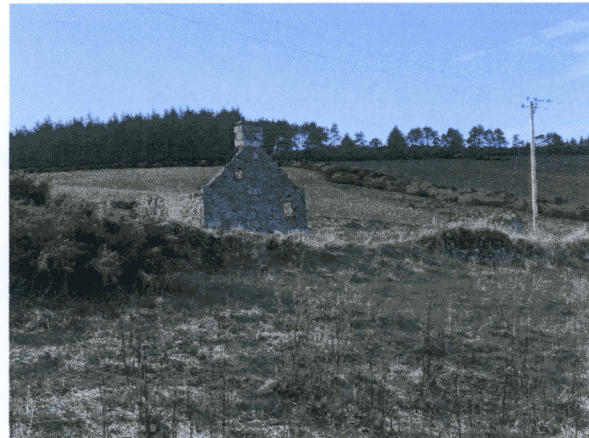
5). Towards NW. As above, showing an electricity pole to provide electrical service to the site.

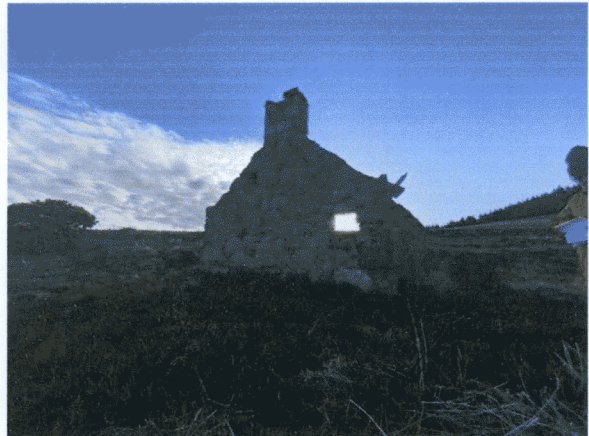
6). Towards W. From within the hollow dip of the proposed development site showing uphill elevation toward skyline forest.

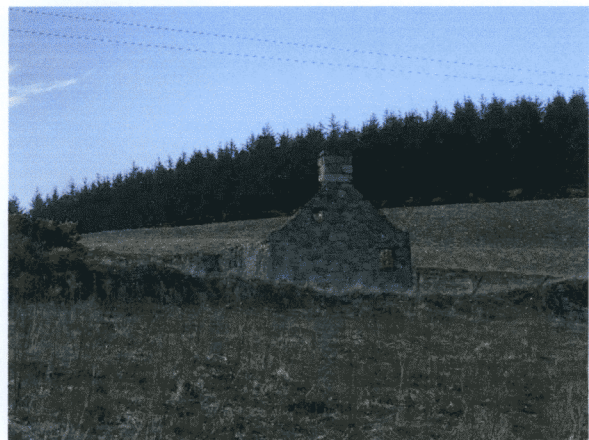
7). Towards NW. Showing the old cottage below the skyline / tree line.

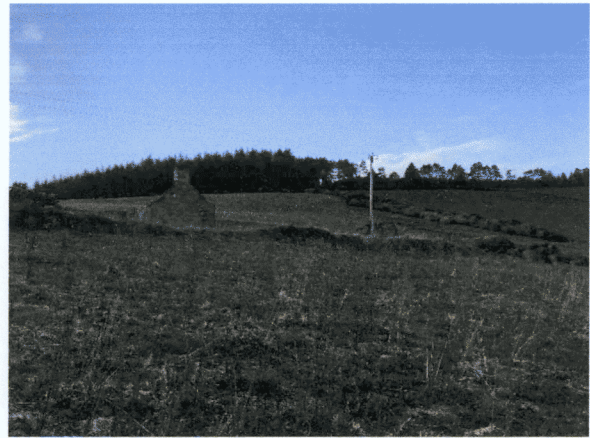
8). Towards NW. Longer shot of the cottage indicating that the development area is obscured by hillside and trees to the left.

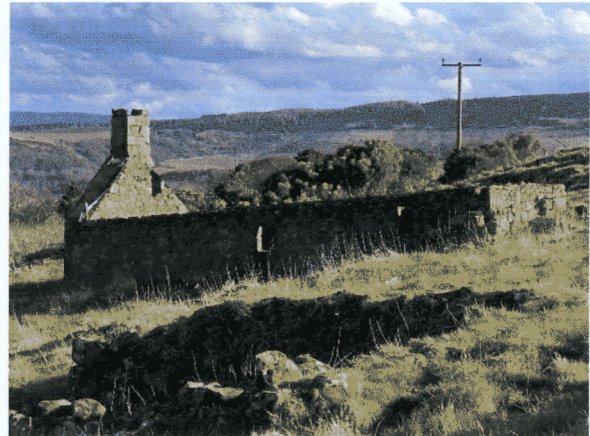
9). Towards S. Showing cottage in hollow, and remnants of the old outbuilding plus an electricity pole near the development boundary line.

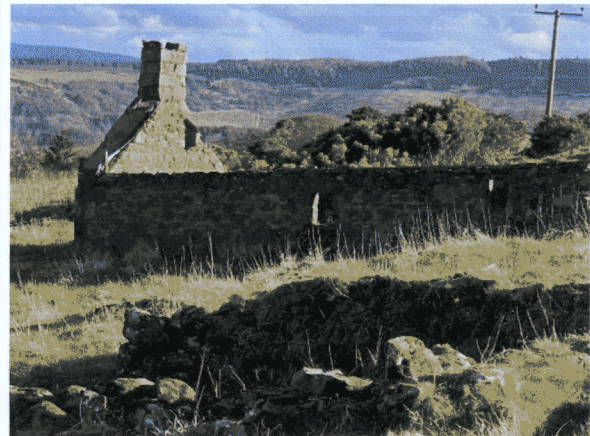
10). Towards S. Ruined outbuilding in foreground, with cottage and electricity pole close.

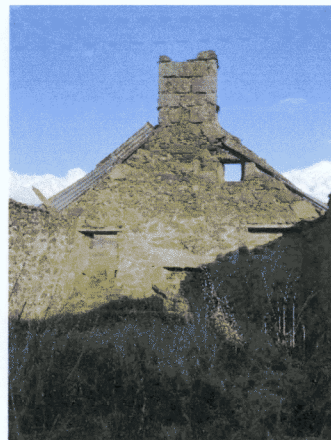
11). Internal photo showing fireplace, with two open and one bricked up window plus chimney stack and remnants of corrugated iron roof.

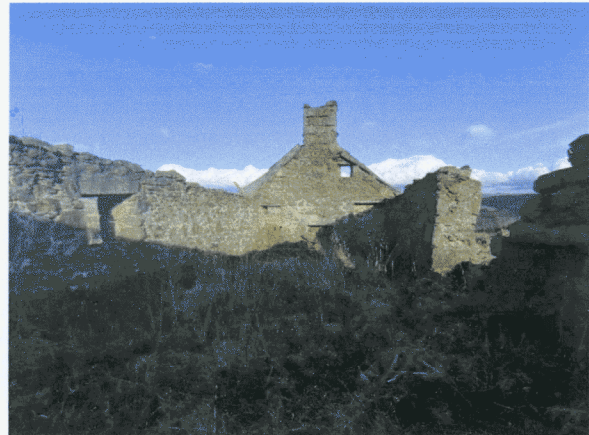
12). Same as 11 above, but showing one more window to left and collapsed entrance doorway to the right.

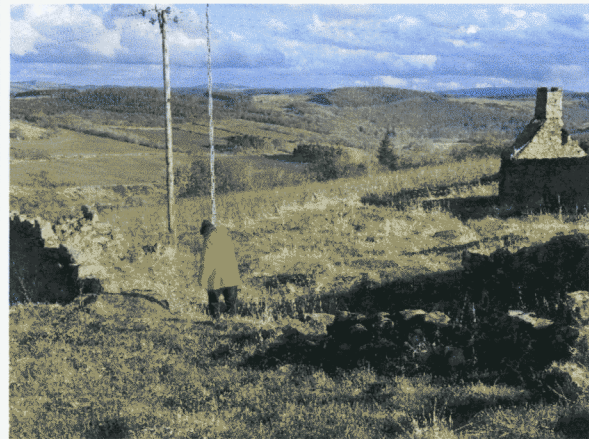
13). Towards S. Rough survey estimating fall in ground level from rim of hollow to ground level within the old out building.

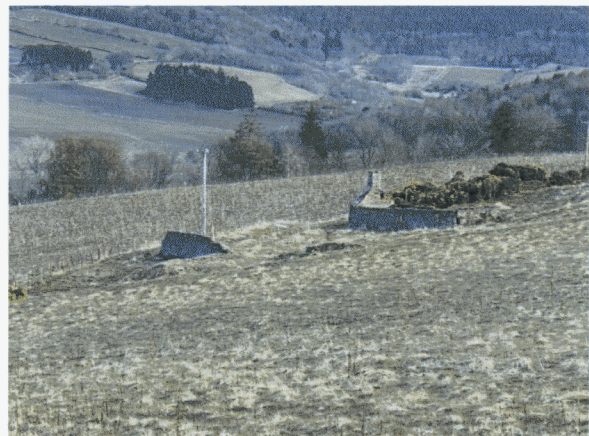
14). Towards SE. Long shot showing proposed development site in landscape.

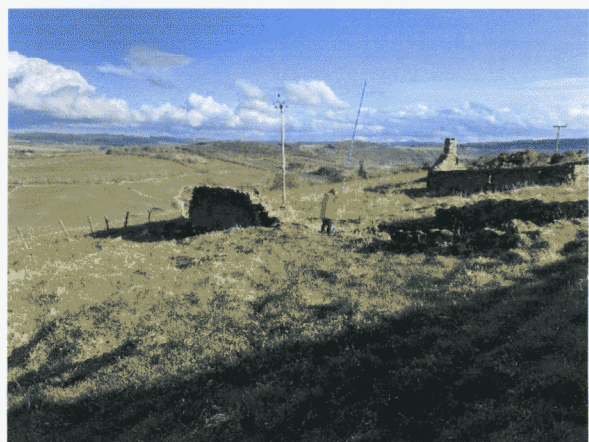
15). Towards S. Across valley showing proposed development site in hollow and drop in ground level from hollow rim to lower levels.

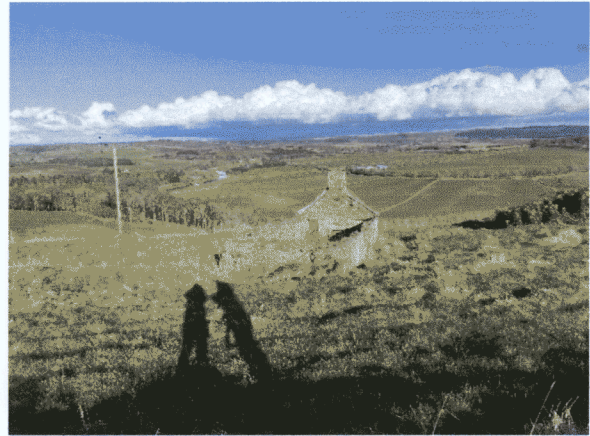
16). Towards SE showing view across valley. A large complex of farm buildings can be seen, but houses across the valley are barely visible to the naked eye. The same applies in reverse. From across the valley the proposed development would be barely visible from approximately half the points of the compass, and totally invisible from approximately half the points of the compass at any distance which is visible to the normal naked eye. Trees and hill humps exclude the development from view except from distant high spots on the other side of the valley.

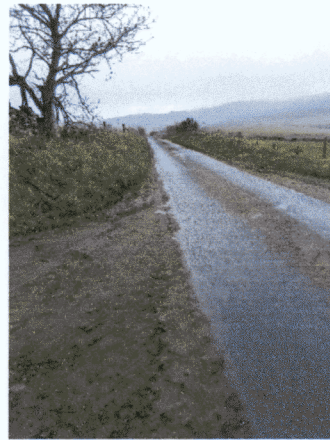
Access to the public road from the track has good visibility to the left, and to the right, and can easily be made to comply with the standards required by the roads department by provision of suitably constructed splays. Provision will be made for roadside collection of refuse in accordance with regulations.

17). Leftward access to public road.

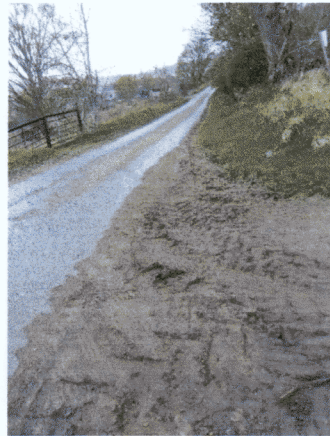
18). Rightward access to public road.

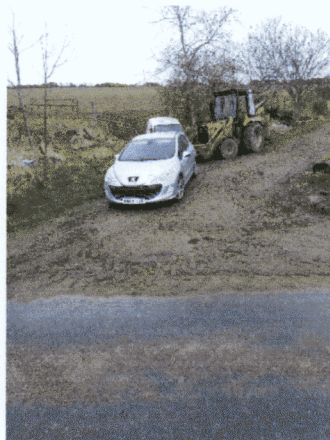
19). Access track to public road viewed from across the road.

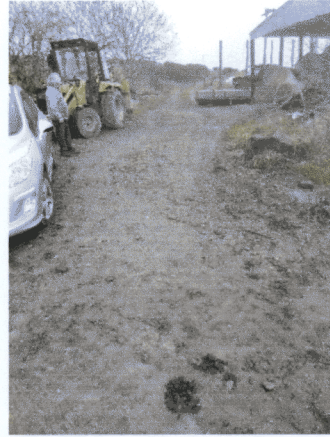
Access to the site is by means of a farm track currently owned and maintained by Mr Rust. The track will need to be upgraded with hardcore and resurfaced.

20). View up the access track from near to the public road.

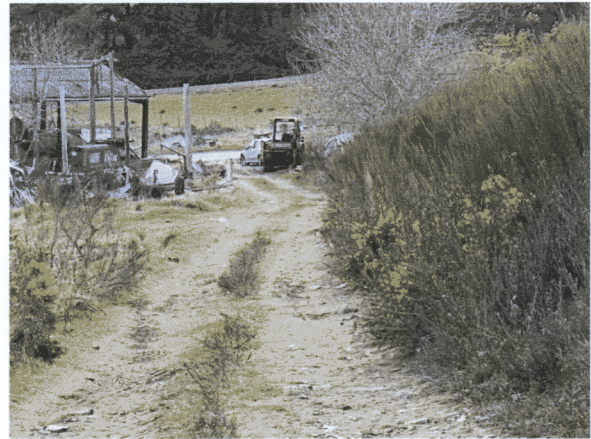
21). View down the access track to the public road.

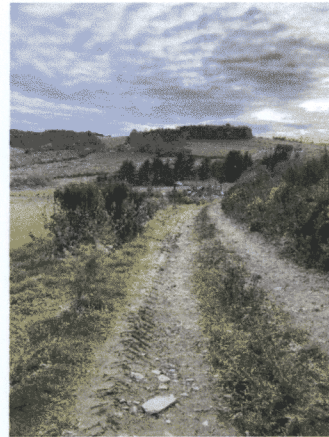
22). View down the access track towards the public road.

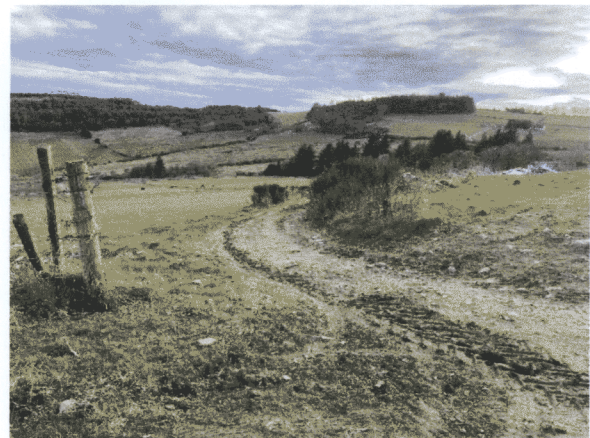
23). View down the access track from near the top nearer to proposed development.

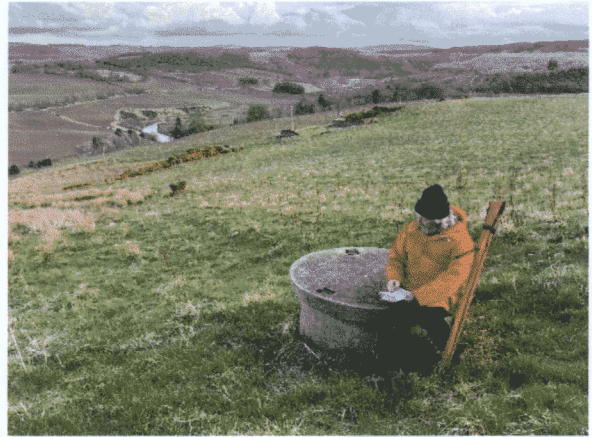
Water is to be supplied from a currently working well situated higher up the hill above the proposed development. The well is working and appears to be in good repair at ground level. No inspection below ground was performed, and no analysis of the purity water was undertaken.

24). Toward S. View of the well, with proposed development site downhill.
