BEAUCHAMP LODGE  
TWO MILE LANE  
HIGHNAM  
GL2 8AB

Project Number: FEN210522

# Contents

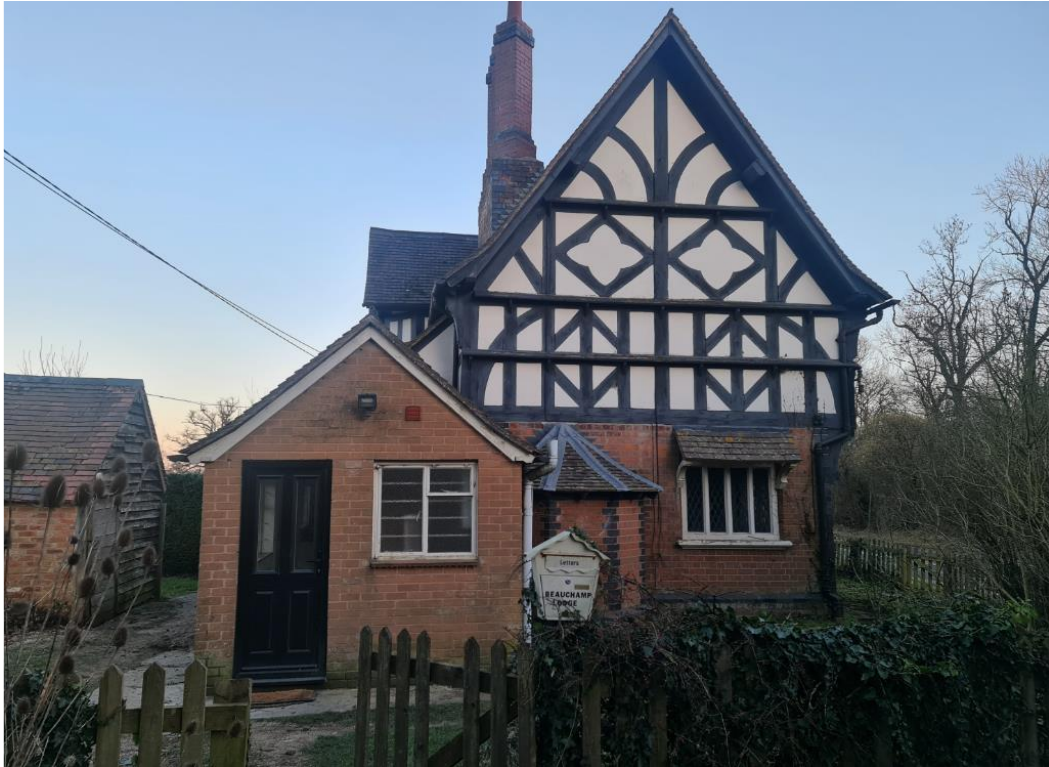
*Figure 2: Front (west) elevation of Beauchamp Lodge*

**5.3** Damage caused by subsidence of the site has been reported to the kitchen extension only. The following areas of movement have been reported: -

- The cracking is at the junction where the extension abuts the main house. There is gapping at the ceiling and cracking extending above the side window which is mirrored externally. There is also diagonal cracking to the rear wall of the enclosed wc.
- The damage is indicative of subsidence of the extension with it tilting to the west. The bed joint tilt was measured at 1 in 95 which equates to a drop of c.40mm on the end wall of the extension compared to where it abuts the main house.
