DESIGN AND ACCESS STATEMENT

BEAUCHAMP LODGE TWO MILE LANE HIGHNAM GL2 8AB

Doc Ref: FEN210522 – D&A

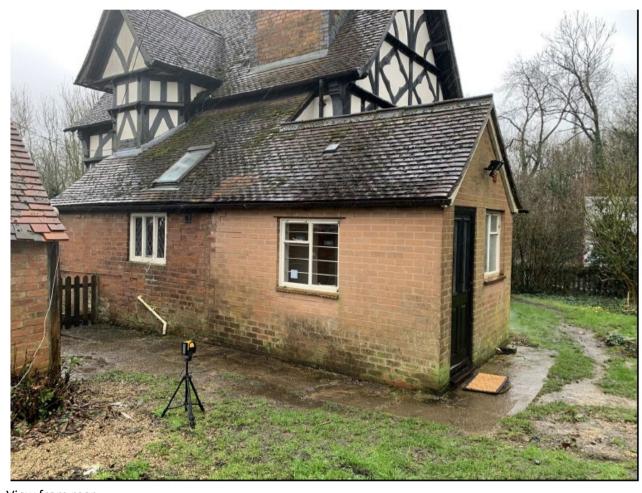
View from rear
