TREE SURVEY

THE CHANTRY, BISHOPTHORPE

PREPARED BY LANPRO SERVICES

Project Reference: 2820

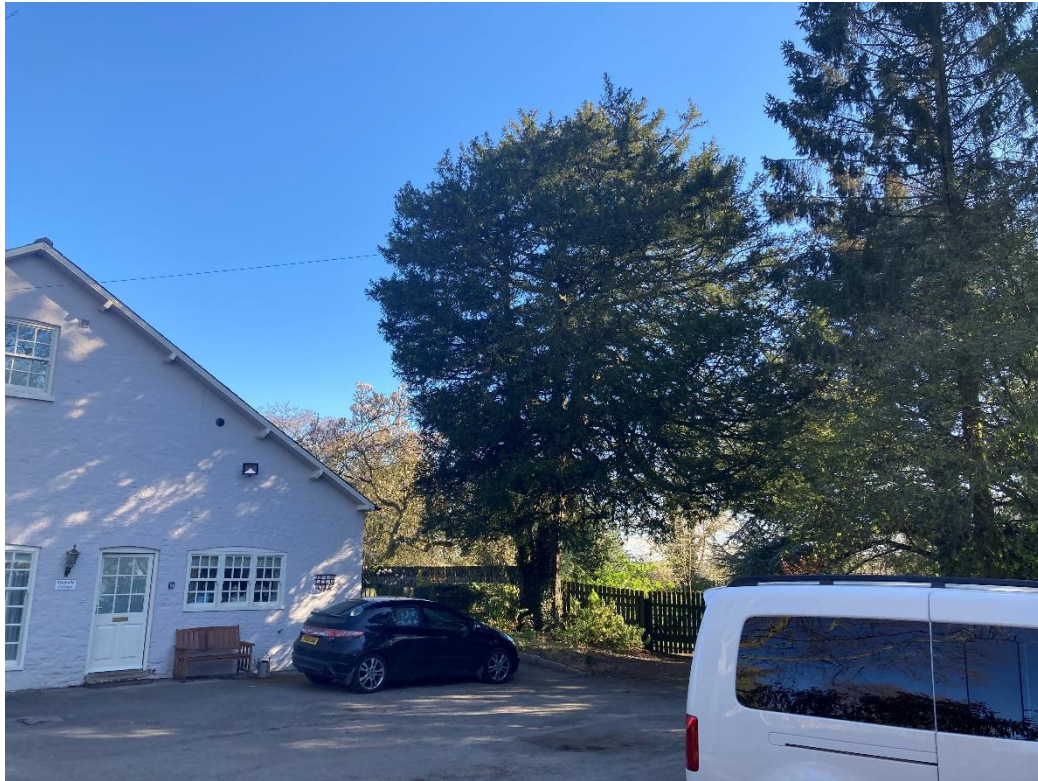
6.10 The decking proposed to the east of the extension falls within the RPA of T1 and encroaches close to the stem of T1. To avoid any negative impacts to the tree there should be no excavation or ground or level changes within uncultivated land within the RPA to facilitate the decking construction. The decking should utilise permeable geotextile sheeting for any required weed suppression, while still allowing rainwater runoff to permeate within the built decking area. The decking materials should be inert including any stains or preservatives so they do not leach into the soil which may damage roots.

Photograph 1: Looking north east at T1

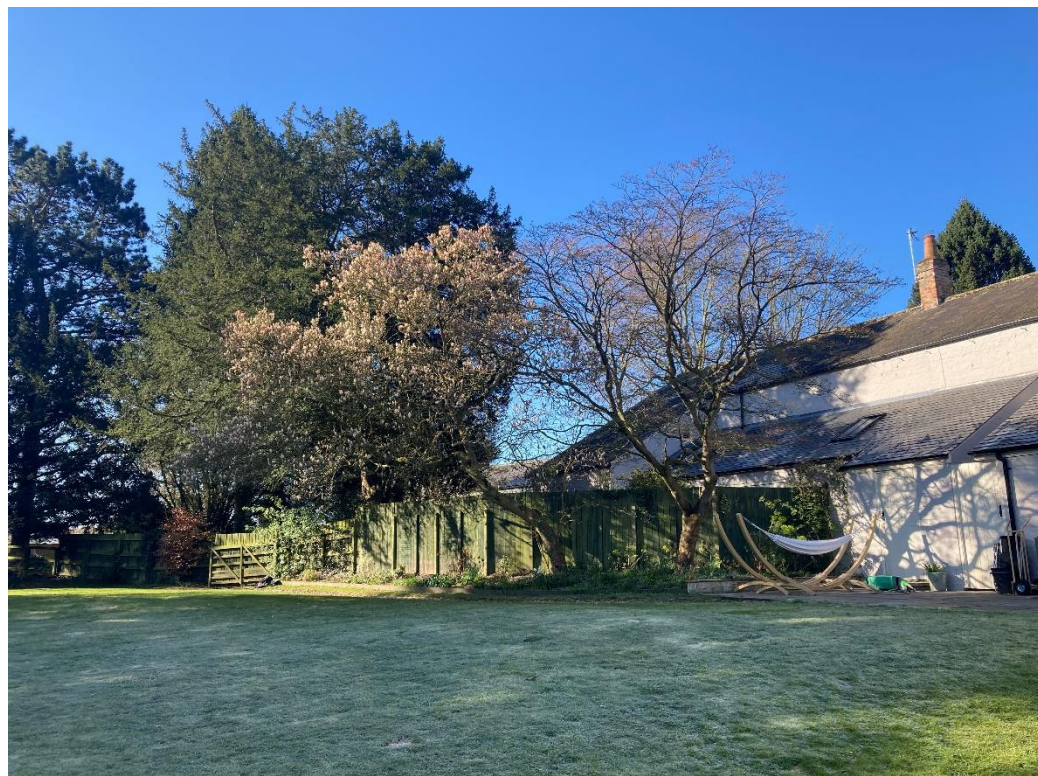
- 6.3 The trees that require removal are T2 and T3. These trees have been identified in red on the drawing 2820-00-102 Tree Impact Plan (Appendix C).
- 6.4 The trees that require removal are lower value, retention category 'C'. T2 is a Magnolia that has had a substantial western stem removed in the past and has produced a lot of epicormic growth as a result. T3 is a Japanese Maple with multiple pruning wounds from past management. Both trees have a significant eastern lean, likely a result of suppression from T1.

Photograph 2: Looking south west with T3 (right) and T2 (left) with T1 in the background

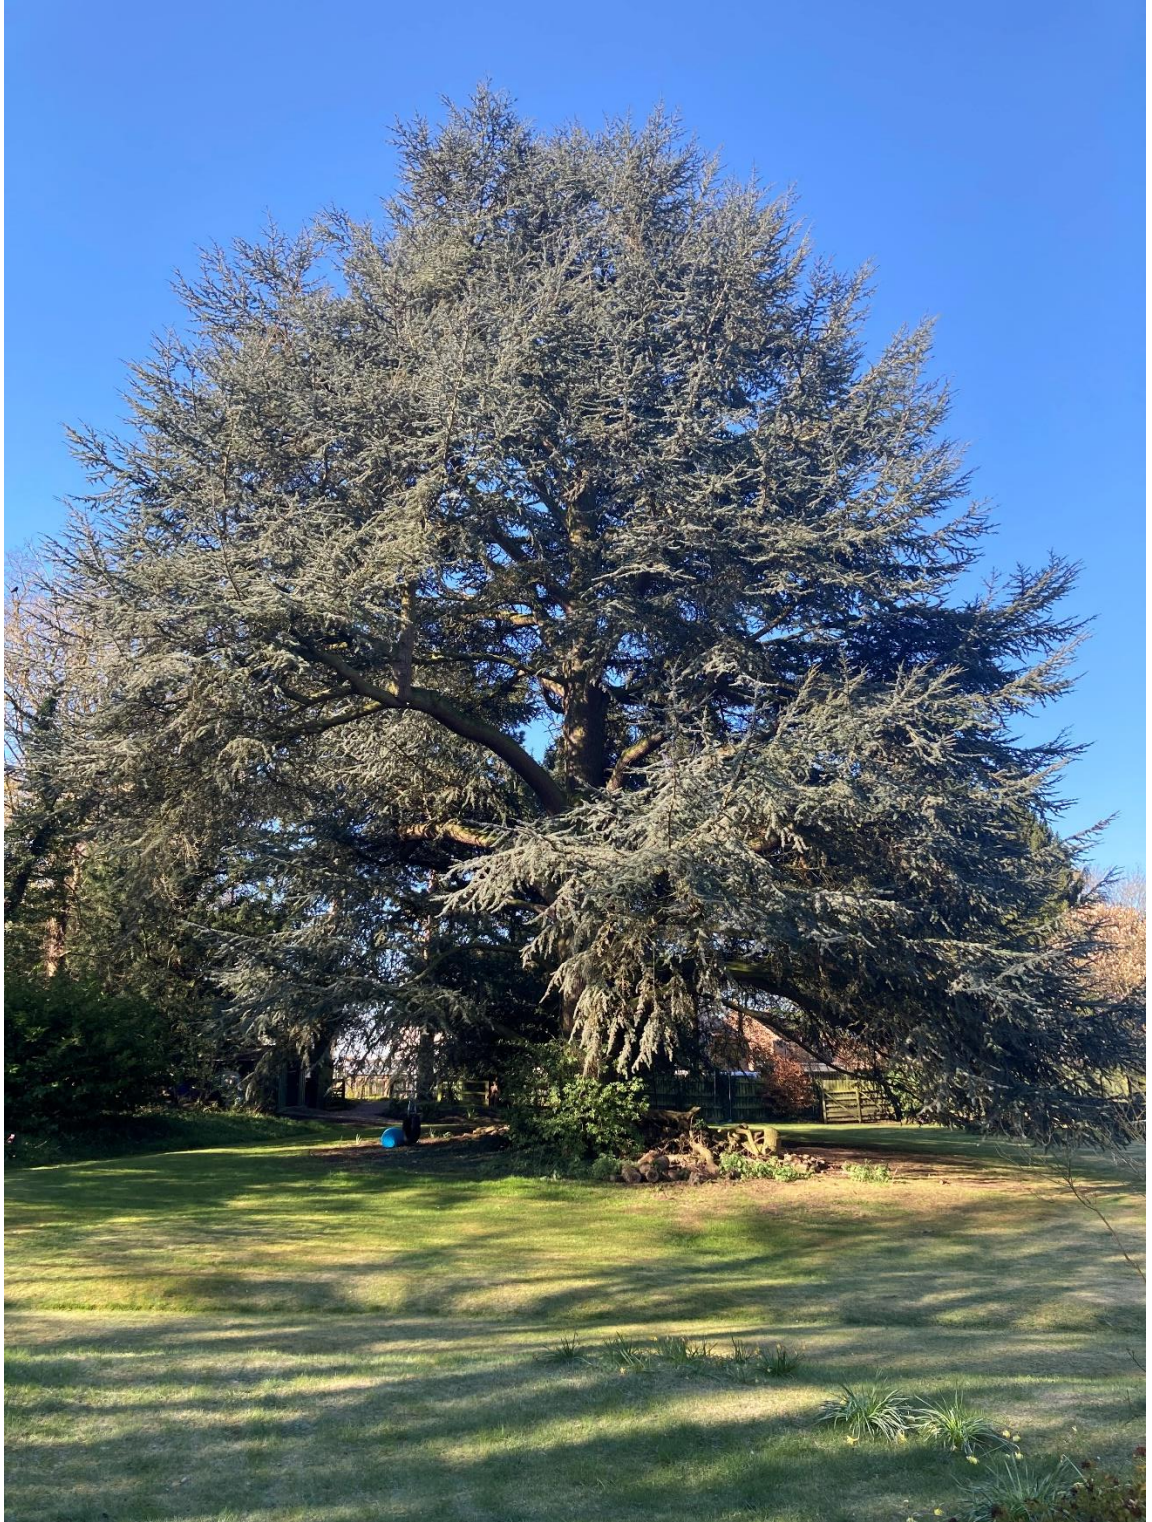
- 5.4 The most notable tree is the mature Cedar, T17, situated on the lawned area of the rear garden. This tree is prominent throughout the entire site and provides a good level of amenity value and arboricultural interest.

Photograph 3: Looking west at T17

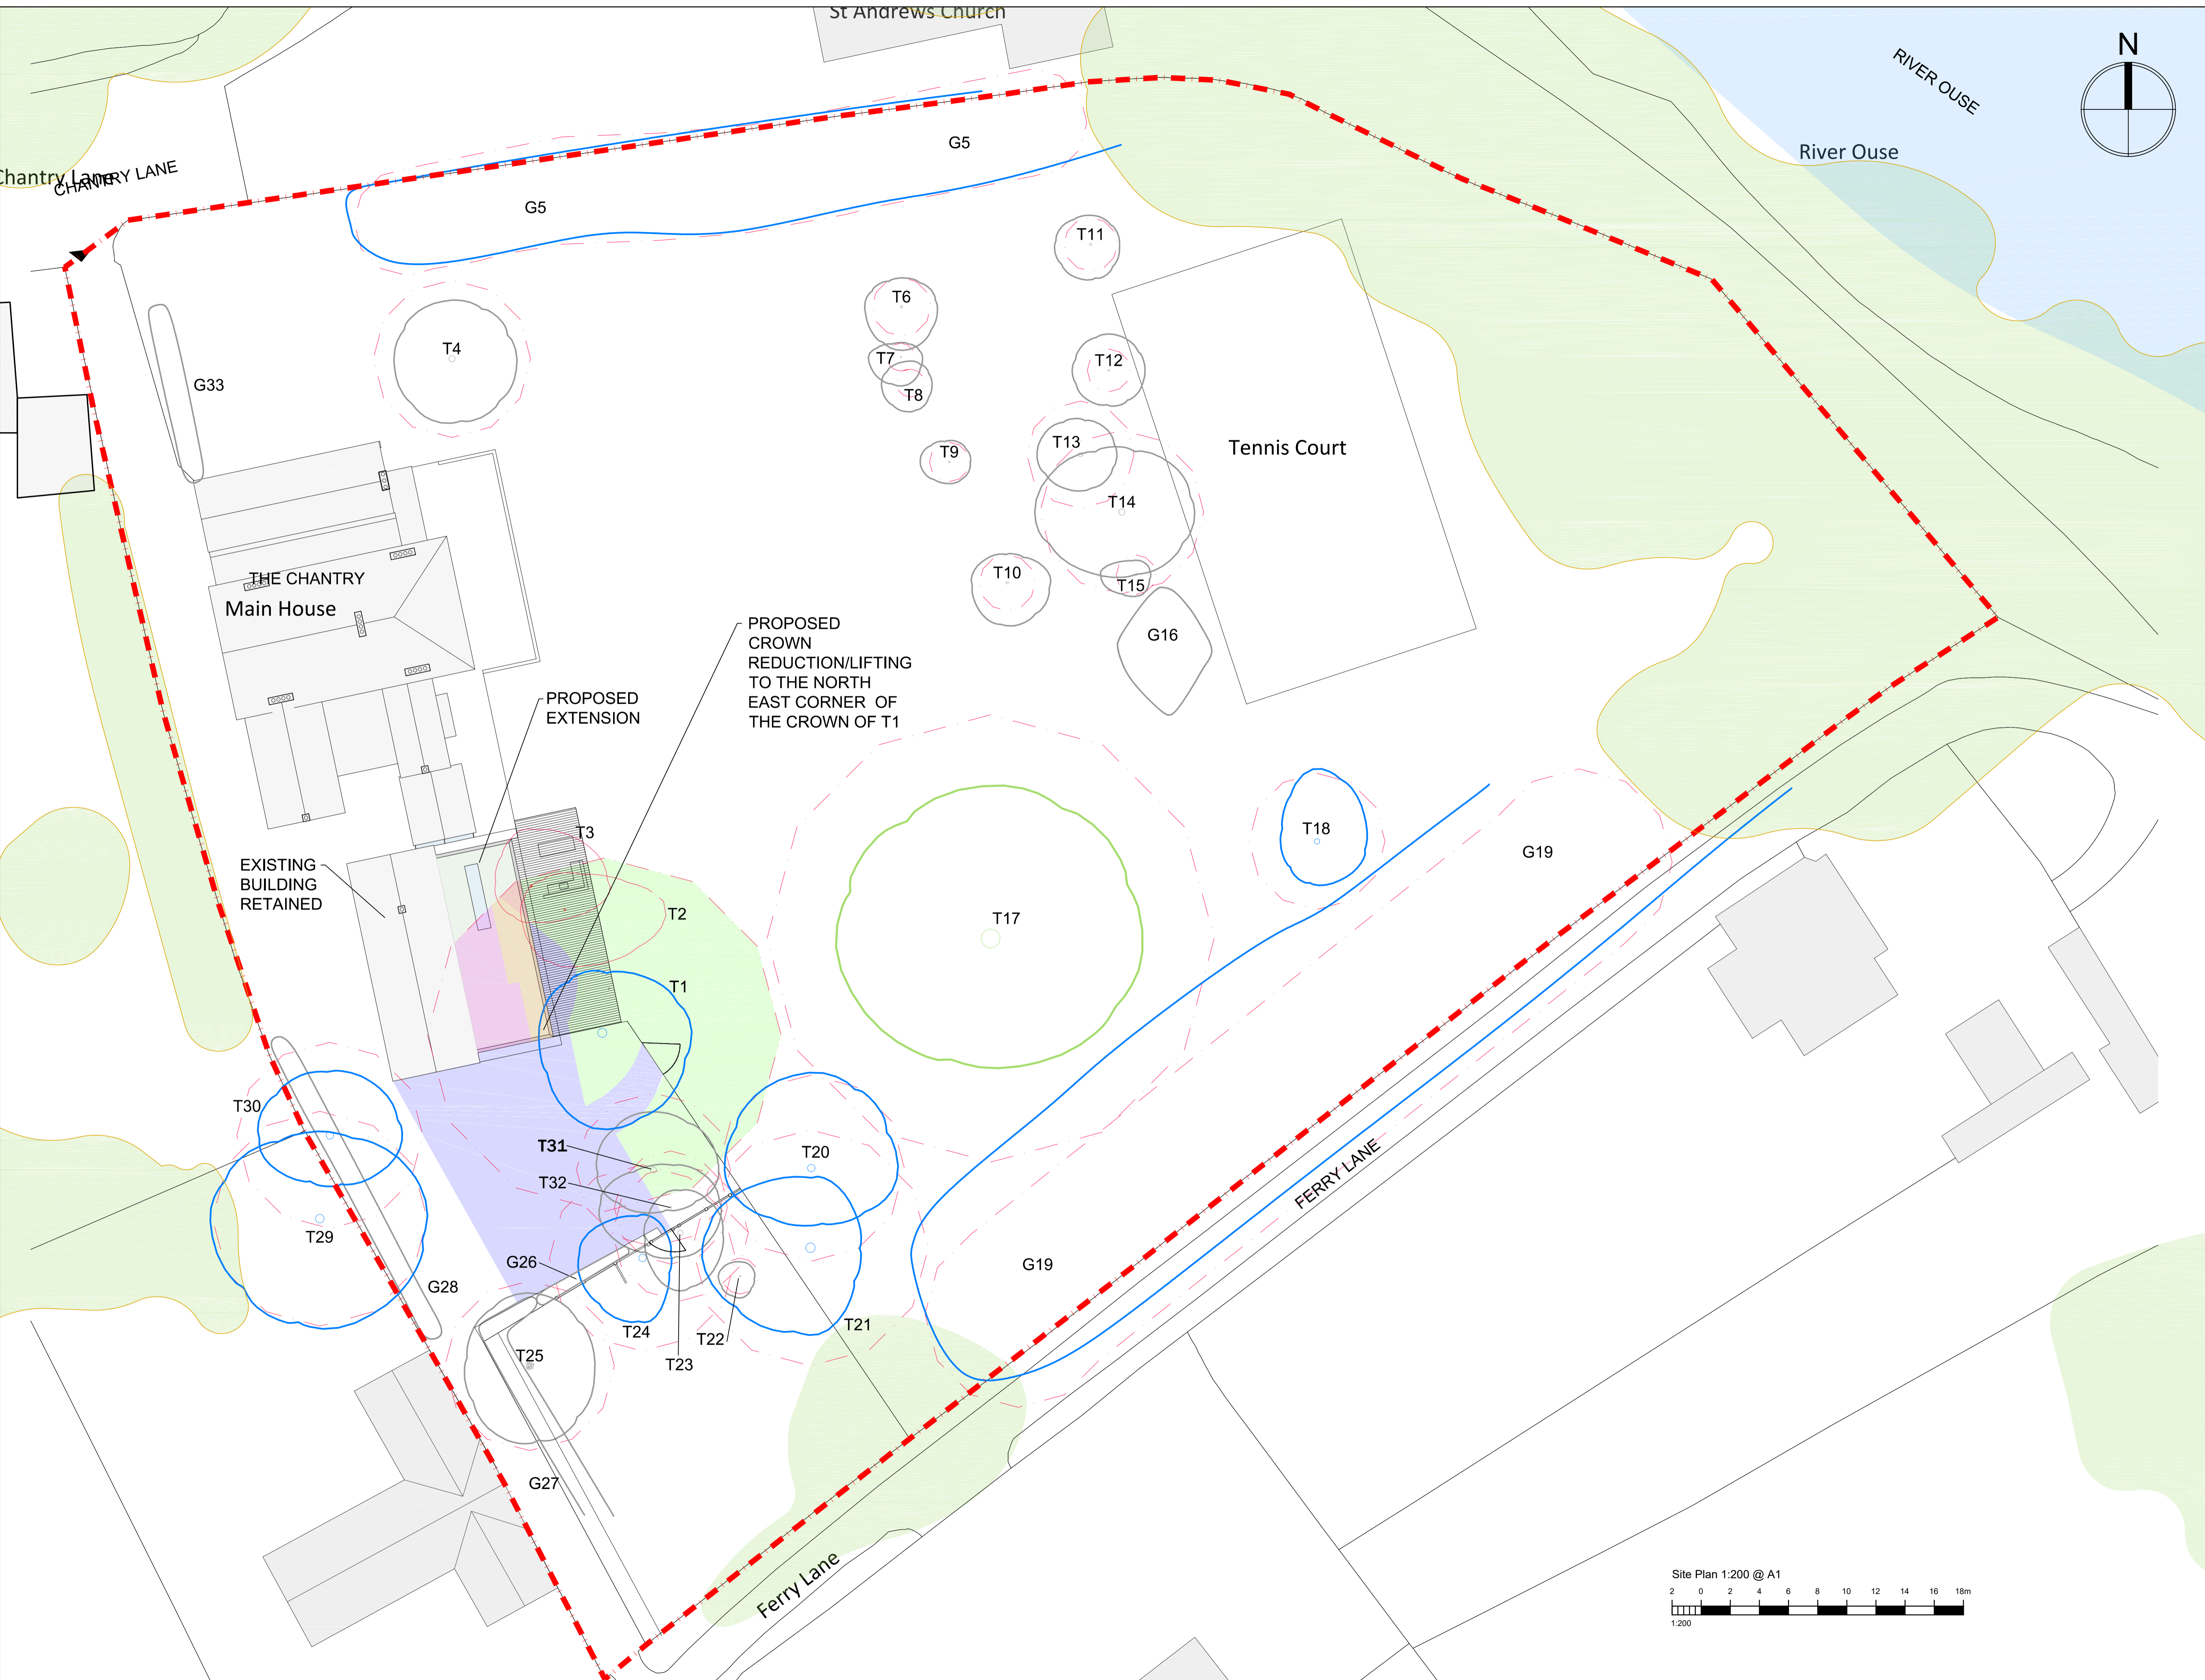
Appendix C: Tree Impact Plan - Drawing 2820-00-102

- Existing permeable surface and levels within the RPA of T1 to be retained
 - Existing permeable surface within the RPA of T1 to be replaced by new building with specialist construction in line with proposed Arboricultural Method Statement

- Existing impermeable surface within the RPA of T1 to be replaced by new building with specialist construction in line with proposed Arboricultural Method Statement

- Existing building within the RPA of T1 to be replaced by new building with specialist construction in line with proposed Arboricultural Method Statement

PROPOSED CROWN REDUCTION/LIFTING TO THE NORTH EAST CORNER OF THE CROWN OF T1
