FLOOD RISK ASSESSMENT

Site Address: North of Fairlie Bowling Club, Main Road, Fairlie, Largs, Ayrshire

Proposal: Formation of a garden centre and restaurant with associated landscaping and road works

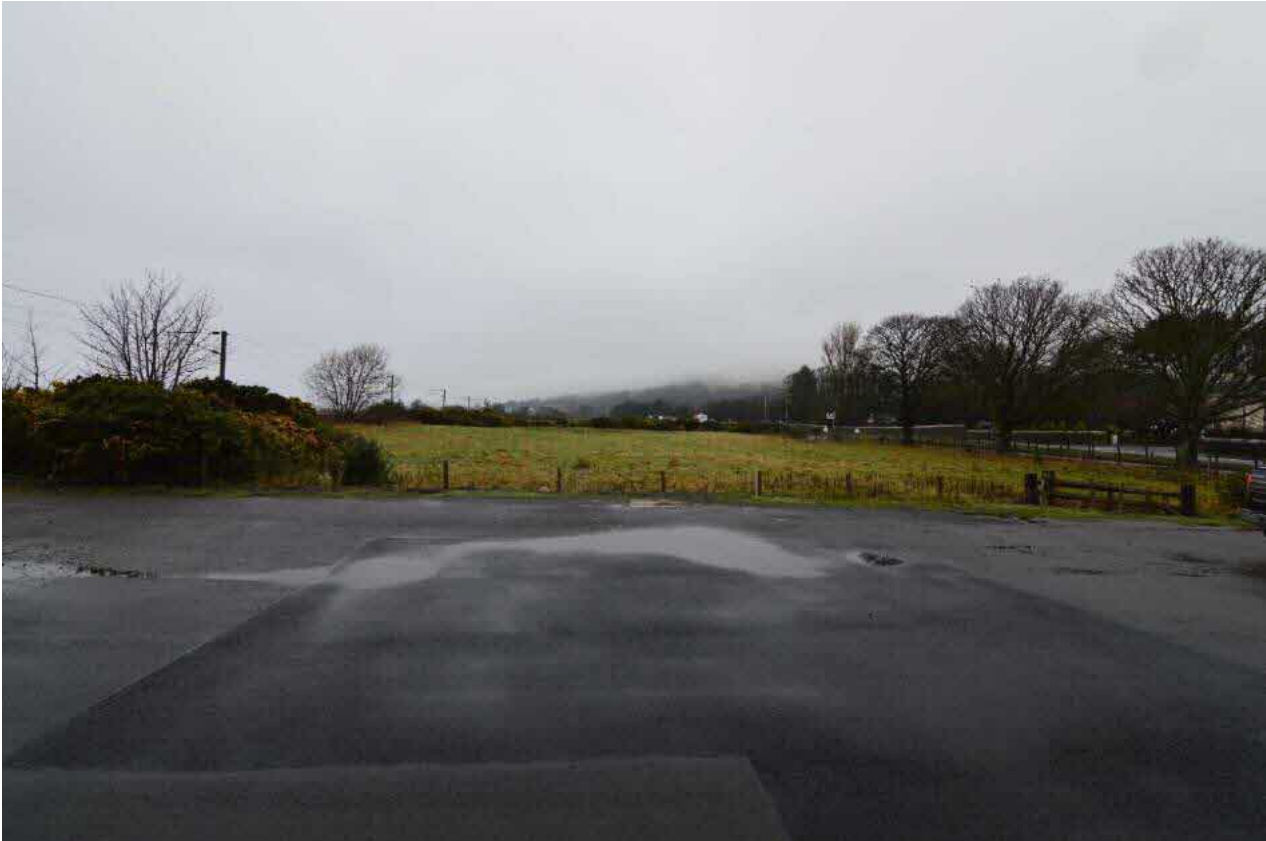
Plate 1: Looking north towards proposed development site. Bowling Club car park in foreground. Photograph taken from NS 20978 56192.

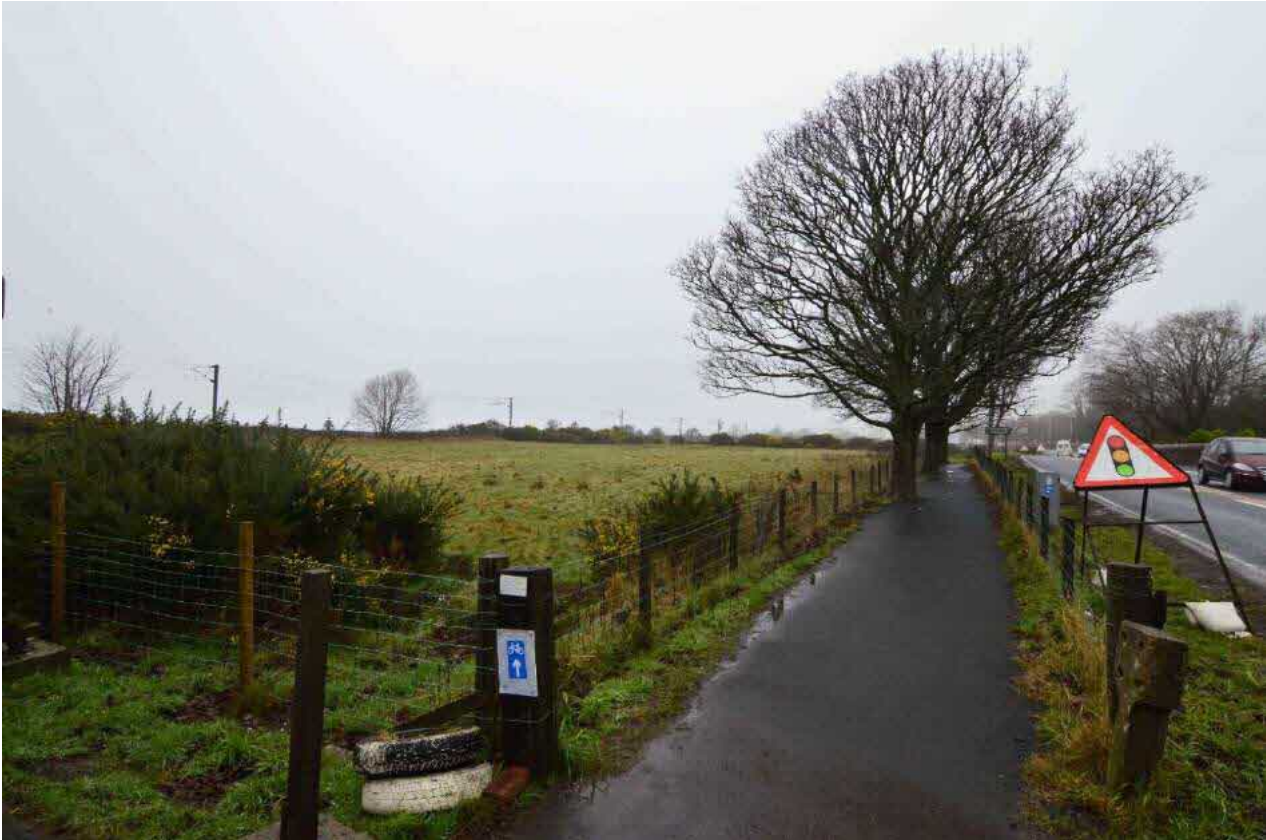
Plate 2: Looking north towards proposed development site from where cycle track meets Bowling Club car park. Photograph taken from NS 21008 56200.

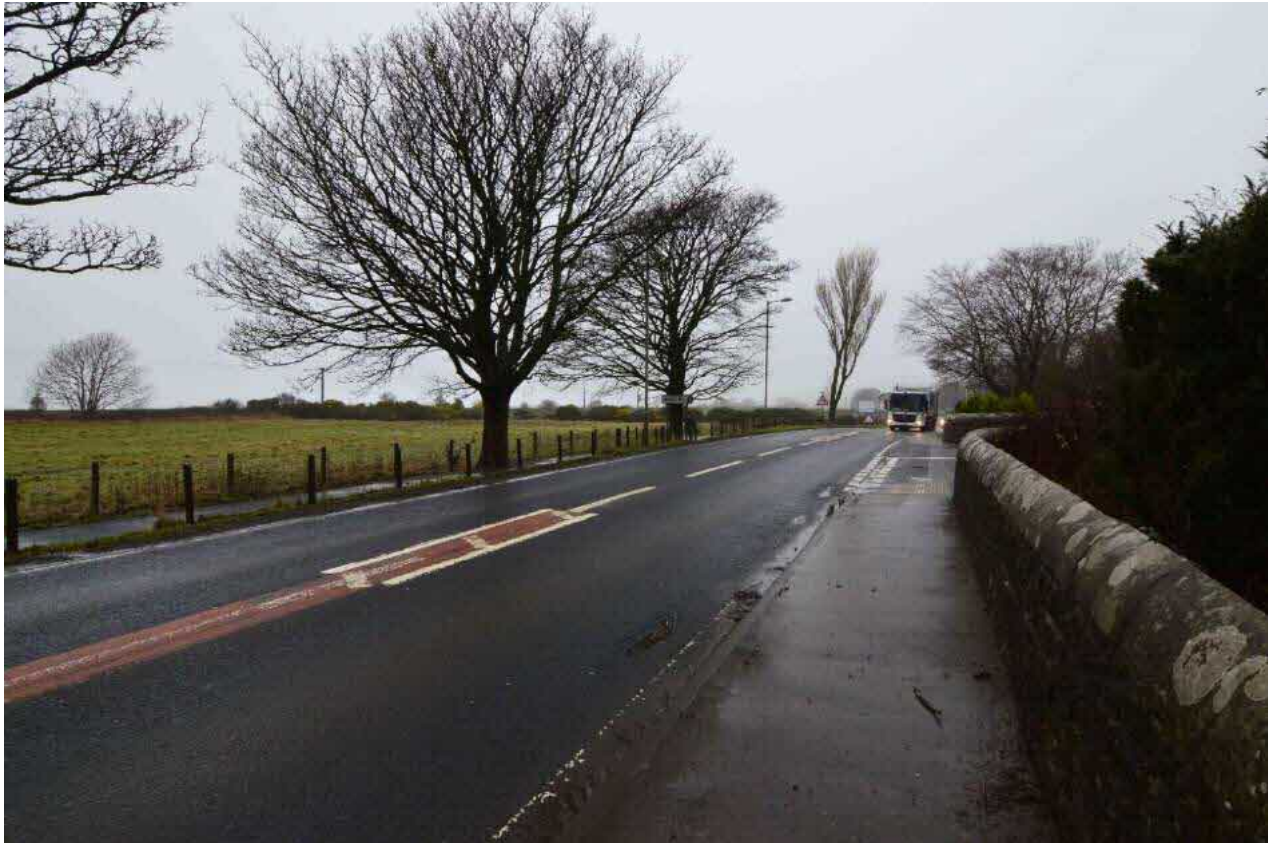
- 2.4 The map also indicates a medium likelihood of surface water flooding at the NW and SE extents of the land proposed for development. The flooding shown doesn't appear to mirror actual ground levels at the site. For example, ground levels at the NW extent of the site are similar to those at the SW extent (plates 2 and 3) and no significant depressions in the landform were observed during the site visit nor appear in the topographical survey data. The same applies to the flooding shown at the SE extent. This is located on the left-hand side of plate 3. This too indicates inaccuracy in the digital terrain data used for the flood map at this location.

Plate 3: Looking north with proposed development site on left of frame (the gorse in the distance runs along the banks of the subject watercourse). Photograph taken from NS 21025 56217.

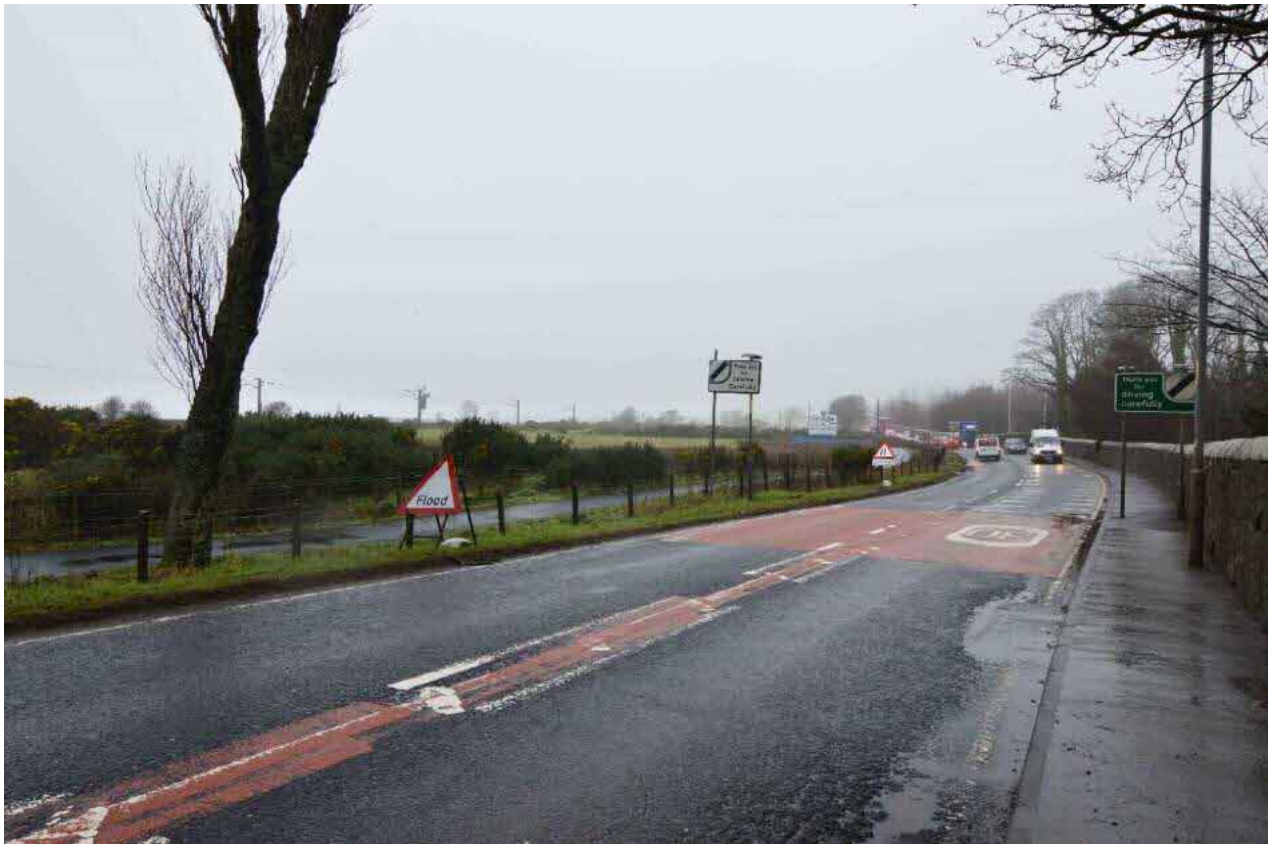
- 3.7 It is not known whether the wall has been repaired since our site visit but assuming it has/will be then for a 1:200 year flood event water will flow behind it in northerly direction towards the unnamed burn which lies north of the entrance to the Kelburn Castle Country Centre. This flood water will not reach the site due to the lower lying land in this location (best viewed in plates 4 and 6).

Plate 4: Looking north with subject watercourse on left of frame (the gorse behind the tree lies either side of the watercourse channel). Photograph taken from NS 21034 56271. NB: Beyond the site boundary/watercourse the landform slopes north.

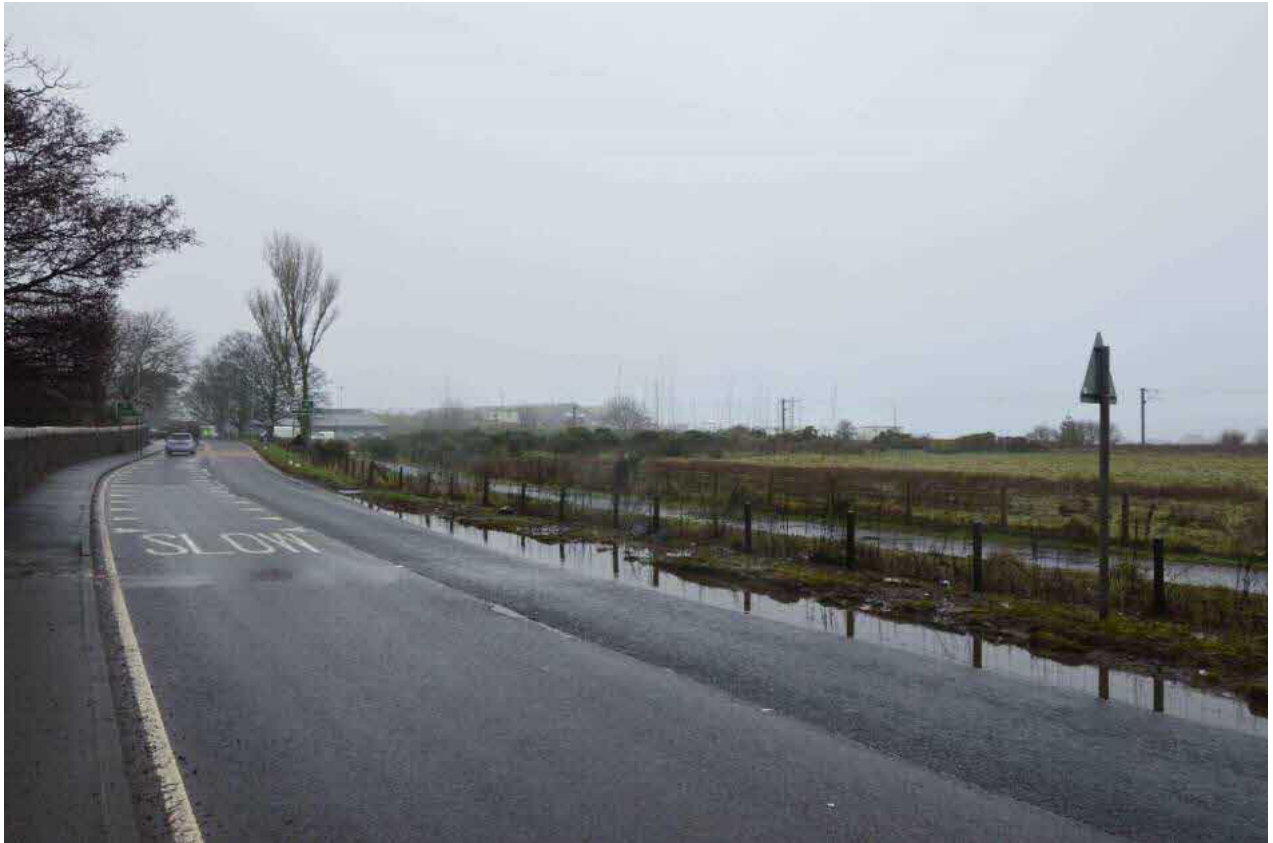
- 3.6 The field shown in plate 11 is already subject to waterlogging due to poor drainage which results in water flowing through a break in the wall adjacent to the A78 (plates 6 and 7) and pooling on the trunk road (plates 5 and 6). Note that the slope of the road is north i.e. away from the site.

Plate 5: Looking southwest towards subject watercourse. This plate shows pooling of water on the A78 near the foot of the hill (i.e. beyond the site). Photograph taken from NS 21053 56348.

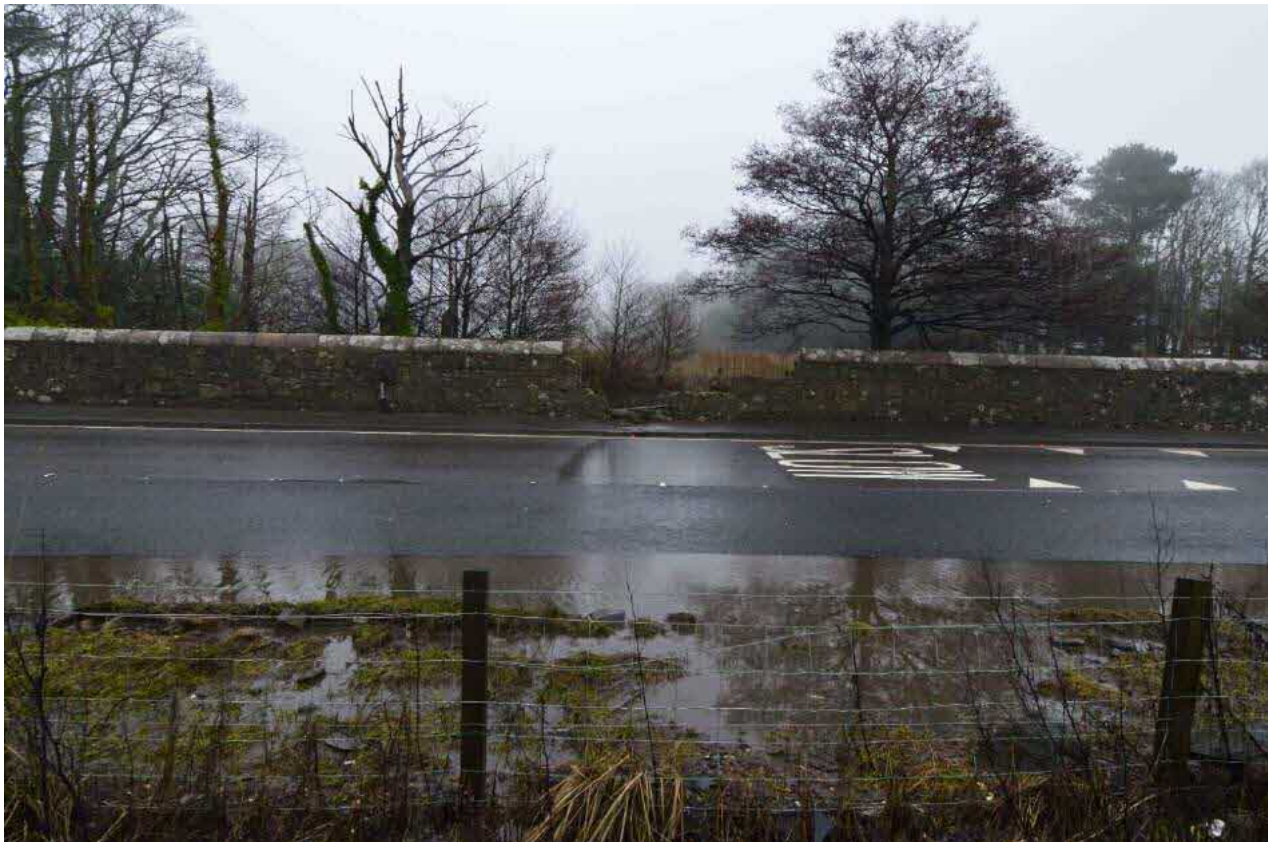
Plate 6: Looking east towards the source of the water pooling on the A78. The break in the wall was caused by a car crash. The field behind the wall is poorly drained and run-off flows onto the road. Photograph taken from NS 21039 56338.

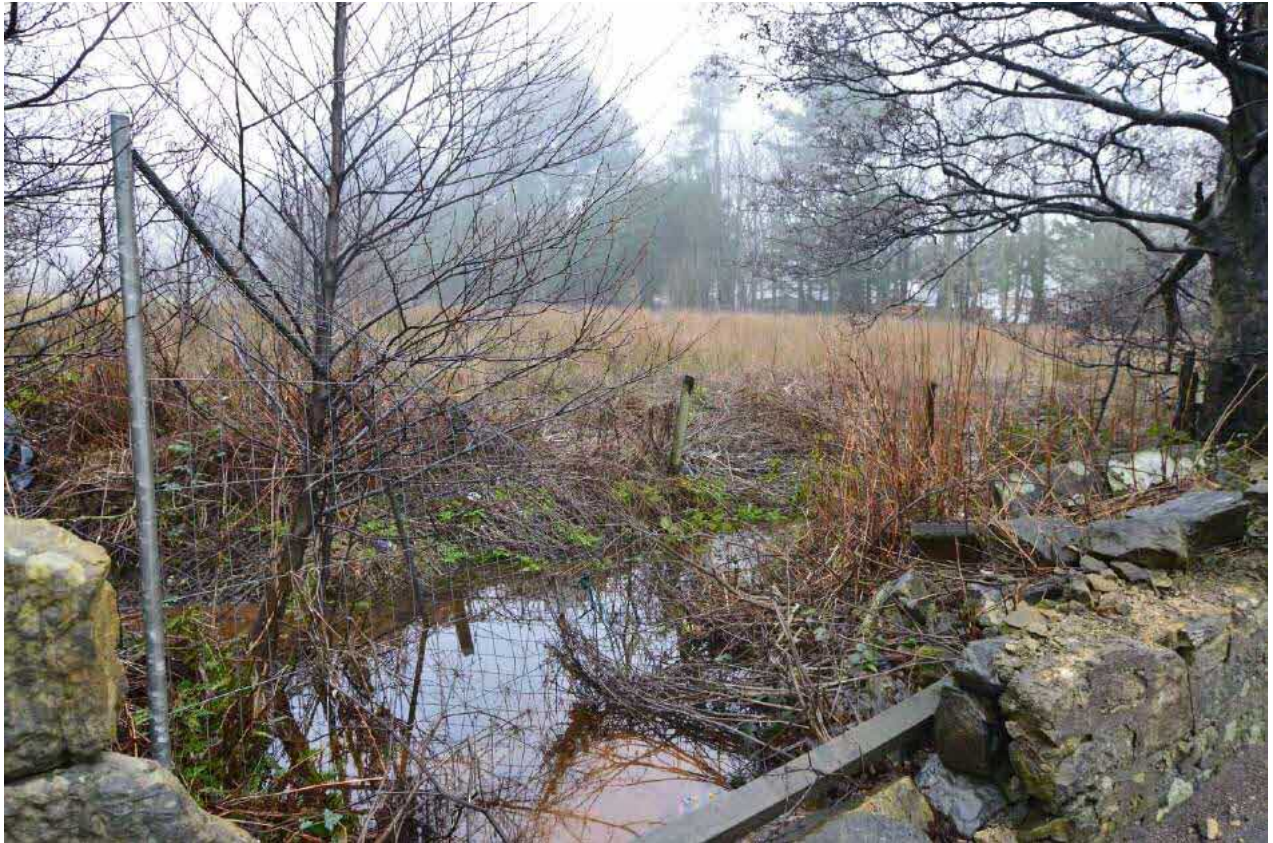
**Plate 7: Source of A78 flooding.
Photograph taken from NS 21050 56336.**

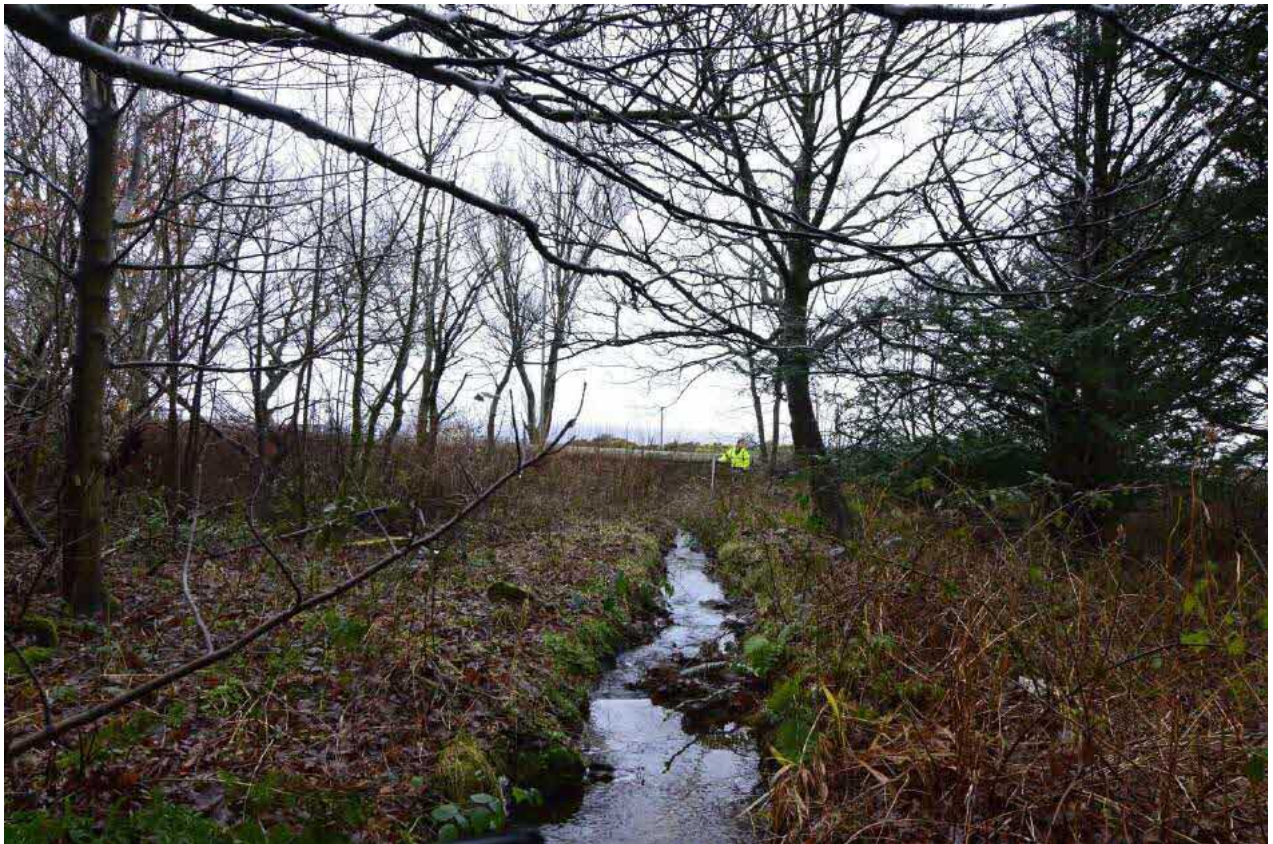
- 3.4 The constraint to fluvial flow at the site is the culvert intake (plates 8 and 9). This has an ID of 0.55 m which provides a cross-sectional area of 0.2 m². This is significantly smaller than the minimum cross-sectional area of the open channel which from the site visit and the topographical survey⁽⁴⁾ was estimated to be in excess of 5.0 m². Even when taking into consideration the higher roughness of the open channel and the slightly lower slope it provides significant capacity to convey the maximum discharge from the culvert.

**Plate 8: Subject watercourse upstream of A78 culvert intake.
Photograph taken from NS 21065 56283.**

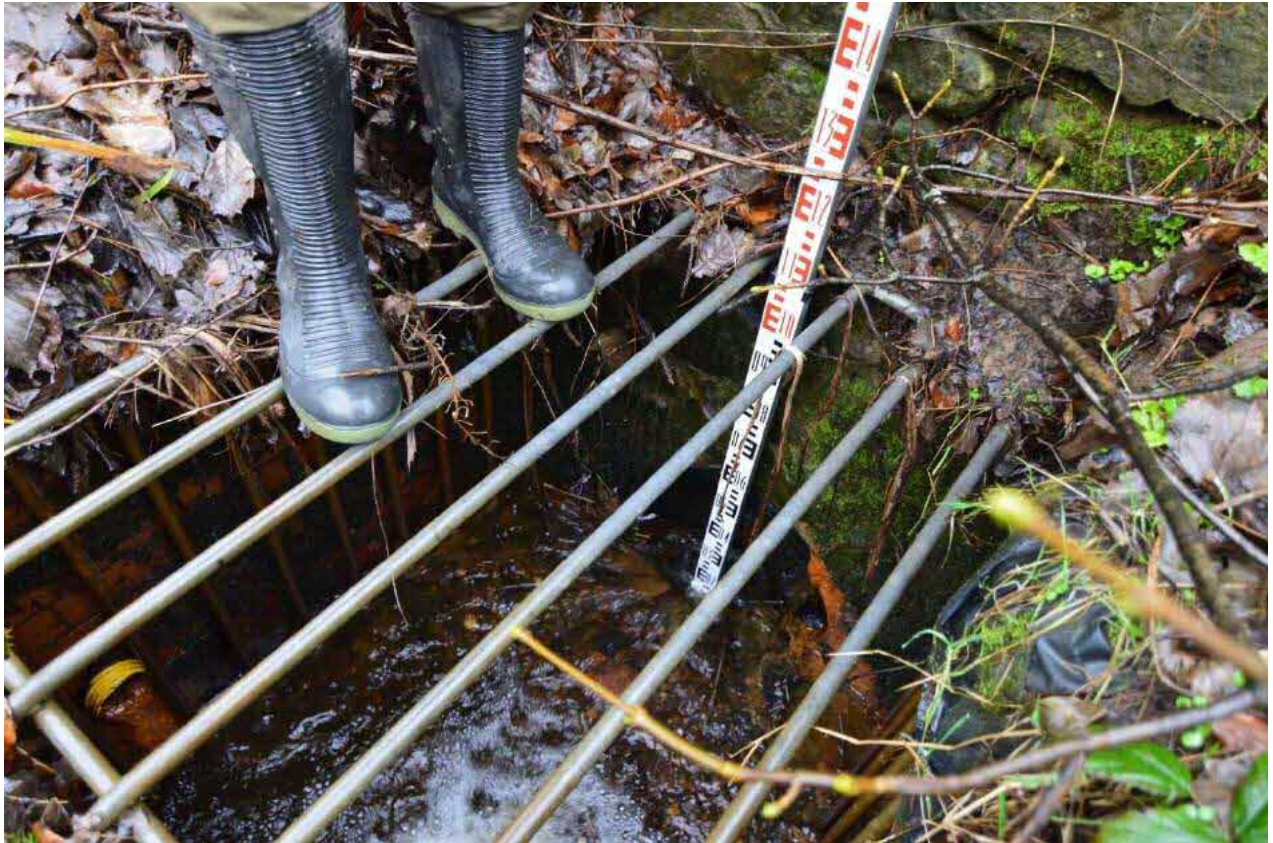
- 3.2 Flow from the catchment enters a 0.55 m ID circular pipe (plate 9) which travels beneath the A78/cycle track and discharges into the open channel (plate 13) towards the north end of the proposed development site (plates 14 to 17). Somewhere beneath the A78/cycle track the 0.55 m ID pipe connects into a 0.55 m H x 0.7 m W ID elliptical vitrified clay pipe which forms the outfall (plate 12).

Plate 9: A78 culvert intake (0.55 m ID pipe with corrugated inner walls and trash screen with circa 100 mm spaced bars). Top of wall is c. 2.2 m above screen. Photograph taken from NS 21040 56284.

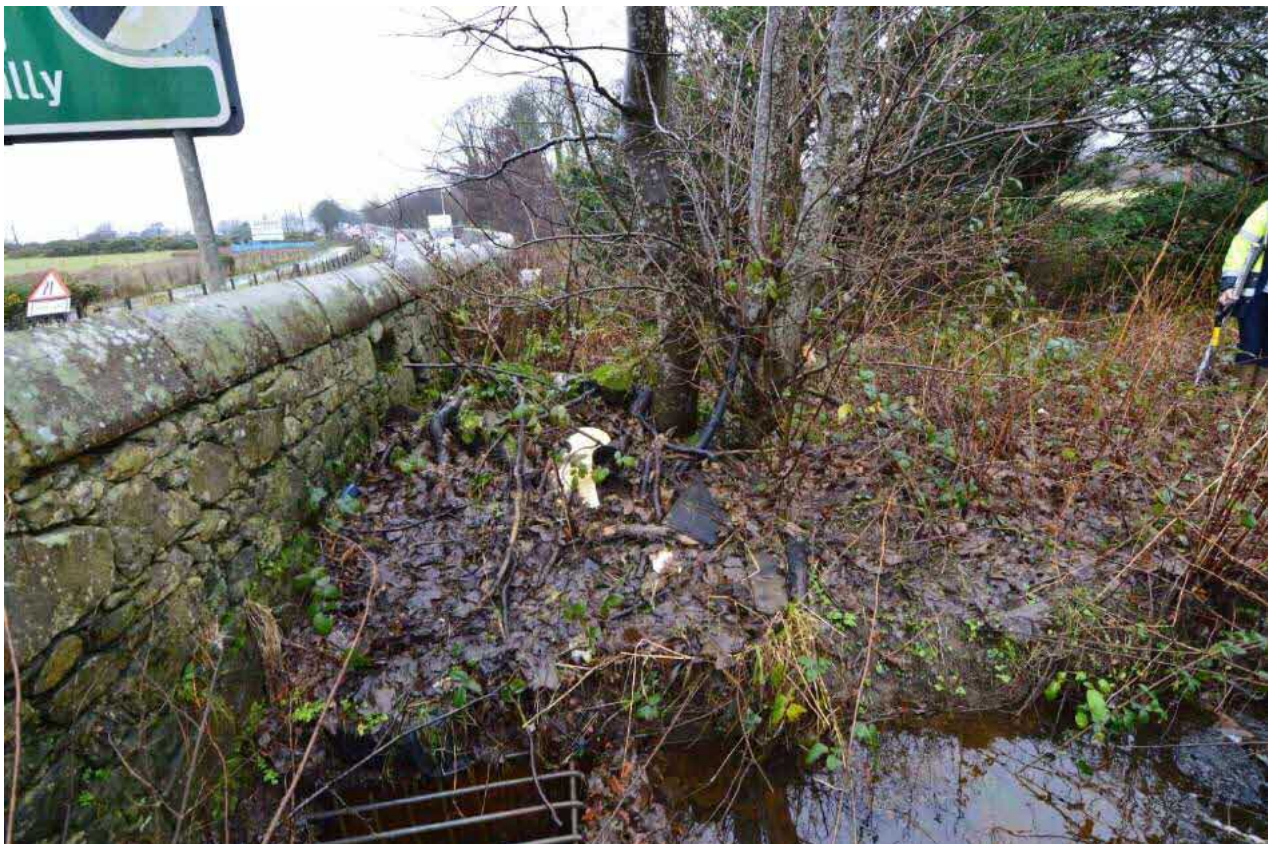
- 3.5 Should the culvert intake be surcharged during a 1:200 year event the flood water will flow north down a steep incline into the field shown in plate 11. The location where flood water would overtop the north bank which is at lower elevation than the south is shown in plate 10.

Plate 10: Watercourse at A78 culvert intake. Flow route during surcharge will be north into adjacent field (next plate). Photograph taken from NS 21040 56283.

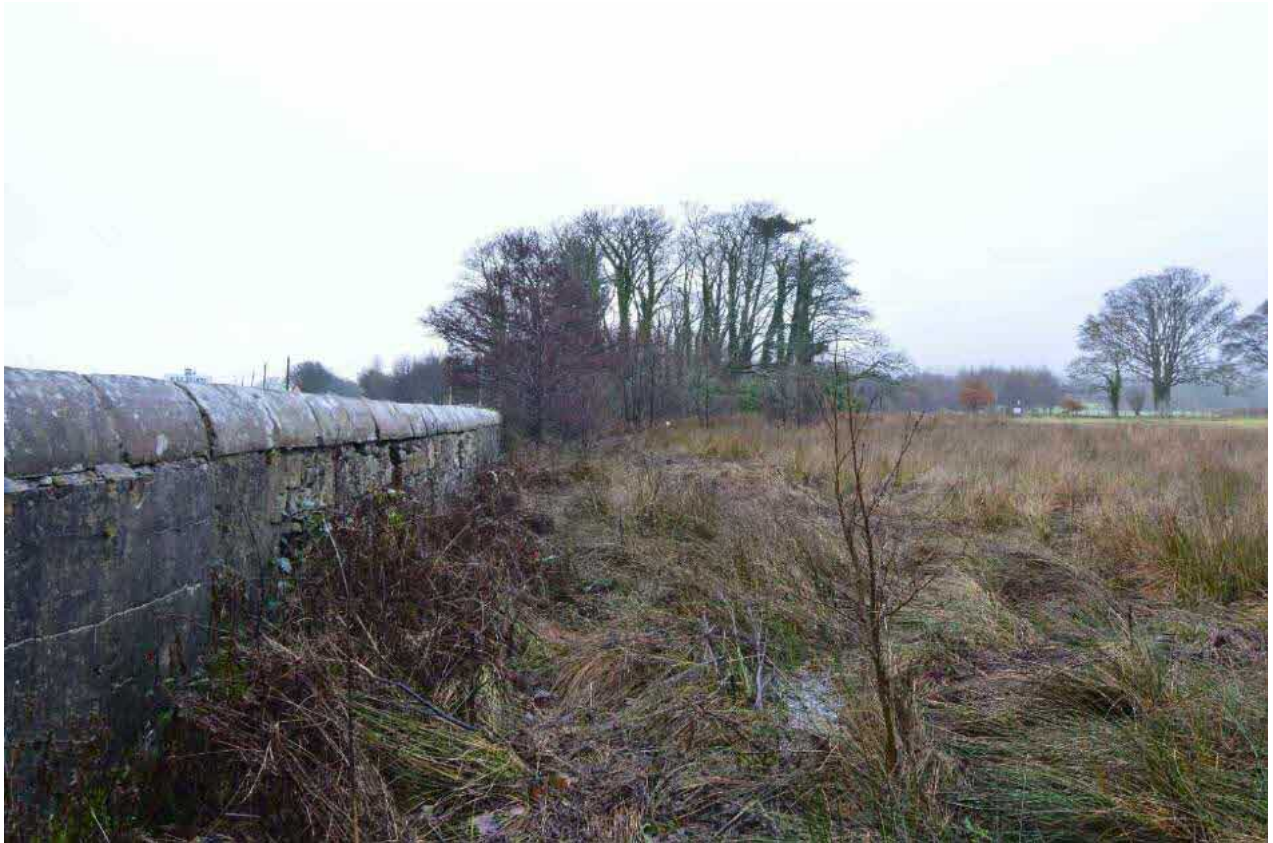
Plate 11: Adjacent field.
Photograph taken from NS 21044 56295.

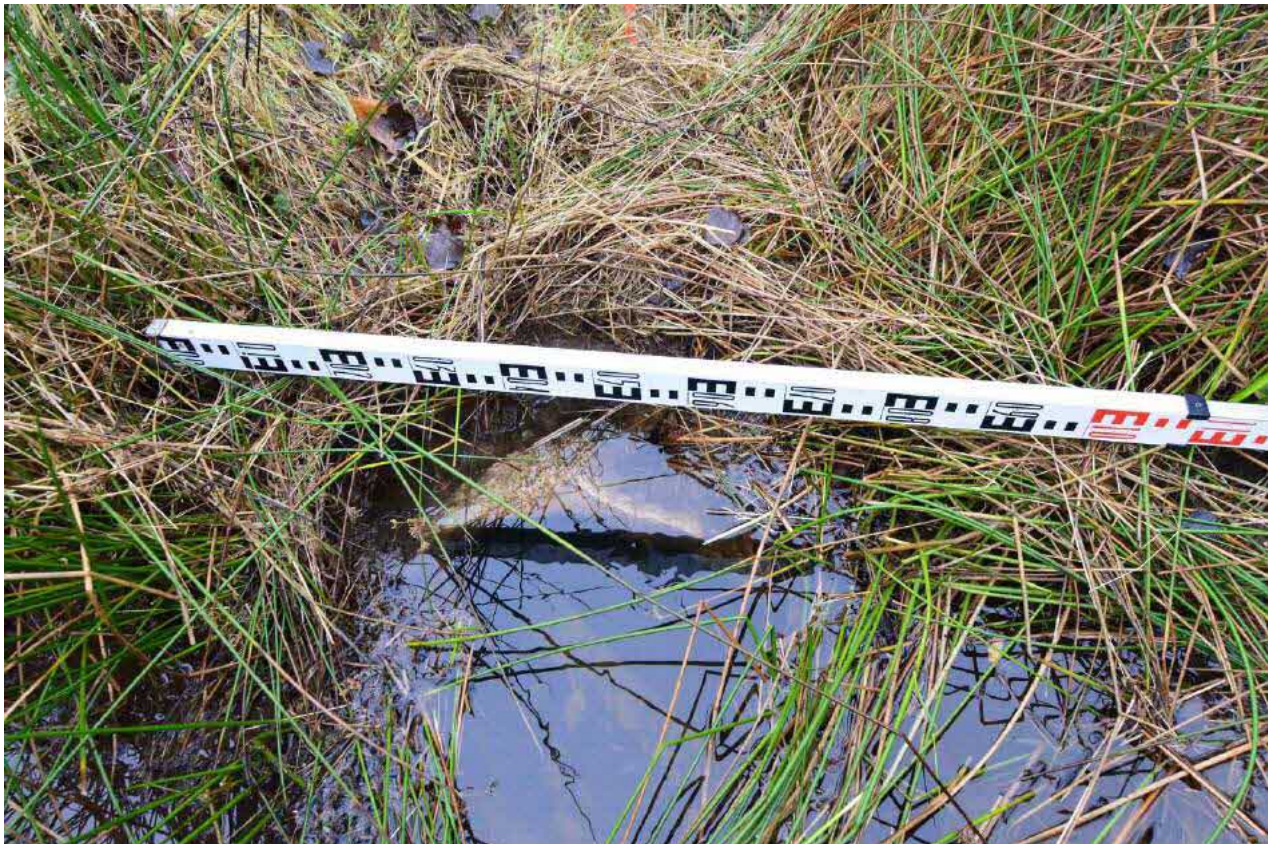
Plate 12: Culvert outfall (ID: 0.55 m H x 0.7 m W elliptical VCP pipe).
Photograph taken from NS 21022 56291.

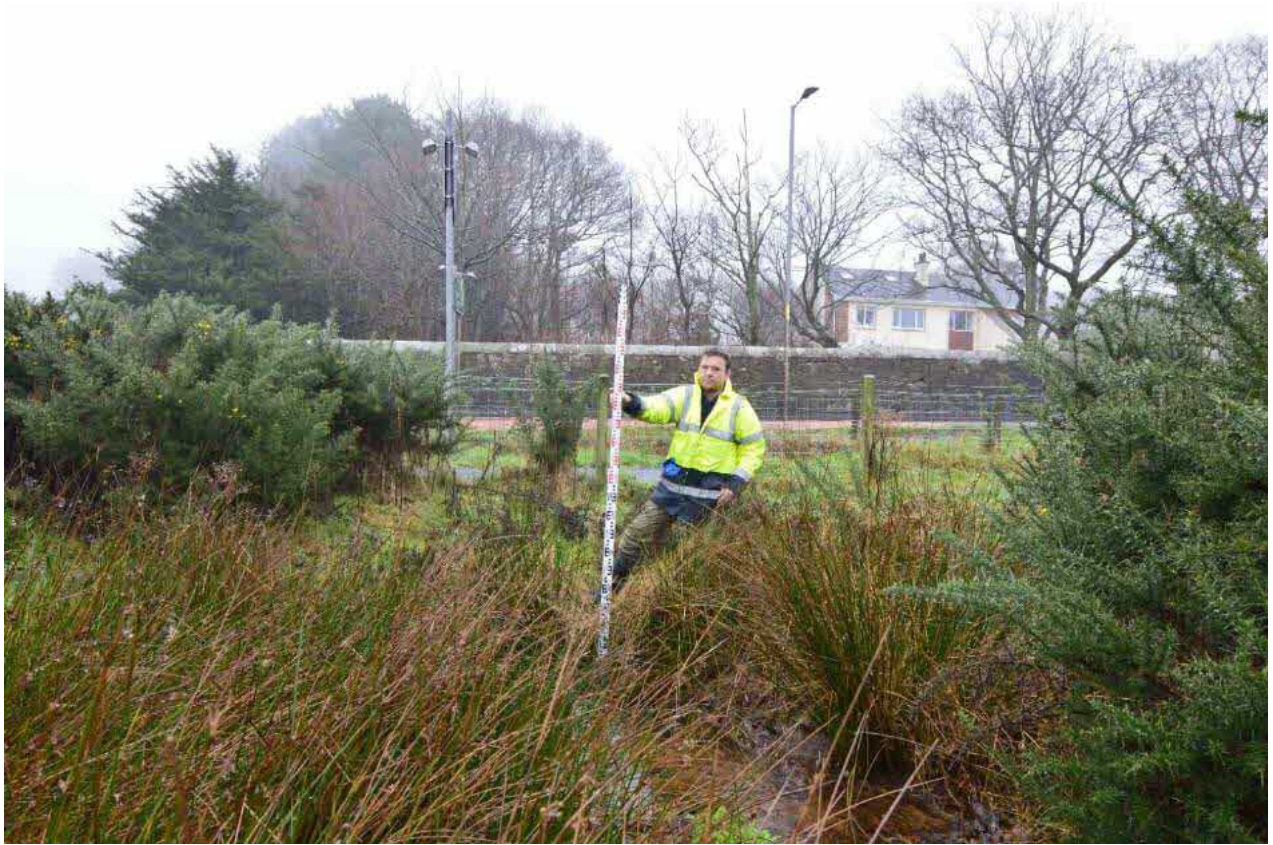
**Plate 13: Channel of subject watercourse at culvert outfall.
Photograph taken from NS 21018 56294 looking upstream.**

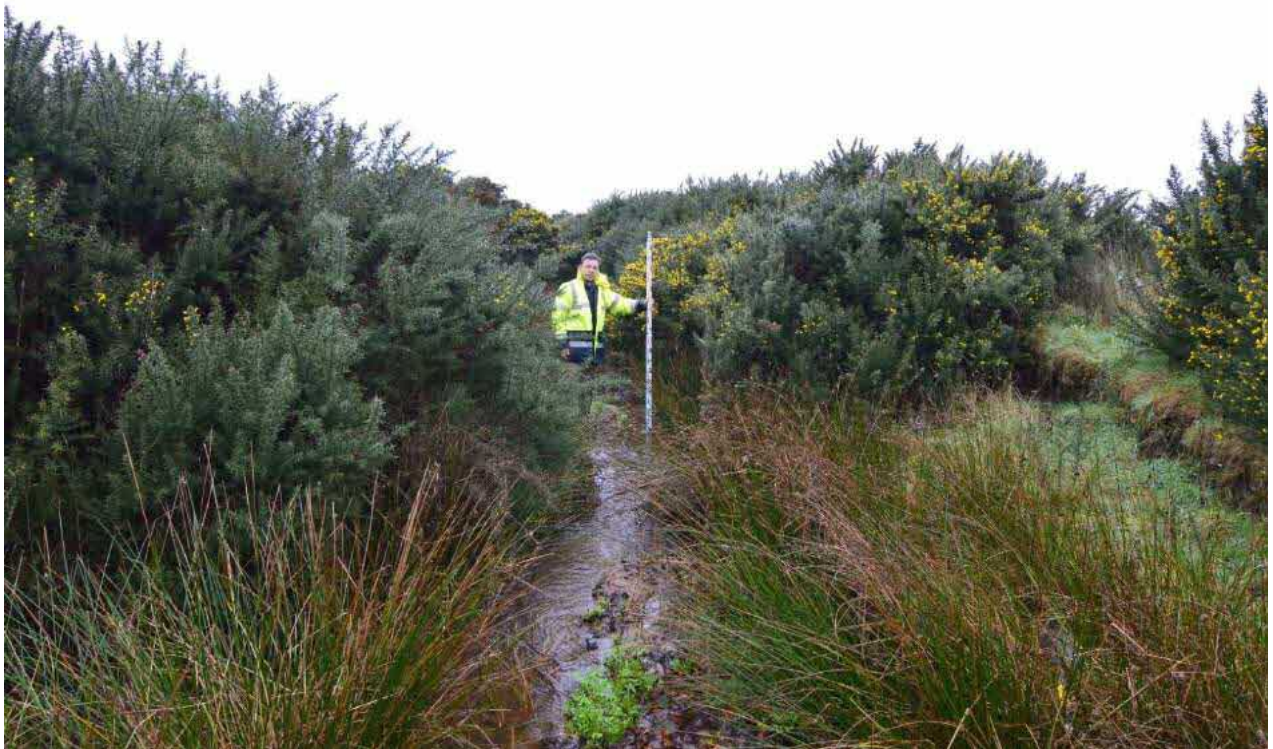
**Plate 14: Channel of subject watercourse downstream of culvert outfall.
Photograph taken from NS 21024 56293 looking downstream.**

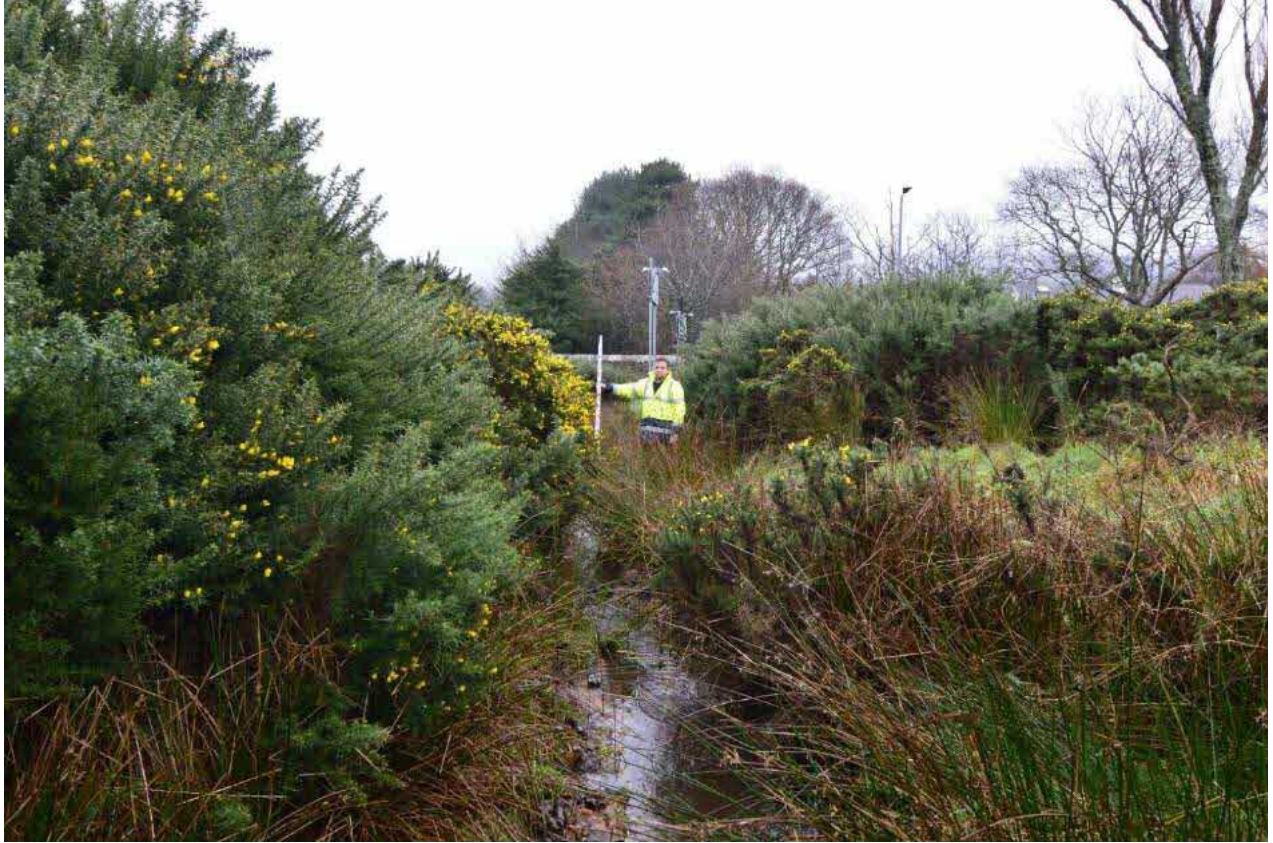
Plate 15: Channel of subject watercourse.
Photograph taken from NS 21008 56295 looking upstream. Staff in same location as plate above.

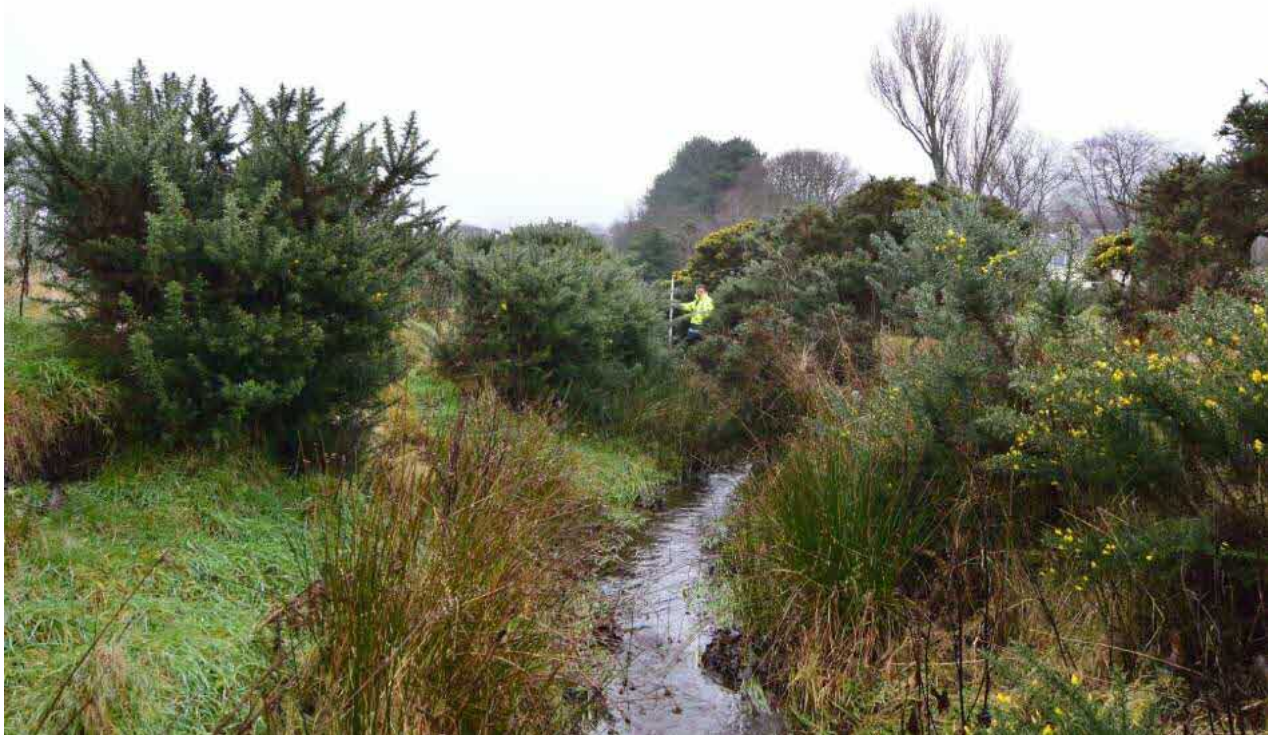
Plate 16: Channel of subject watercourse.
Photograph taken from NS 20977 56296 looking upstream.

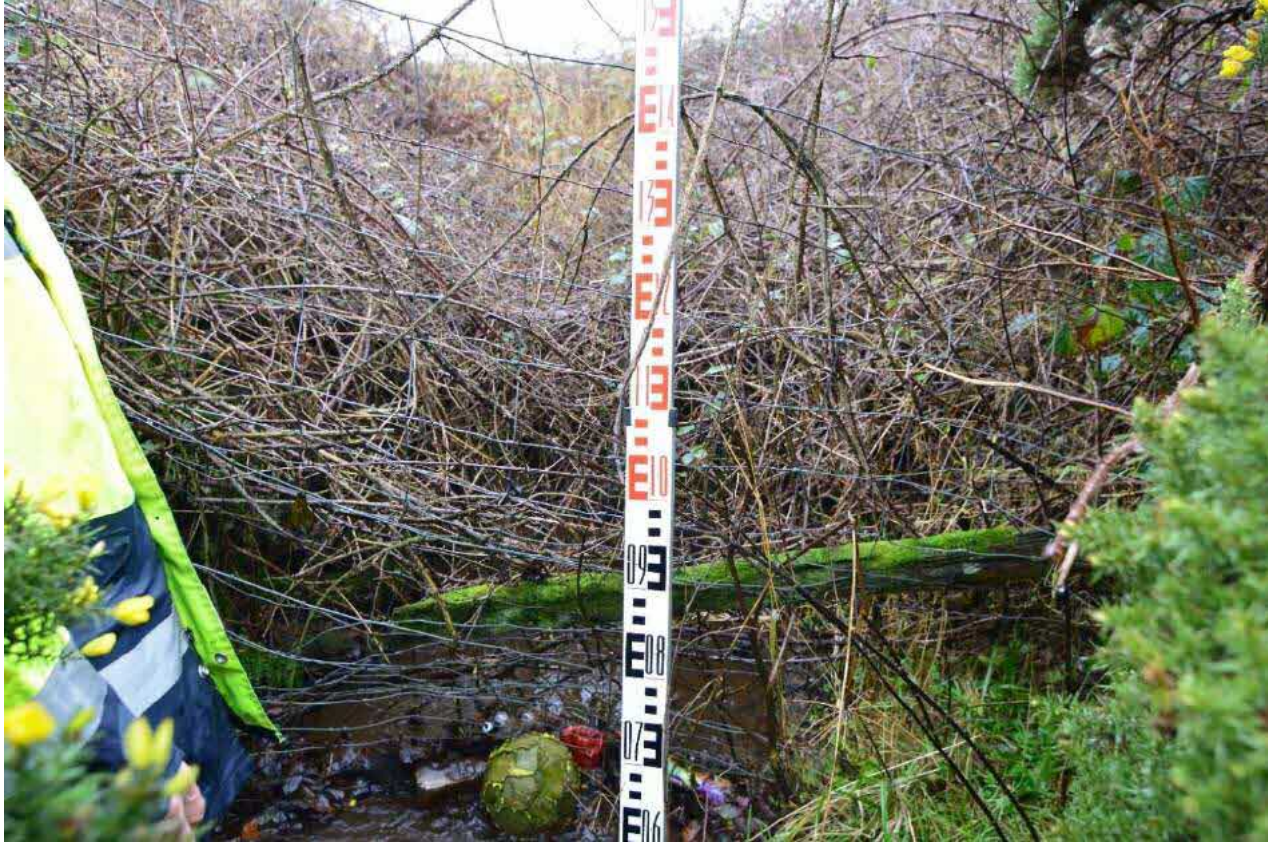
**Plate 17: Channel of subject watercourse in front of railway line culvert.
Photograph taken from NS 20965 56296 looking downstream.**
