Planning & Heritage Statement

3 The Rookery, Eye IP23 7AR

Replacement of damaged / cracked roof tiles, hip & ridge tiles, replacement of rotten roof battens, re-pointing of chimney stacks and new lead flashings

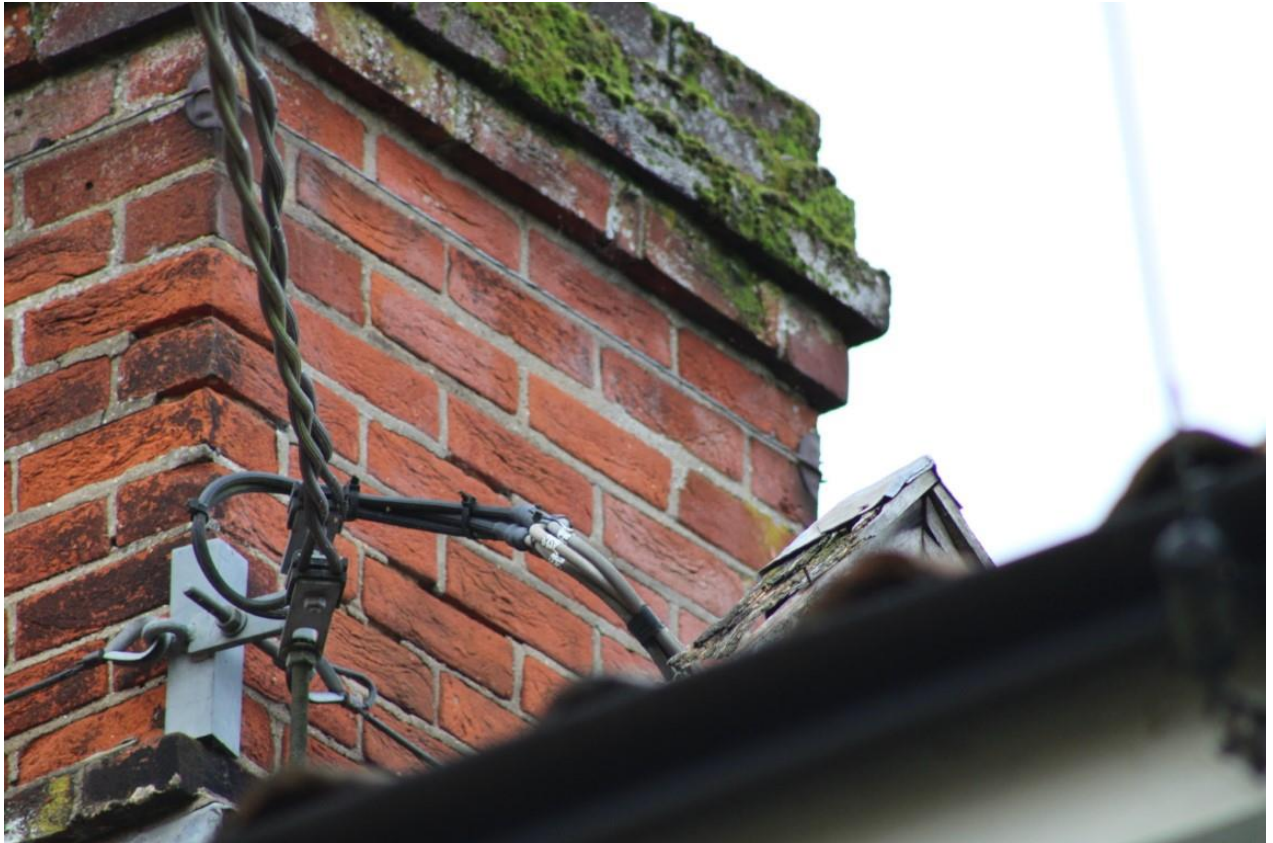
The chimneys have been previously repointed with inappropriate mortar which is now failing and falling out in places. These works will include the removal of the loose and incorrect pointing and repointing the chimneys with hydrated lime mortar with flush or slightly recessed jointing.

The front chimney stack viewed from the front, cement pointing between the bricks.

- Supply scaffold to allow for safe access to the working area.
- Rake out any mortar joints that require attention on the chimneys. We will then re-point with hydrated lime mortar.

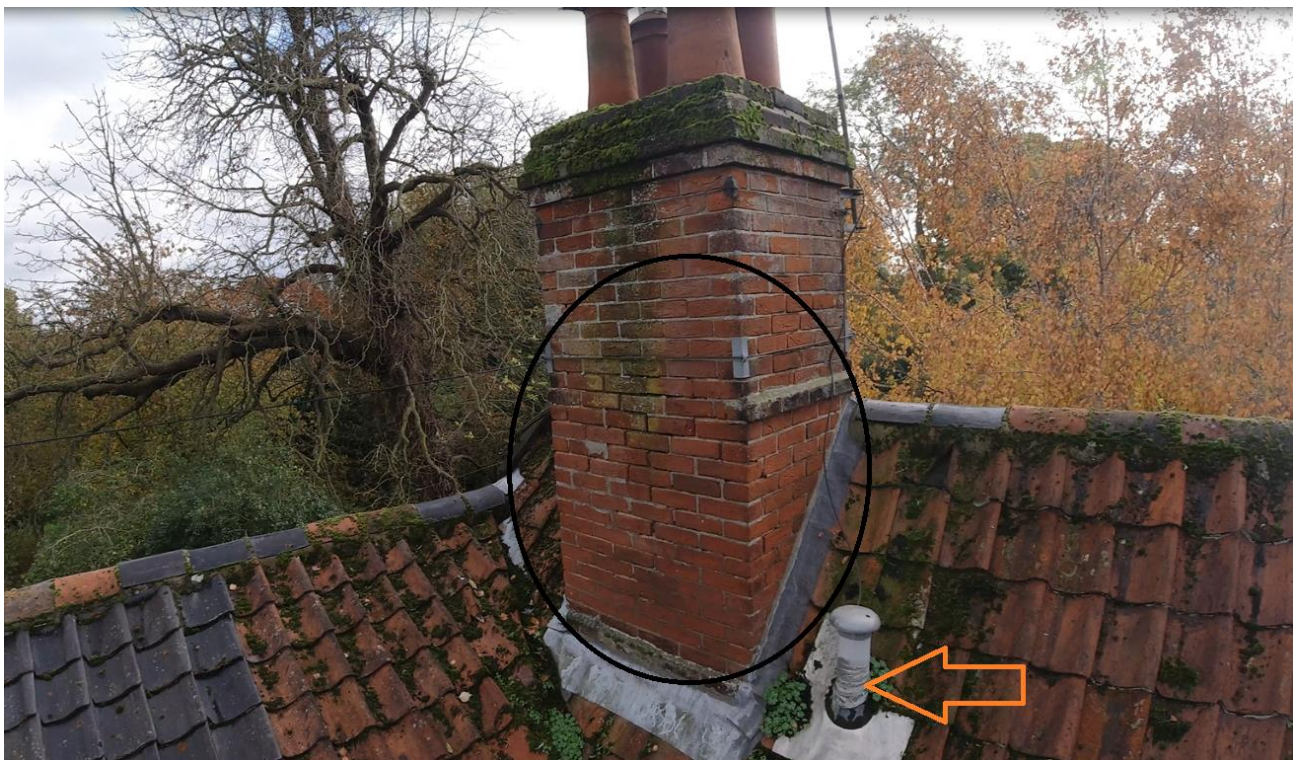
The chimney stack from the rear, and the damaged soil vent pipe.

- Clear out the roof valley and inspect. We will then be re-pointed using lime mortar.
- Fabrication and installation of new lead slate to flash the existing SVP.

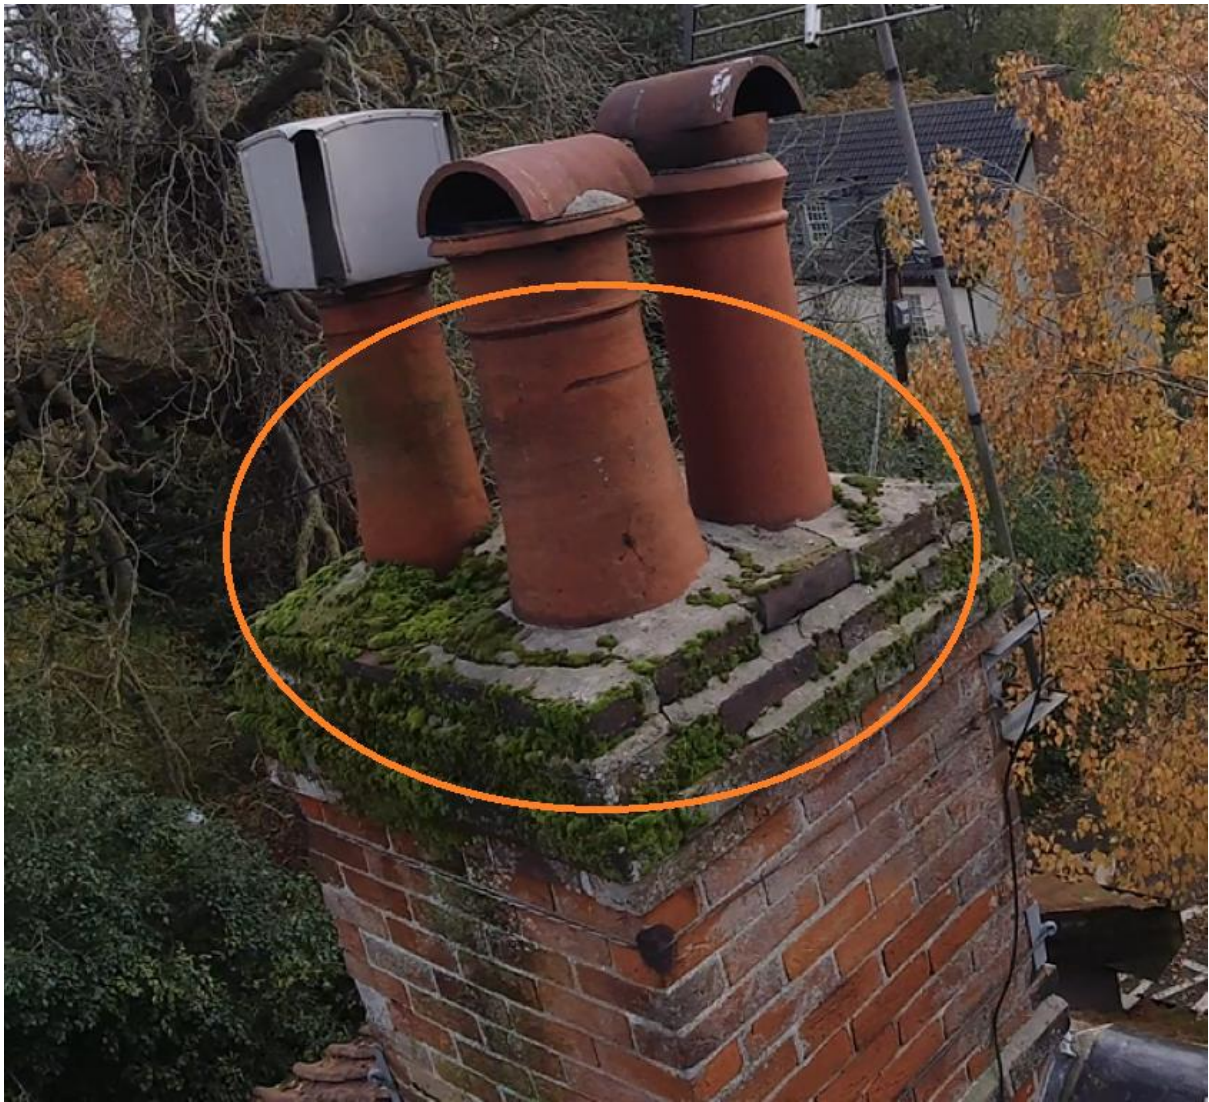
The concrete cap to the top of the main chimney stack.

- Re-flaunch the chimney caps using the same hydrated lime mortar mix. A new pot will be supplied and fitted to one chimney along with new cowls.
- Assess the condition of the concrete in-fills and if the brick can be replaced/repairs we will do so.

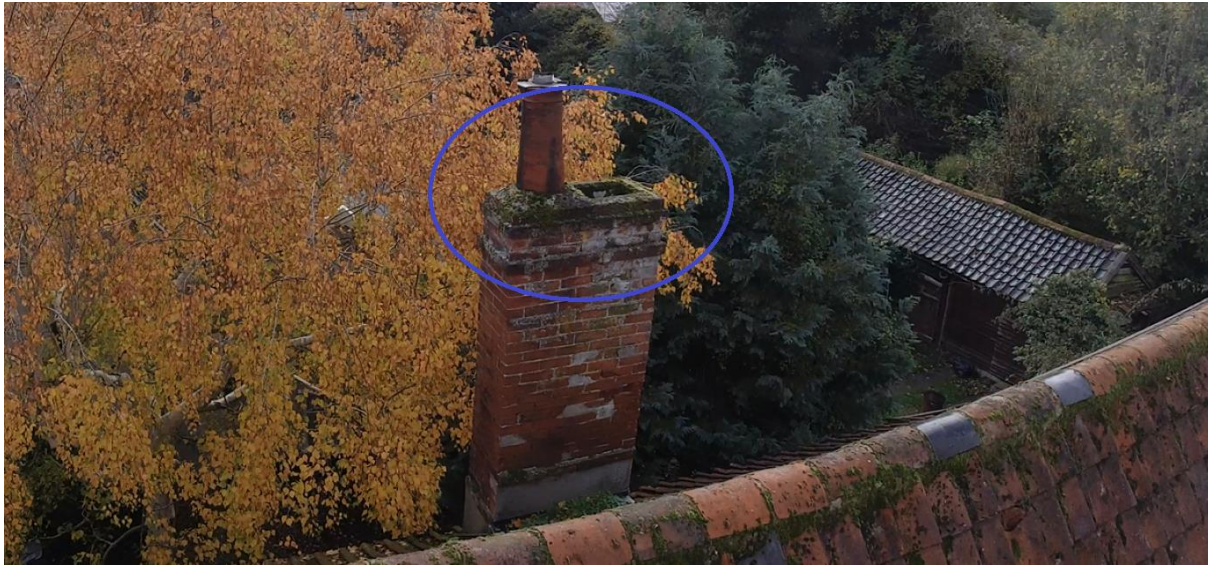
The rear chimney stack, with an open flue.

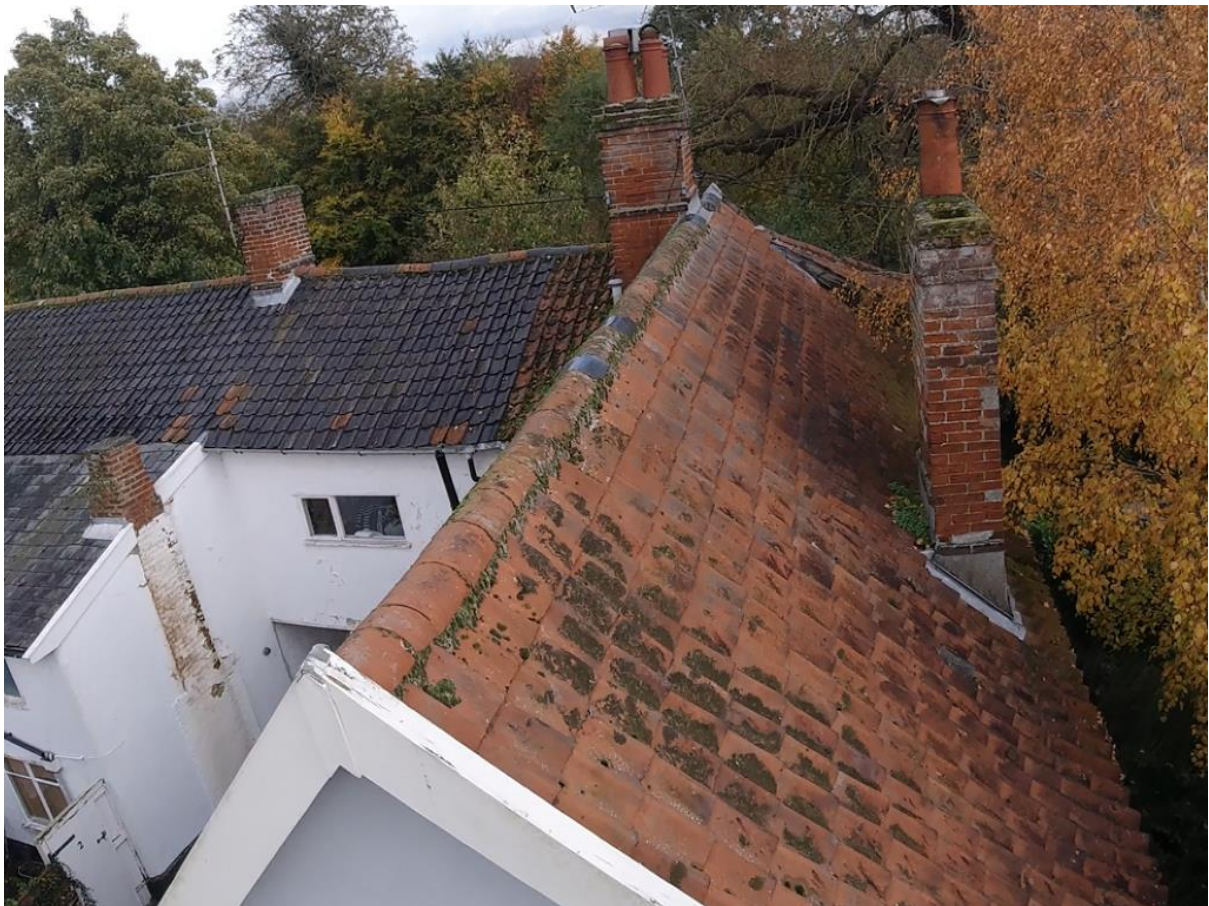
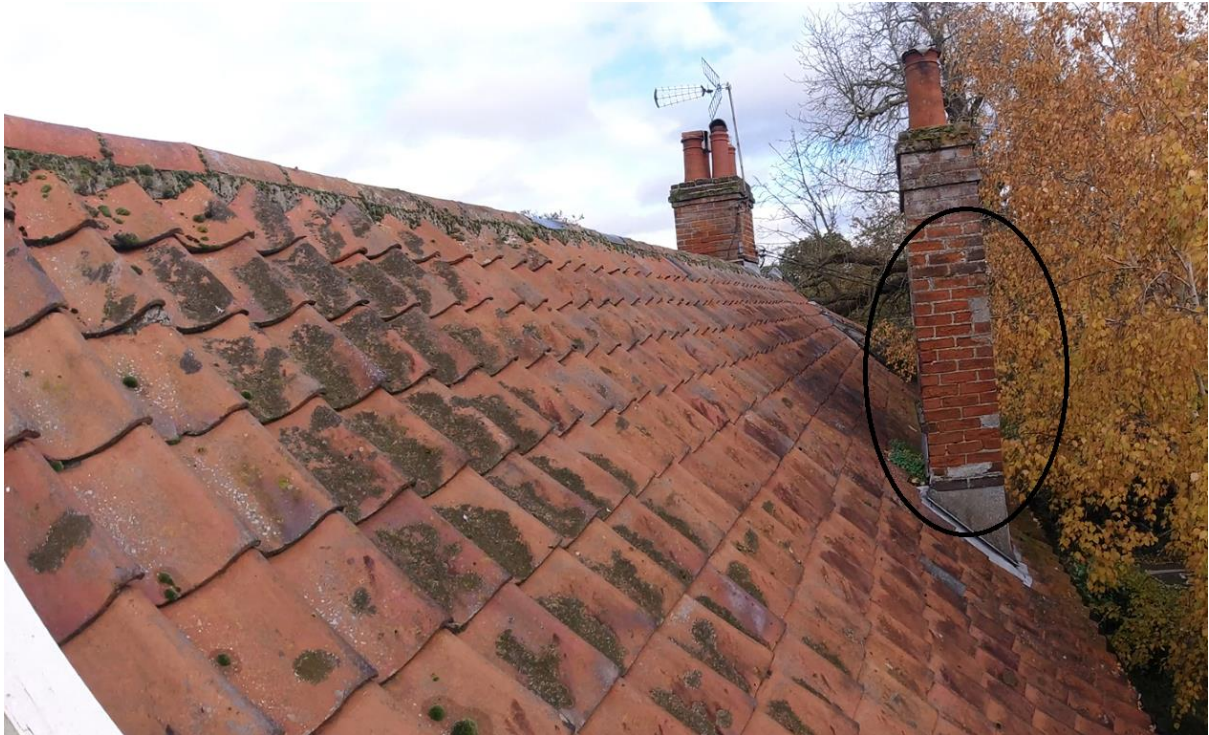
Concrete infill to the rear chimney stack, due to weathered faces to the bricks.

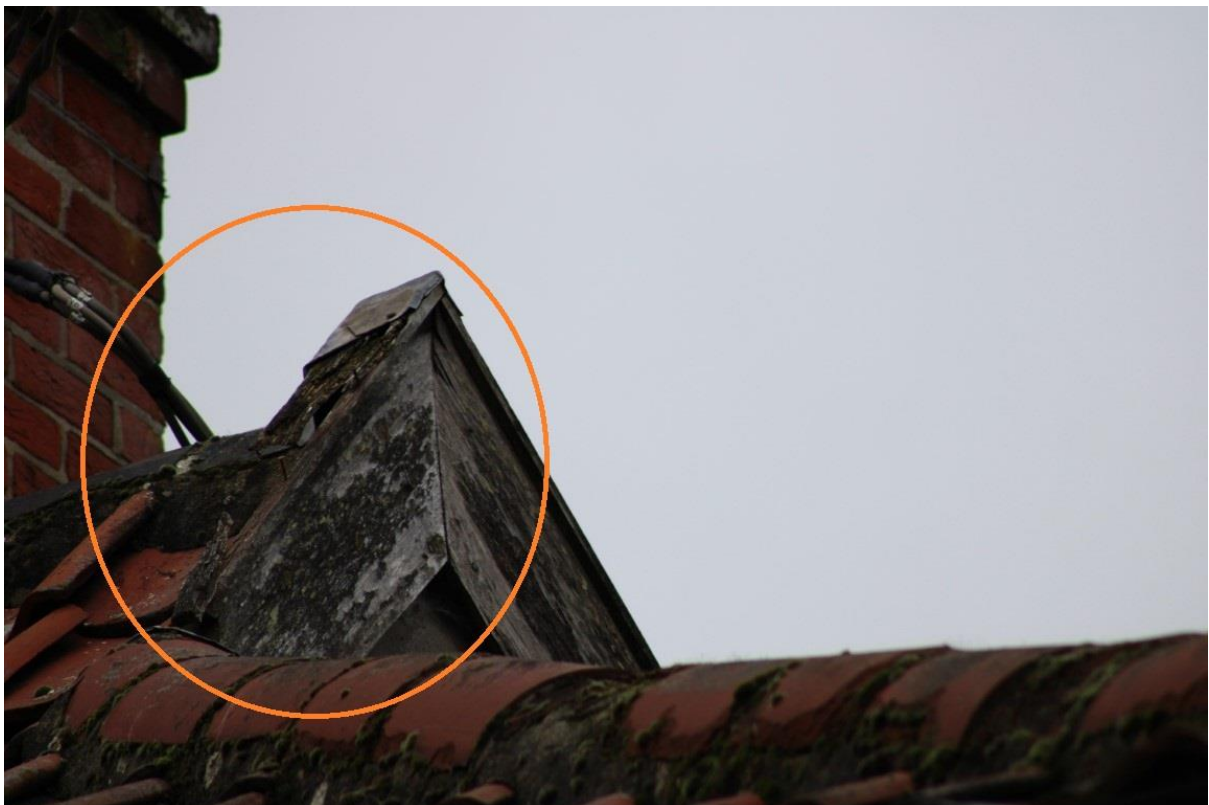
The front roof, rotted timber trim.

- Replace the timber to the gable end at the front of the property with new PSE timber finished in a black barn paint.
- Strip back the hip, keeping any tiles that are in an adequate condition. The hip will then be re-bedded using a hydrated lime mortar.

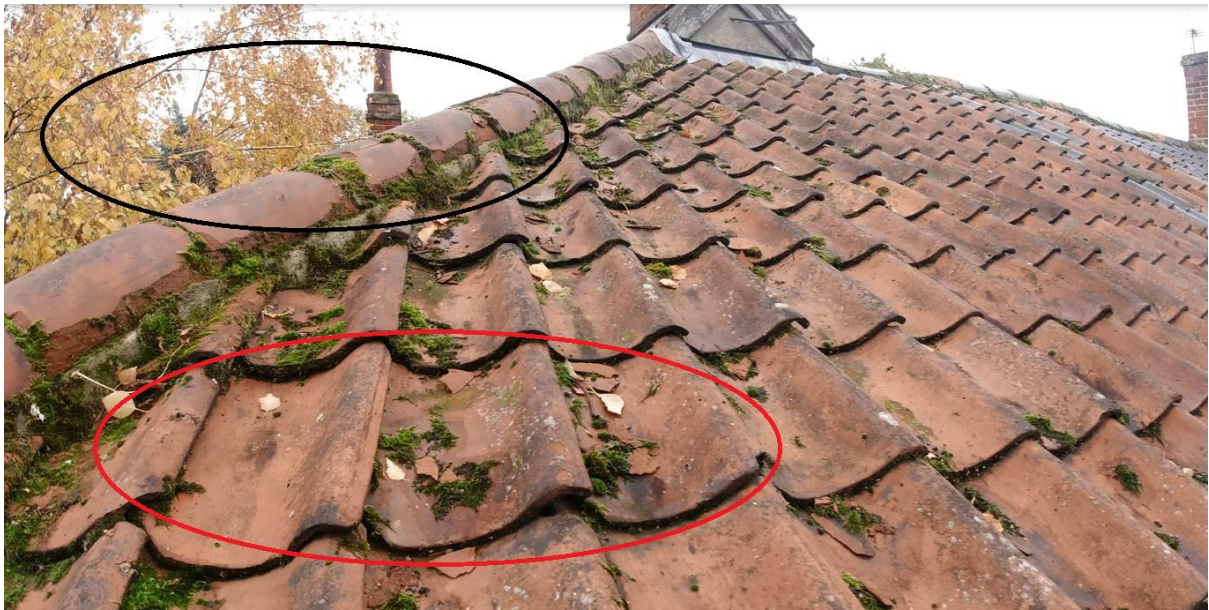
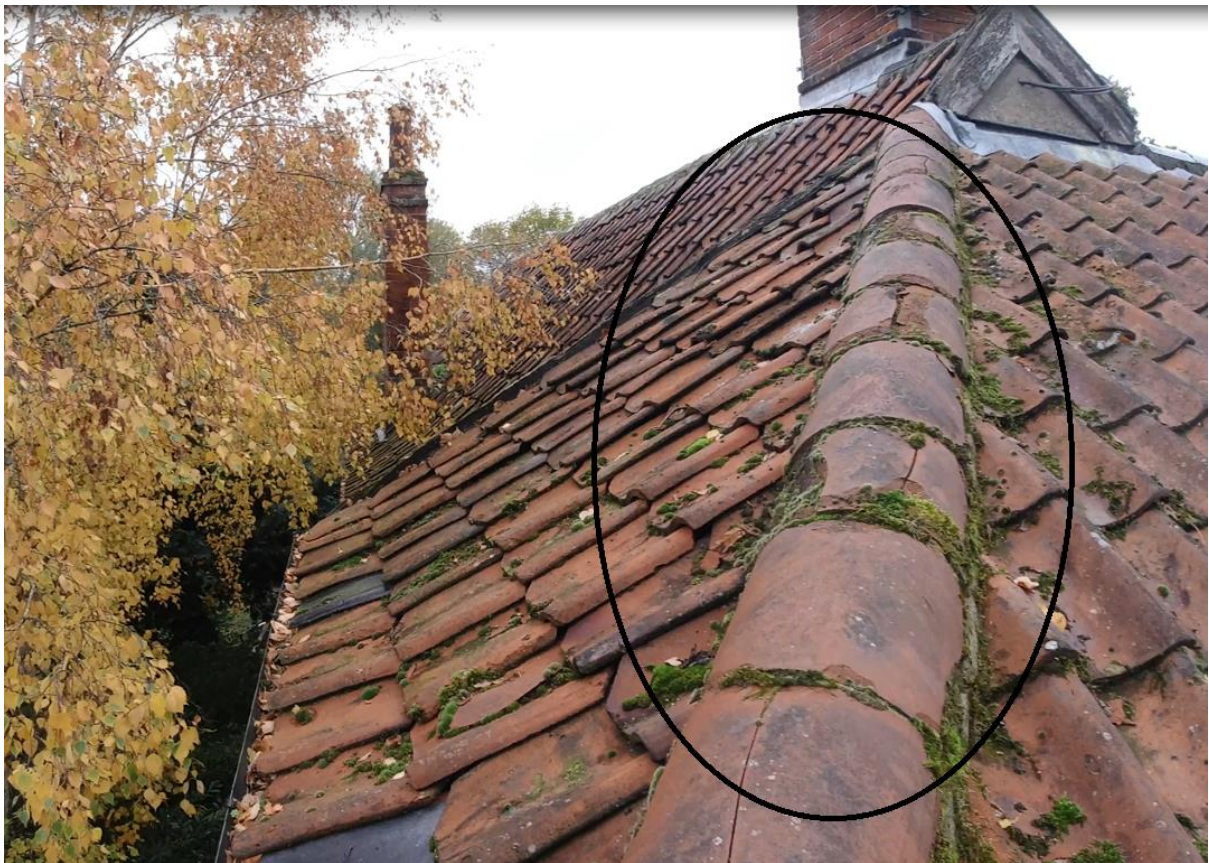
Damaged hip tiles to the front roof.

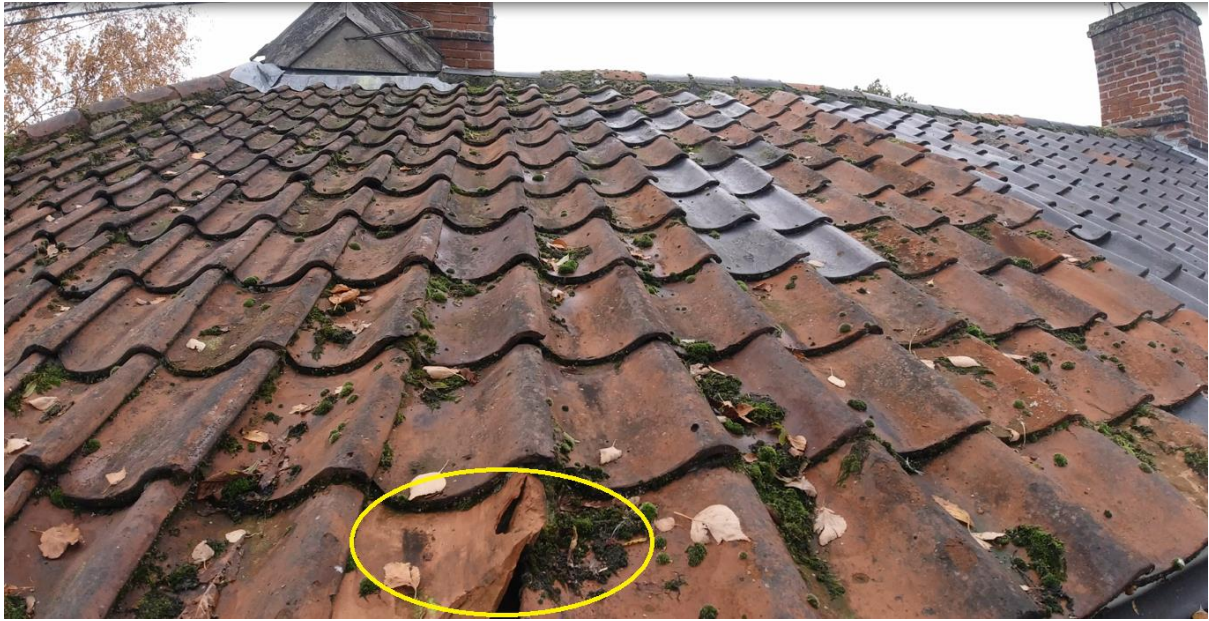
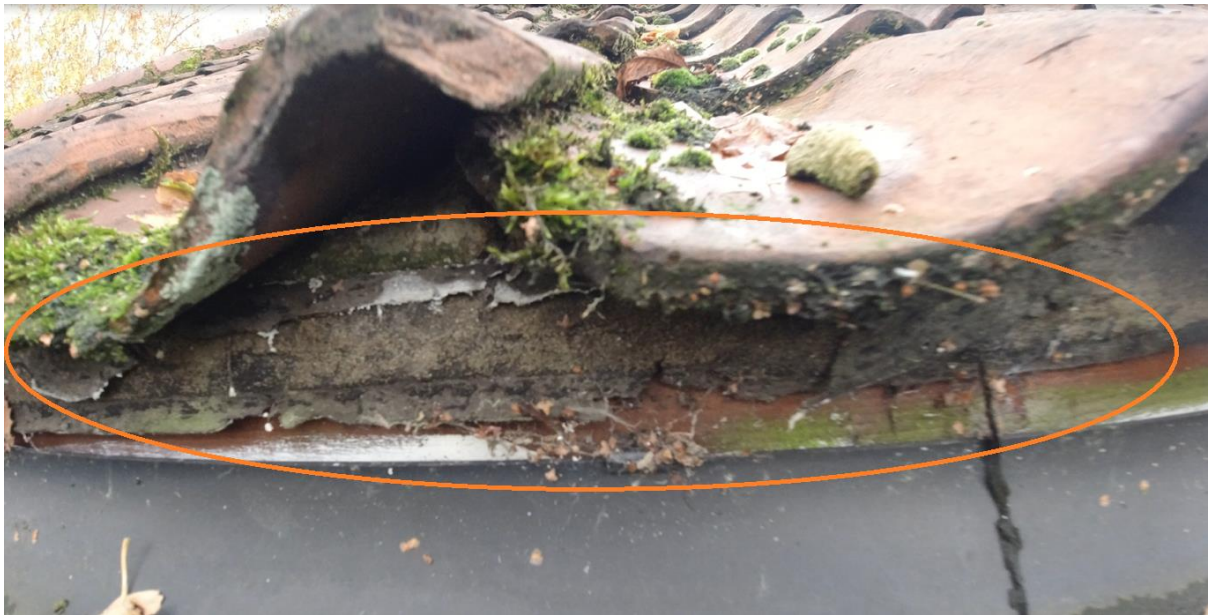
The proposed works entail the replacement of various broken and cracked roof tiles and hip / ridge tiles that have degraded over the years and are largely reaching the end of their natural life span. There are also pockets of rotten timber roof battens that are a result of the broken roof tiles and these battens are to be exposed and replaced with new treated timber battens.

Damaged tile and rotted underlay to the front roof.

- Inspect the eave felt and replace where necessary. Supply and fit of new felt support trays.
- Source and supply of 'like for like' reclaimed replacement tiles were needed.

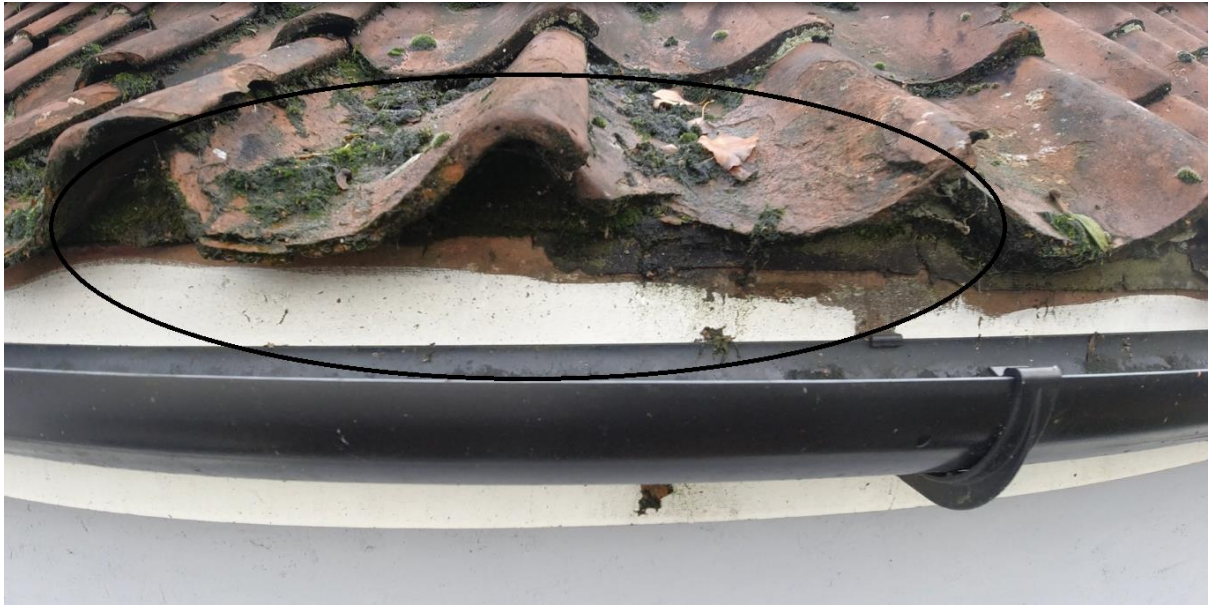
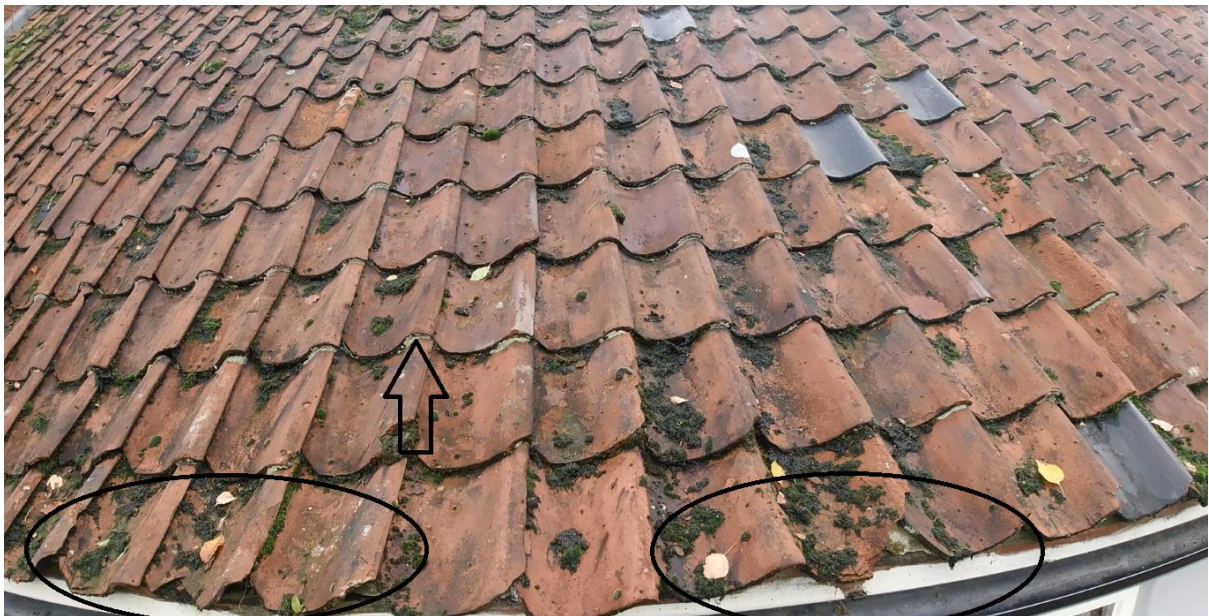
Damaged tiles to the rear roof. The arrow indicate the remains of mortar applied to the lower edges of the tiles as an attempt to reduce draughts under the tiles.

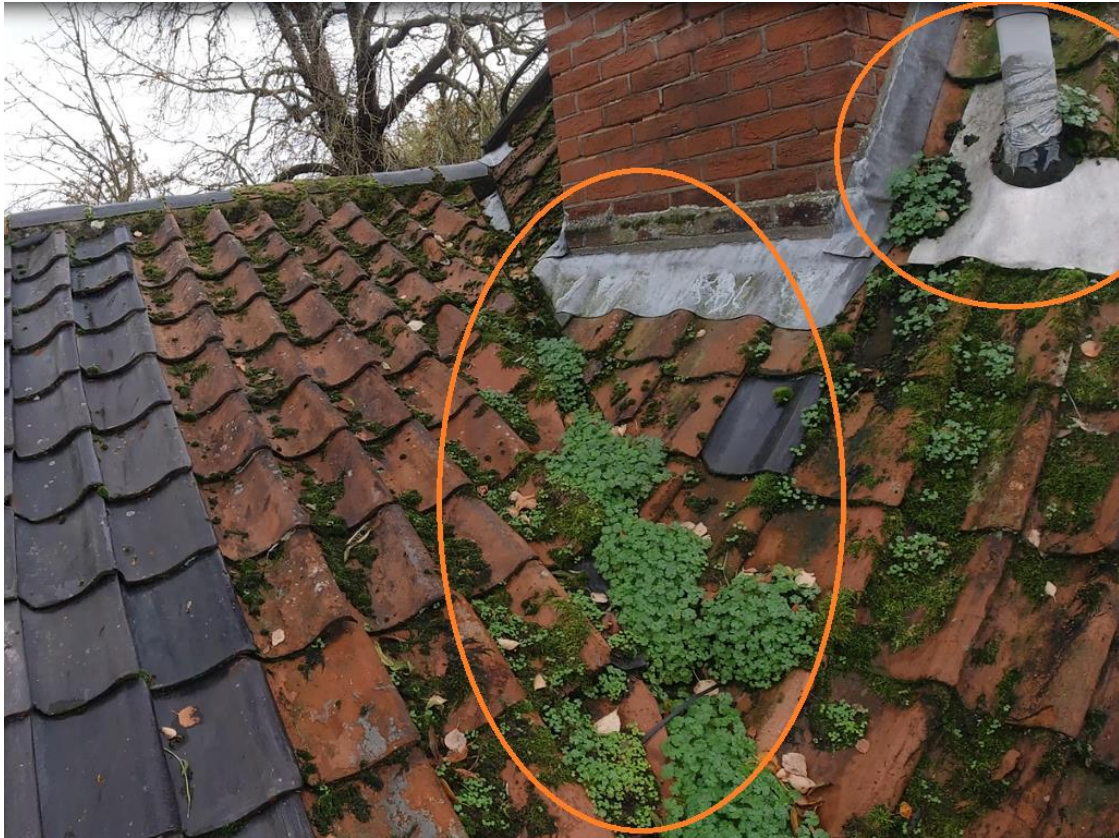
Debris to the roof valley.

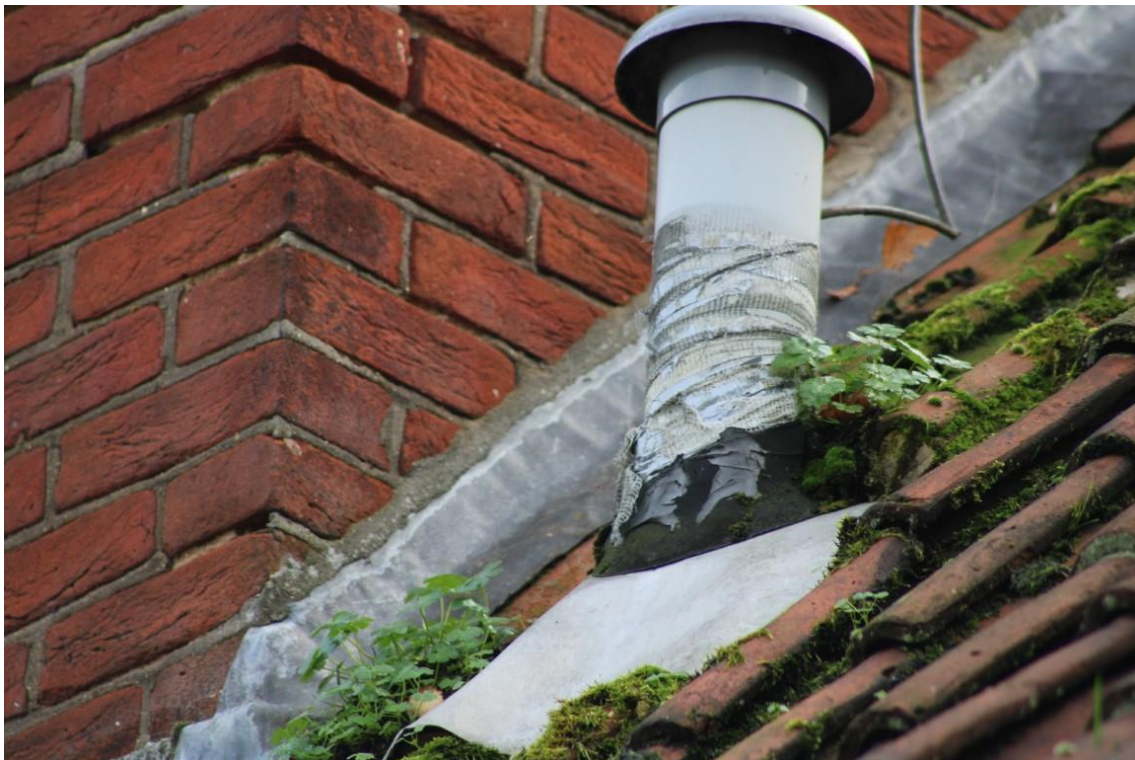
The taped up damaged soil vent pipe, and debris.
