Land front of 44 to 70 Molesworth Road
Stoke Plymouth
PL1 5PD

Prepared for: Mr D Preece
Prepared by: Kevin Johnson MBE
21 May 2021
Proposal number: v2

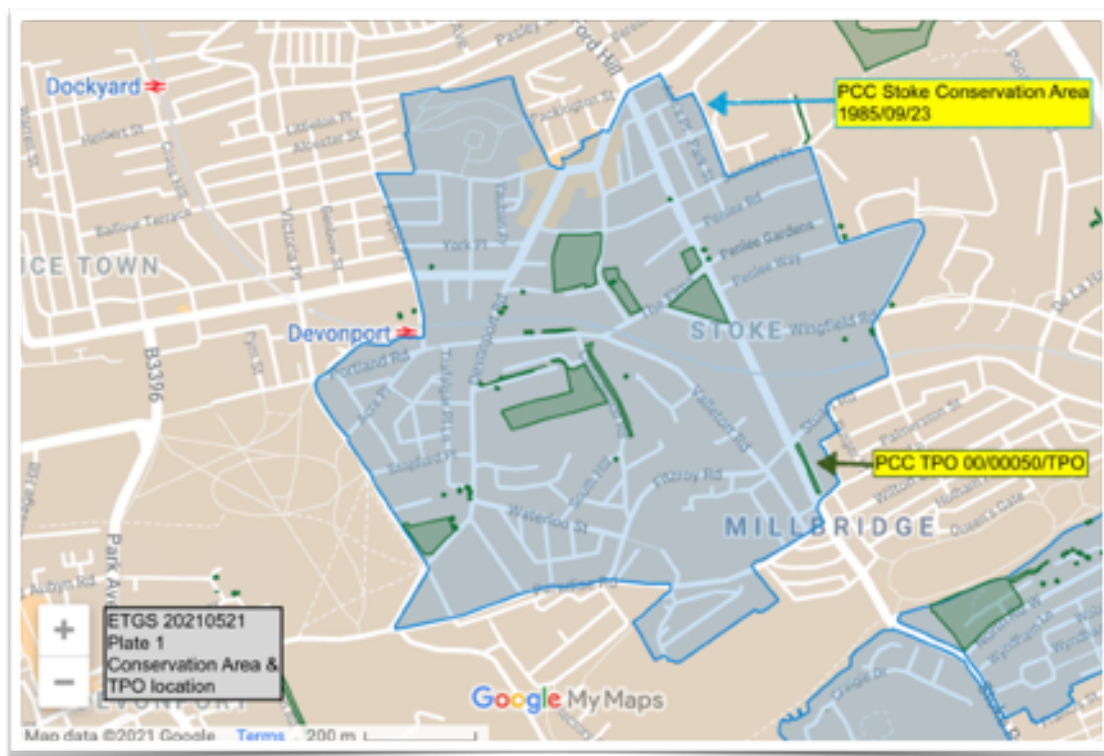
Desk top survey was conducted utilising PCC TPO mapping system (plate 1) but information available was limited and appeared contradictory (plate 1a.)

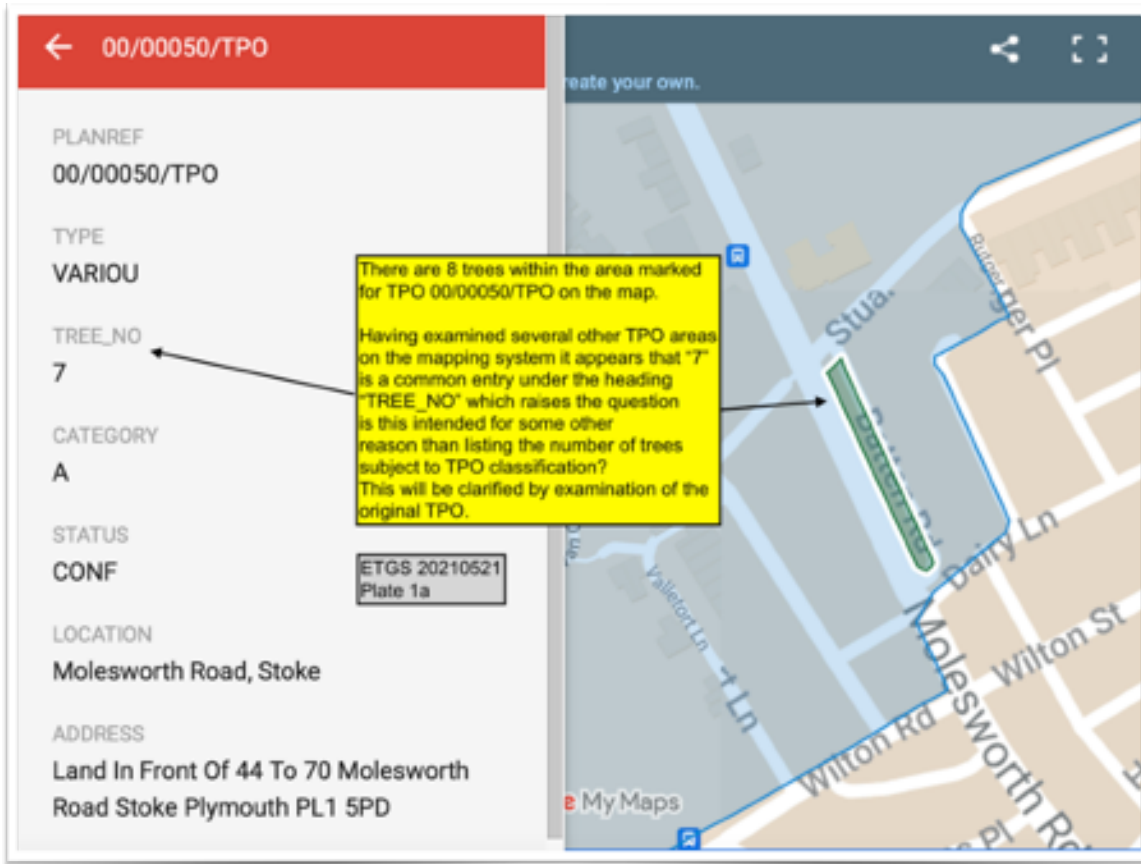
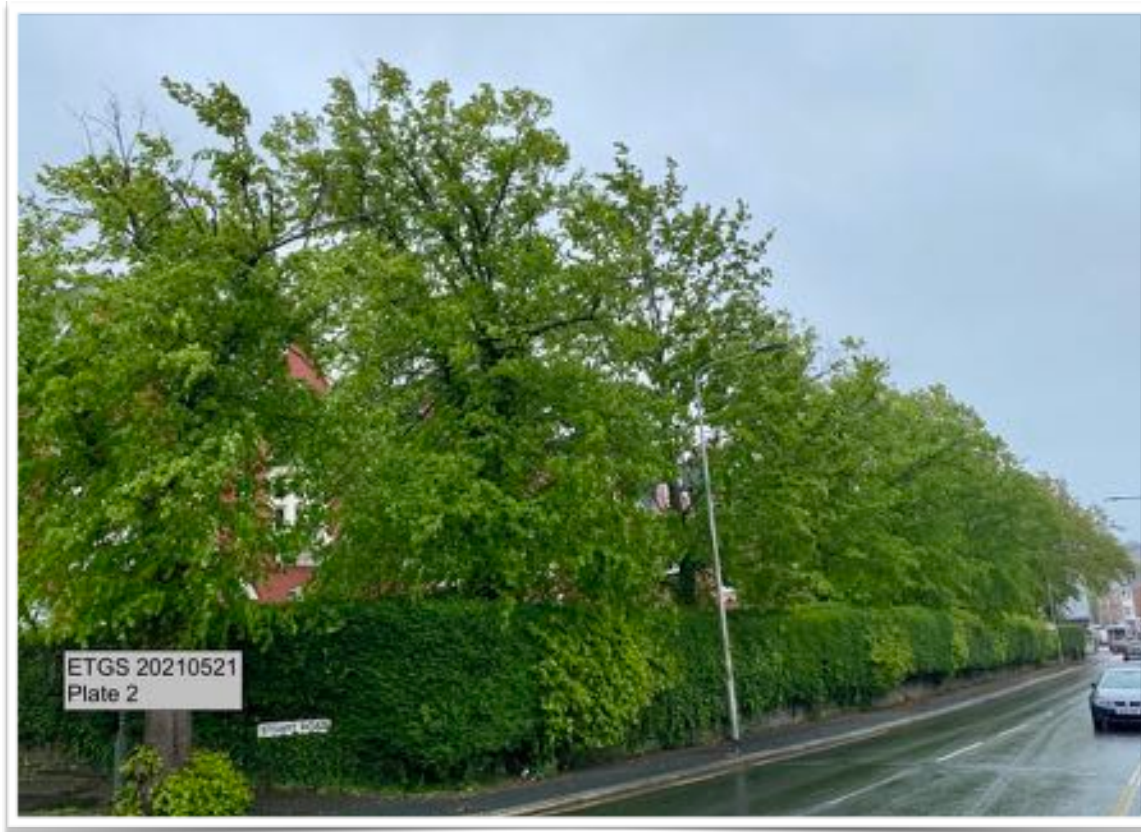
The tree(s) are immediately adjacent to a ground level change of +/- 1500mm (down) to the West which is formed with a stone and cement wall making the boundary with the metalled surface of the pedestrian footway alongside Molesworth Road (plate 2.) There is a margin of utility grass which extends to +/- 3000mm East and then gives way to compacted granular surface dressing used for car parking (plate 3.)

As a general observation, the Oak(s) were presenting uniform but potentially sparse early leaf formation (plate 4) and the Lime(s) were showing notable crown dieback (visible in plate 2) - likely attributable to the sub-optimal rooting environment.

- late pollard to suitable stem unions not exceeding 200mm as defined in Reference E (plus removal of basal epicormic) for the Lime,
- crown raise to achieve minimum 5.4m height clearance (plus 5m clearance from street lamps) for the Oak.

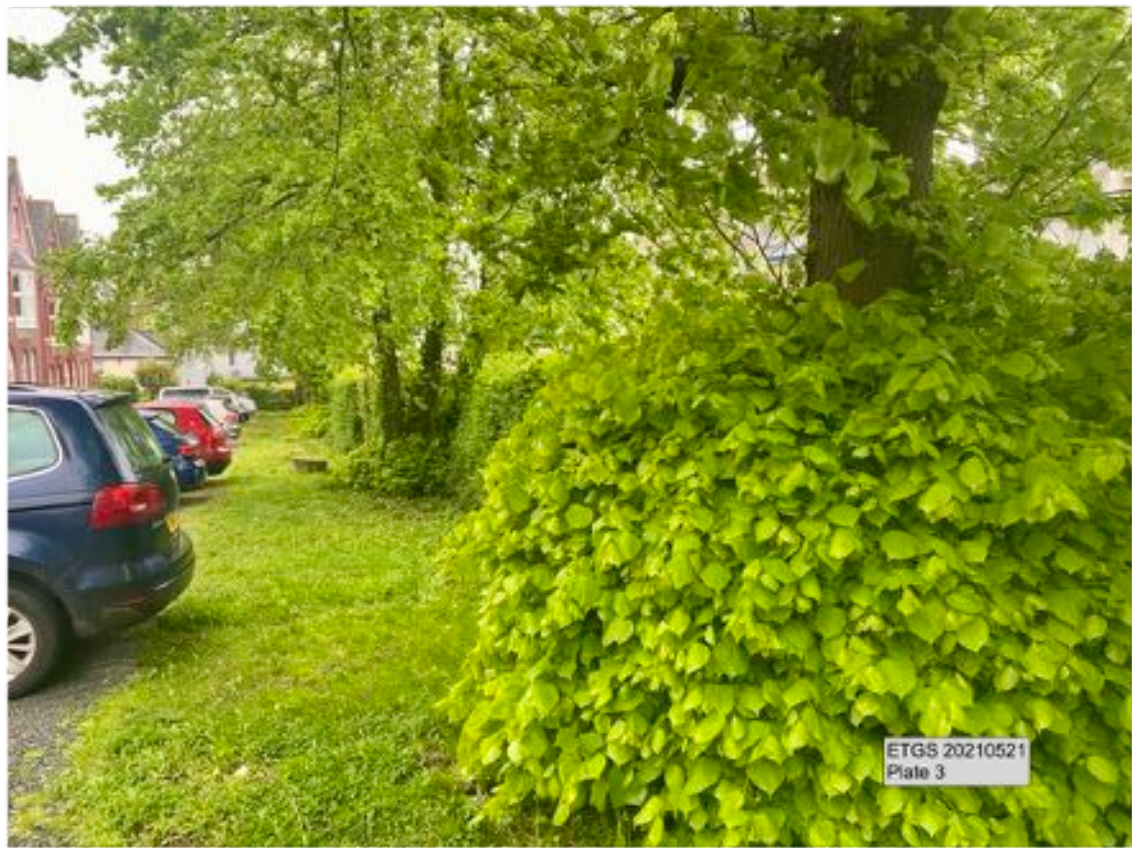
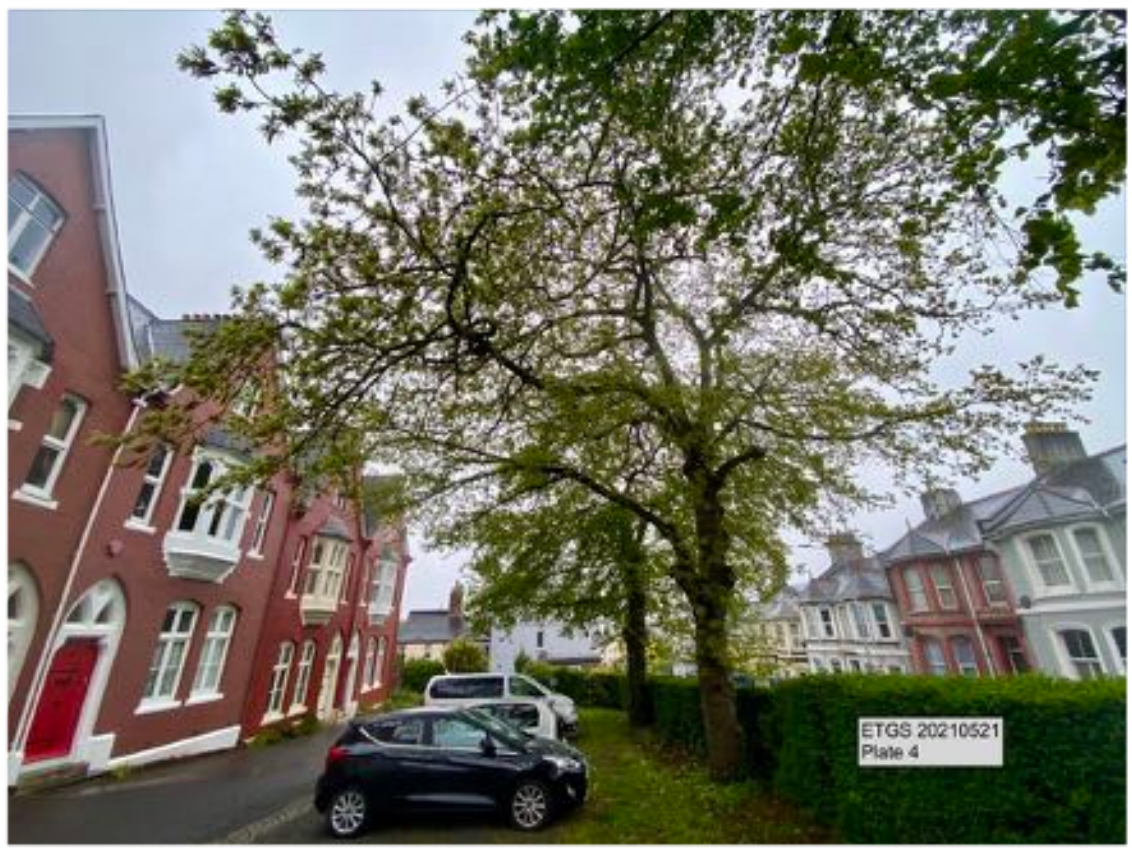
Where accessible, the lower stem and root plate of each tree was examined. Excessive epicormic growth (plate 3) precluded thorough examination of the majority of Lime tree(s.) There were no observable structural defects which would give rise to reasonable concern for whole tree or significant stem failure.

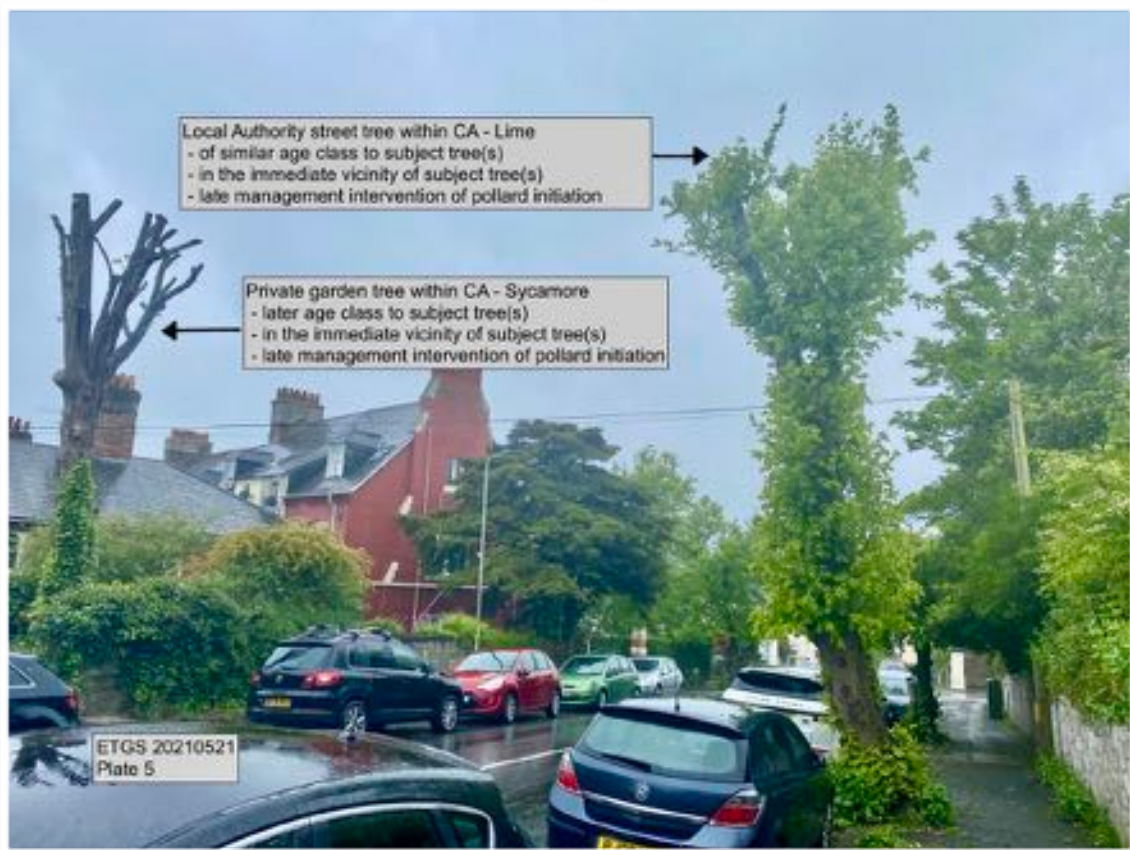
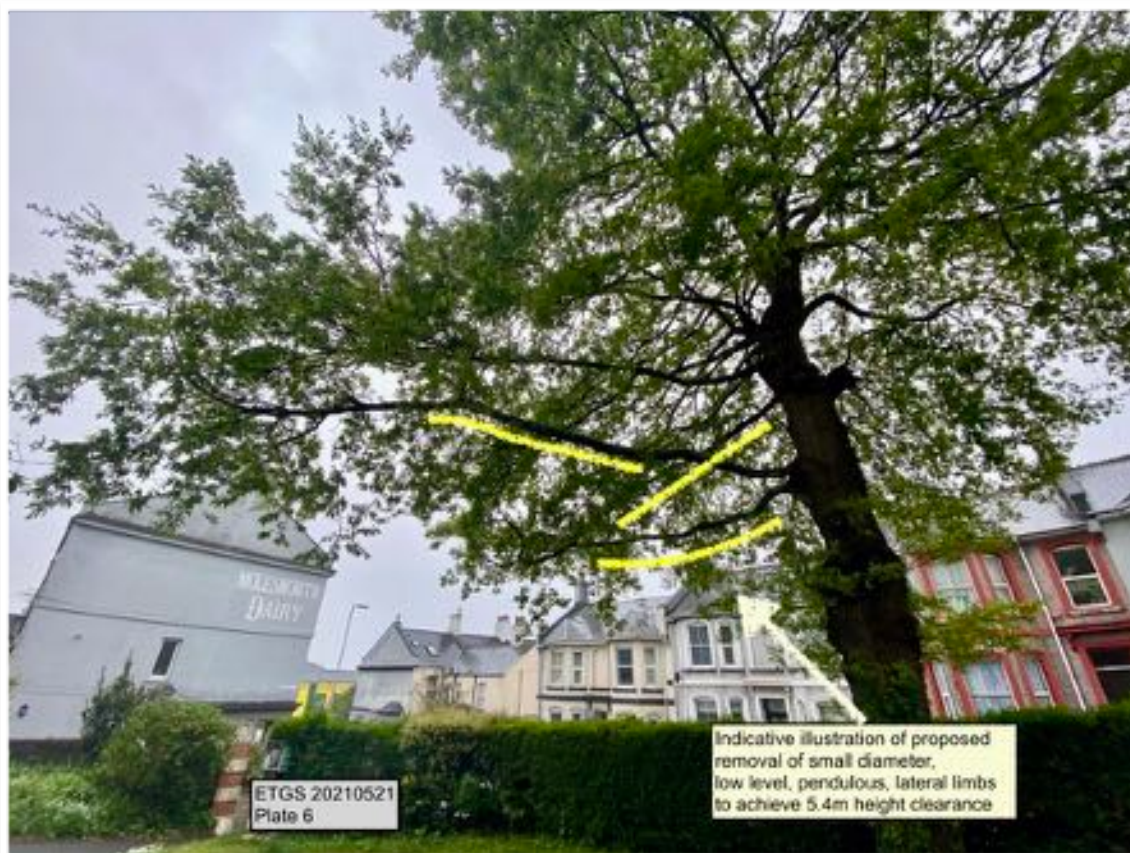
The Oak tree(s) (most notably 02121 & 02122) have extensive low level pendulous peripheral growth (East) which creates a height restriction above Batten Road and the associated off-street parking area (plate 4.) Discussion with the client suggests that a

previous s154 Highways Act notice has been served by the LA in relation to limbs overhanging Molesworth Road (West) and that this remedial action has been implemented. The visual consequence of this is an asymmetric crown with retained low level lateral limbs (East.) The s154 rationale similarly applies to those low level lateral limbs (East) which restrict access to high sided vehicles such as house removals etc and this supports the recommendation that the Oak tree(s) be subject to a crown raise to allow minimum 5.4m clearance above Batten Road.
