PROPOSED CAR PARK EXTENSION GULDENFORD BURFORD

1:50
BURF2018 CP A

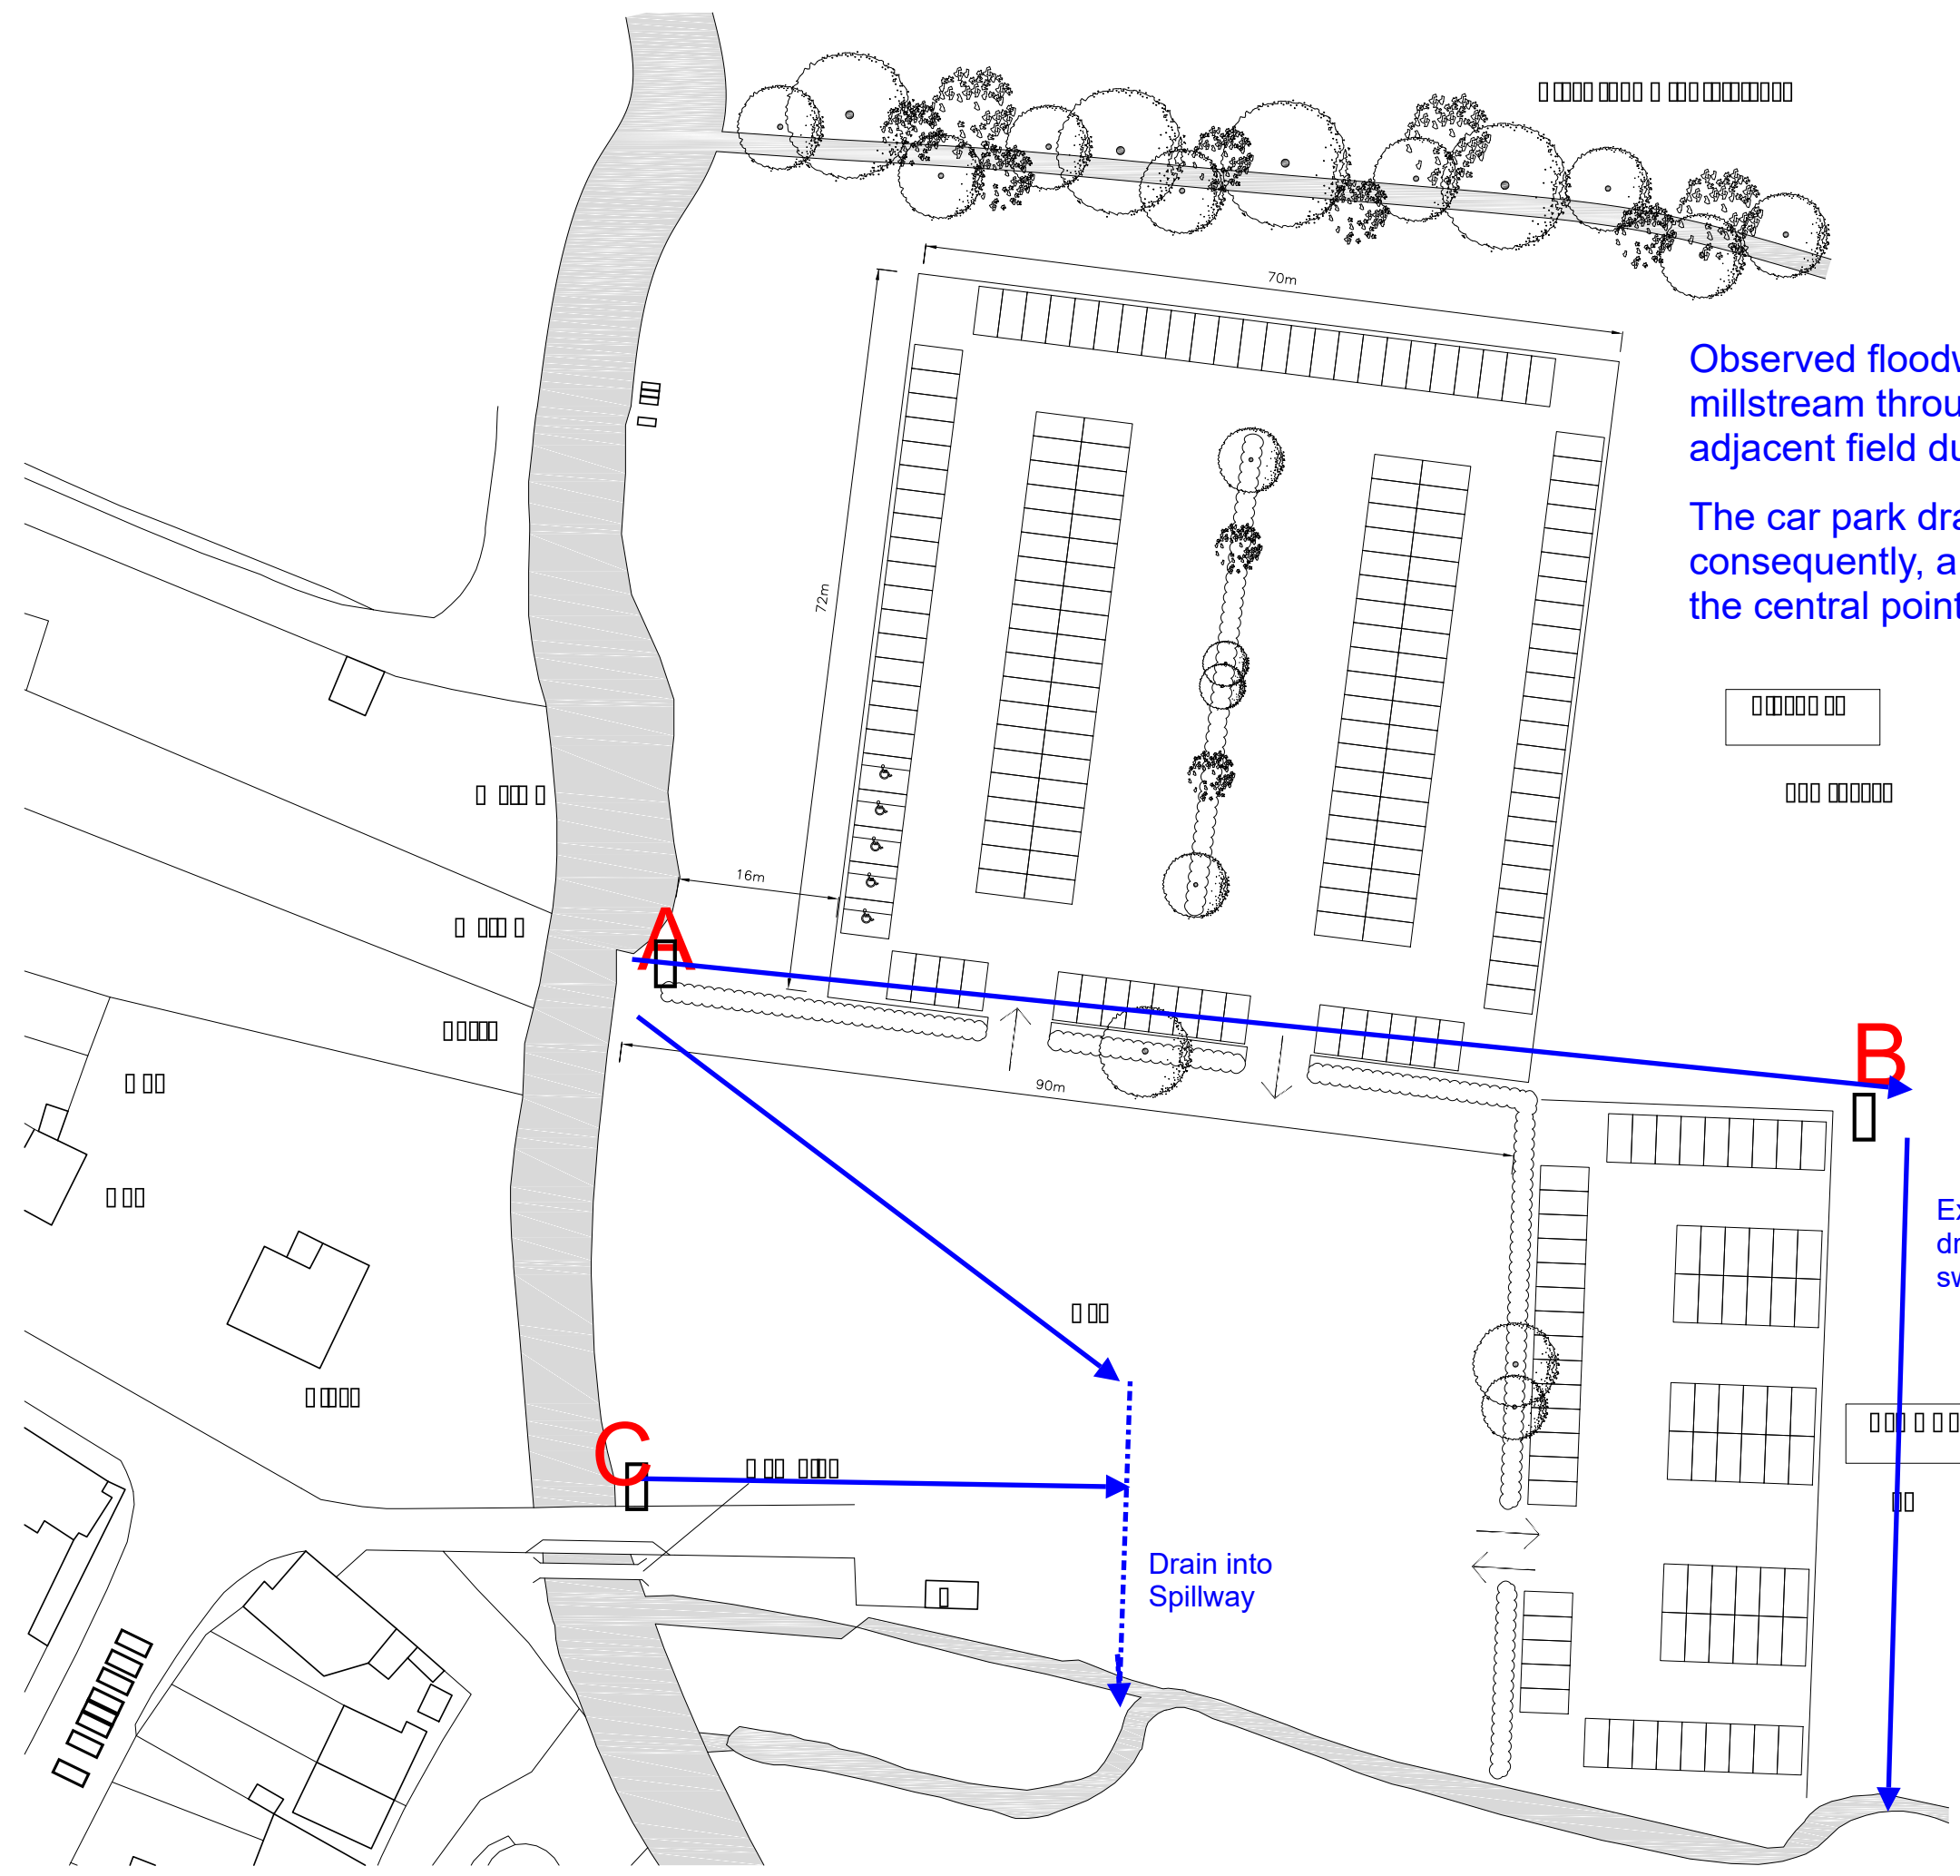
Observed floodwater flow paths from millstream through WODC car park and adjacent field during the winter season.

The car park drain is inadequate and, consequently, a lake forms in the car park at the central point during heavy storms and rain.

Existing field drainage swale.

Drain into Spillway
