# Design and Access Statement

for the  
5 High Row  
Gainford DL2 3DN

Prepared by  
Harris Irwin Associates  
10<sup>th</sup> June 2021

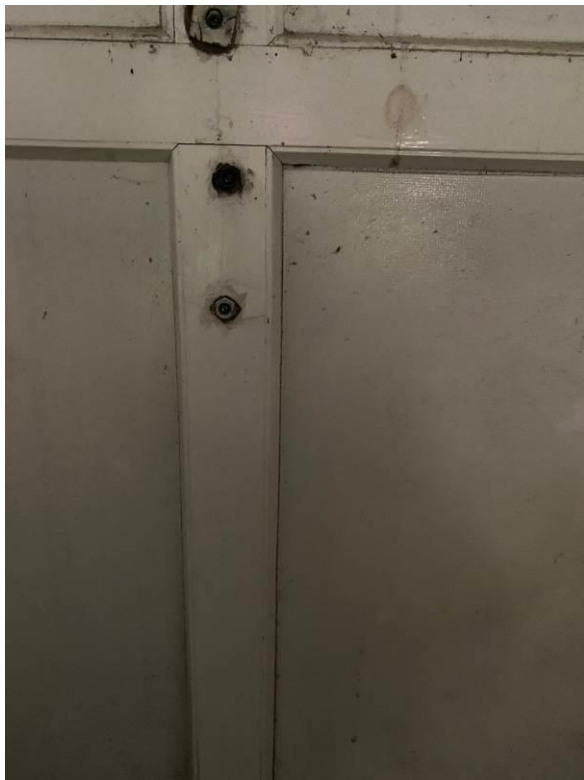
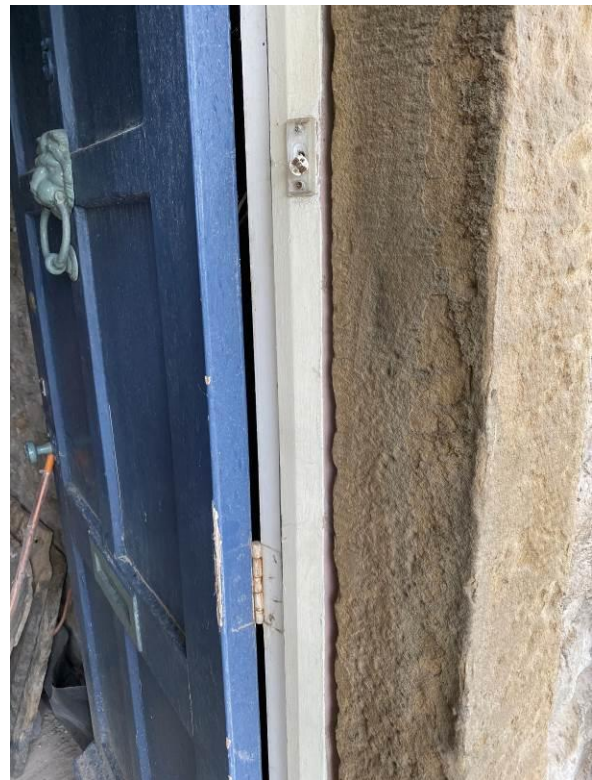
The front entrance door and frame is not original and is of poor quality. The existing frame is simply chamfered where a cock mould would have been normal and the fanlight above is without any form of mould being left square. We would expect to see a ½" or ⅝" cock bead mould on the frame with the transom recessed and moulded.

The door itself is without moulding with the panels being rebated with a bevel mould internally. Traditionally the panels would be grooved into the door with these being either raised panels with a mould to the door or a bolection mould on the outside with a panel mould internally. The door knocker is plastic.

*Existing photographs of door*

We proposed to replace the door with a new softwood 6 panel door in a pattern to match the existing with a hardwood cill complete with a 3 panel fanlight with larger middle section – all to match the existing.

We would propose to provide a bead to the door frame and to recess this behind the stonework. The transom would be provided with beads to the top and bottom edges and the fanlight glazed using toughened heritage double glazed units. The door is to be painted and is to be of a style and pattern to match the existing and reflect the period and character of the building.

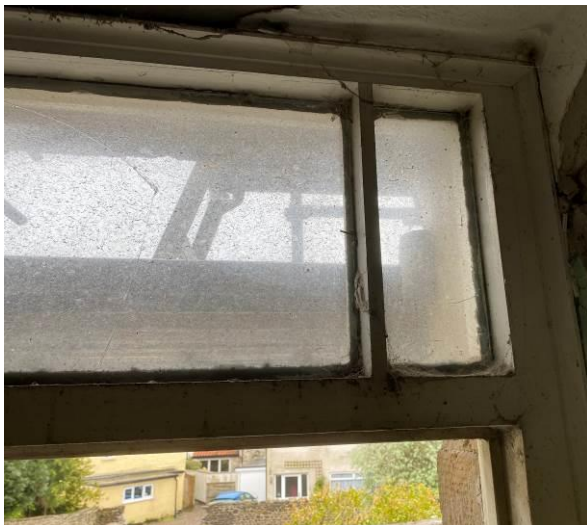
*Existing photograph of fanlight*

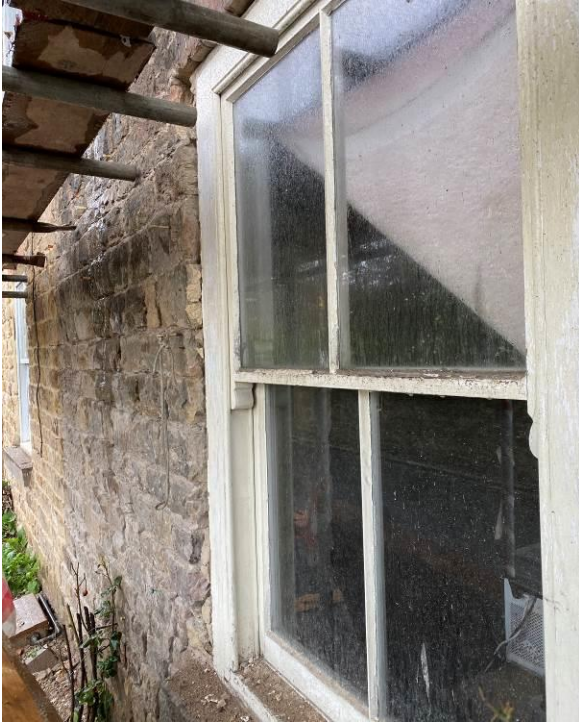
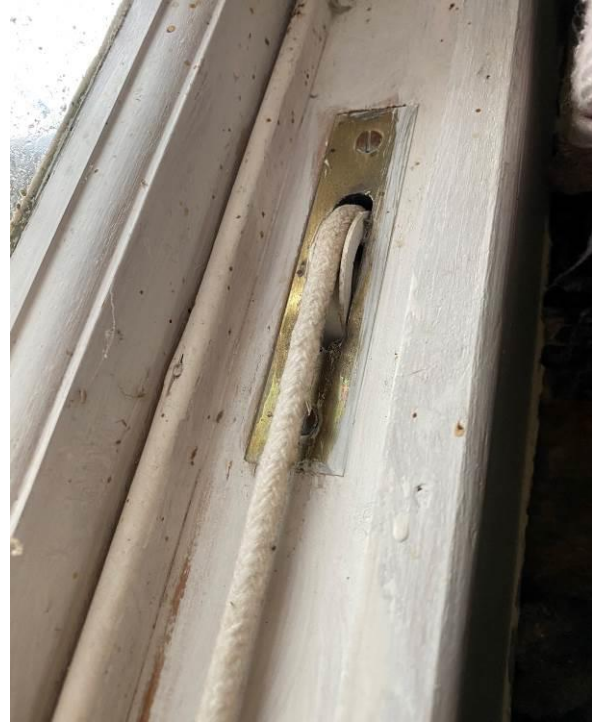
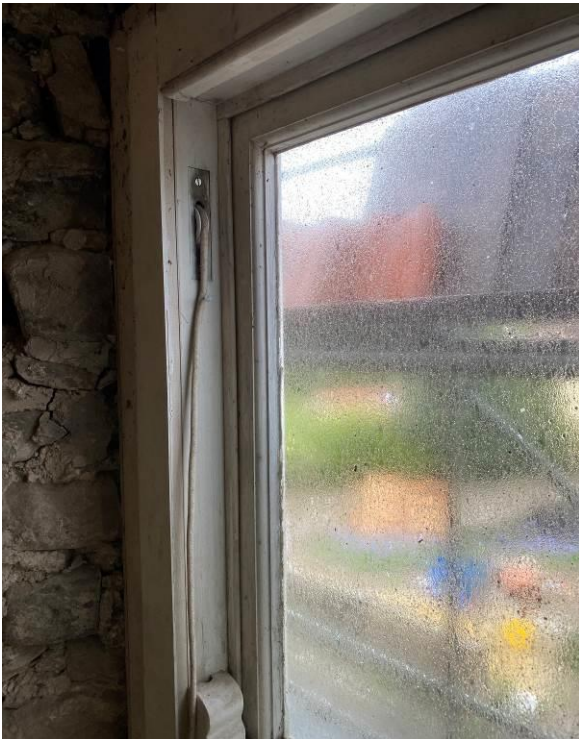
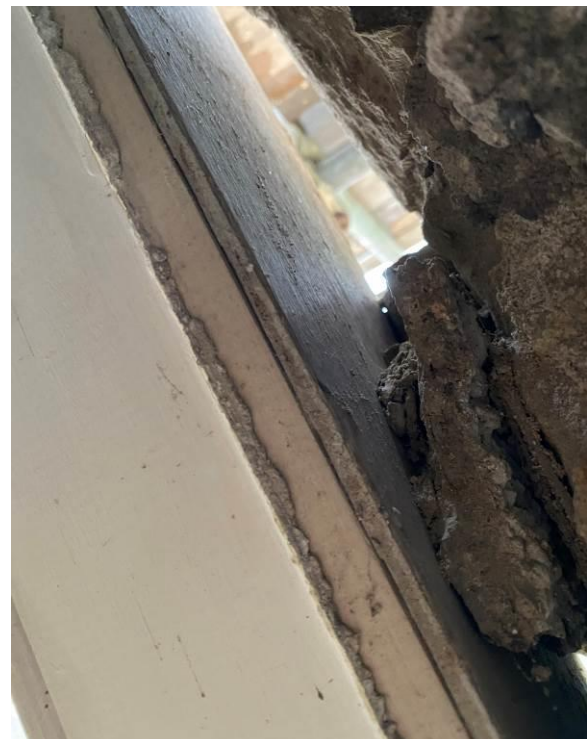
The existing windows to the property probably date to somewhere around the 1990's given their nylon pulley wheels and plywood backs (which would traditionally have been thin timber). The windows themselves are installed flush with the front of the stonework which can be seen in the photographs below, this is not how these windows would traditionally be fitted and is bad practice as it does not allow any opportunity to point up around the window.

*Photographs of existing windows*

All the existing windows are in a poor condition, are not well made and are poorly fitted.

We would propose to replace all the existing windows with new purpose-built joinery items in patterns to match the existing. All the new windows will be traditional timber sliding sash windows in a period style with appropriate glazing pattern (to match existing) and detailing finished gloss white. The proposal is to install 4-6-4mm double glazed units within the windows.

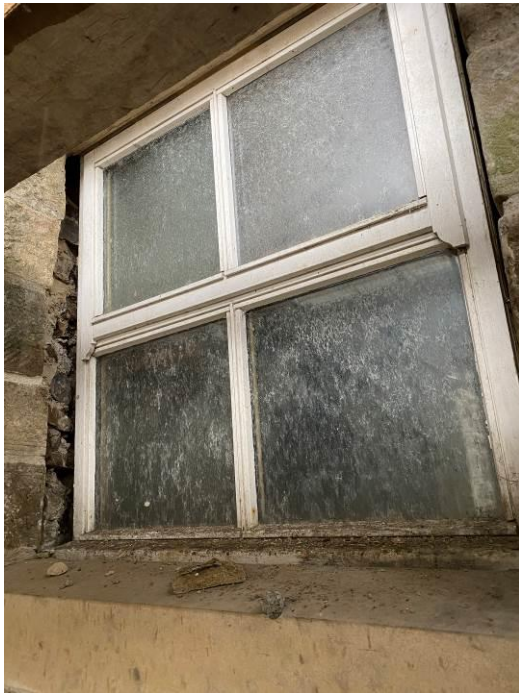
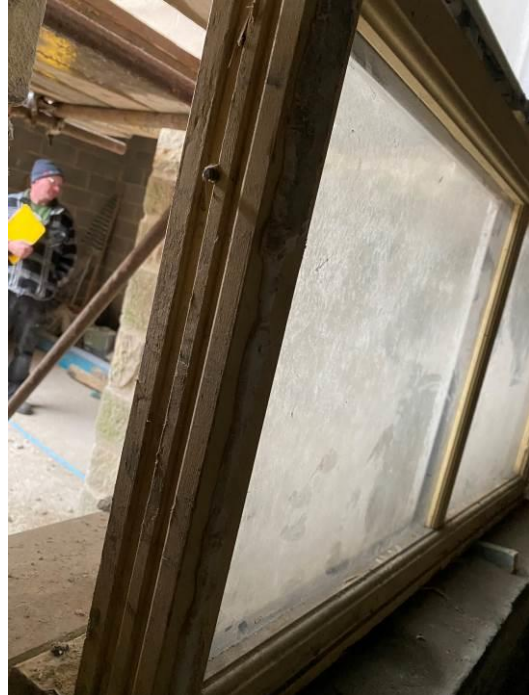
This window is a modern mass produced softwood casement window which is top hung, outward opening with half-lap horns and mortar keys grooved into the edges as can be seen in the photos below.

*Photographs of existing window*

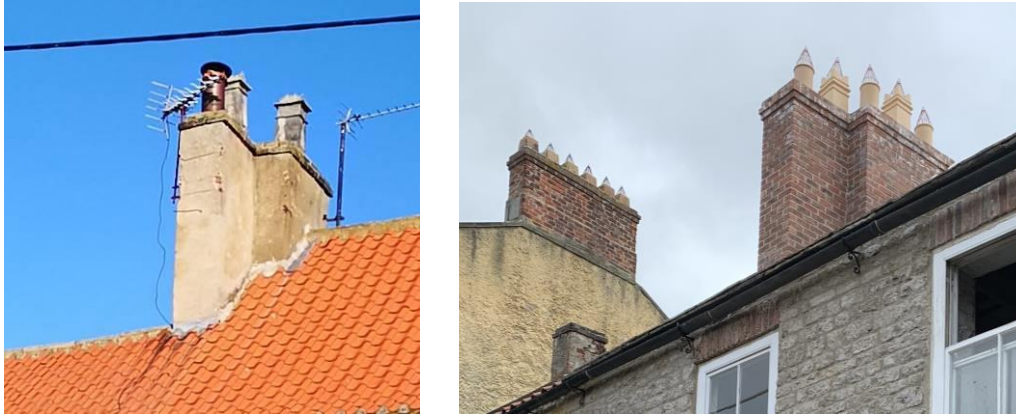
The existing chimneys were found to be in a poor condition with chimney pots missing, cracked render falling off and crumbling brickwork beneath as can be seen on the photograph to the left below.

*Before and after replacement of chimneys*

Further detailed photographs, from the time of undertaking the works, can be found in the Heritage Statement. These clearly illustrate the poor condition of the render, the degradation of the brickwork, movement of the brickwork and the lack of mortar.

The chimney has been taken down and re-built in matching red brickwork with the Victorian style chimney pots being replaced with new pots in a similar style. The finished chimney is of similar components and design to that on the property further down High Row in the photo above.

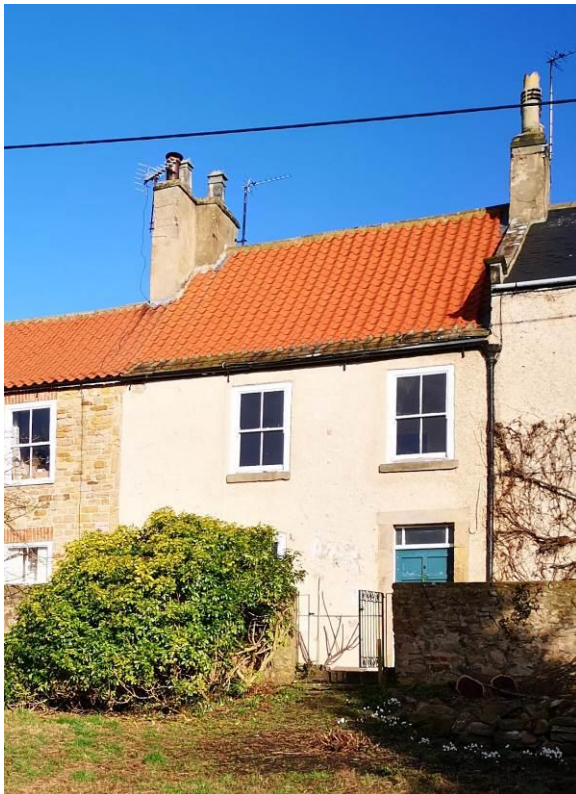
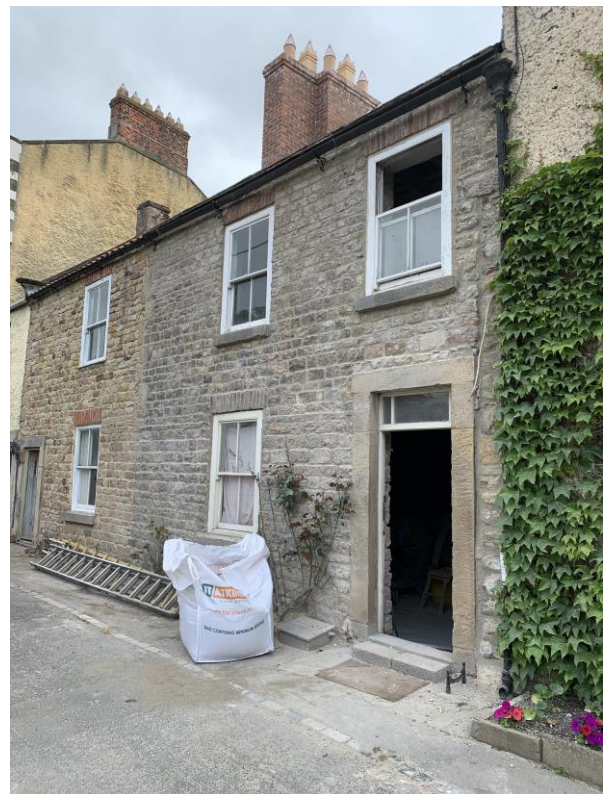
The existing render from the front elevation has been removed as this was found to be in a poor condition. While removing the render the very nice coursed dressed stone beneath has been exposed.

It seems that nos. 5 & 6 High Row were constructed at the same time as the coursed stone runs continuously between the properties with no straight-joint or abutment present, at least up to the first floor level. This is further demonstrated by the bricked up openings which have been uncovered between the properties.

*Front Elevation - before and after the removal of render*

On the basis of the above we propose to leave the dressed coursed stone exposed and to not re-render the property as we feel this to be truer to the original intent.
