# Arboricultural Impact Appraisal and Method Statement

## **The Old Vicarage, 6 High Street, Abbots Langley, Herts WD5 0AS**

<b>CLIENT:</b>	<b>Mr Steven Deering</b>
<b>CLIENT REF:</b>	<b>SD/TOVSLCALH</b>
<b>URBAN FORESTRY REF:</b>	<b>SAL/KMA/10593a - REVISION</b>
<b>UF CONSULTANT:</b>	<b>Shane A. Lanigan</b>
<b>REPORT DATE:</b>	<b>27<sup>th</sup> January 2021</b>

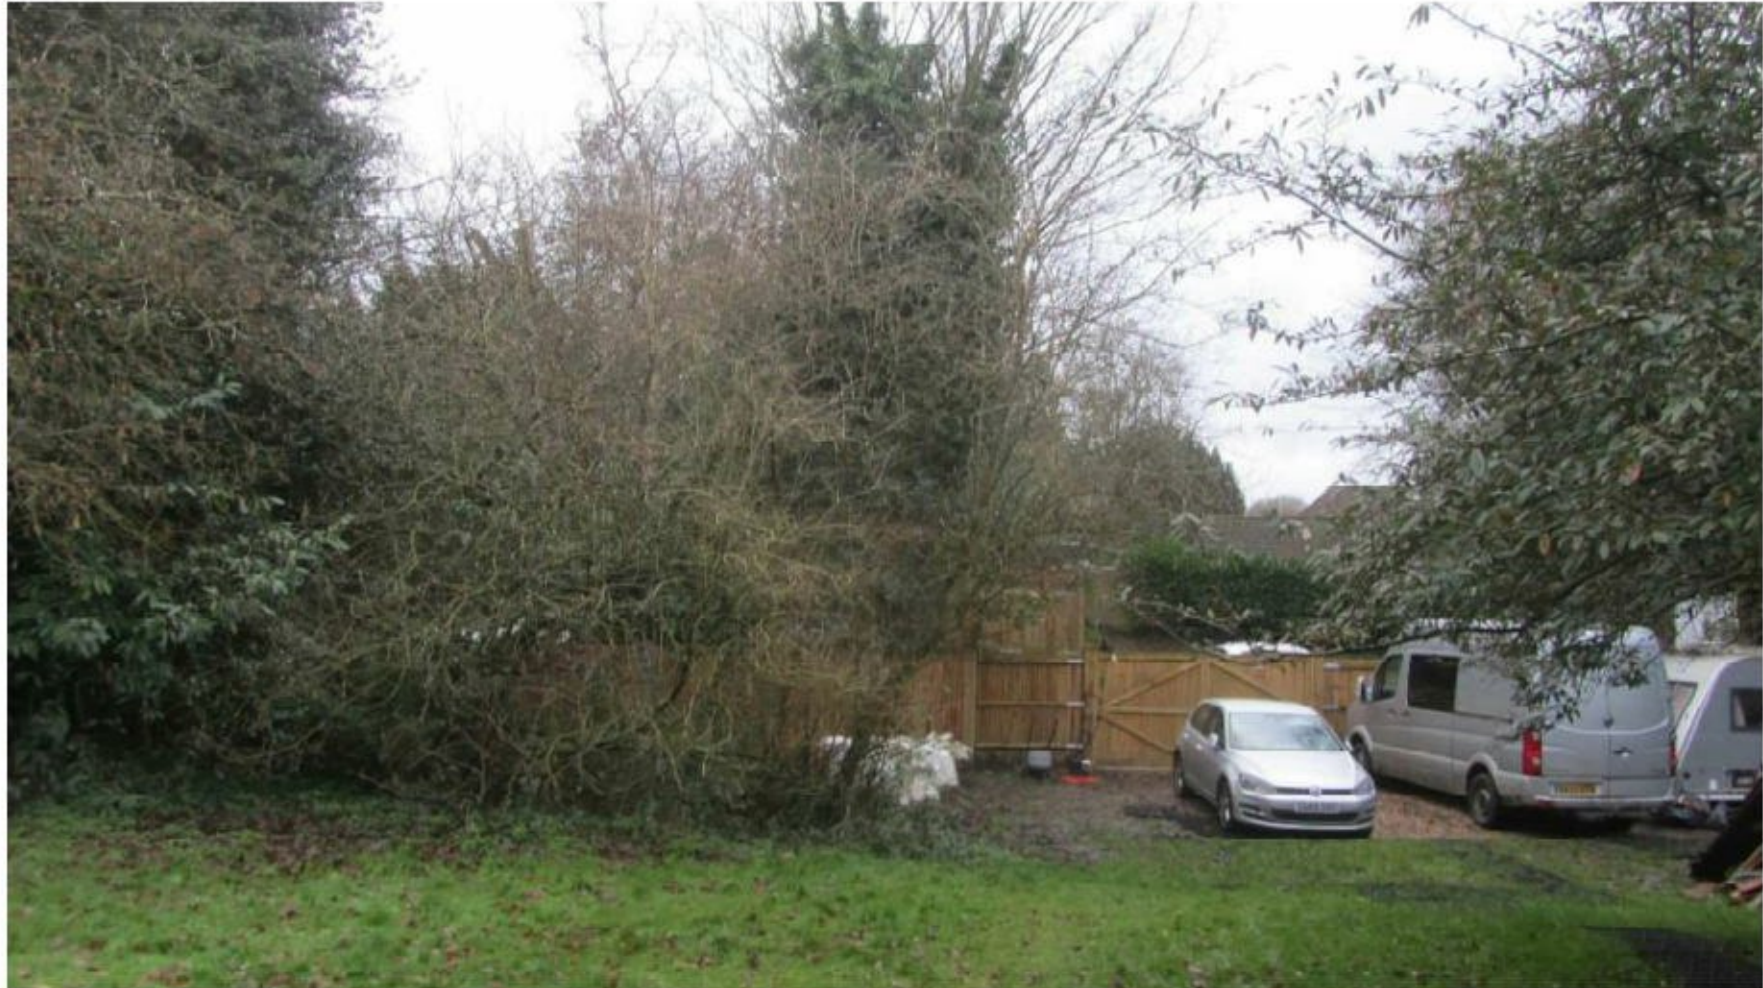
One category B tree (sycamore-T1) will need to be lightly pruned on the north side to enable construction of the garage.

One category C tree, magnolia (T3) will need to be pruned back on the western side to enable construction of the garage.

**PHOTOGRAPH NO. 1 - SYCAMORE (T1) BACKGROUND –  
MAGNOLIA (T3) CENTRE LEFT**

3.5.1 **Tree work recommendations:** I have specified some relatively minor crown lifting and lateral branch reduction works to the sycamore (T1) and magnolia (T3). These will enable the garage to be built whilst retaining the trees as effective screening to soften the rigid architectural building lines.

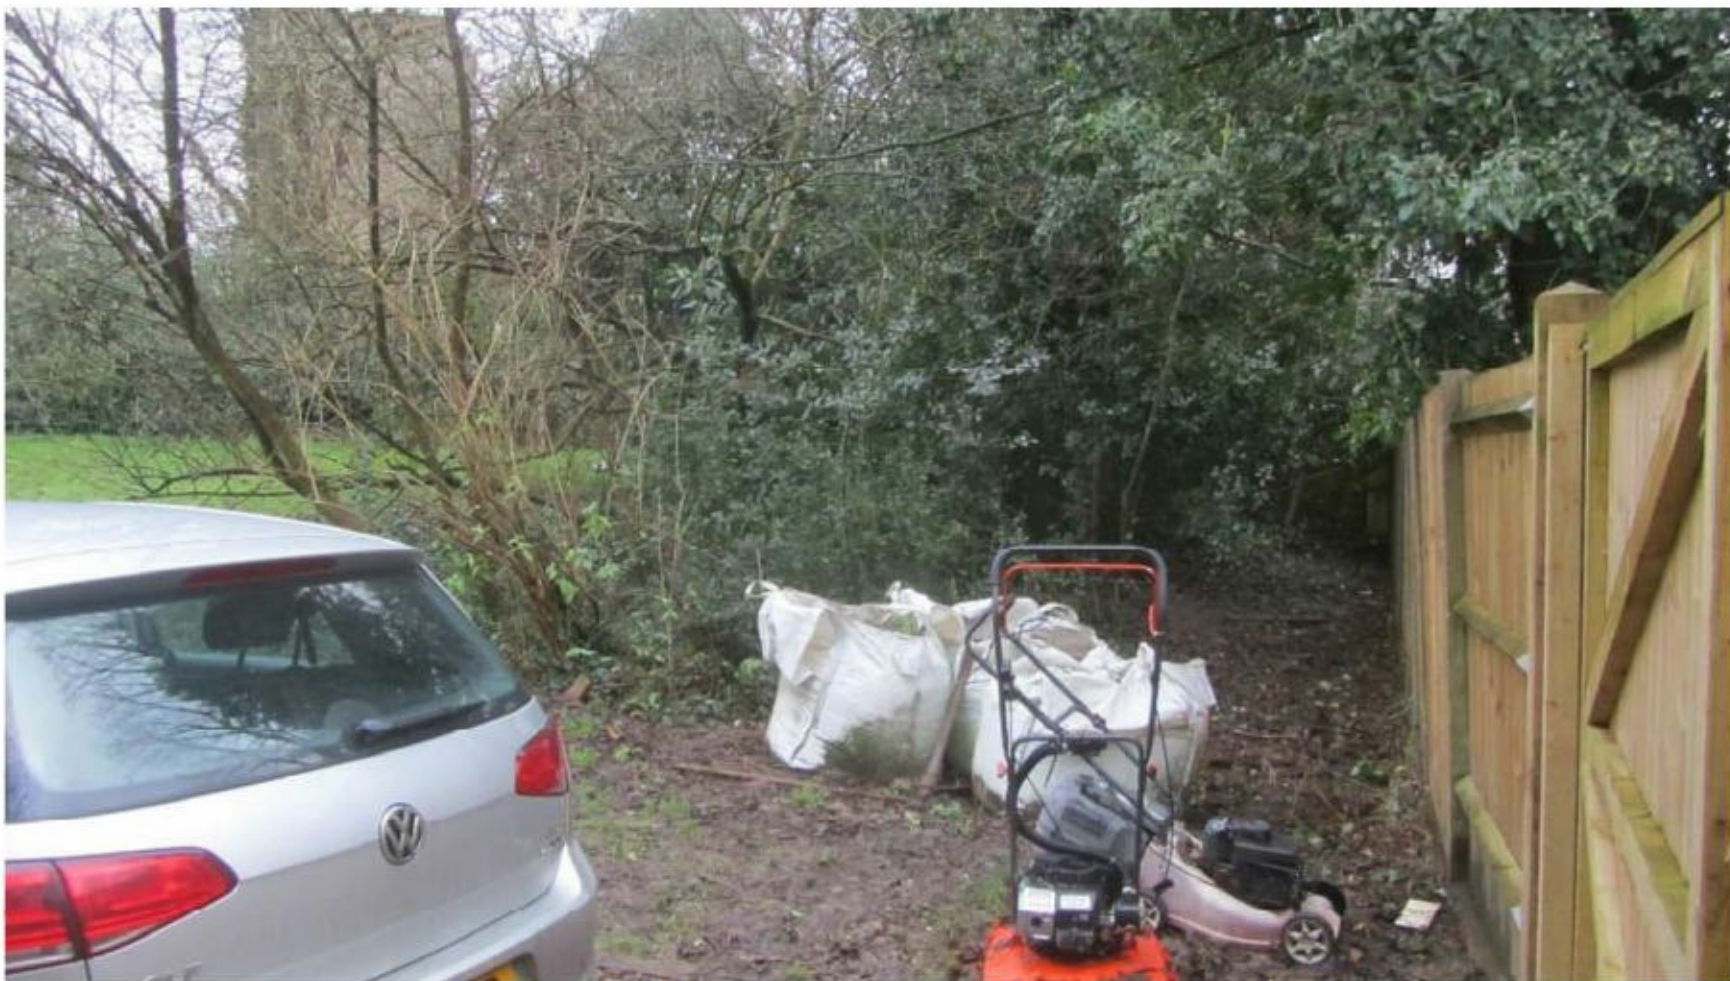
**PHOTOGRAPH NO. 2 - AREA FOR PROPOSED GARAGE/OUTBUILDING**

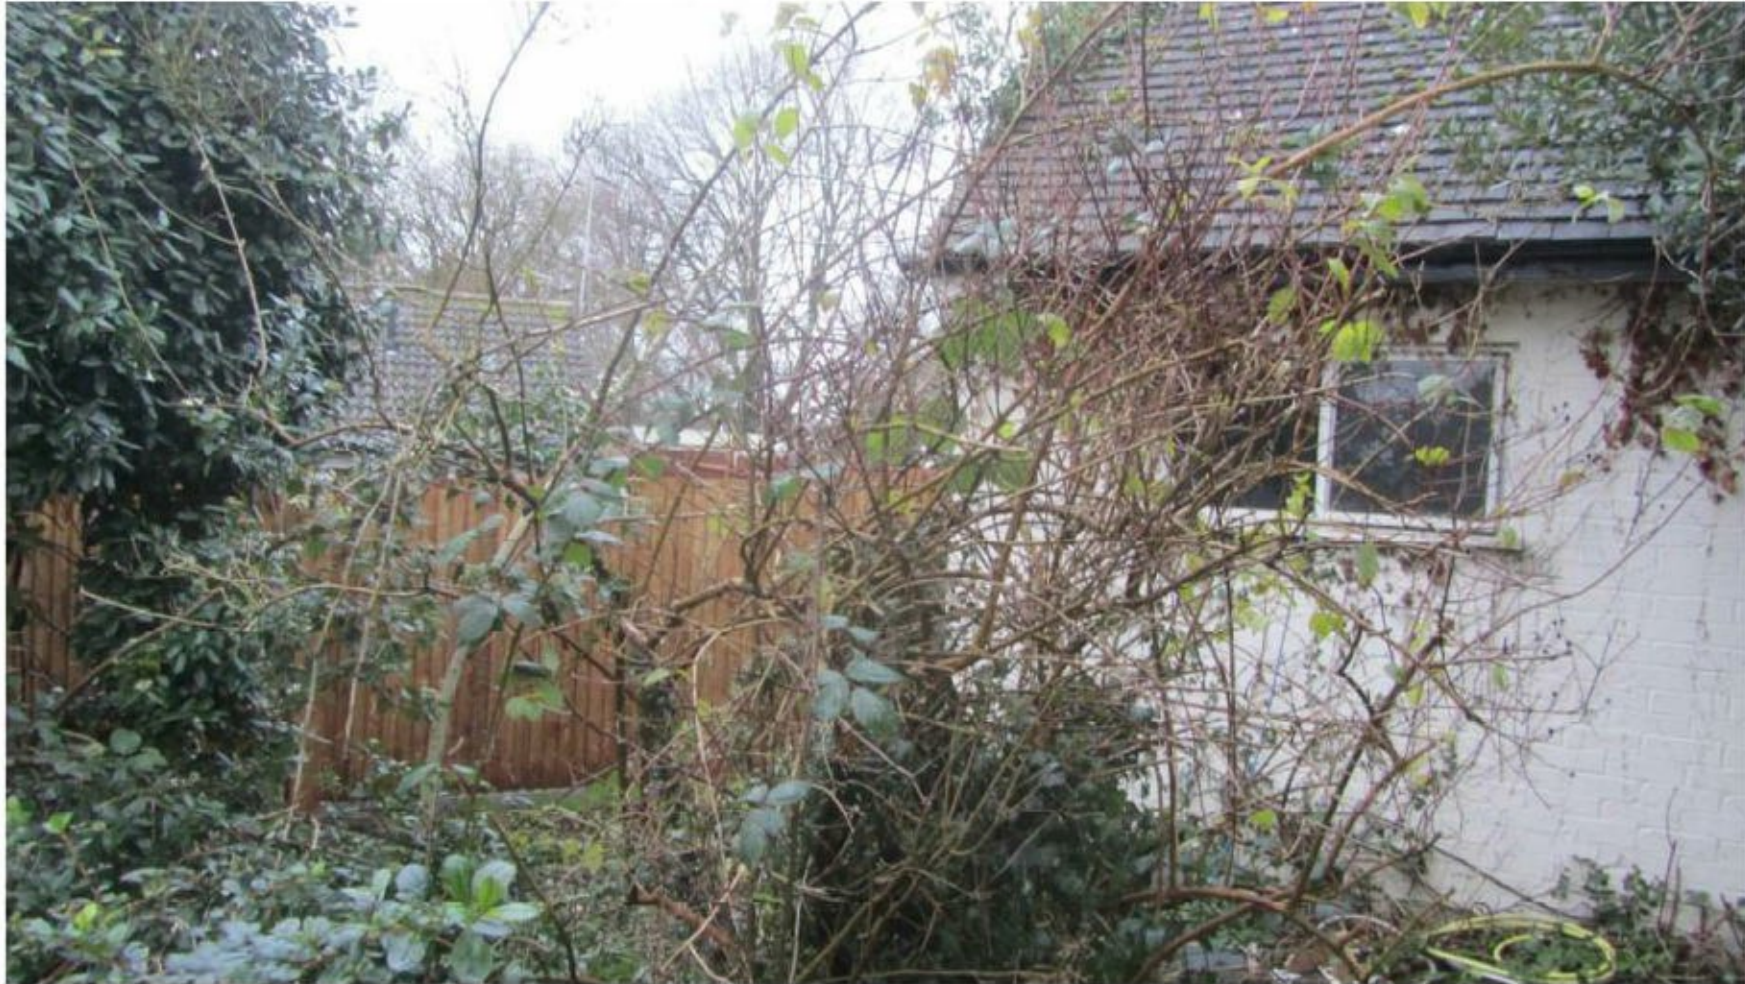
**PHOTOGRAPH NO. 3 - AREA OF PROPOSED ORANGERY SHOWING GARAGE WHICH IS TO BE DEMOLISHED**
