Barn to the Rear of Porch Cottage

Design, Access & Heritage Statement

Structural Survey Summary of Findings by Mann Williams

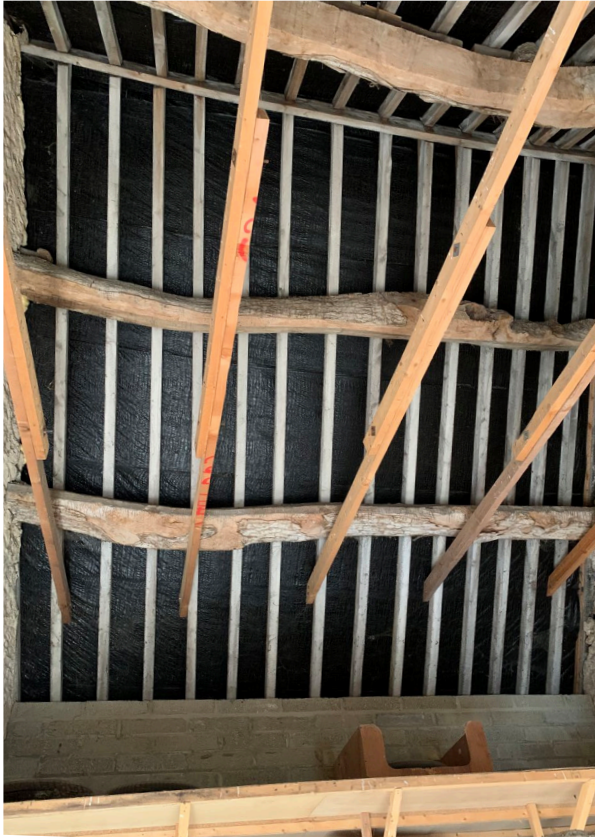
Figure 7: "Ad hoc" Roof Structure of the Bull House

- Viewed externally the roof is severely dished; internally the reason for this is clear, the purlins are inadequate resistance to thrust, and ad-hoc ties have been added in an attempt to arrest lateral movement at the eaves.

- For the roof strengthening a very honest intervention is suggested – small steel sections alongside the purlins, carrying the roof loads. The existing purlins could be retained for historical context and visual interest. The addition of a ridge beam would enable the later ad-hoc ties to be removed, creating an open roof space.

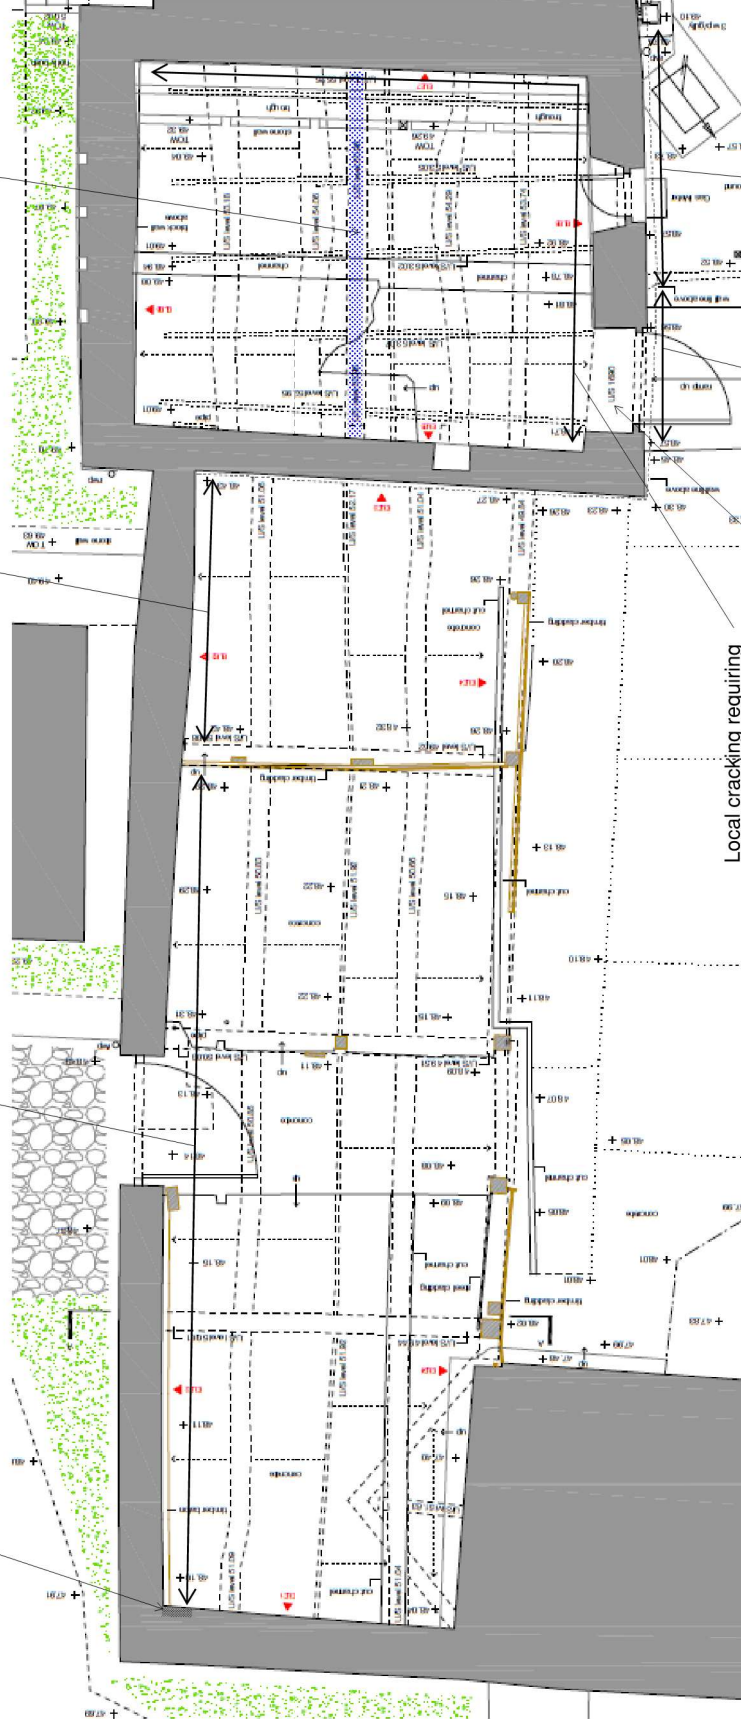
TITLE
Structural Survey
Summary of Findings
Ground Floor

First floor beam heavily decayed and cracked; inadequate for first floor loading. Replace beam or retained and strengthen

This section of rear elevation has a significant inwards bulge, where the ground externally is at its highest. Rebuild approximately 4m length of wall.

Rear elevation over this length appears to lean out slightly, but not significantly. No remedial works necessary. External elevation requires local masonry consolidation

Local crack stitching/repointing required due to voiding and cracking

Local cracking requiring stitching and repointing on these two walls

Timber lintels require further investigation; decay evident. Possible replacement

This section of front wall bows outwards heavily; local rebuild required.

Slight lean of elevation.

The addition of a first floor structure would maximise the amount of masonry that could be retained if detailed to provide significant lateral restraint

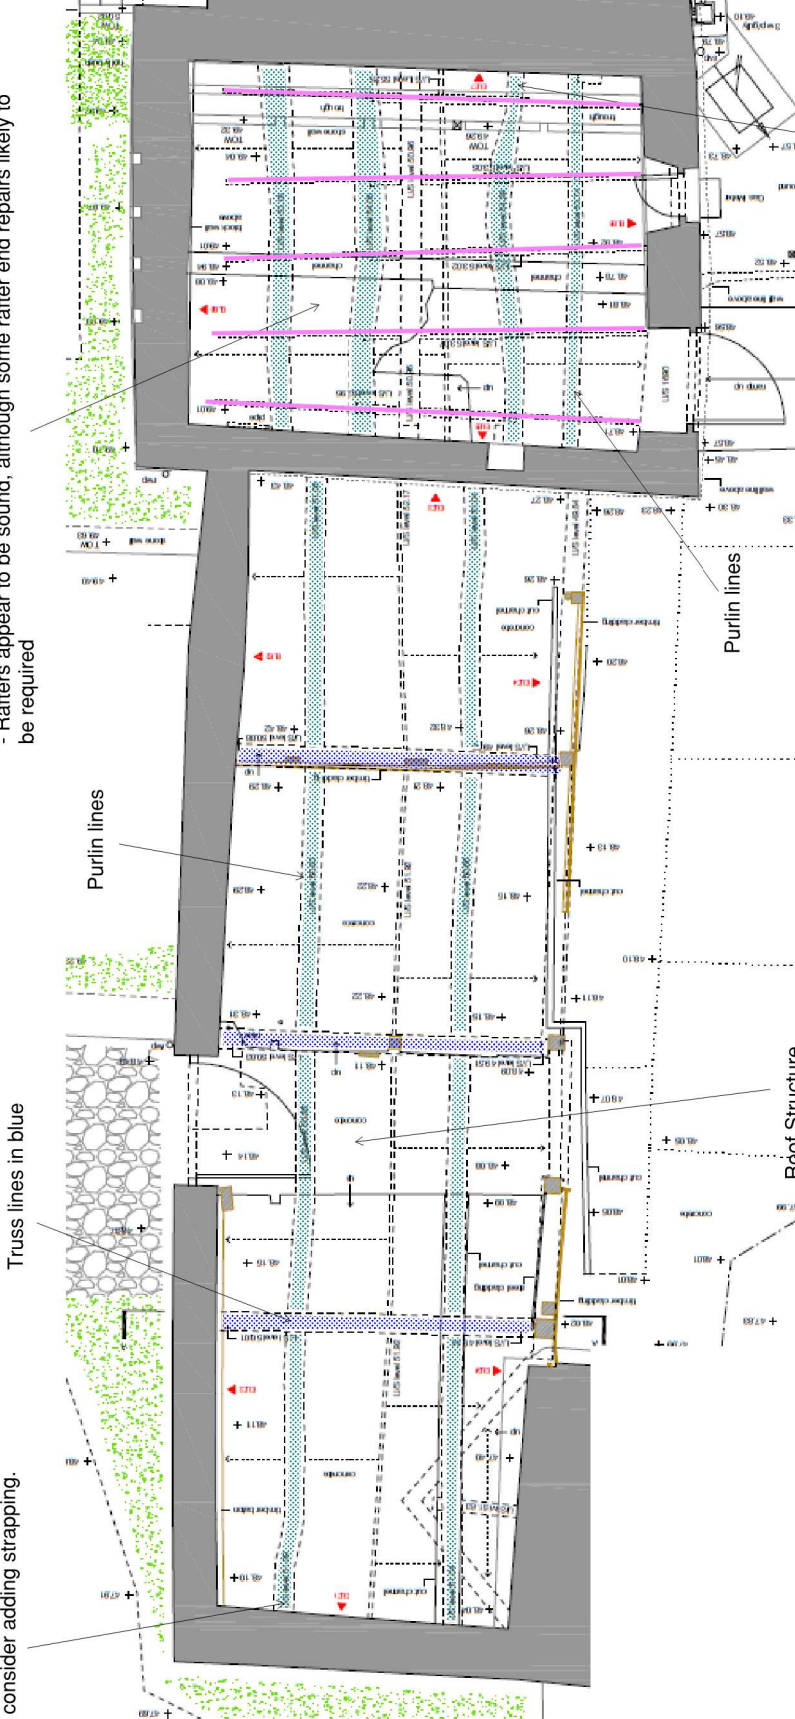
TITLE
**Structural Survey
Summary of Findings
Roof Structure**

- Roof is severely dished due to inadequate purlins deflecting
- Purlins are very irregular, one purlin has been replaced with a purlin of inadequate size
- Roof has inadequate resistance to thrust, ad-hoc ties have been added to resist lateral eaves movement. Ties shown in pink.
- Strengthening required, possibly via small steel sections alongside existing retained purlins
- Insertion of ridge beam would enable later ties to be removed, creating an open roof space
- Rafters appear to be sound, although some rafter end repairs likely to be required

- Trusses lean heavily towards the front elevation - possible removal of saddle stones/brick plinths under the truss support posts? Consider jacking up trusses carefully or dismantling and re-erecting.
- Two outer trusses appear to be sound; the central truss has decayed timber tie and principal rafter shows decay and voiding. Repairs required to both possibly with steel face plates. Alternatively the principal could be replaced if acceptable.
- Purlins have local pockets of timber decay, some require strengthening, but in general appear to be sound.
- Roof structure appears to be adequate for an increase in roof loading from clay tiles or slate.
- Rafters appear to be sound, but some missing. Local rafter end repairs likely to be required

Gable wall at high level would benefit from additional restraint due to slight lean; tidy up purlin bearings and consider adding strapping.

General - purlin bearings poorly built in, pack and consolidate masonry
