Discharge Condition 7

of Planning Consent: PA20/00759 for replacement dwelling

Location : Kilten Cottage, Road from Wheal Sperris Villa, to North of Hugus Farm, Hugus, Truro TR3 6EQ

Surveyor : M. Noon, BSc (hons) Landscape Design, Lantra Professional Tree Surveyor. Discharge of conditions dated 23rd May 2021

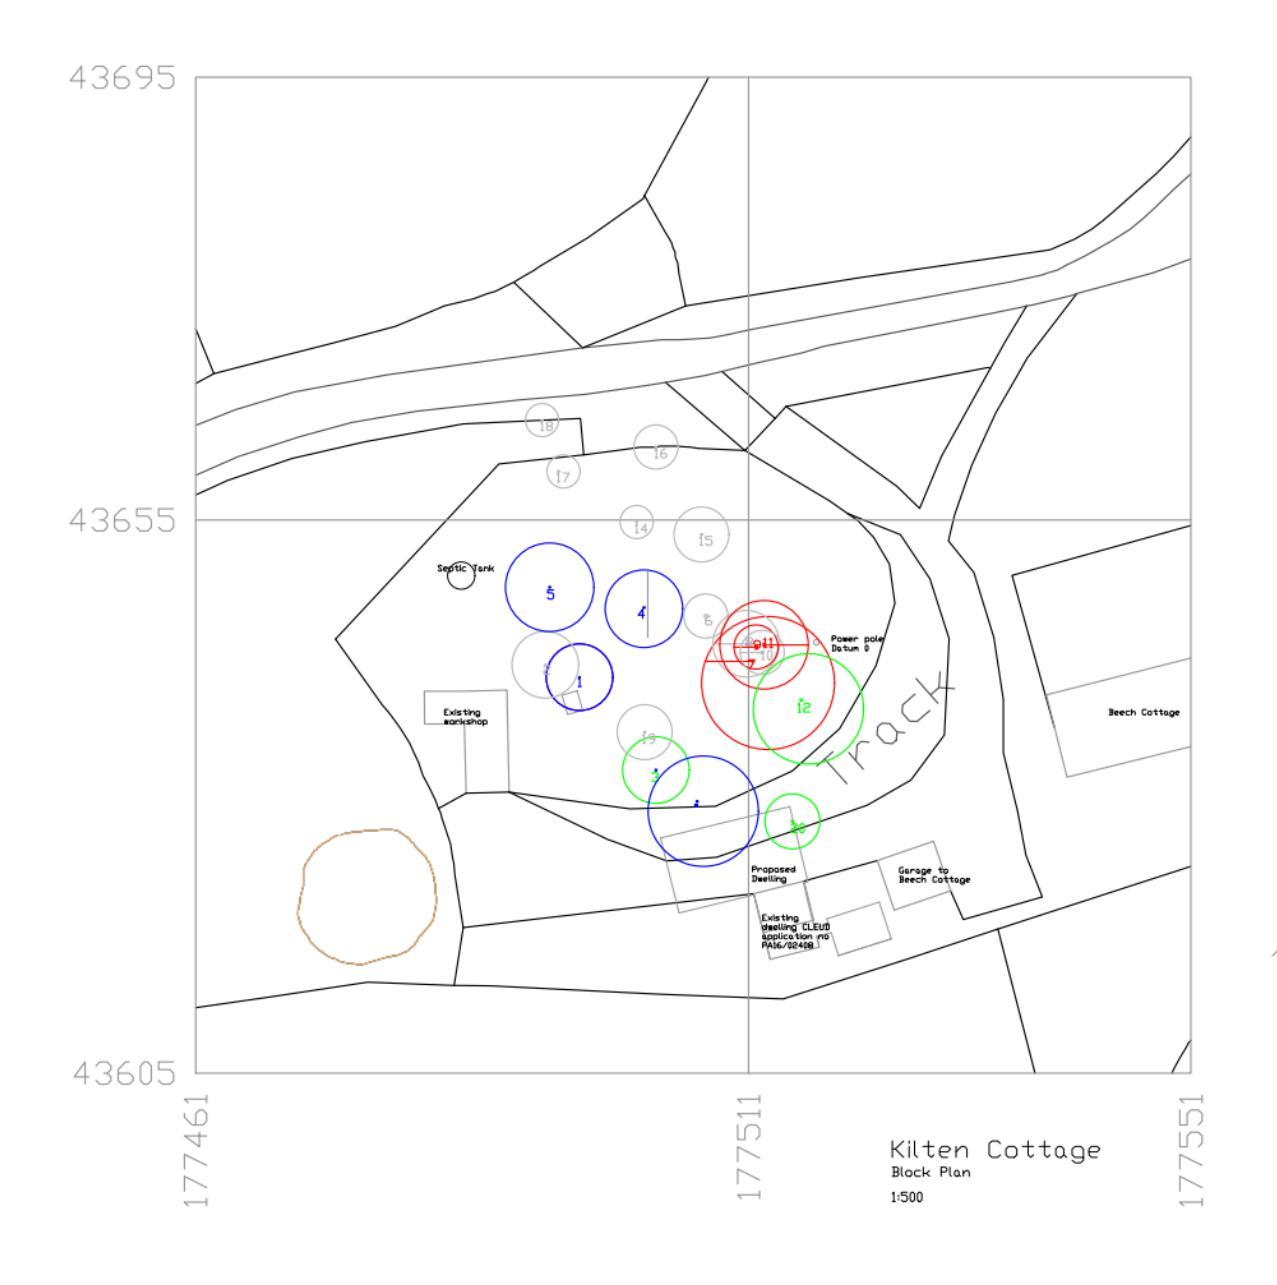
APPENDIX A. TREE SURVEY PLAN

As per the initial tree survey and subsequent move of the proposed new dwelling the RPA of only two trees are affected by building works. These are T13 and T20. All of the other trees on site are not affected by the development.

As the site is currently a residential dwelling, trees T13 and T20 will remain and protective fencing will be erected prior to any construction works commencing around these affected trees. Please see plan attached which identifies trees T13 and T20.

The remediation proposal is to keep these trees on site until the concrete slab foundations are dug in the area in which the RPA of trees T13 and T20 occur. Prior to the digging of these foundations trees T13 and T20 will be removed from site. It is proposed that due to the planting of the additional trees mentioned above, that this will lead to an enhanced tree coverage on site and minimise the disruption of the appearance of the site due to the construction works undertaken.
