**QINETIQ SITE,
FORT HALSTEAD, KENT**

**ARBORICULTURAL IMPACT
ASSESSMENT**

Report No: RT-MME-150872-02
Revision D

Date: June 2021

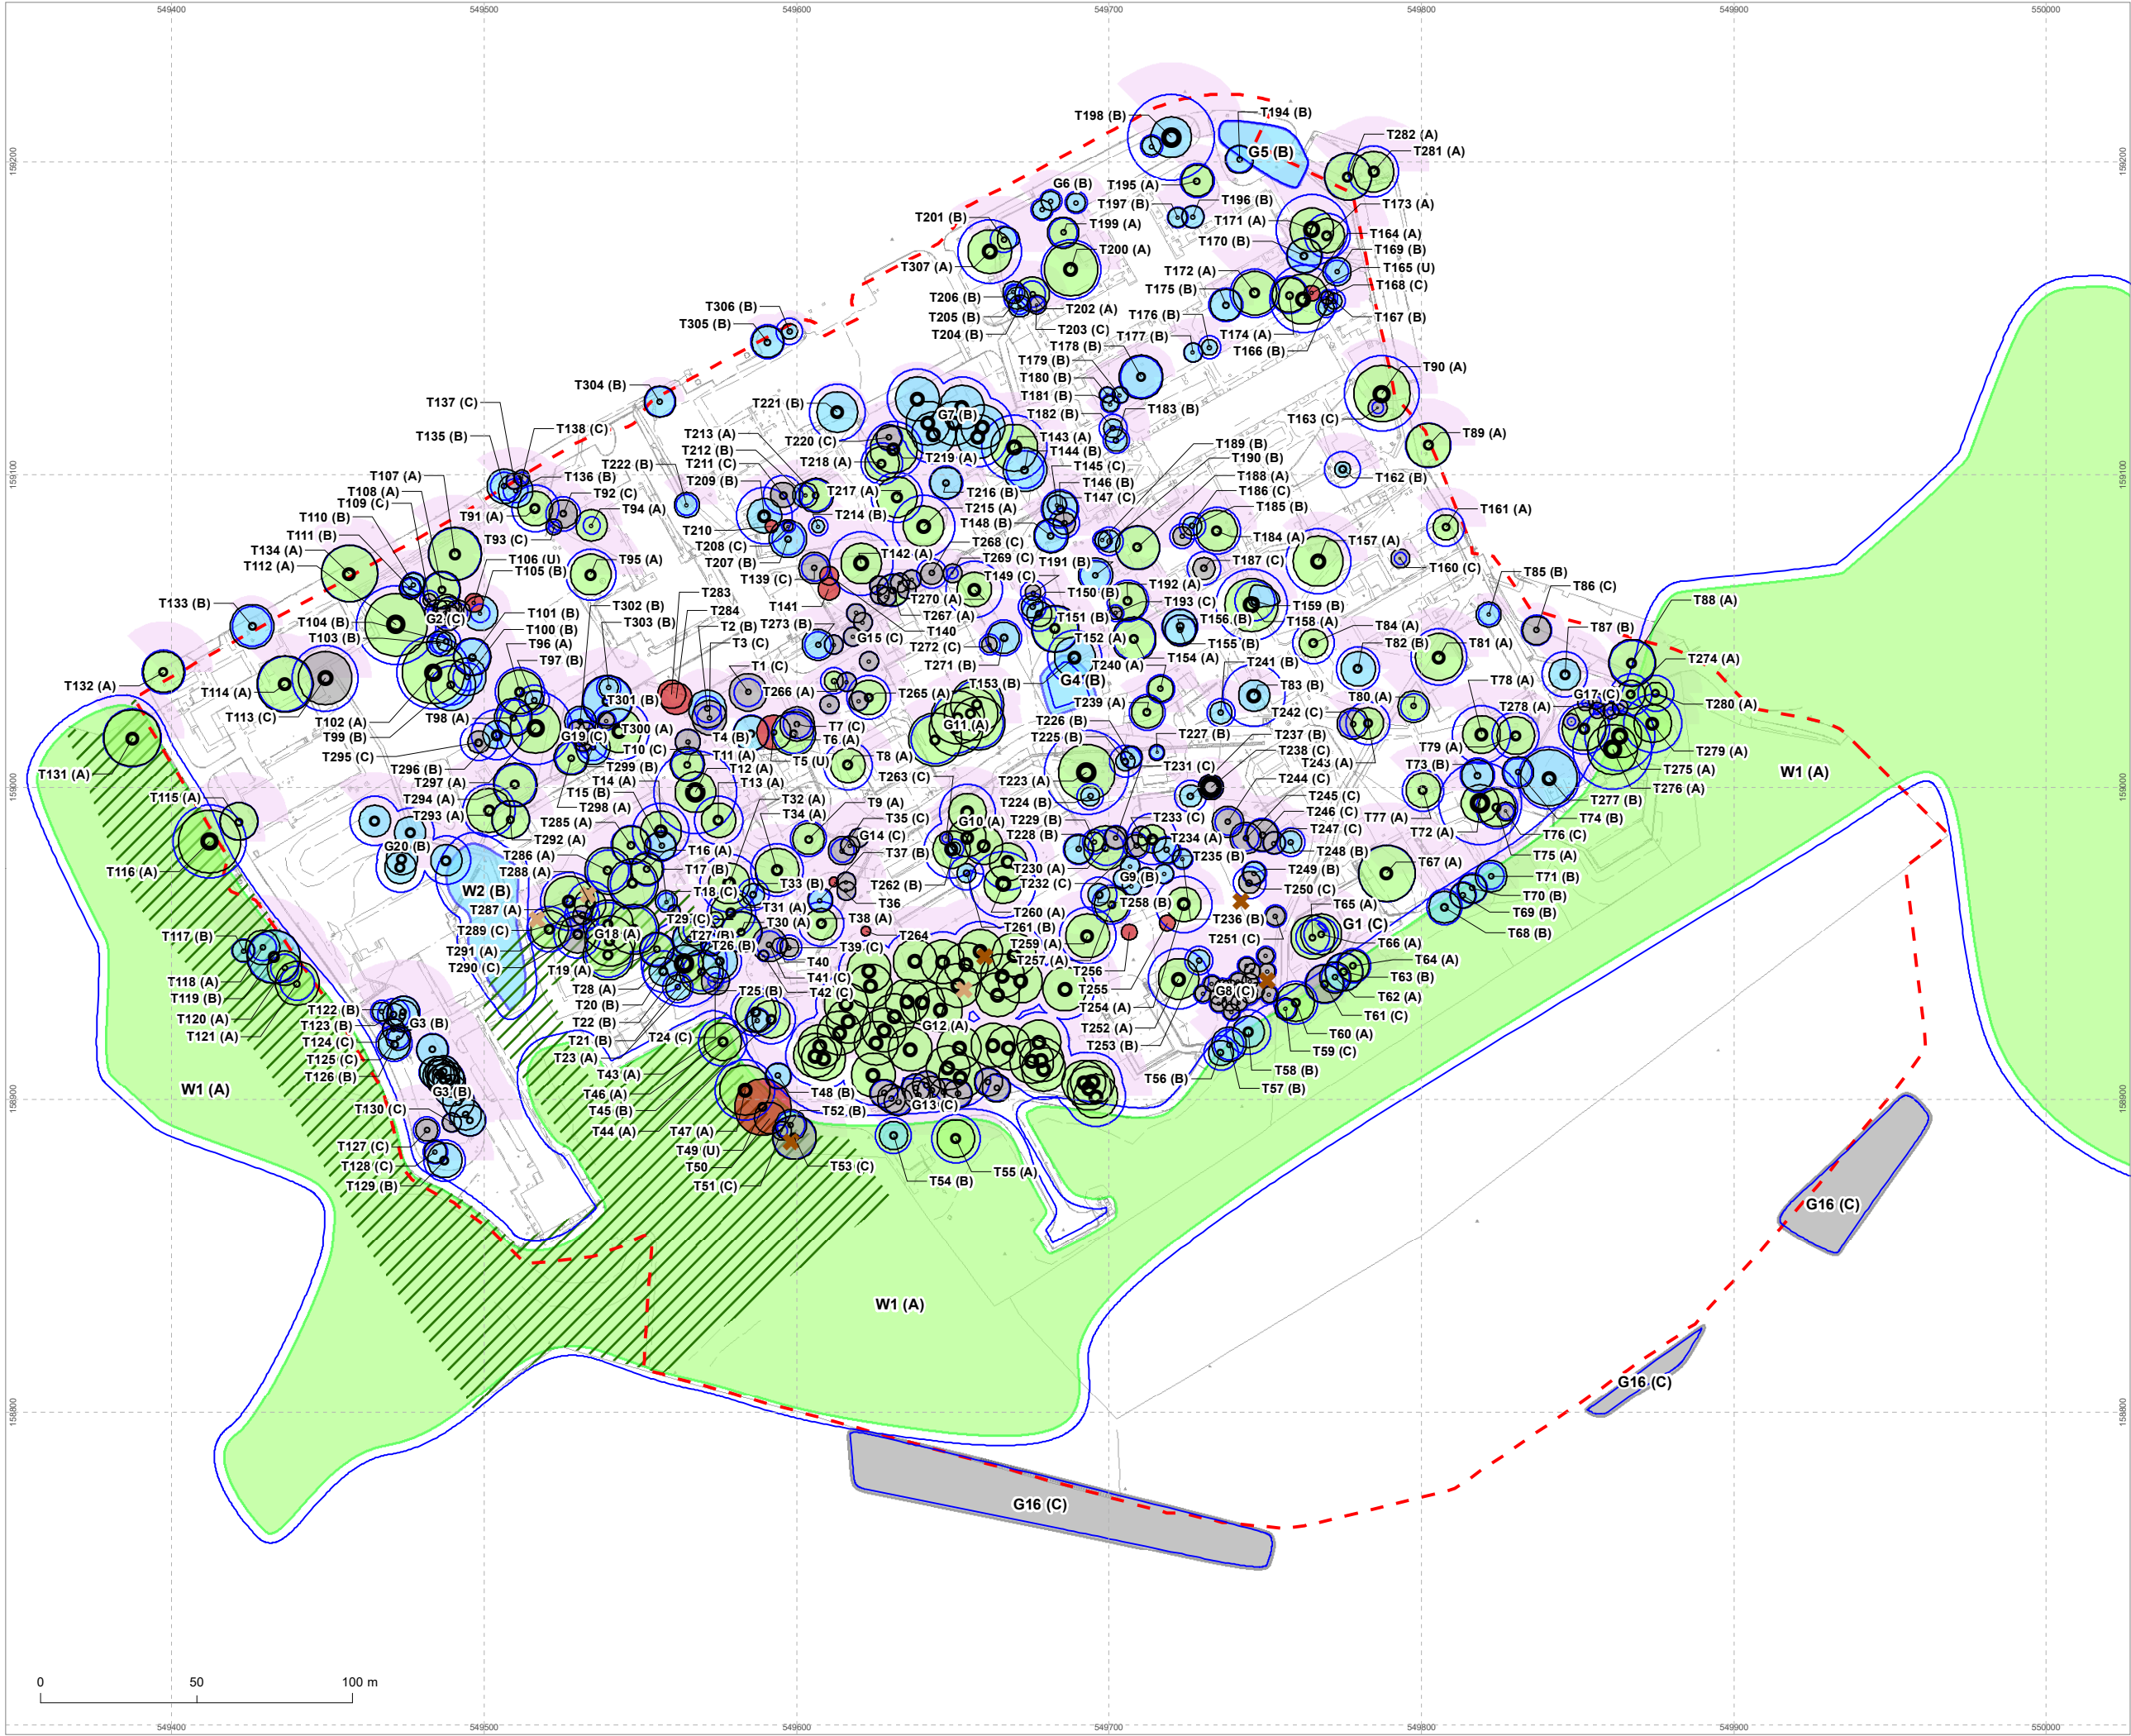
C150872-01-01-RevA

The location of the trees can be found on the Tree Survey Plan (C150872-01-01 Rev A) and a schedule of the trees (Appendix A) attached to this report.

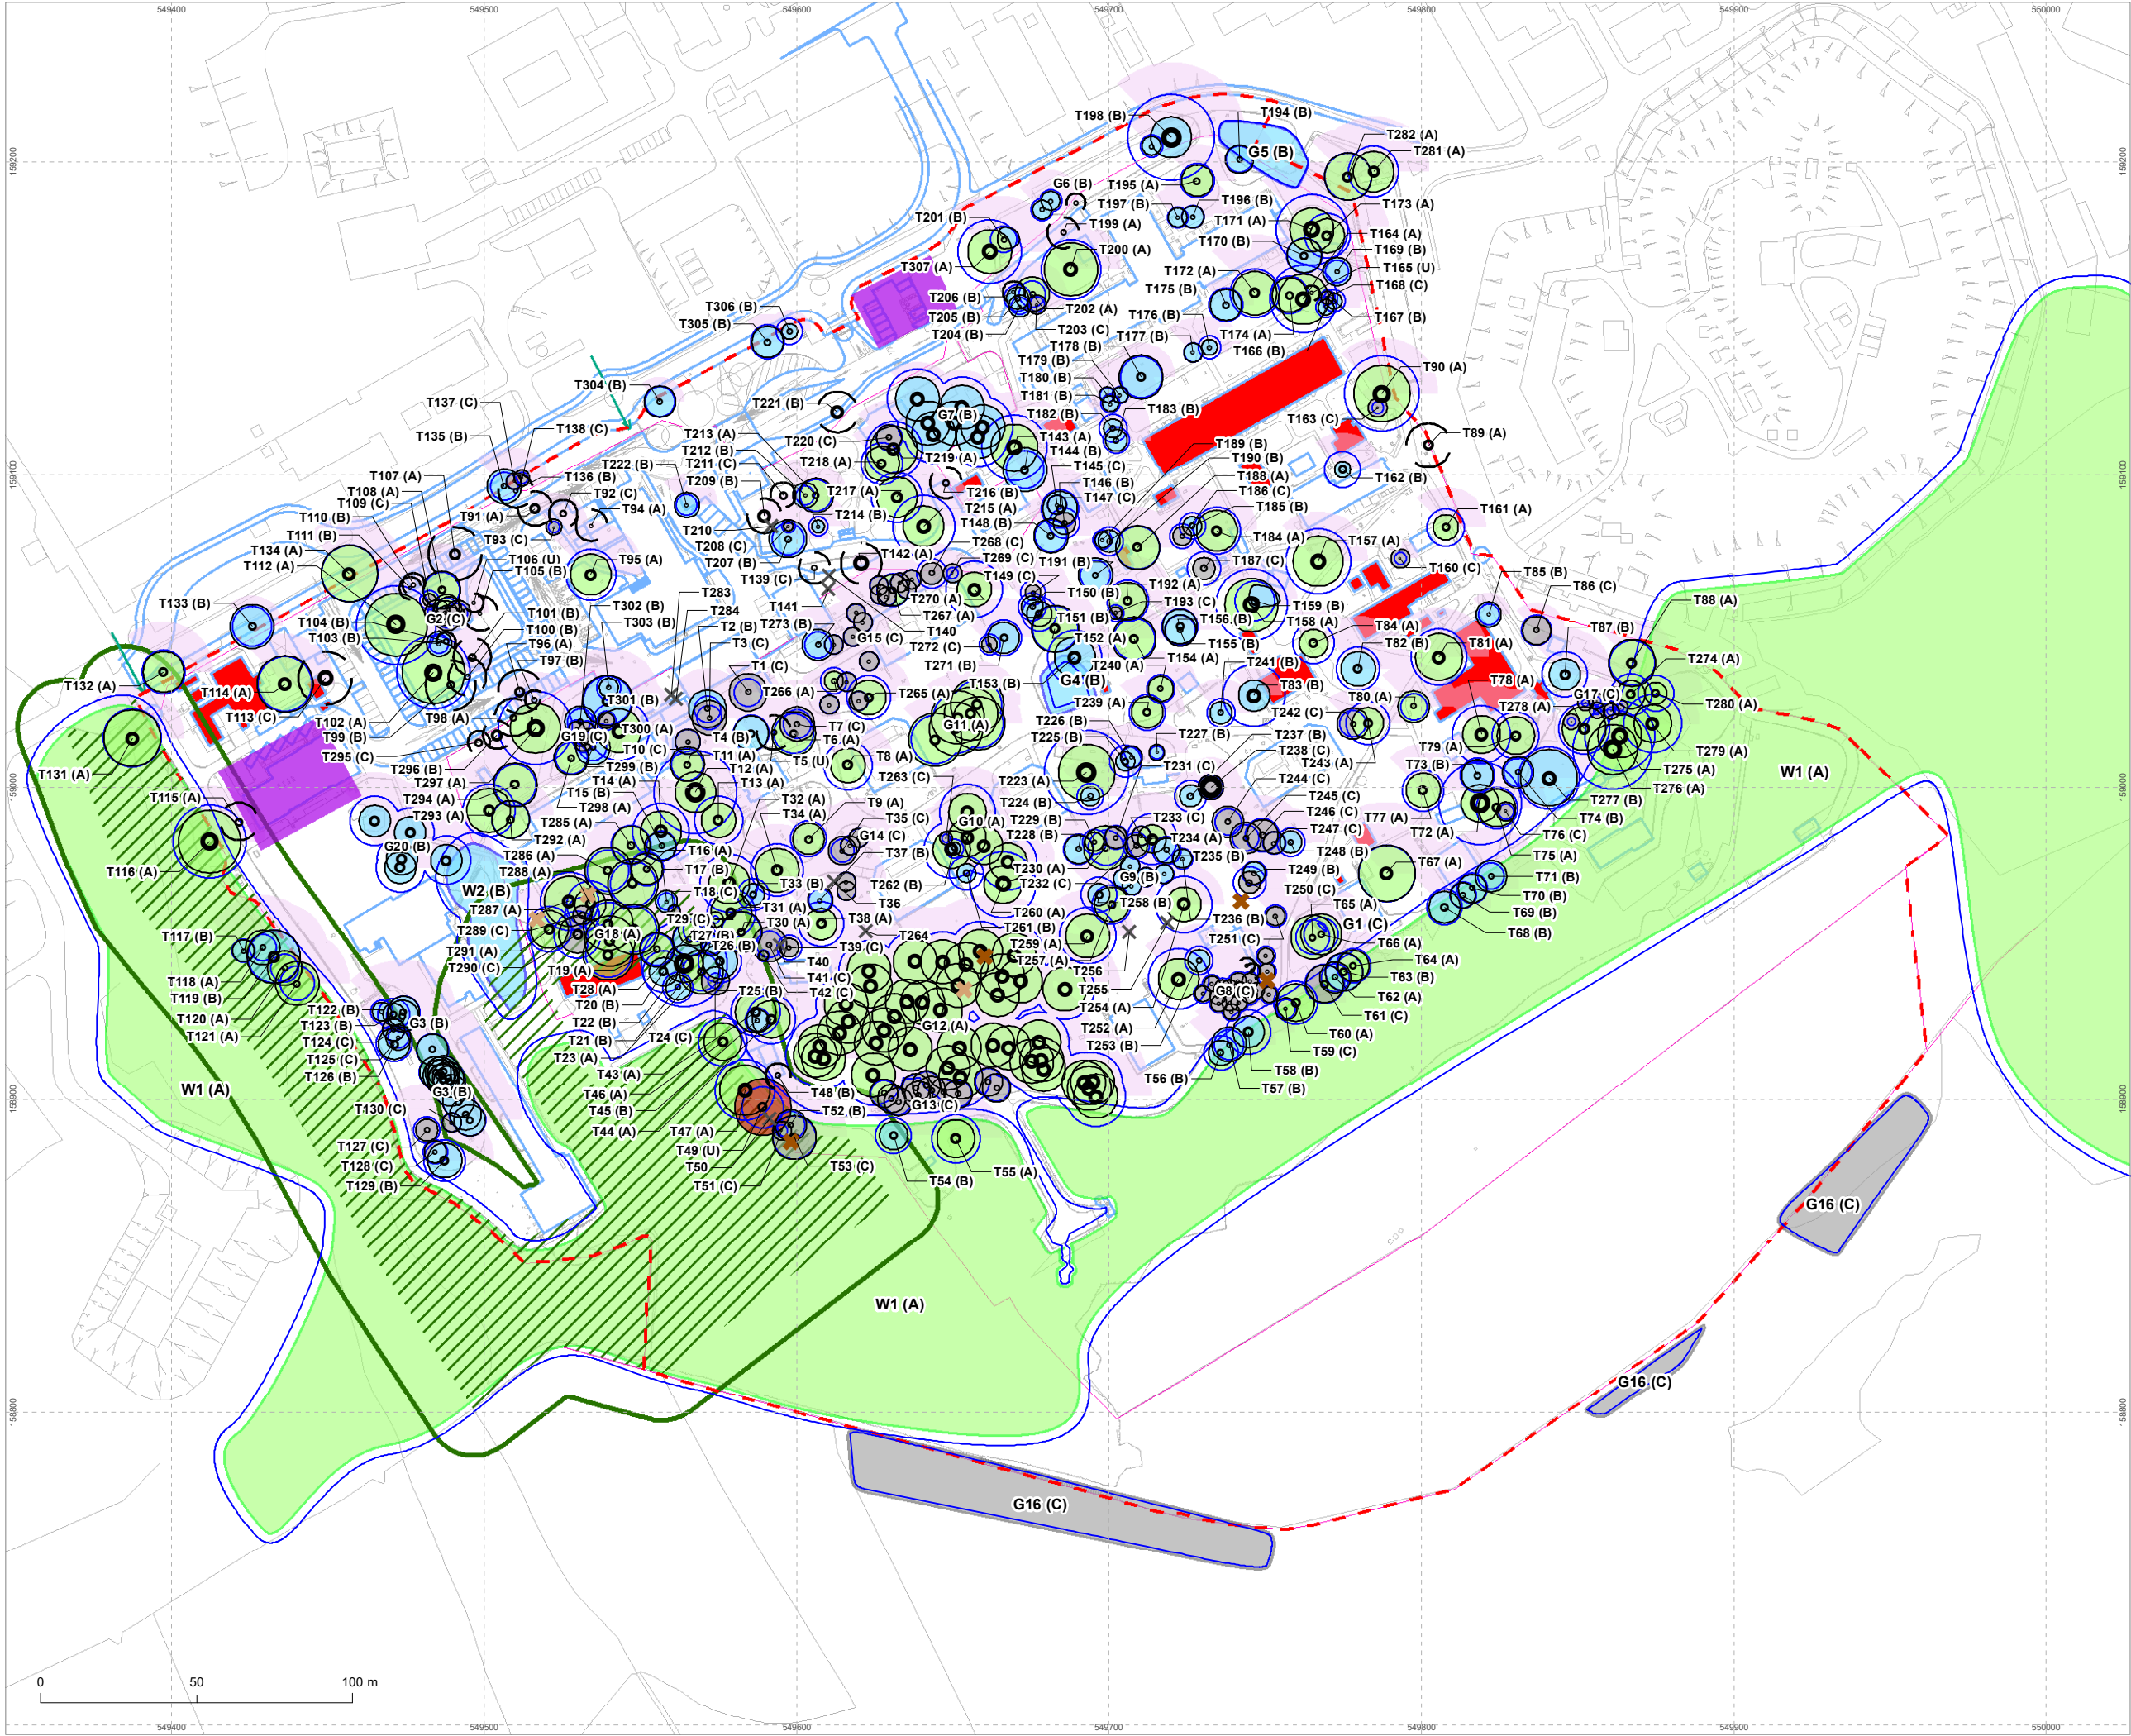
C150872-02-01-RevC

These individual trees were deemed unsuitable for future retention within the site due to their poor structural condition. The trees removed since the Arboricultural Survey are identified on the Tree Retention Plan (Drawing Number C150872-02-01 Rev C) attached to this report.
