OMC Associates

BS 5837 Arboricultural Impacts Assessment

SITE: Hoys House, Wixoe CO10 8UD

DATE OF REPORT: 22 June 2021

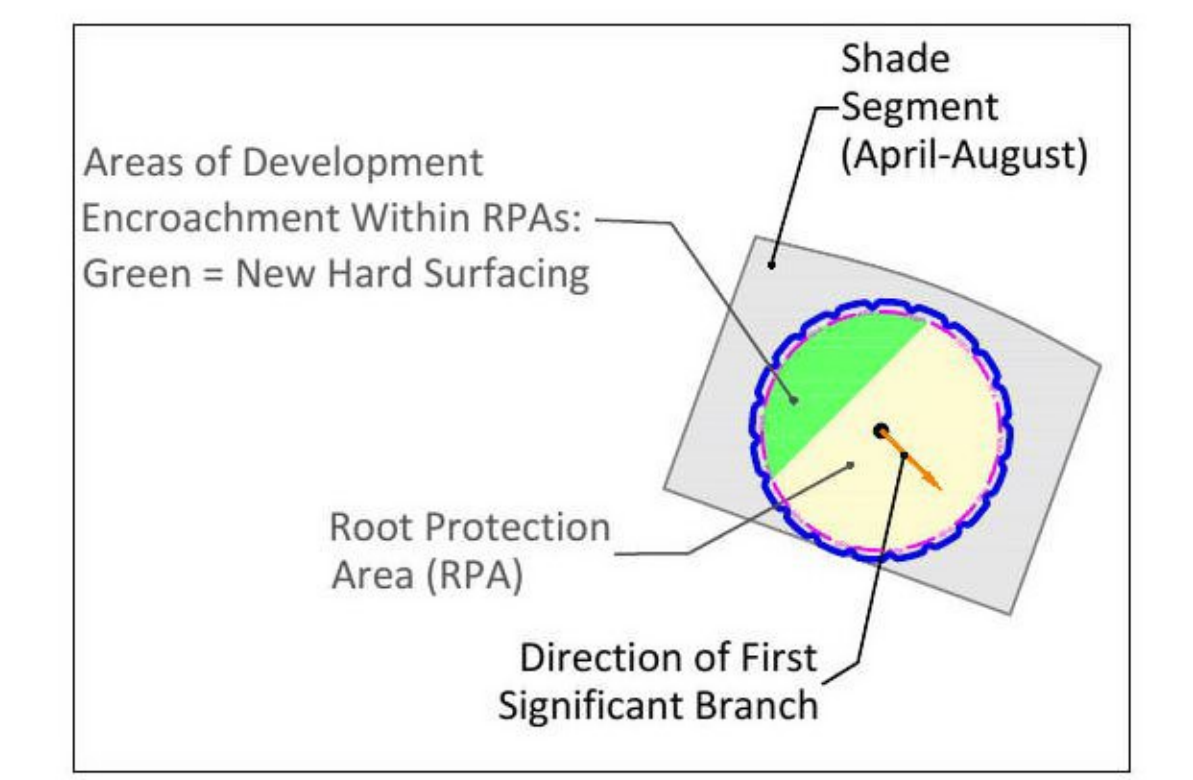
Title
Tree Constraints Plan

The drive entrance marginally and peripherally encroaches upon the RPA of T1. This is low, (less than 5%) and well below the threshold detailed in BS 5837. No adverse impact on health or stability is anticipated on T1.

In view of sections of RPAs of T1-T3 & T7 that extend into areas that will become subject to relatively intensive construction activity, potential impacts may arise, particularly as a consequence of ground compaction (see section 4.1.2).

Construction activity can, however, be avoided in the RPAs of T1-T3 & T7 relatively easily by Construction Exclusion Zones (CEZ) and can be detailed in an arboricultural method statement.

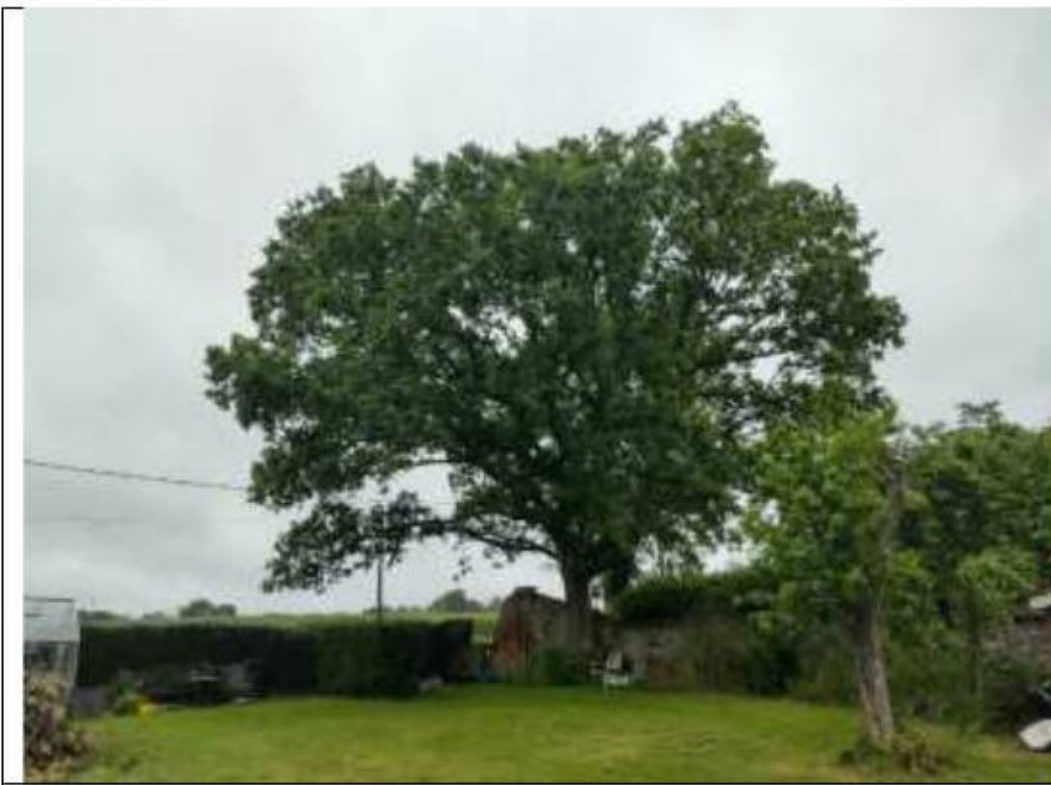
Photo 1

The oak T7 is a fine, shapely specimen oak prominently located to the front of the site. It is in good condition and greatly enhances the proposed scheme by providing it with a setting and softening the proposal.

- T7

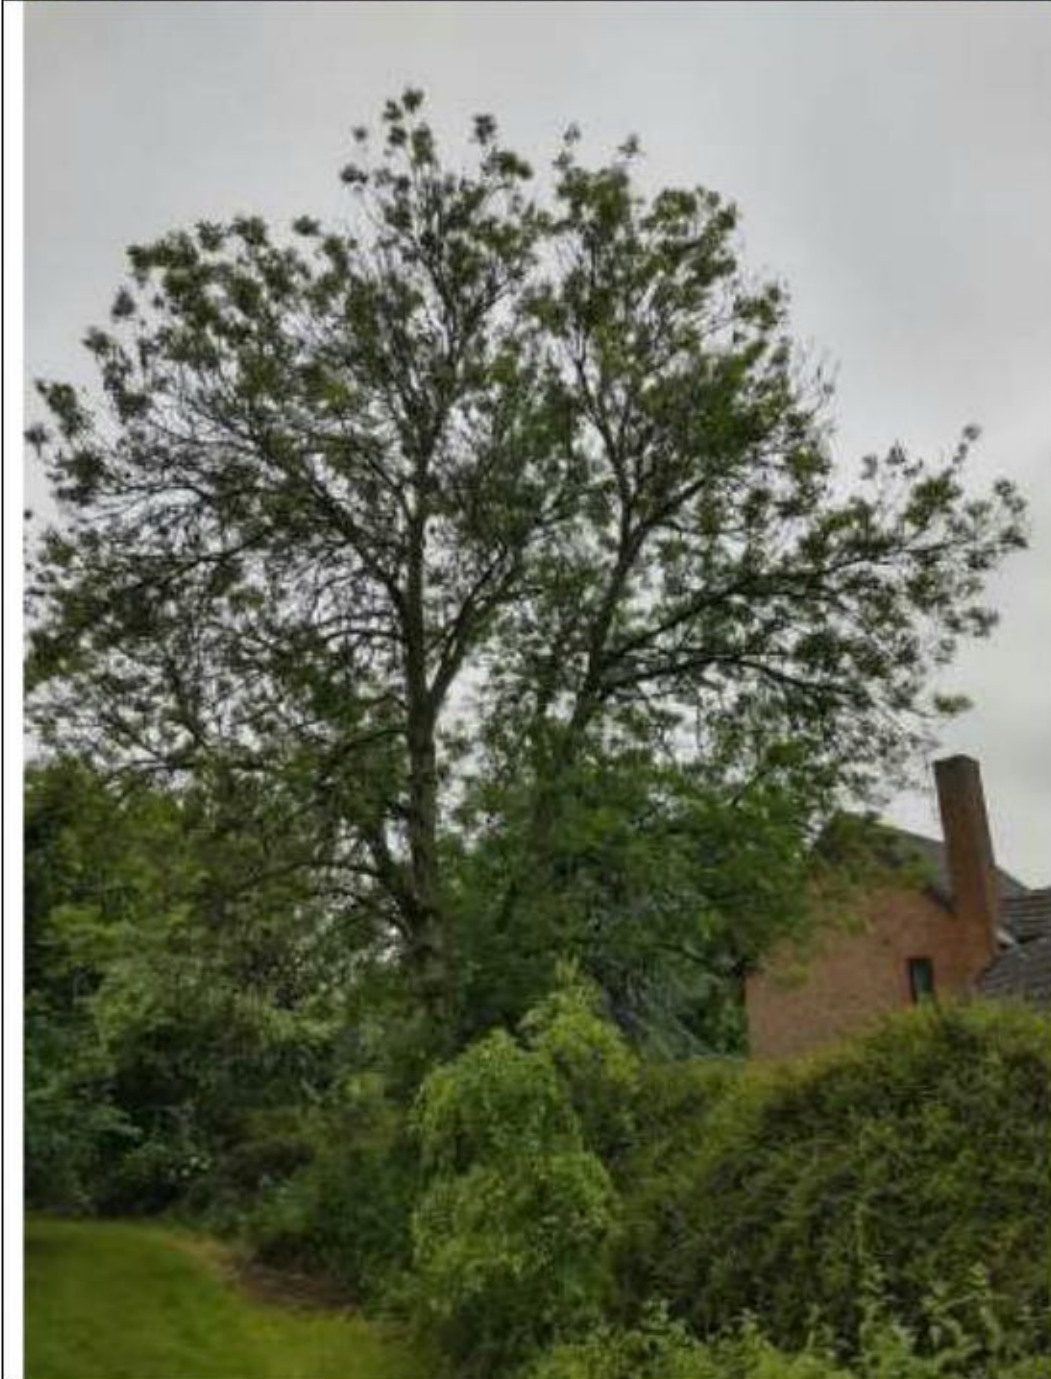
Photo 2

T1-T3 are mature, B grade trees on the western boundary to the north of site. All are prominent and in good health and provide a natural backdrop to the site.

- T3 looking south

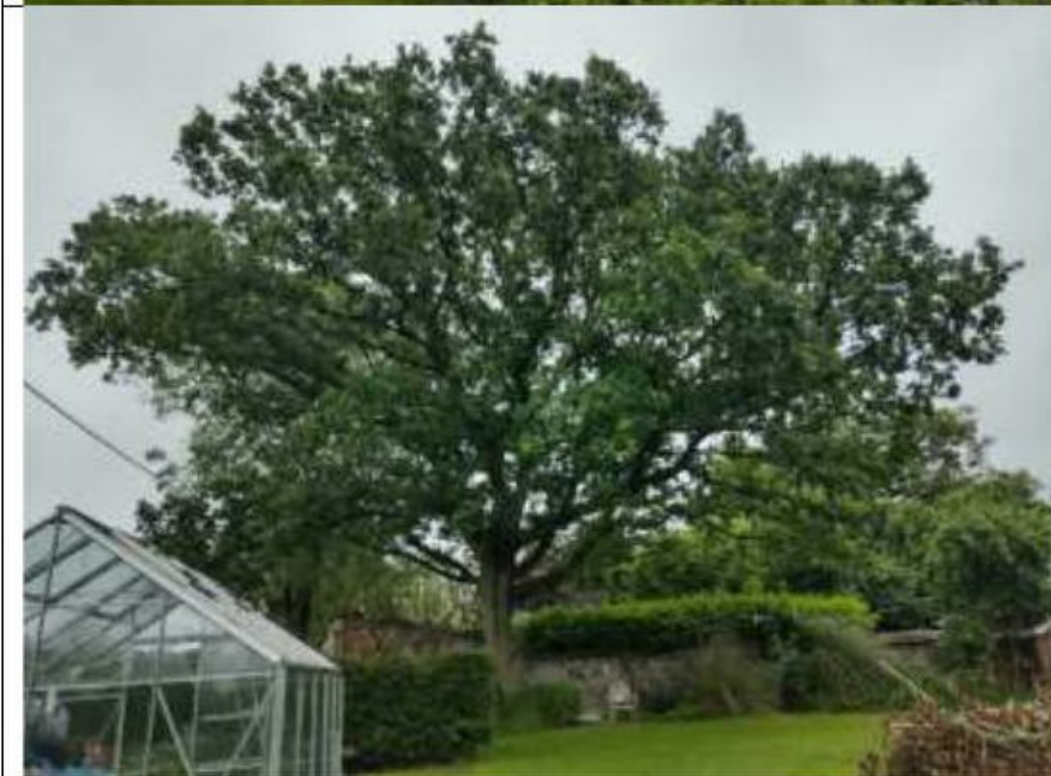
Photo 3

- T7

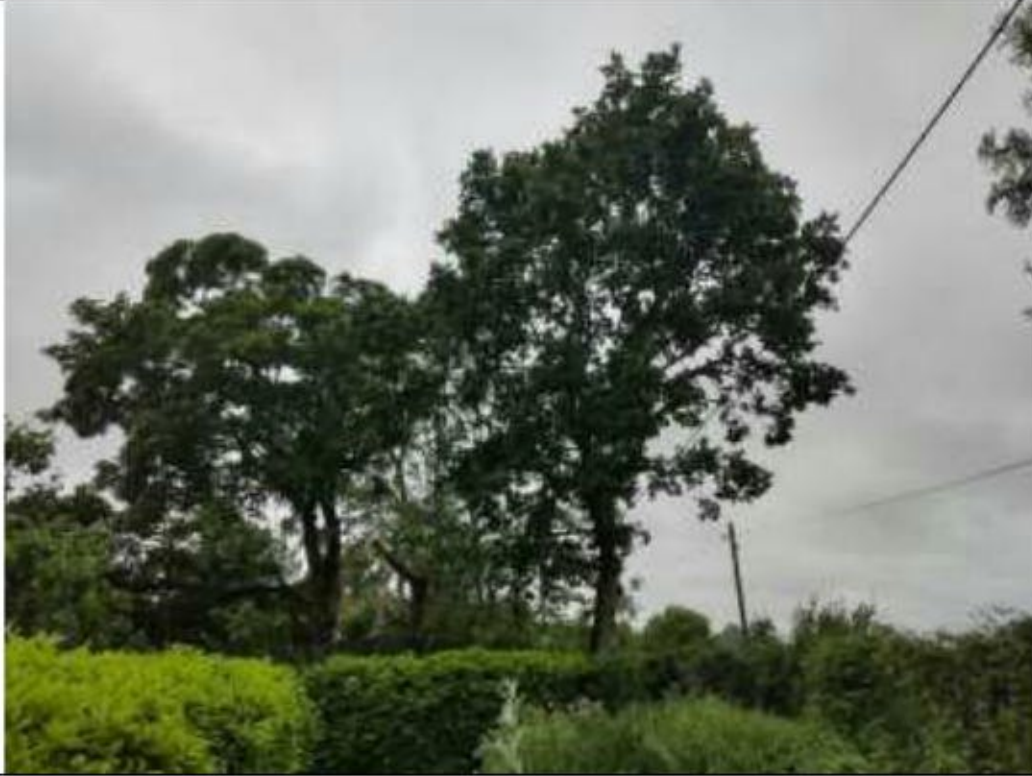
Photo 4

- T1 & T2 looking west

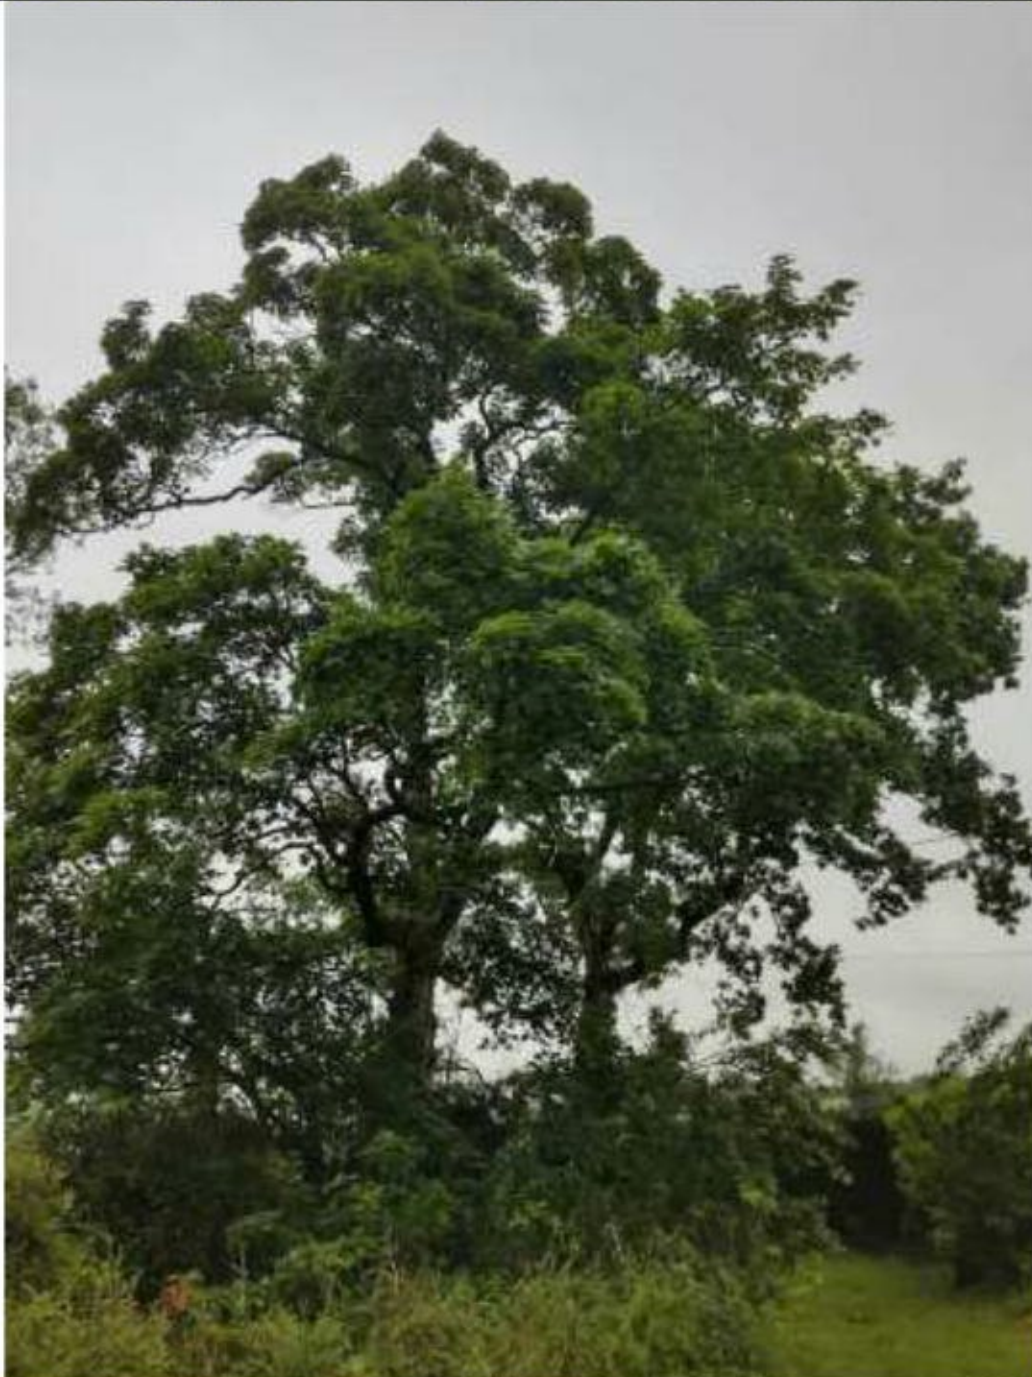
Photo 5

- T1 & T2 looking north
