#### Land at Church Villa, High Street, Ruardean, GL17 9US, - BS5837 Tree Constraints, Tree Impacts and Tree Protection Method Statement for REVISED residential development.

Land at Church Villa, Ruardean, GL17 9US – BJUFC BS5837 inspection – 19th February 2019

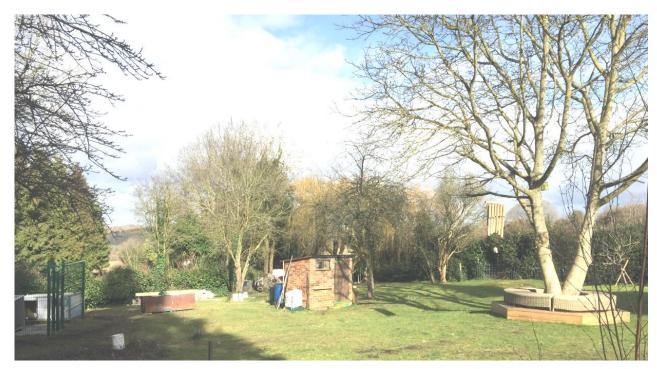
4.4.1 View north from existing parking area. Walnut T14 to the right. Brick-built shed and T13 ahead. Hedge H12 to the left.

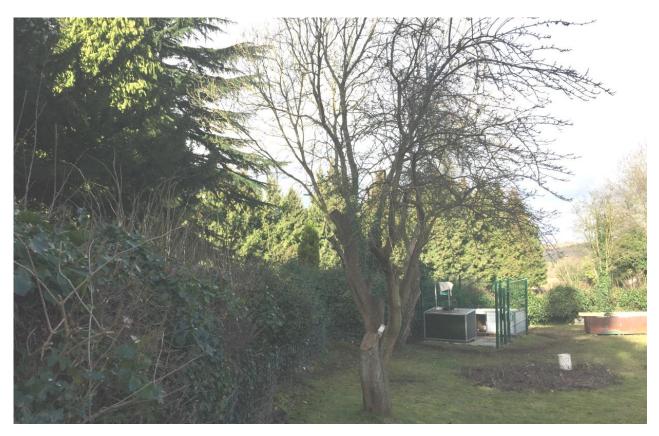
4.4.2 View north along hedge H12. Plum T9 ahead, with off-site Trees T32 and T33 to the left.

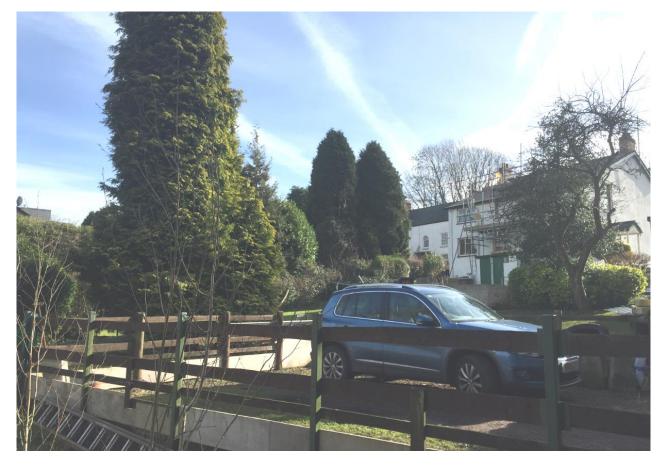
4.4.3 View south east from G8. Golden cypress T7 ahead, with apple T5 to the right. Hedge H2 beyond.

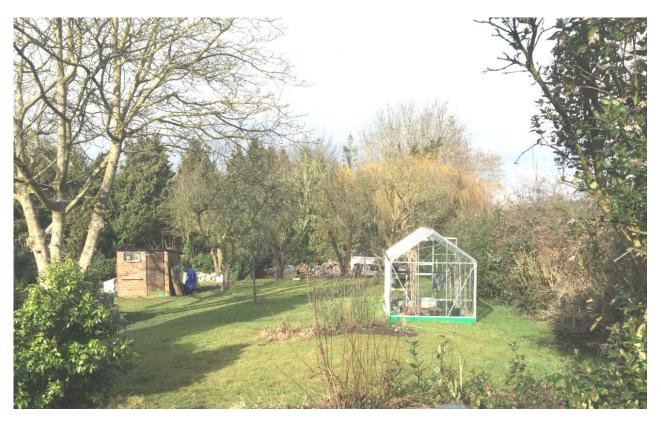
4.4.4 View north of trees T17 to T27 ahead. Walnut T14 to the left, with hedge H4 to the right.

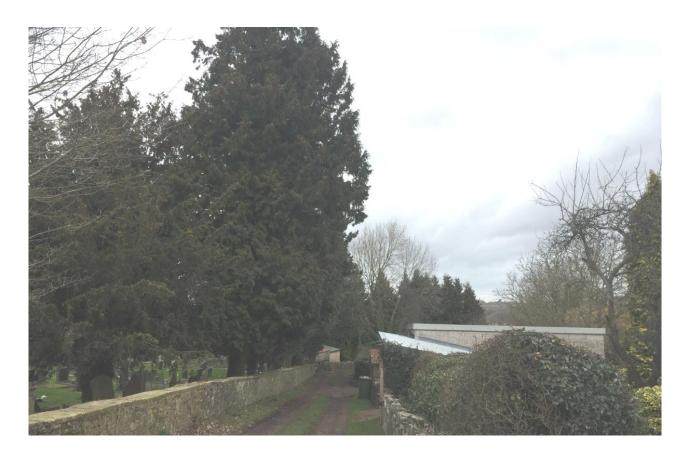
4.4.5 View north along access road, along the site's western boundary. Off-site trees T28 to T33 to the left.
