Retrospective Application for Listed Building Consent for Alterations,  
Planning Permission Application  
For refurbishment works carried out to Basement  
at  
15 Montpelier Square  
London SW7 1JU

## INTRODUCTION

## VISUAL INSPECTION

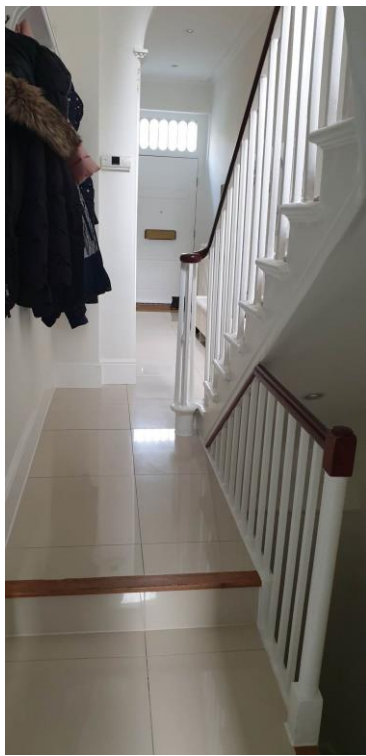
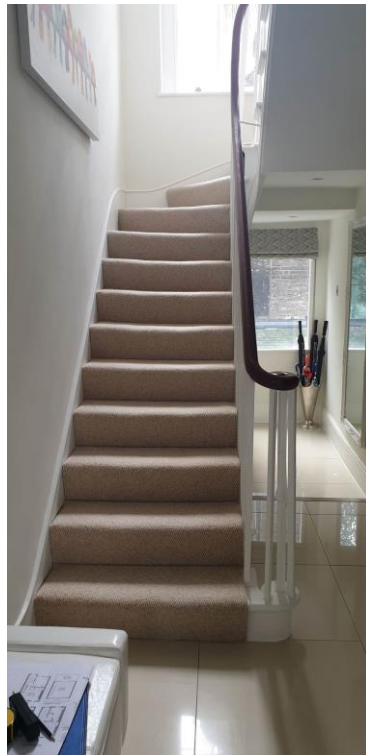
**Hallway Entrance (skirting and architrave)**

It is highly unlikely the skirting, doors and surround architrave would have the matched the standards of the upper floors. Also, the doors to the upper floors would have been replaced/upgraded to meet building regulation standards, especially if purchased as an investment for renting.

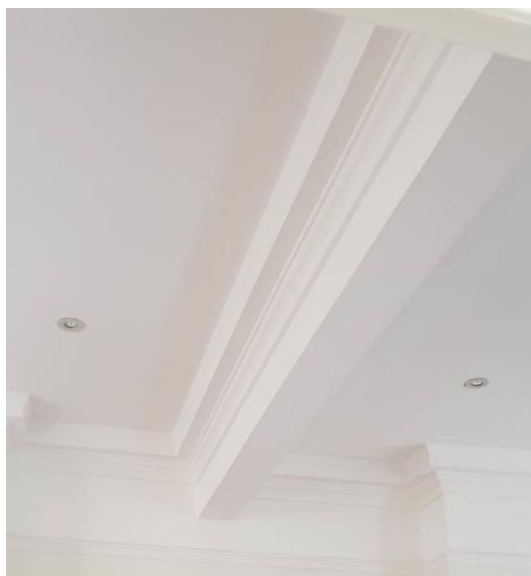
**Standard of Architrave to Main Rooms**

Leading to the basement, the skirting matches the main staircase skirting to the same high standard.

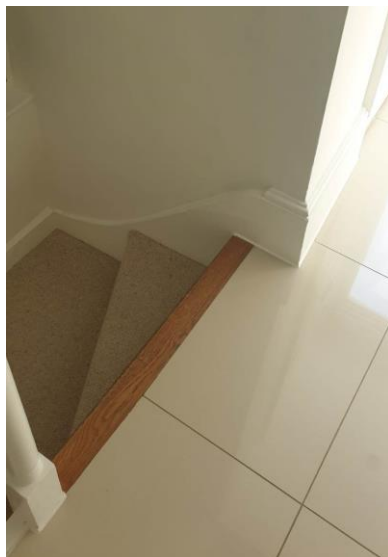
### **Staircase Leading to Basement**

Without any records on the type of work carried out, there is a possibility of all the original features remained. The plasterboard would be fixed to a new stud or battened boarded wall and plaster (as shown below), leaving the original features completely untouched.

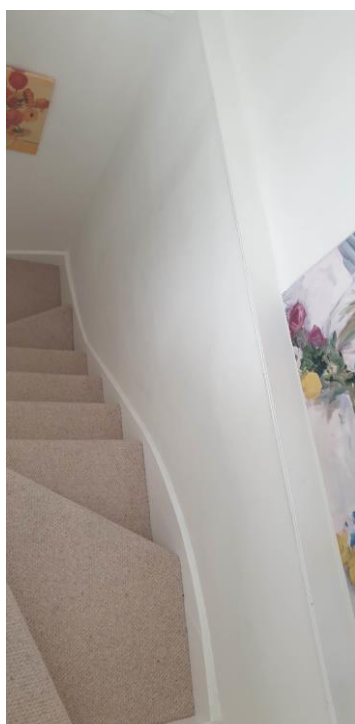
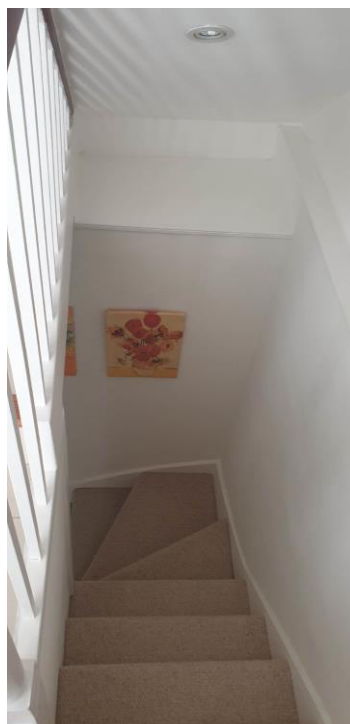
### **Evidence of New Stud Walls to Boundary Walls**

The basement has been refurbished to a high standard. A lowered ceiling would indicate the original ceiling detail and features would have remained untouched. Further evidence is indicated by the thickness of the door frames. The distance from the back door frame to the line of the wall is far greater than under normal circumstances. This possibly shows a new stud or battened wall and plastered without affecting the existing wall. A new false wall would also allow the first fix to lay cables and pipes without chasing into the existing wall. Noting the second fix is flush with the wall providing a tidier finish.

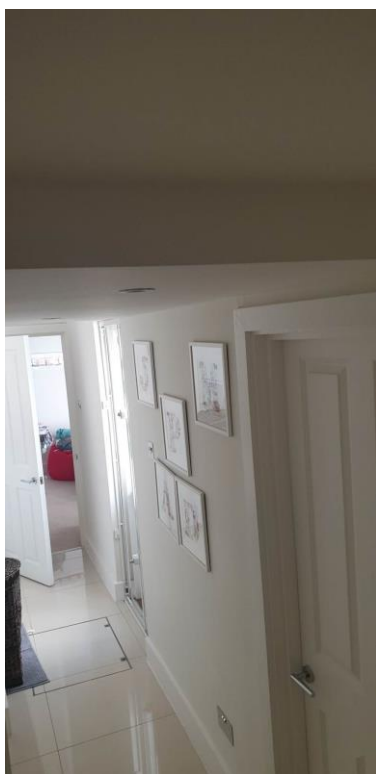
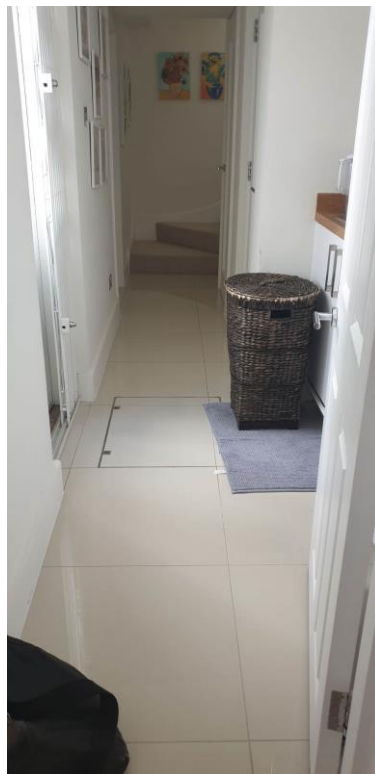
### **Basement Landing**

4 panel (fire) doors, architrave, skirting, and tiled floor are to the same high level throughout, matching the standard of the remaining approved upgrade to the upper floors.

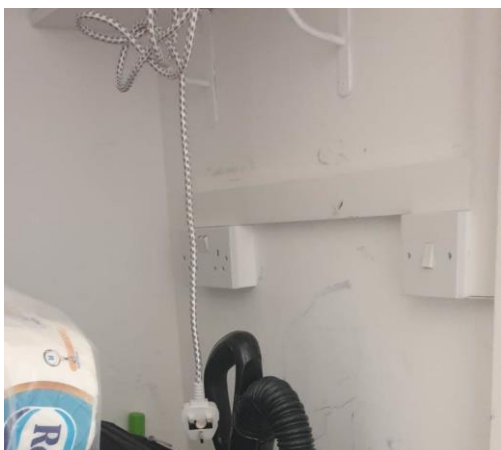
Cable ducting used in cupboards to avoid chasing cables into existing walls.

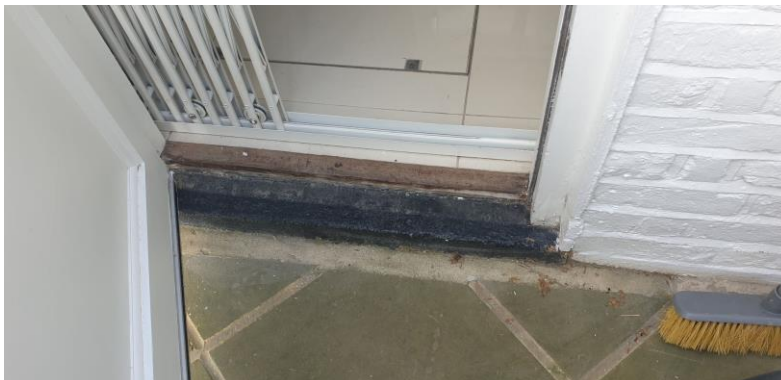
**Evidence of Raised Floor**

There is also evidence of the basement floor being raised with the possibly of the original floor untouched. Similar reasons for first and second fix, resulting in a tidier finish. Below is evidence of the raised floor with a new timber threshold fixed above the existing.

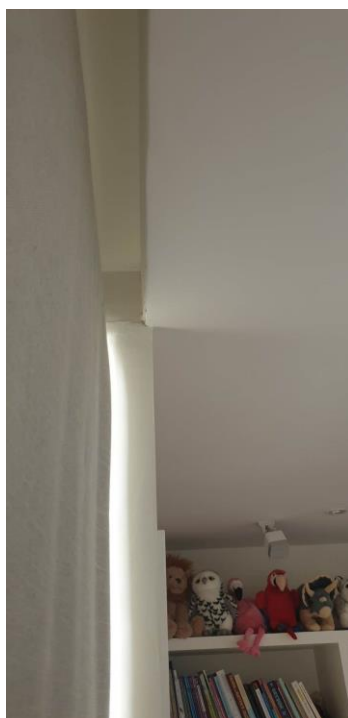
**Evidence of Lowered Ceiling in Snug Room**

Evidence of a lowered ceiling. The ceiling level is lower than the top of the window. Again, with the possibly of the original ceiling untouched.

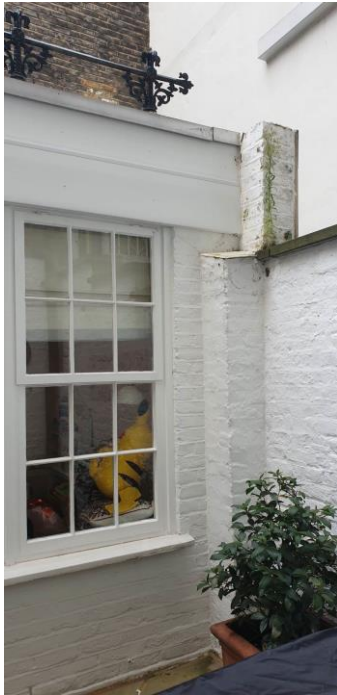
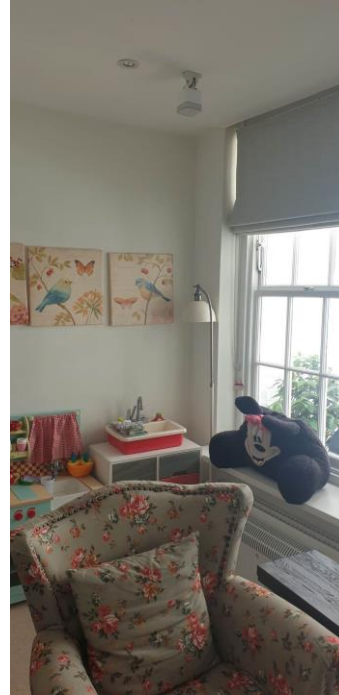
**Visual Difference Externally and Internally**

There is possibly a new stud wall to the southwest boundary wall. The distance from the boundary wall to the window externally (approx. 450mm) is far greater than the distance internally at approximately 260mm. This would indicate a new stud wall with the existing wall remaining untouched.

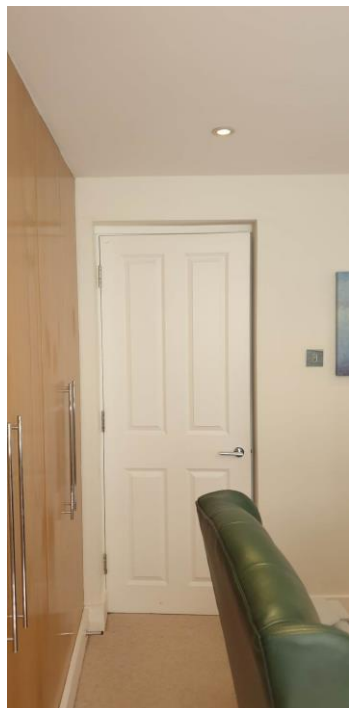
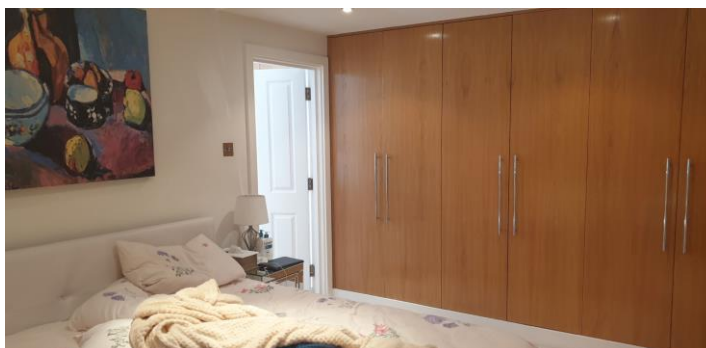
## **Internal Wall Thickness**

Further evidence of the walls possibly remained untouched during the refurbishment is indicated in the study and spare room, by the thickness of the door frames/wall, distance from the back door frame to the line of the wall. The Internal wall thickness is normally 100mm. The wall between the study and spare room is 200mm. This possibly indicates a new stud or battened wall and plastered without affecting the existing wall. A lowered ceiling throughout the basement would indicate the original ceiling detail and features would have remained untouched.

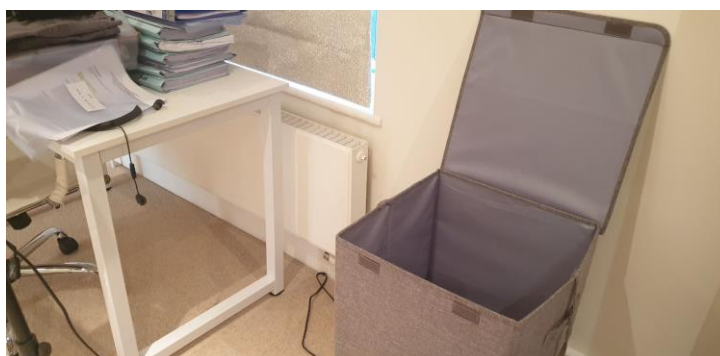
## **Windowsill Overhang in Spare Room**

The windowsill overhang distance from wall is almost non-existent. This would indicate a new stud or battened wall and plastered without affecting the existing wall and window.

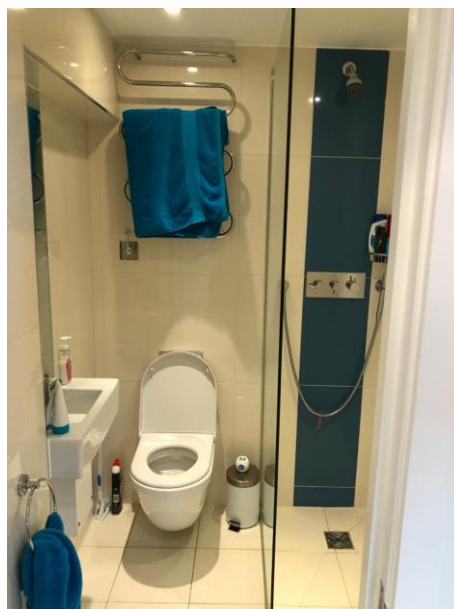
### Bathroom

The tiling and hidden plumbing is a good indication of a new stud without affecting the existing wall. A lowered ceiling throughout the basement would indicate the original ceiling detail and features would have remained untouched.
