Arboricultural Report

Holmside
145 Barnet Road
Arkley
EN5 3JZ

July 2021

140518-PD-21

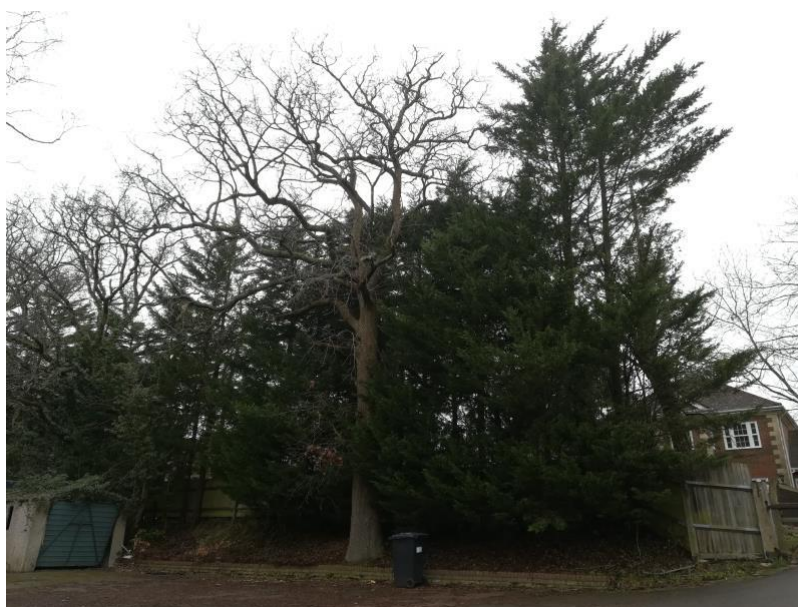
- 4.2 The most visually prominent trees are situated adjacent to Barnet Road. On the western side of the main driveway there is group of mature oak and Leyland cypress (T2 to G8), while on the eastern side there is a group of ash trees (T35 to T41). The ash tree surveyed within this area are in poor condition and given the surrounding targets, they pose a high level of risk to people and property.

Image 2: View of the oak T3 and Leyland cypress G8 located adjacent to Barnet Road.

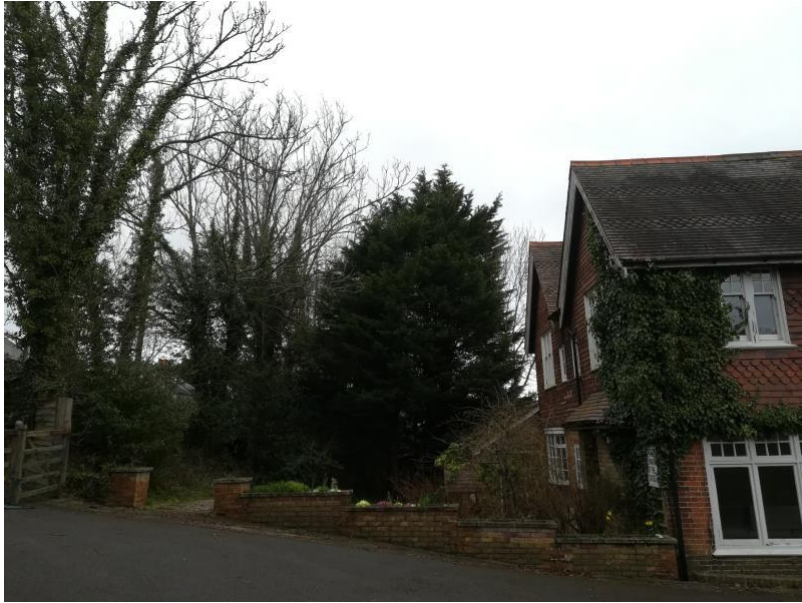
Image 3: View of the Leyland cypress and ash trees (T32 to T41) in the northern most corner of the site.

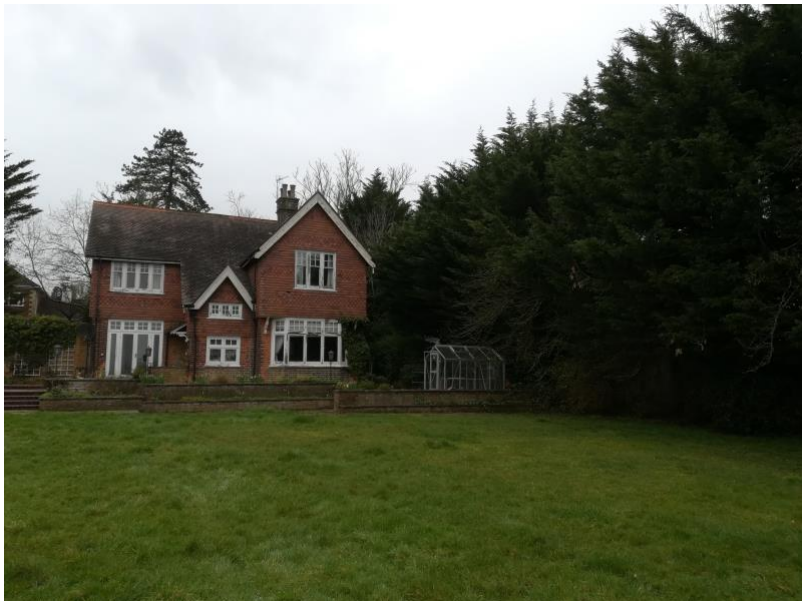
Image 4: View of the Leyland cypress group G31 located along the boundary with the neighbouring property.

- 6.3 The eastern boundary Leyland cypress tree group (G31) will open up the boundary between the two sites; however, these trees are of low quality and value and appropriate replacement planting has been proposed to mitigate their loss.

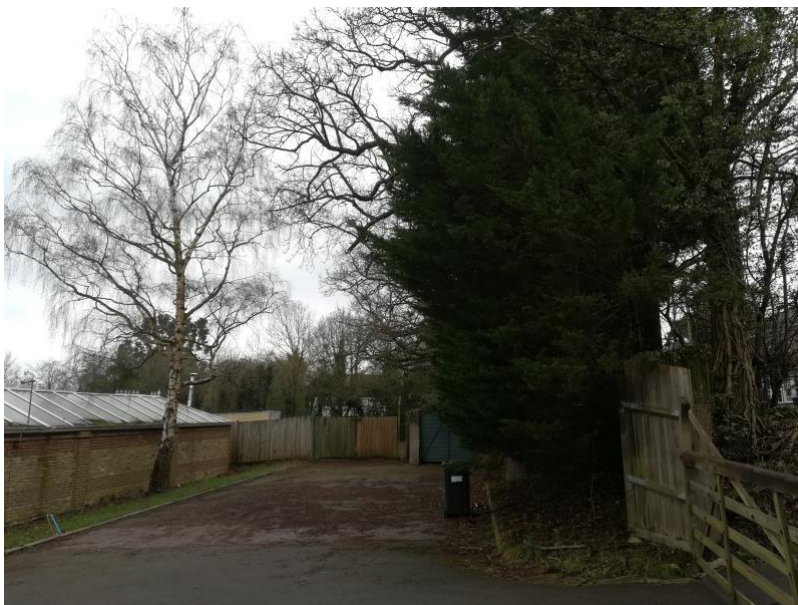
- 6.2 The silver birch (T9) is the only moderate quality tree proposed to be removed as part of the development works. The loss of this tree will not have a significant impact in visual terms, as it is both located internally within the site and screened by the adjacent more prominent mature oak trees, that are located along the site boundary.

Image 5: View of the silver birch T9.

- 6.4 The proposed development is accompanied by a landscaping concept scheme that specifies new trees and hedgerows. New planting is shown along the site boundaries and adjacent to Barnet Road to replace the poor and low quality trees that are recommended for removal. In addition, a feature tree has been shown within the grassed area of the site to replace the moderate quality birch tree (T9).

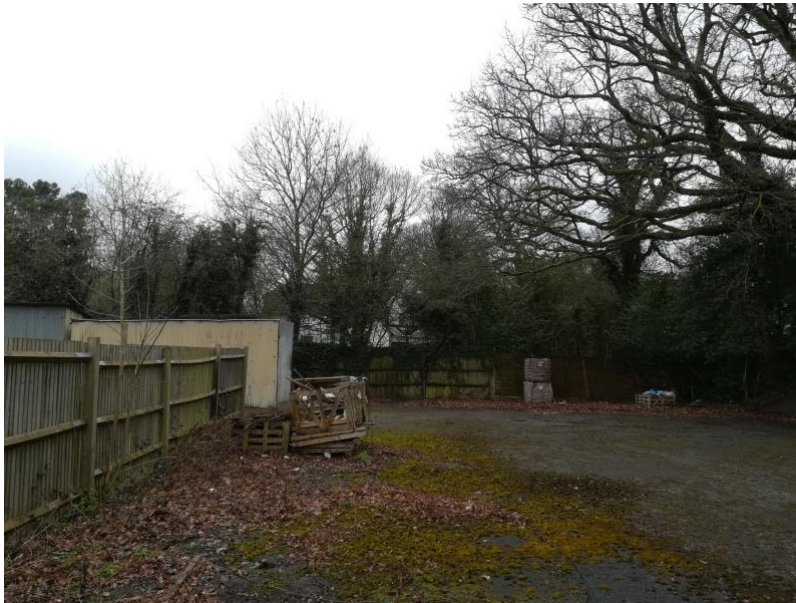
Image 6: View of the existing hard standing to be removed within the RPAs of oak trees T4 to T6.

- Works will commence at the point closest to the tree and operate backwards until outside the designated RPA to avoid moving over exposed ground.
 - Working from either outside the designated RPA or from an area of existing hard standing or temporary ground protection, the upper surface layer of hard standing will be fractured into small sections.

- Broken material will be manually lifted and removed to a designated storage area located outside the RPA of retained trees.

- The removal of the sub-base material will be undertaken in a careful manner, ensuring that no excavation works occur beyond the depth of the built material and into the soil layer below.
- The area within the RPAs of T4, T5, T6 will be restored to grass. Once the hard standing has been removed, topsoil will be spread across this area and it will be irrigated to prevent root desiccation from occurring.
- New hard surfacing will replace the existing hard surfacing within the RPA of T2. No roots will be exposed during this process. If required, ground protection mats must be installed.
