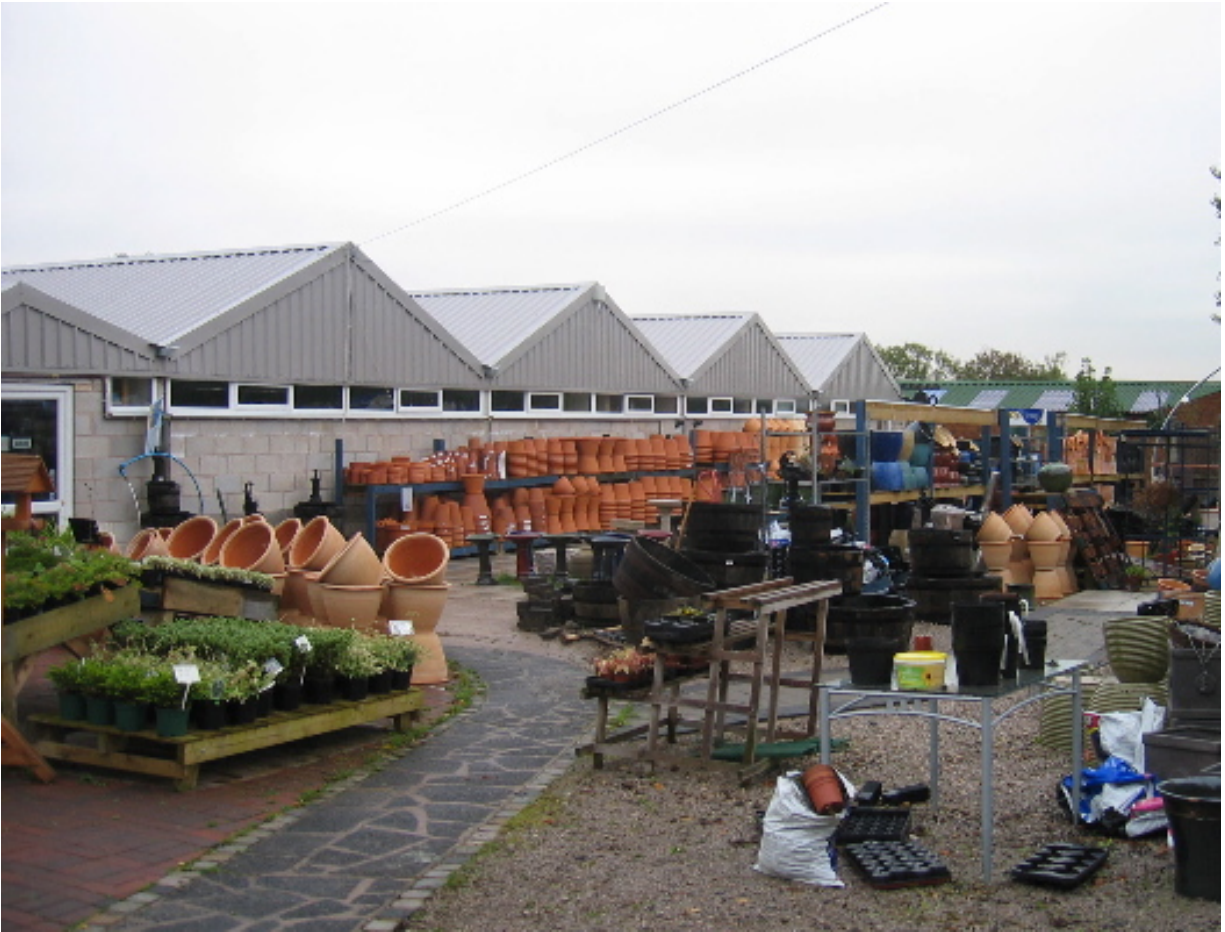
Elevation of the re-modelled building

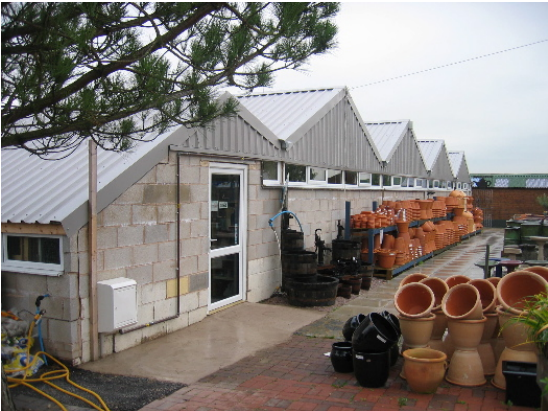
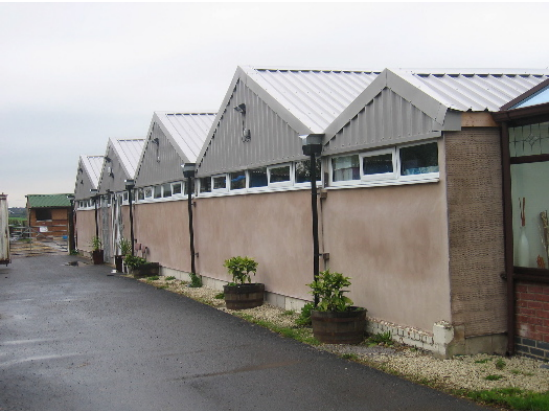
Both side elevations of the re-modelled building

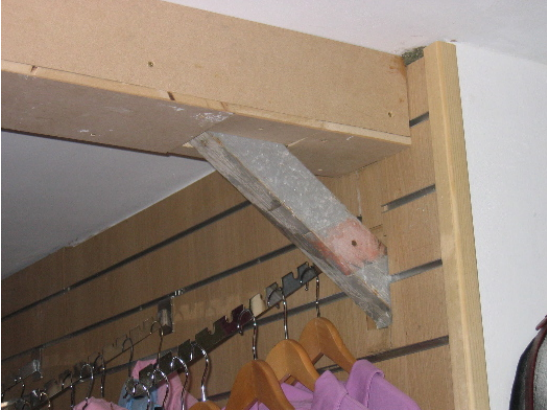
Interior of the building identifying the boxing in of the metal frame of the original glasshouse structure

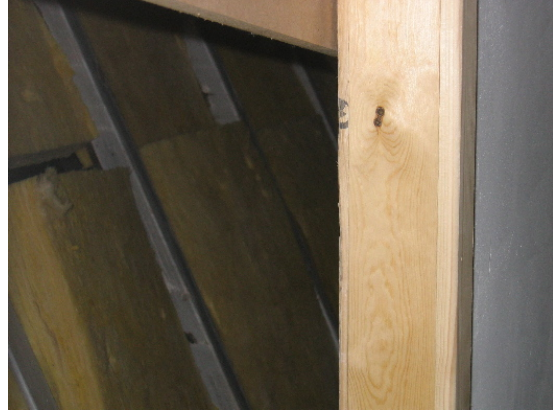
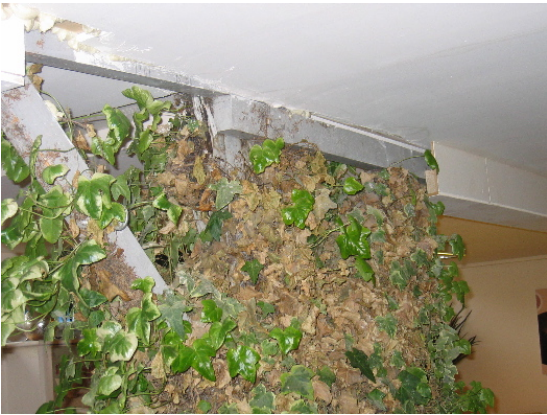
An ivy plant grown in the ground in the original glass house structure; the ivy is seen still climbing the exposed portion of the metal frame
