Low Farmhouse  
Low Road  
Keswick  
Norwich  
NR46TX

**Heritage Statement: Listed Building consent to remove Concrete Render and replace with Lime Render**

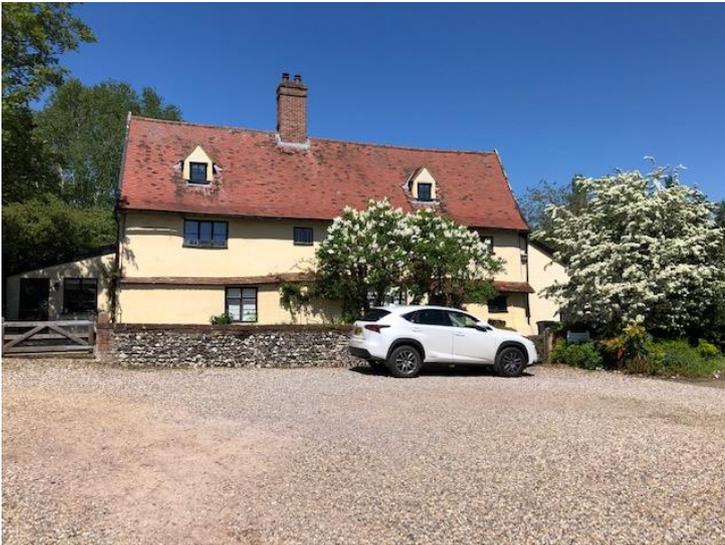
Front Elevation of Low Farmhouse. Note Tiled offset between ground and first floor.

- vii. The “tiled offset” will be replaced

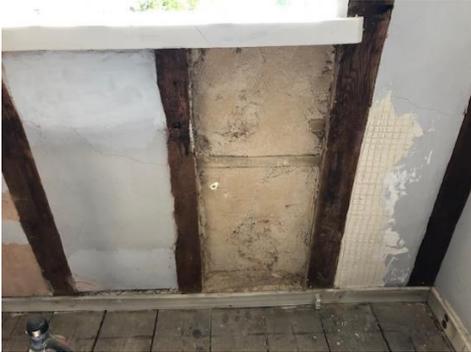
Internal picture revealing external render visible after “blown” panel removed at Low Farmhouse. Also visible is gypsum plaster board and gypsum plaster repair during earlier renovations and old pine floorboards laid over original badly damaged oak flooring.

- iv. It is expected that some panels will require repair (previous work in the small bedroom at the northern end of the eastern wall revealed some panels to be unstable, although the framing posts were intact). Repair will be with lathe and plaster

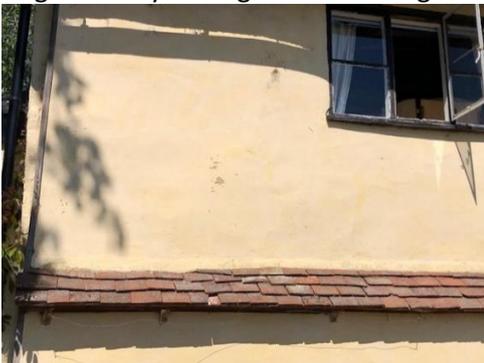
Front Elevation south end showing damaged concrete render

- i. Phase a. in 2021 will involve the removal of concrete render from the front elevation at first floor and ground floor level. This may/will require temporary removal of the tiled offset between the ground and first floor.

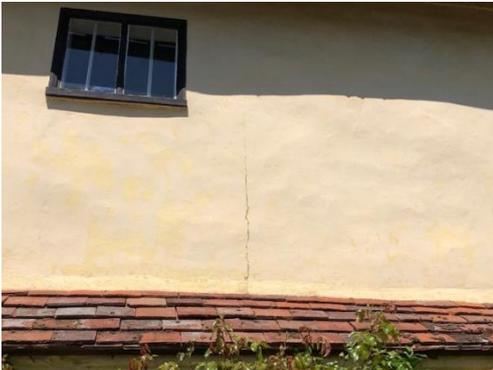
Cracked render and poorly applied limewash flaking off the render.

- v. Window frames may also require repair
- vi. Once these repairs are complete then lime render will be reapplied and once dry the render will be finished in a Limewash or Kiem mineral paint.

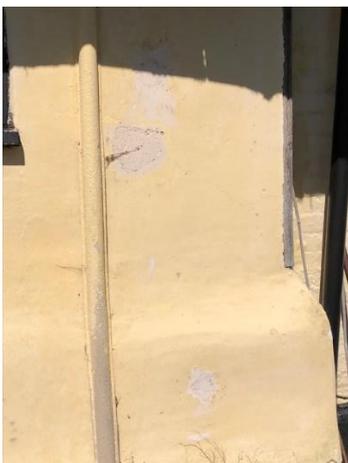
Further patching of render at North end of Front elevation
