Project: 21_5837_06_15
Site: 6 Chantry Walk, Wirral, CH60 8PX
Client: Mark Lawrie

Document Title:	Tree Survey
Document Author:	Ffion Maguire
Project Title:	6 Chantry Walk, Wirral, CH60 8PX

Tree Survey & Arboricultural Impact Assessment to BS 5837 2012 of trees at: 6 Chantry Walk, Wirral, CH60 8PX.

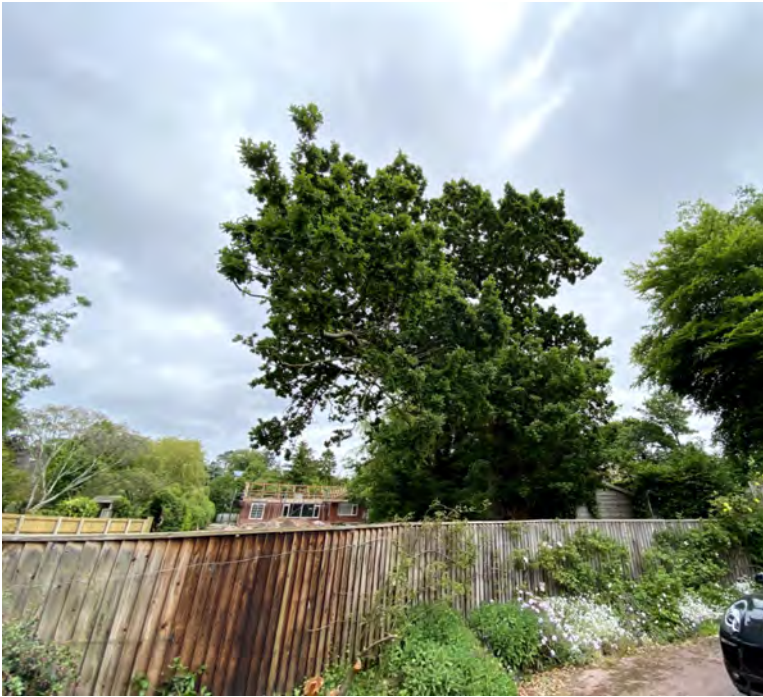
Photographic plate showing tree T1, a mature Common Oak.

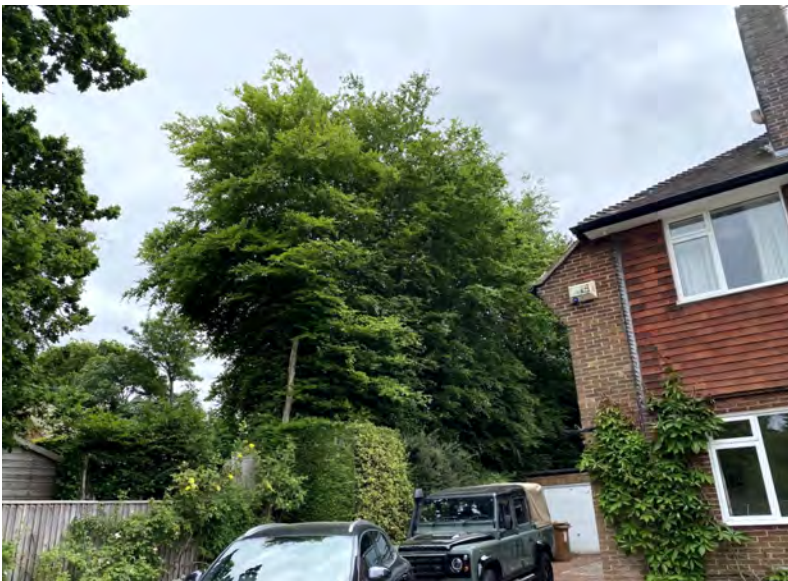
Photographic plate showing a linear feature of Beech trees, situated on the site's eastern boundary.

T3	Common Beech	<i>Fagus sylvatica</i>	Mature	Yes	12	N-2	1	310	N/A	4	4	4	4	3.7	Good	Fair	Fair	B	20 to 40 yrs	1 Arboricultural Values;2 Landscape Values	Good	Crown reduction to ease encroachment upon building.	Part of a linear feature of 8 Beech trees acting as a hedge row, branches encroaching over boundary line and building.
T4	Common Beech	<i>Fagus sylvatica</i>	Mature	Yes	12	N-2	1	300	N/A	4	4	4	4	3.7	Good	Fair	Fair	B	20 to 40 yrs	1 Arboricultural Values;2 Landscape Values	Good	Crown reduction to ease encroachment upon building.	Part of a linear feature of 8 Beech trees acting as a hedge row, branches encroaching over boundary line and building.
T5	Common Beech	<i>Fagus sylvatica</i>	Mature	Yes	12	N-2	1	400	N/A	4	4	4	4	3.7	Good	Fair	Fair	B	20 to 40 yrs	1 Arboricultural Values;2 Landscape Values	Good	Crown reduction to ease encroachment upon building.	Part of a linear feature of 8 Beech trees acting as a hedge row, branches encroaching over boundary line and building.

T6	Common Beech	<i>Fagus sylvatica</i>	Mature	Yes	12	N-2	1	350	N/A	4	4	4	4	3.7	Good	Fair	Fair	B	20 to 40 yrs	1 Arboricultural Values;2 Landscape Values	Good	Crown reduction to ease encroachment upon building.	Part of a linear feature of 8 Beech trees acting as a hedge row, branches encroaching over boundary line and building.
T7	Common Beech	<i>Fagus sylvatica</i>	Mature	Yes	12	N-2	1	400	N/A	4	4	4	4	3.7	Good	Fair	Fair	B	20 to 40 yrs	1 Arboricultural Values;2 Landscape Values	Good	Crown reduction to ease encroachment upon building.	Part of a linear feature of 8 Beech trees acting as a hedge row, branches encroaching over boundary line and building.
T8	Common Beech	<i>Fagus sylvatica</i>	Mature	Yes	12	N-2	1	400	N/A	4	4	4	4	3.7	Good	Fair	Fair	B	20 to 40 yrs	1 Arboricultural Values;2 Landscape Values	Good	Crown reduction to ease encroachment upon building.	Part of a linear feature of 8 Beech trees acting as a hedge row, branches encroaching over boundary line and building.

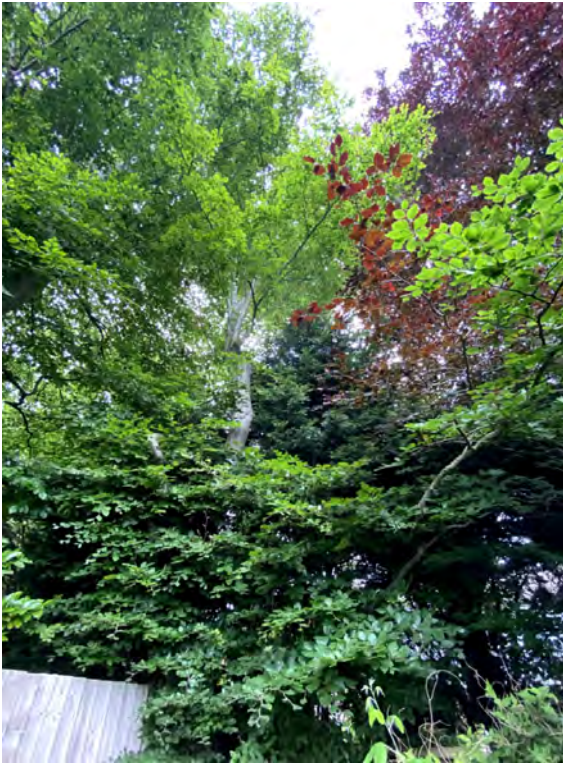
Photographic plate showing trees T9 and T10, situated offsite, on the southeast corner of the site.

T9	Common Beech	<i>Fagus sylvatica</i>	Mature	Yes	12	N-2	1	400	N/A	4	4	4	4	3.7	Good	Fair	Fair	B	20 to 40 yrs	1 Arboricultural Values;2 Landscape Values	Good	Crown reduction to ease encroachment upon building.	Part of a linear feature of 8 Beech trees acting as a hedge row, branches encroaching over boundary line and building.
T10	Leyland Cypress	<i>X Cupressocyparis leylandii</i>	Semi-mature	Yes	7	N-2	1	150	N/A	2	2	2	2	3	Fair	Fair	Fair	C	10 to 20 yrs	2 Landscape Values	Fair	No remedial works required.	Situated offsite, part of an overgrown hedgerow feature.
T11	Copper Beech	<i>Fagus sylvatica f. purpurea</i>	Mature	Yes	11	N-4	1	210	N/A	3	3	3	3	4	Good	Good	Fair	A	>40 yrs	1 Arboricultural Values;2 Landscape Values	Good	No remedial works required.	Part of a linear feature of 4 Beech trees, mechanical damage noted.
T12	Copper Beech	<i>Fagus sylvatica f. purpurea</i>	Mature	Yes	11	N-4	1	400	N/A	3	3	3	3	4	Good	Good	Fair	A	>40 yrs	1 Arboricultural Values;2 Landscape Values	Good	No remedial works required.	Part of a linear feature of 4 Beech trees, mechanical damage noted.

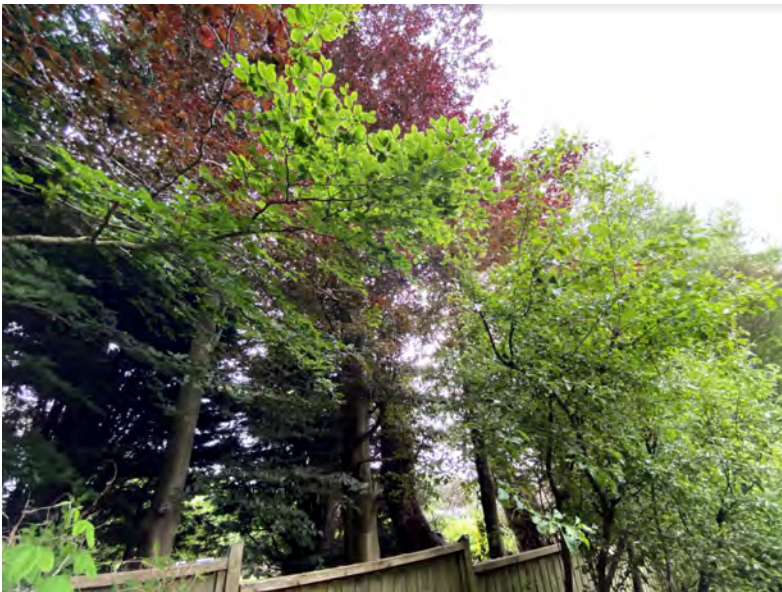
Photographic plate showing trees T11, T12, T13 and T14, situated offsite.

T13	Copper Beech	<i>Fagus sylvatica f. purpurea</i>	Mature	Yes	11	N-4	1	190	N/A	3	3	3	3	4	Good	Good	Fair	A	>40 yrs	1 Arboricultural Values;2 Landscape Values	Good	No remedial works required.	Part of a linear feature of 4 Beech trees, mechanical damage noted.
T14	Copper Beech	<i>Fagus sylvatica f. purpurea</i>	Mature	Yes	11	N-4	1	210	N/A	3	3	3	3	4	Good	Good	Fair	A	>40 yrs	1 Arboricultural Values;2 Landscape Values	Good	No remedial works required.	Part of a linear feature of 4 Beech trees, mechanical damage noted.
T15	Black Poplar	<i>Populus nigra var betulifolia</i>	Mature	Yes	14	E-3	1	750	N/A	6	6	6	6	4	Good	Ivy	Fair	B	20 to 40 yrs	1 Arboricultural Values;2 Landscape Values	Good	Crown reduction to ease encroachment upon building.	Situated offsite within the school grounds, unable to inspect stem or base due to being offsite, compaction around base, branches encroaching building.
T16	Scots Pine	<i>Pinus sylvestris</i>	Mature	Yes	10	NE-6	1	250	N/A	2	2	1	2	6	Poor	Poor	Fair	C	10 to 20 yrs	2 Landscape Arboricultural Values	Poor	No remedial works required.	Broken branches in crown, mechanical damage, leaning northeast towards house.

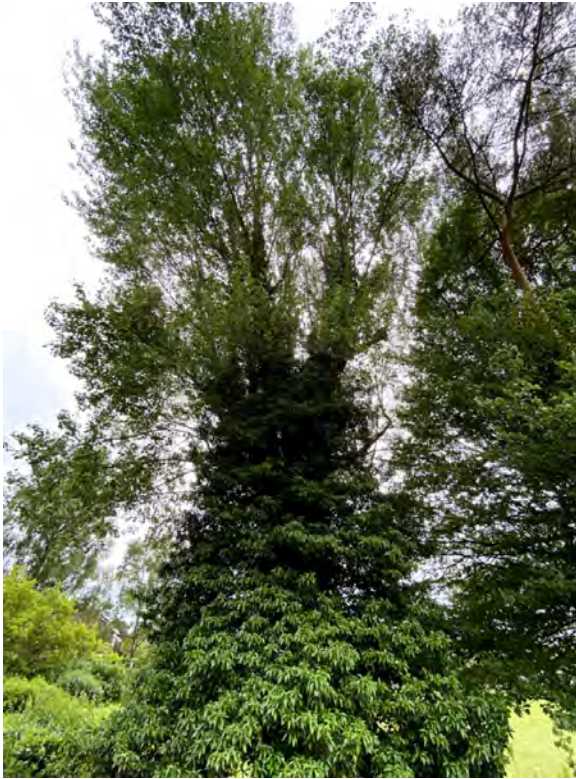
Photographic plate showing tree T15, a mature Black Poplar.

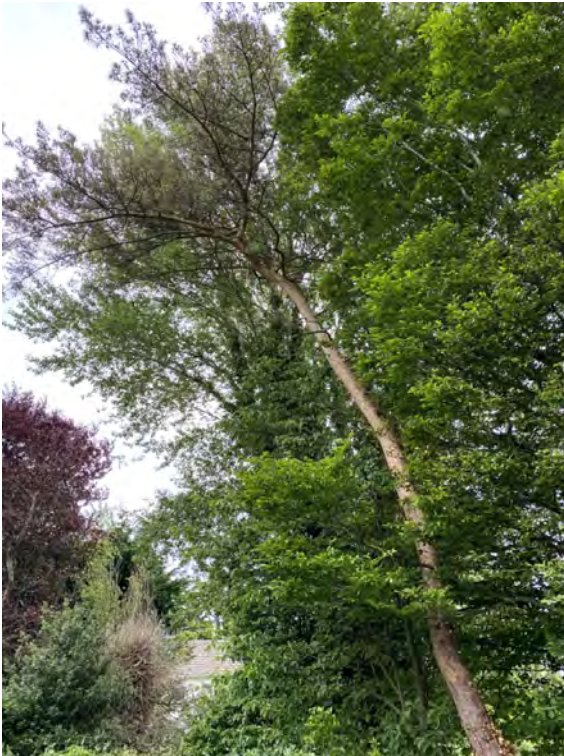
Photographic plate showing tree T16, a mature Scots Pine.

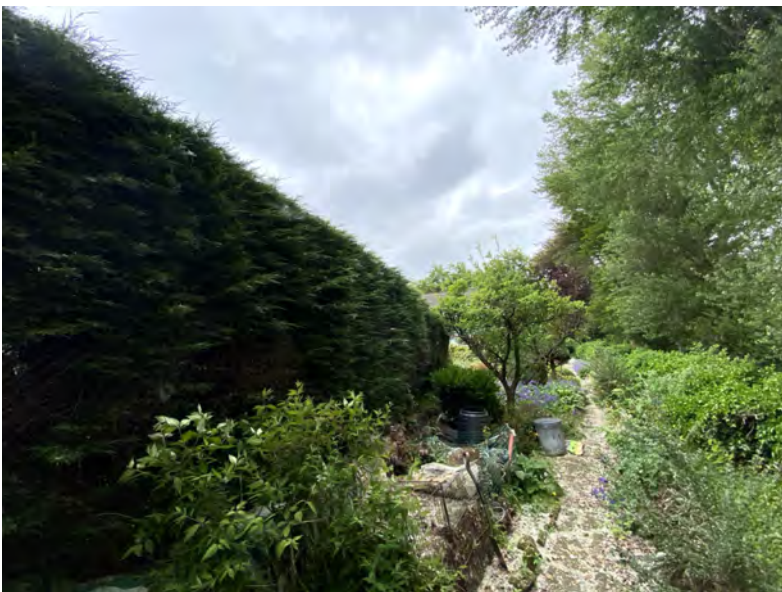
Photographic plate showing hedgerow H1, comprised of young Leyland Cypress.

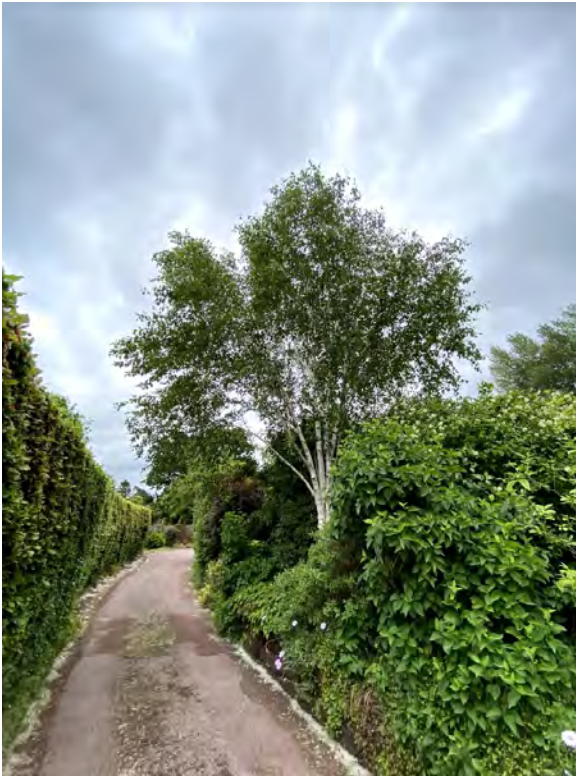
Photographic plate showing tree T26, a semi-mature Silver Birch.

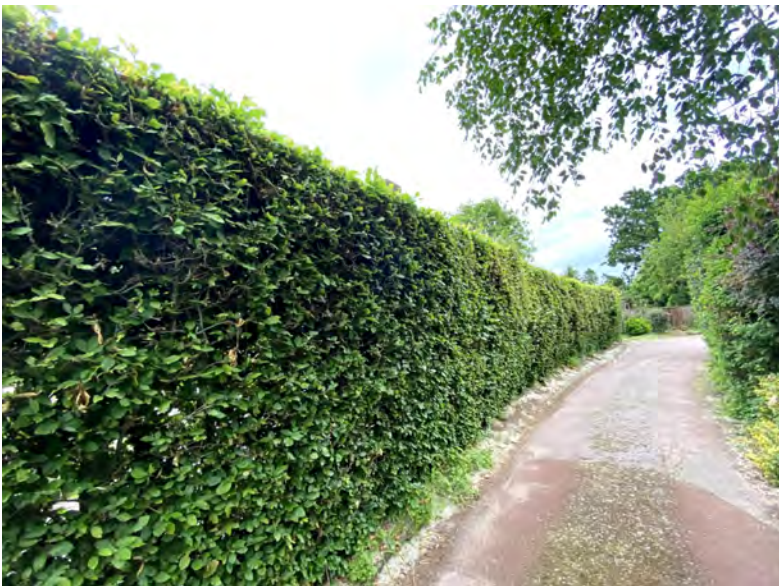
Photographic plate showing hedgerow H3, which runs along the driveway.

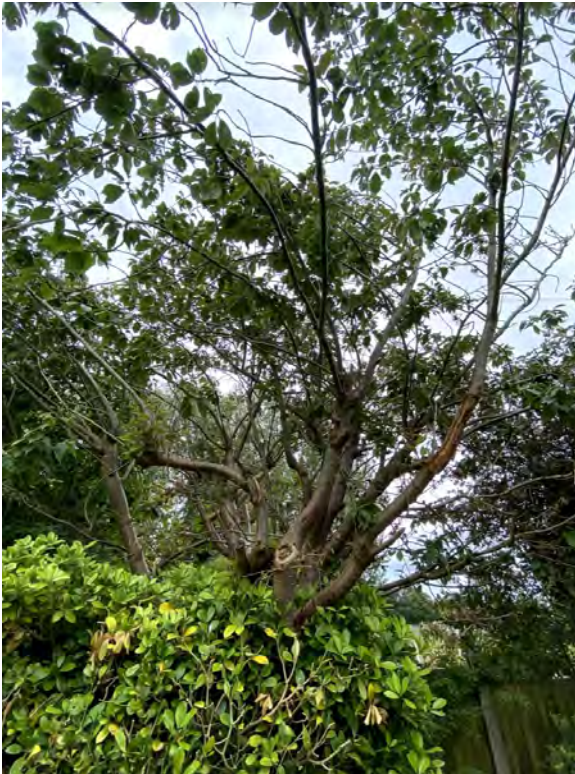
Photographic plate showing tree T27, a semi-mature Wild Cherry.
