# Preliminary Roost Assessment

Cob Kiln Lane

Urmston

# Gritstone ecology

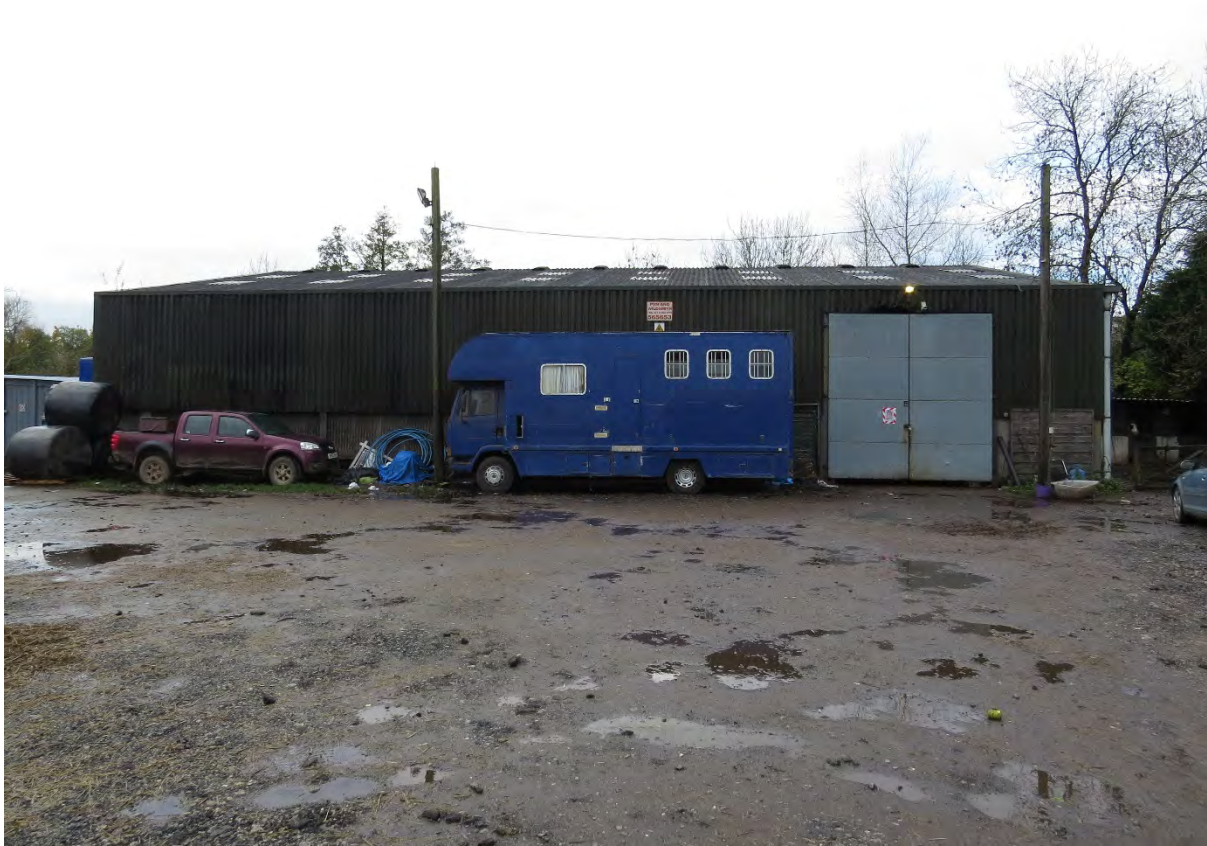
3.1a – The east side of building 1 viewed from the south.

The building has an equally pitched roof, covered with corrugated steel panels, and ridge plates; roof pitches face east & west, gables face north & south. Steel fascia are fitted at the eaves and gables. The building has corrugated steel panel walls, with corrugated asbestos cement panels at the base. The roof is fitted with roof lights, there are no other windows. There is a large steel door on the east wall.

The building is modern well maintained, and in good condition. Wall panels are tightly fitted with no missing or damaged panels, and no gaps. The roof is in good condition, with no missing panels, or gaps between roof or ridge panels. Ventilated panels at the ridge are fitted with an internal steel mesh. Small gaps at the eaves & gables, and gaps around the door give access to bats, or nesting birds.

There are no features externally which are likely be used by roosting bats, and no evidence of use by bats was present during the inspection.

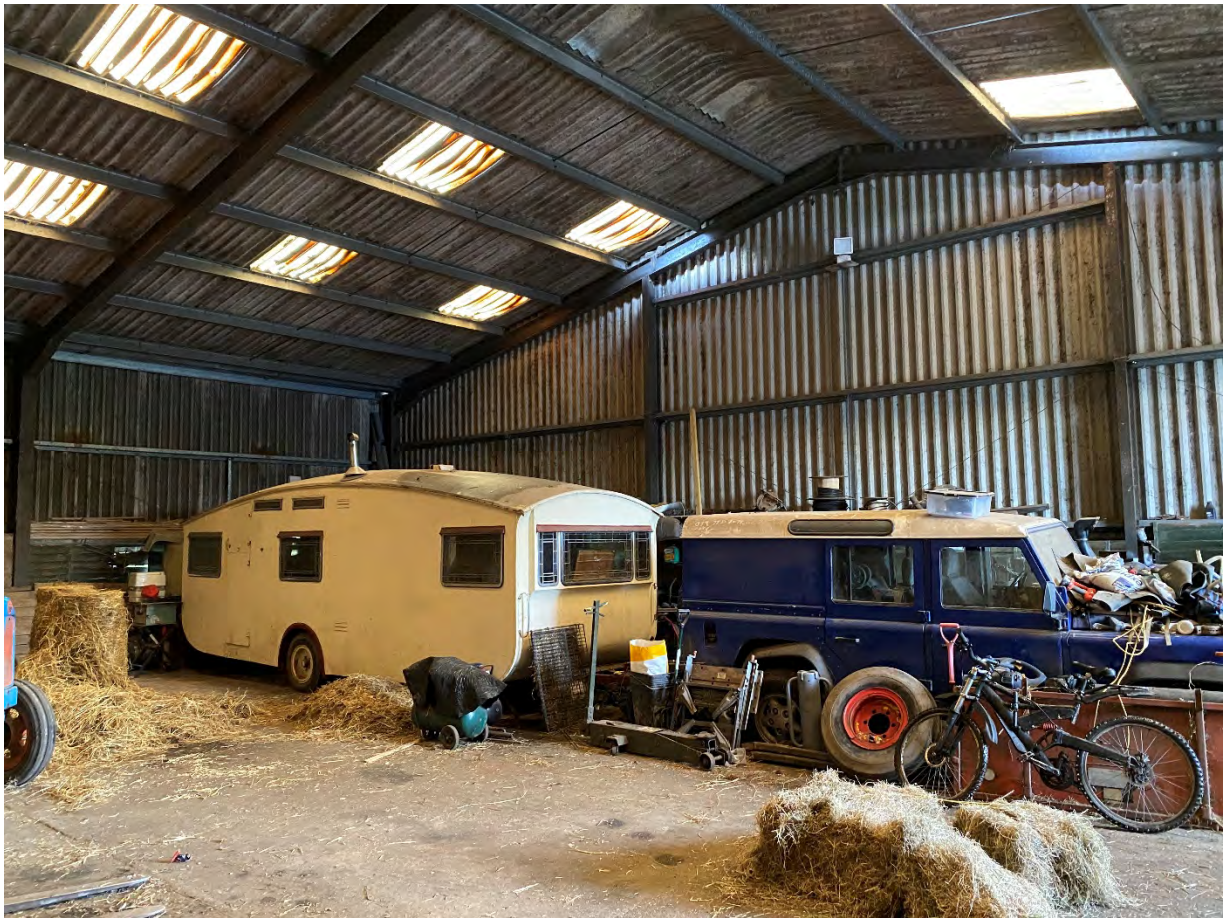
3.2a – The inside of the barn.

The building has a steel framed structure. There is no internal roof void and no other enclosed areas which are suitable for use by roosting bats. Walls are single layered corrugated steel and corrugated asbestos cement panels, with no lining. Floors are solid concrete.

The walls are single layered steel and asbestos cement panels, with no suitable cavities between panels at the overlap. The steel framed structure of the barn provides no suitable crevices for roosting bats.

There are small gaps at the eaves and gables and around the steel door, which could give crawled access to the inside of the building, however no droppings, feeding remains, or other evidence of use was found, and the building has no cavities or other enclosed spaces which could be used by roosting bats.

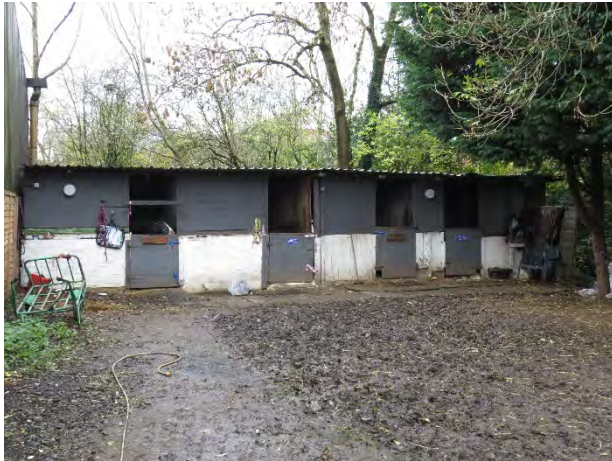
### 3.3 Building 2

Building 2 is a small stable block abutting the north wall of building 1. The building has a single pitched roof covered with corrugated steel roofing panels. Walls are single layered brick at the base, with single layered wooden panels above. Internally the building has a wooden roof structure, there is no roof void, and no internal wall lining.

The stables are in use daily, and although open to bats in flight, offer no suitable roosting features.

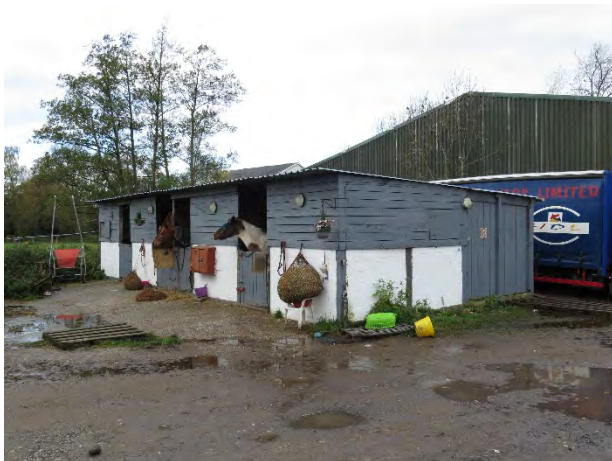
### 3.4 Building 3

Building 3 is a small stable block adjacent the south gable end wall of building 1. The building has a single pitched roof covered with corrugated steel roofing panels. Walls are single layered concrete block at the base, with single layered wooden panels above. Internally the building has a wooden roof structure, there is no roof void, and no internal wall lining.

The stables are in use daily, and although open to bats in flight, offer no suitable roosting features.

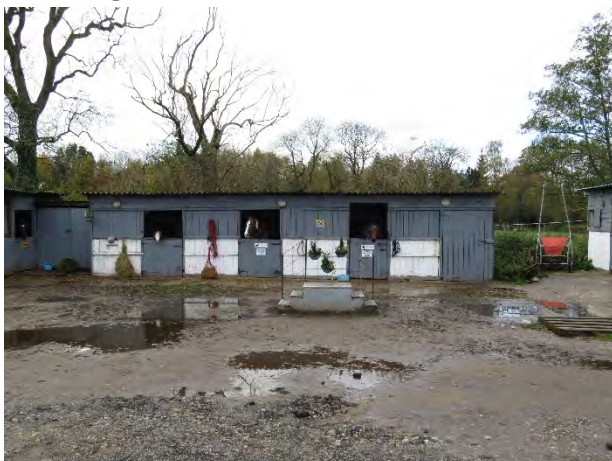
### 3.5 Building 4

Building 4 is a small L-shaped stable block to the south of building 3. The building has a single pitched roof covered with corrugated steel roofing panels. Walls are constructed of single layered wooden panels. Internally the building has a wooden roof structure, there is no roof void, and no internal wall lining.

The stables are in use daily, and although open to bats in flight, offer no suitable roosting features.

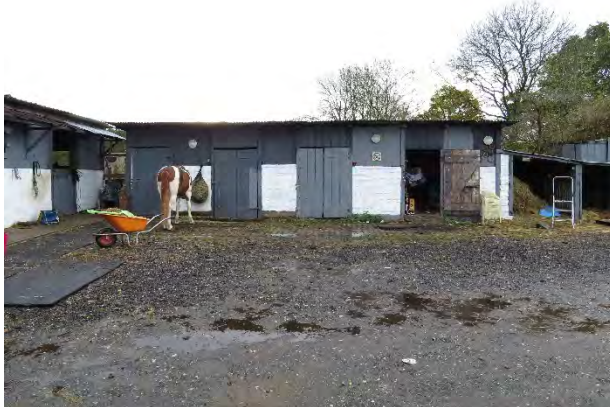
### 3.6 Building 5

Building 5 is a small stable block on the east of Cob Kiln Lane, on the southern site boundary. The building has a single pitched roof covered with corrugated steel roofing panels. Walls are single layered brick at the base, with single layered wooden panels above. Internally the building has a wooden roof structure, there is no roof void, and no internal wall lining.

The stables are in use daily, and although open to bats in flight, offer no suitable roosting features.

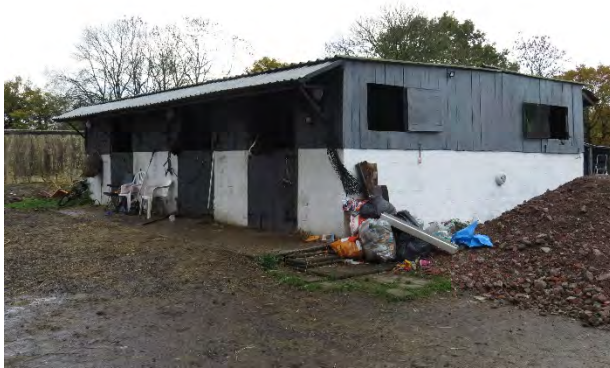
### 3.7 Building 6

Building 6 is a small stable block on the east of Cob Kiln Lane, adjacent building 5. The building has a single pitched roof covered with corrugated steel roofing panels. Walls are single layered concrete block at the base, with single layered wooden panels above. Internally the building has a wooden roof structure, there is no roof void, and no internal wall lining.

The stables are in use daily, and although open to bats in flight, offer no suitable roosting features.

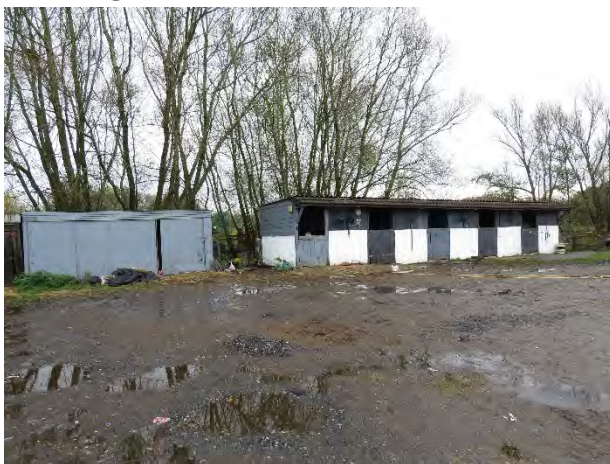
### 3.8 Buildings 7 & 8

Building 7 is a small stable block on the east of Cob Kiln Lane, adjacent the eastern site boundary. The building has a single pitched roof covered with corrugated steel roofing panels. Walls are single layered concrete block at the base, with single layered wooden panels above. Internally the building has a wooden roof structure, there is no roof void, and no internal wall lining.

The stables are in use daily, and although open to bats in flight, offer no suitable roosting features. Building 8 is a steel container which

is used for storage. The building has no features externally, or internally which could be used by roosting bats.

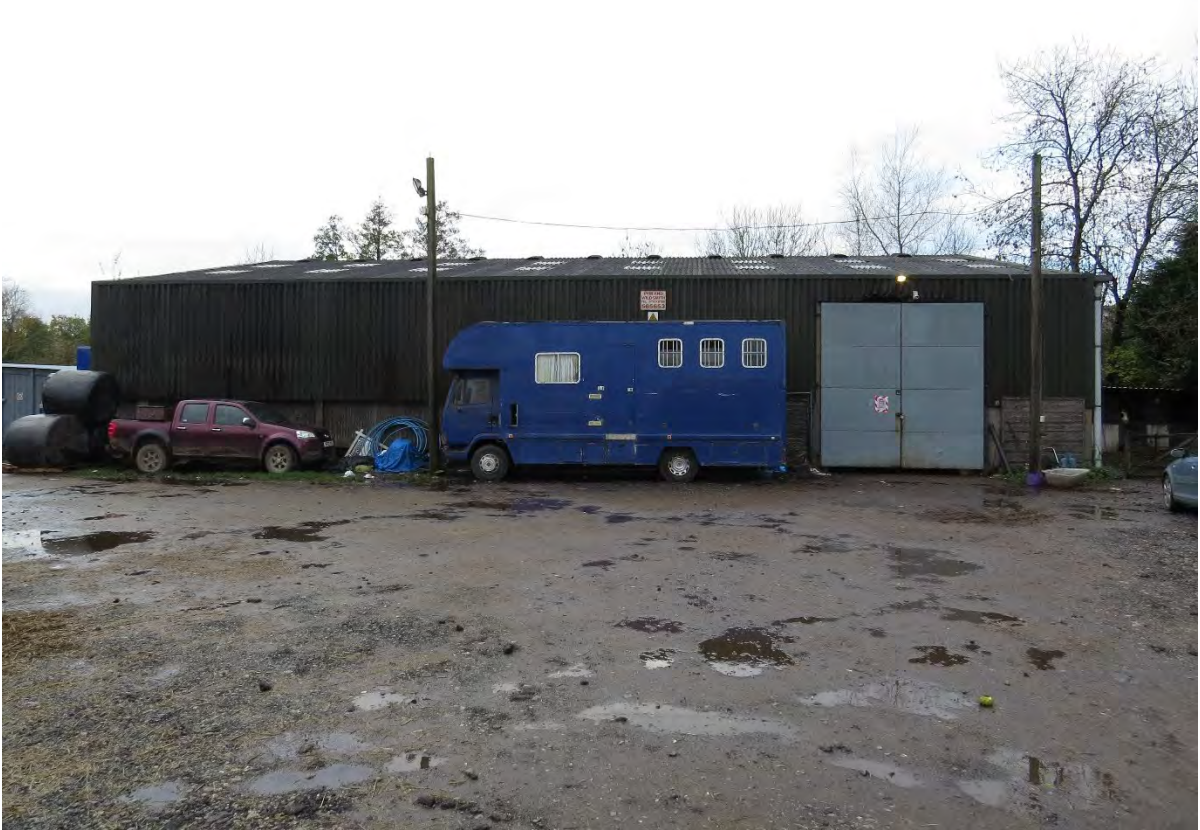
1 – Building 1 is a large steel agricultural building.

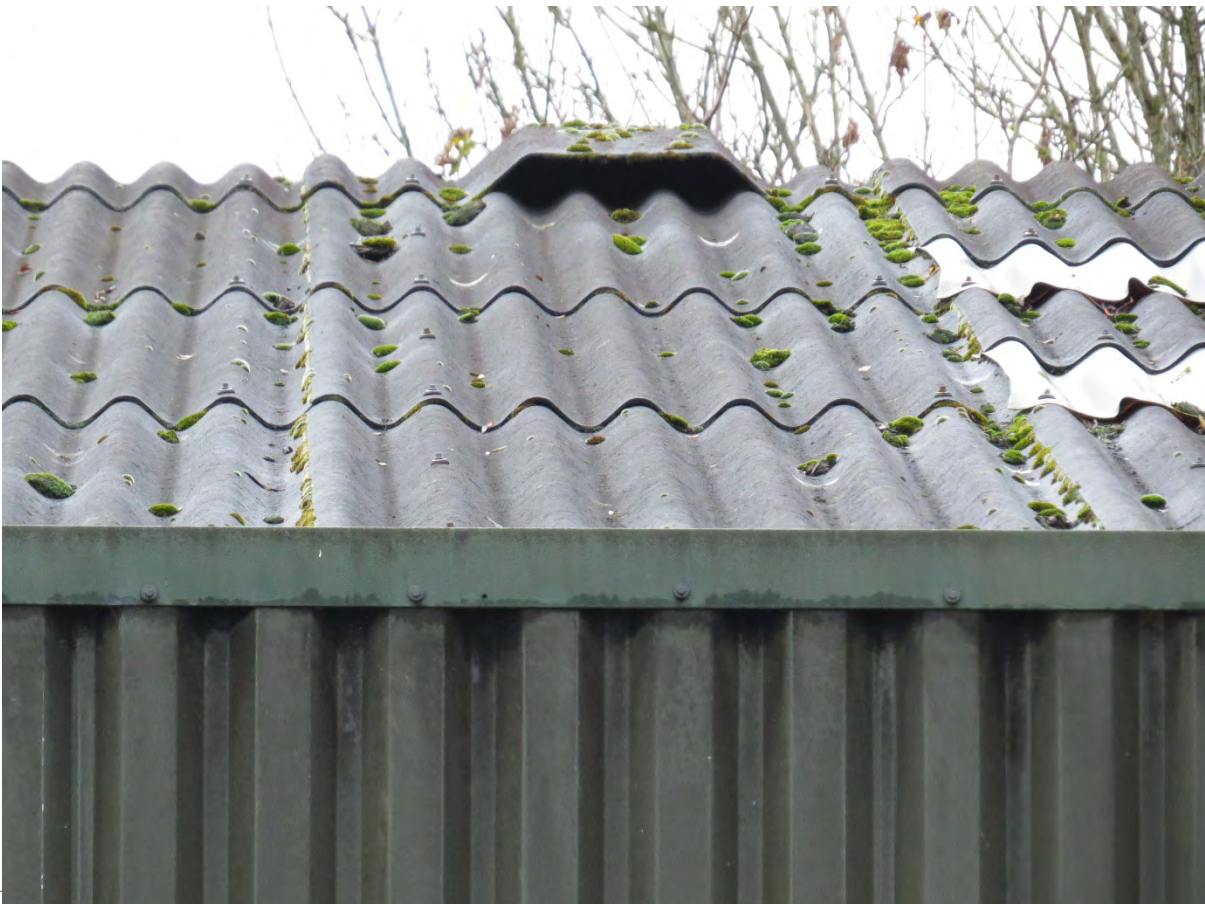
2 – The walls and roof are corrugated steel and corrugated asbestos cement.

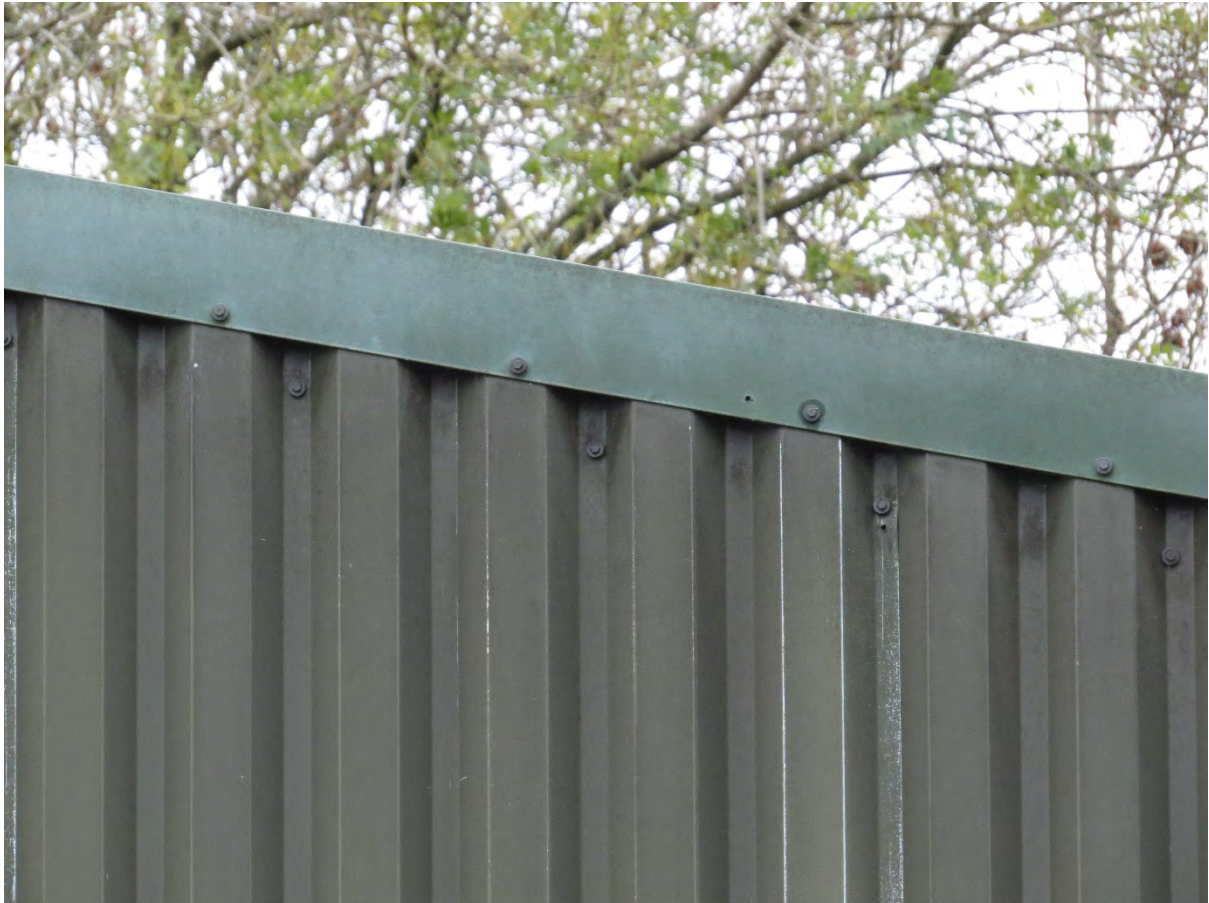
3 – The building has no external features suitable for roosting bats.

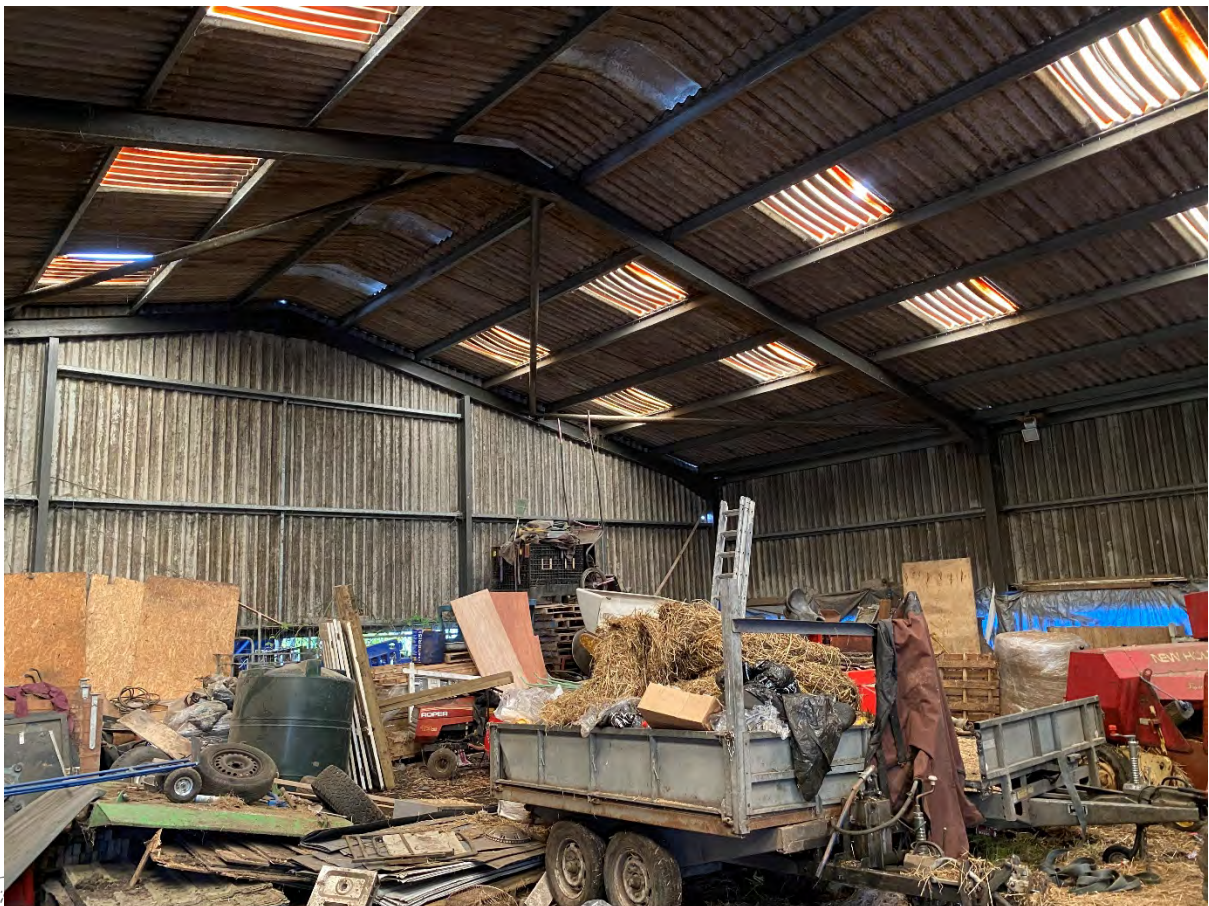
4 – Internally the walls are not lined and there are no features suitable for use by roosting bats.

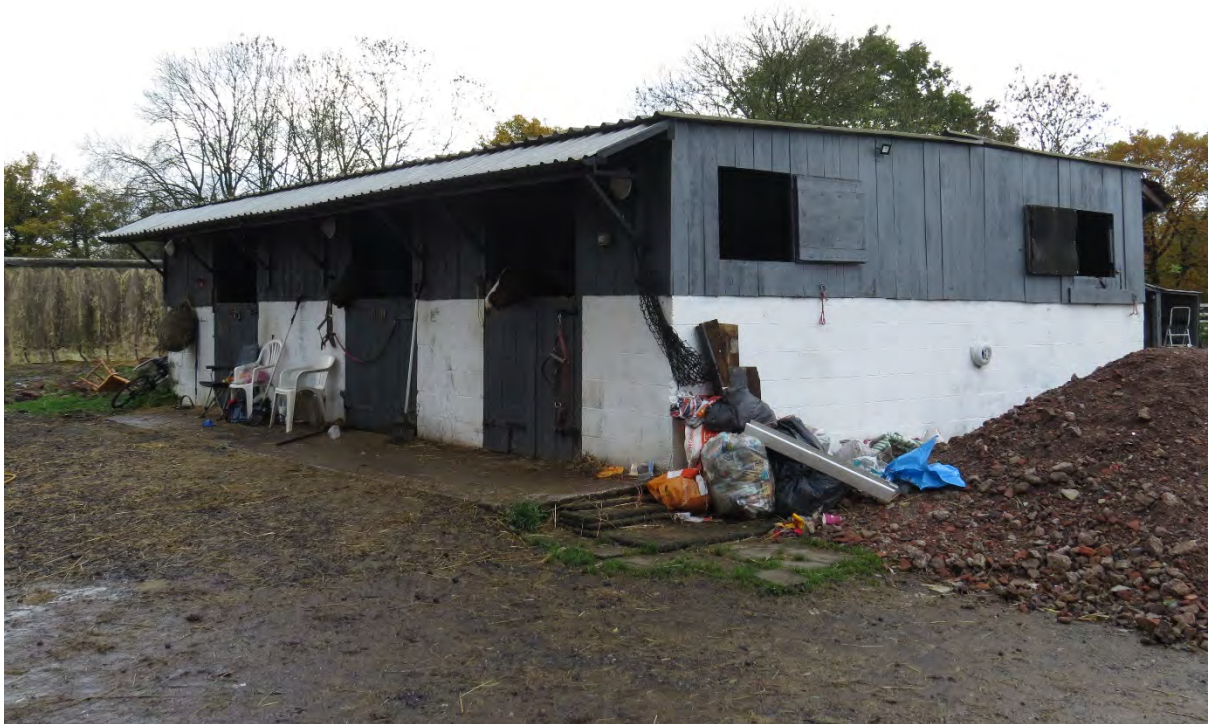
5 – All stable blocks have a similar construction.

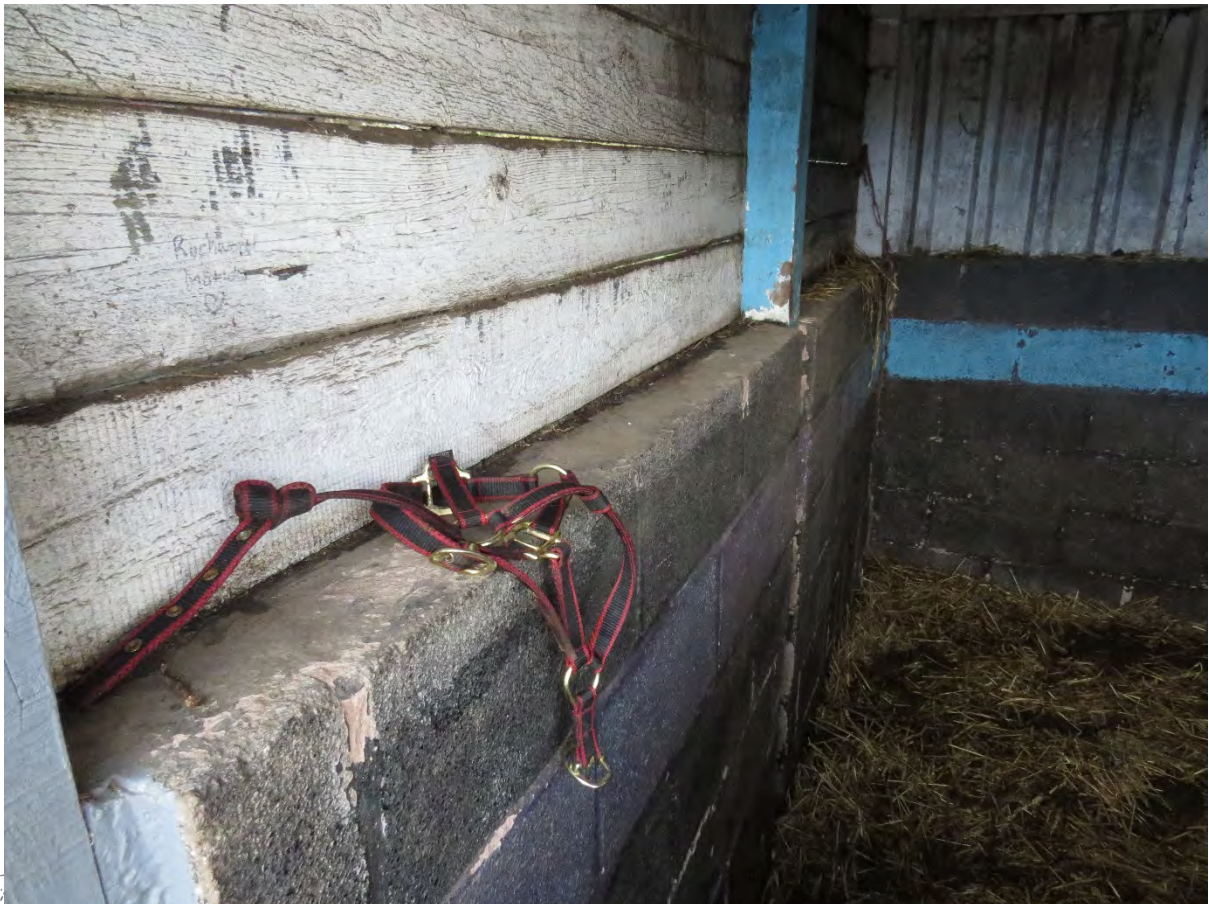
6 – Base walls are solid blockwork or brickwork, with single layer timber or sheet metal walls.

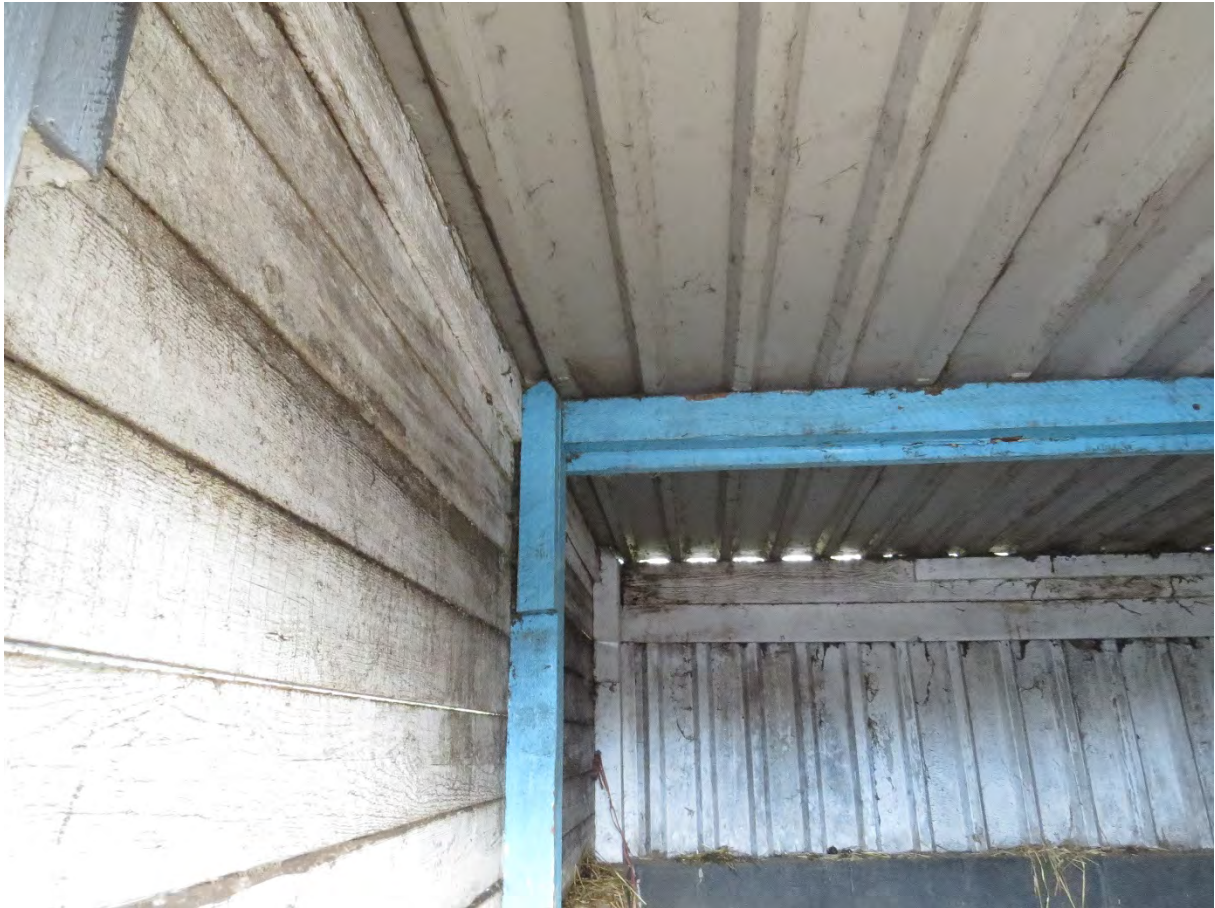
7 – Roofs have a simple timber structure with sheet metal coverings.

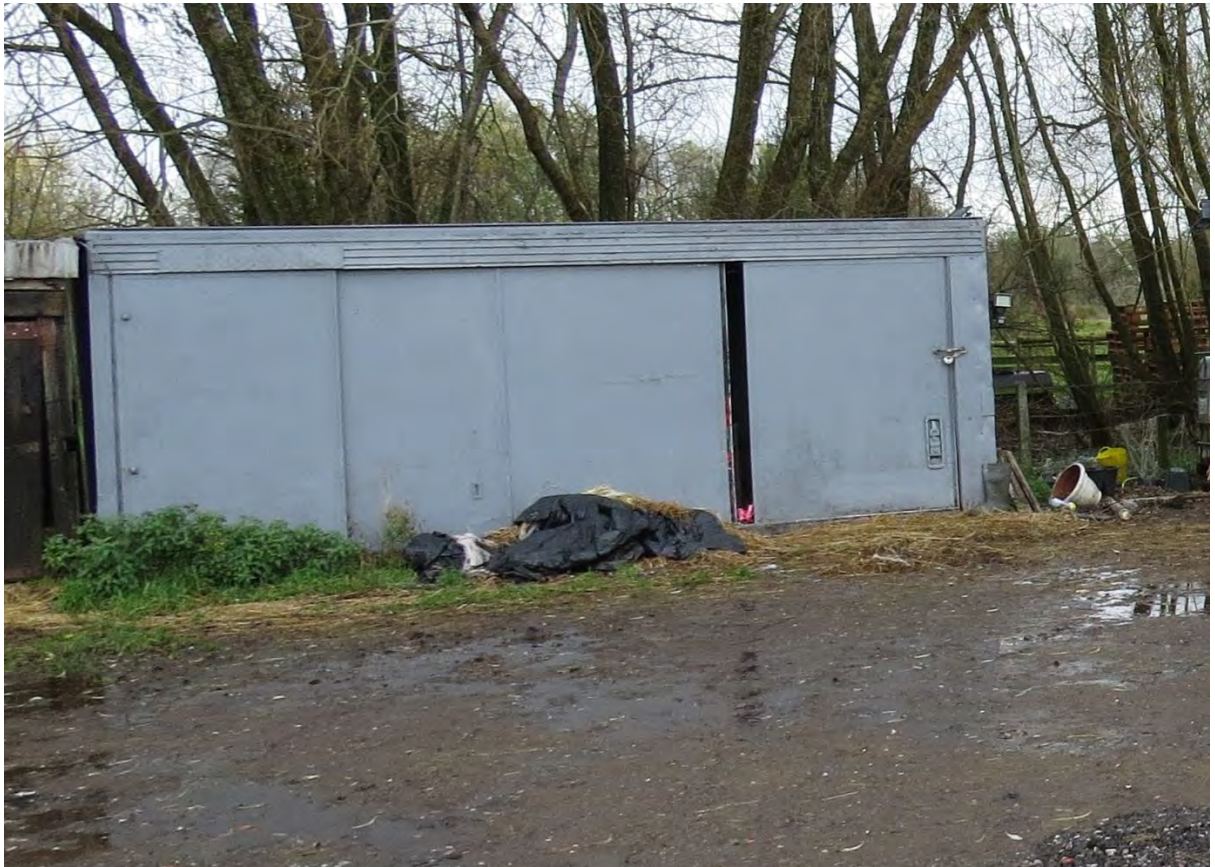
8 – Building 8 is a steel storage container with no suitable features.
